# SKAGIT COUNTY DEPARTMENT OF PUBLIC WORKS

## 2014 ANNUAL BRIDGE REPORT

**SUBMITTED FEBRUARY 2015**

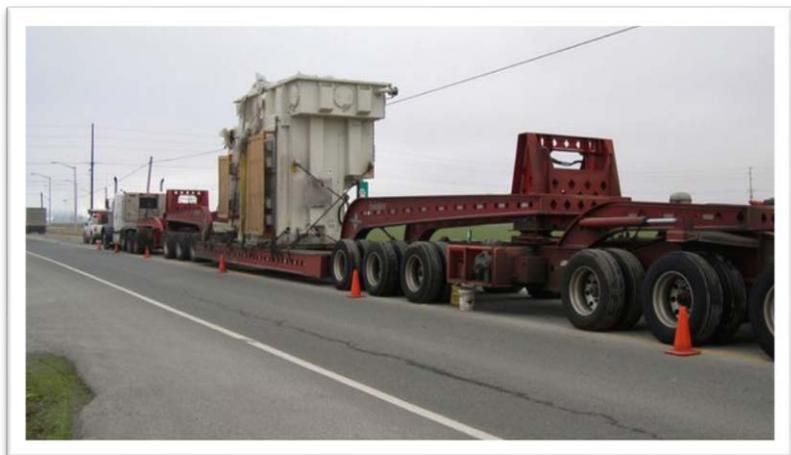
The North Fork Bridge is a viable route for legal limit loads. However, due to various deficiencies with the bridge, overweight load permits are reviewed on a case by case basis. County staff reviews axle loading, number of axles, and how the load is distributed among those axles to determine if the load is safe to cross the bridge.

**An unpermitted overweight load that was ticketed after crossing the North Fork Bridge**

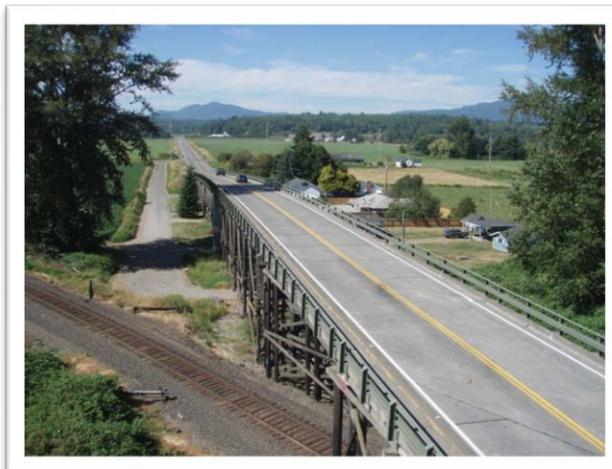
- Burlington Northern Overpass #40111
  - Structurally deficient, timber structure is deteriorating
  - Functionally obsolete, does not meet the geometry standard of the road system
  - Skagit County has secured \$12-million in Federal funding to replace the BNSF Railroad Overpass.
  - Design of the bridge is in progress and is currently nearing the 60% design level.

*Old Highwa y99 BNSF Overpass looking North*

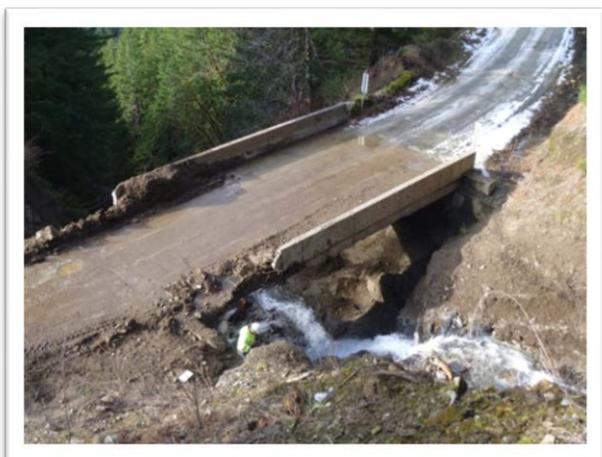
- Cascade River Road at Hard Creek #40076
  - The Hard Creek Bridge experienced heavy damage during a rock slide, reducing it to one lane
  - Skagit County received funding from Federal Highways to replace the existing structure with one that will more easily pass debris limiting future damage
  - This work is in cooperation with Federal Highways Administration and the US Forest Service
  - Design of the new bridge is at the 30% design level and is anticipated to be completed in 2015
  - Construction is scheduled to begin in 2016

*Damage to Hard Creek Bridge after rockslide*

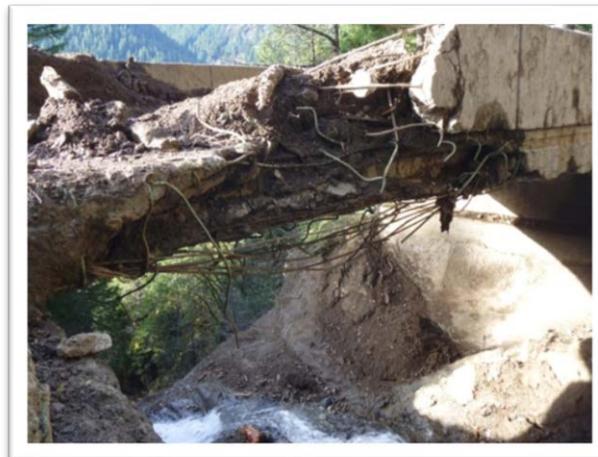
*Section loss on girder with exposed rebar*

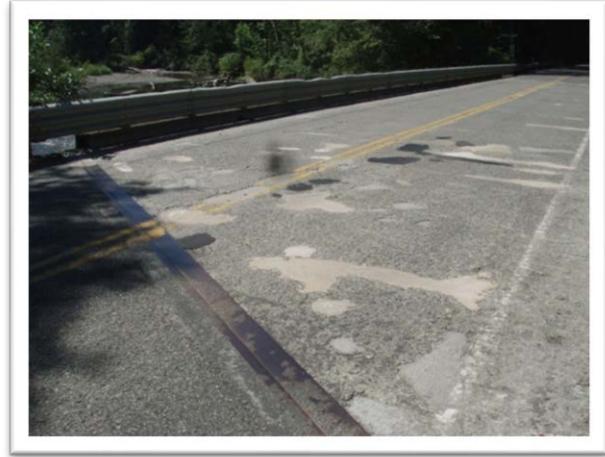
- South Skagit Highway at Finney Creek Bridge #40089
  - The bridge deck is deteriorating due to age and wear resulting in spalling and exposed rebar
  - BRAC awarded Skagit County \$342,000 in Federal funding to resurface the deck and level the approaches

***Deck patching on South Skagit Highway's Finney Creek Bridge***

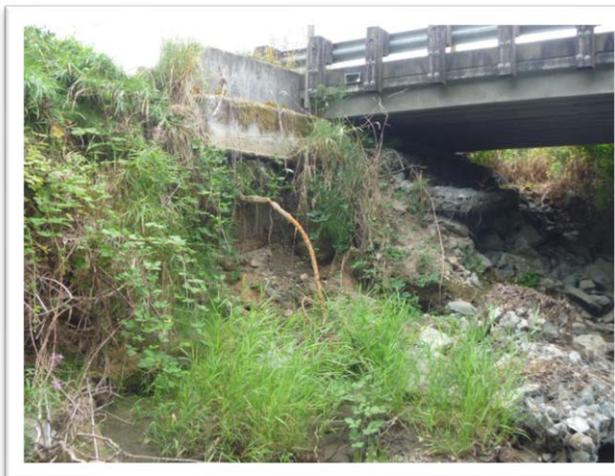
Bank stabilization repair at the Taylor Road Bridge at Walker Creek: A large rain event increased flows on Walker Creek high enough to wash out the existing rip rap and gabions. The scour hole exposed the bottom of the abutment and threatened the subgrade of the bridge approach. County staff worked with State Fish & Wildlife on a permittable repair and completed the repairs in early October.

*Scour hole on Taylor Road Bridge*

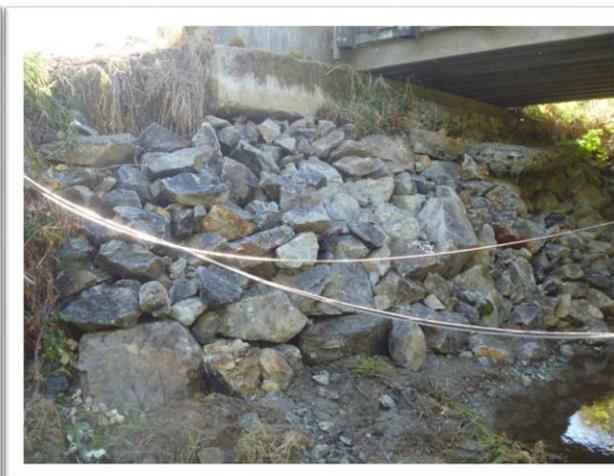
*Completed scour hole repair*

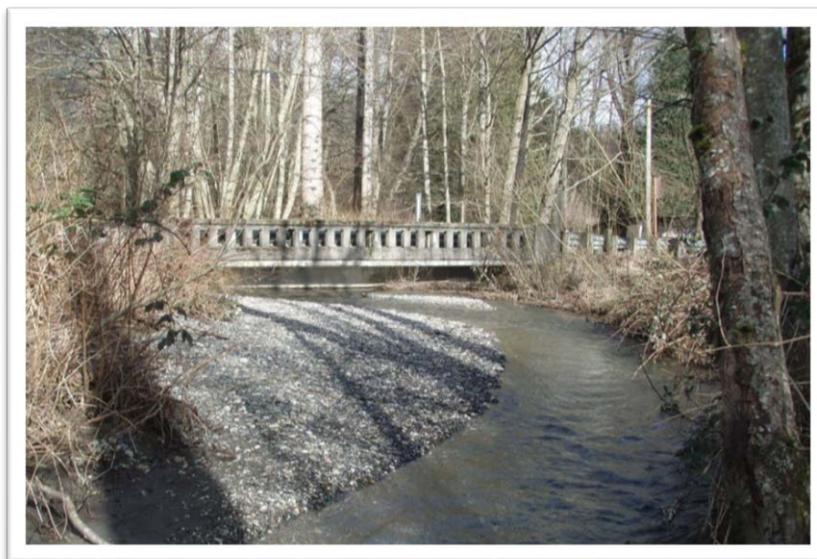
Conveyance at Lyman Hamilton Highway at Childs Creek: County staff is looking at a regional solution to the aggradation problems the County and the State Department of Transportation experience from the Skagit River Tributaries. Currently, staff is focusing on the Childs Creek Basin and the crossing on Lyman Hamilton Highway. The bridge there has very little freeboard and continually becomes blocked from debris. The Drainage Utility permitted the removal of 50 cubic yards of material this last summer and will remove another 50 cubic yards this summer. Long term solutions are being evaluated including a Type Size and Location study to modify the bridge and improve the Childs Creek conveyance under Lyman Hamilton Highway.

*Lyman Hamilton Highway at Childs Creek*

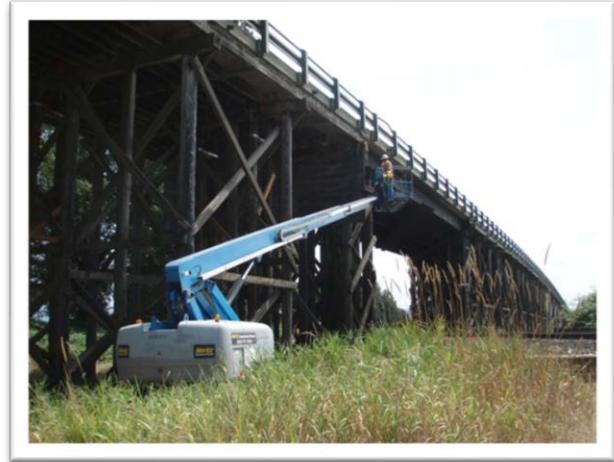
**BNSF Railroad Overpass Inspection:** A follow up inspection was made last summer on the repairs made to BNSF Railroad Overpass pier caps that support the main span. With the aid and direction of our contracted bridge engineer, David Shearer, a high strength epoxy application was injected into the pier caps to strengthen the timber, prevent further rotting, and stop any further crushing from occurring. The inspection showed the epoxy injections holding well and no further crushing has occurred.

*Inspection of the BNSF Overpass main span pier cap.*
