# SKAGIT COUNTY DEPARTMENT OF PUBLIC WORKS

## 2015 ANNUAL BRIDGE REPORT

**SUBMITTED APRIL 2016**

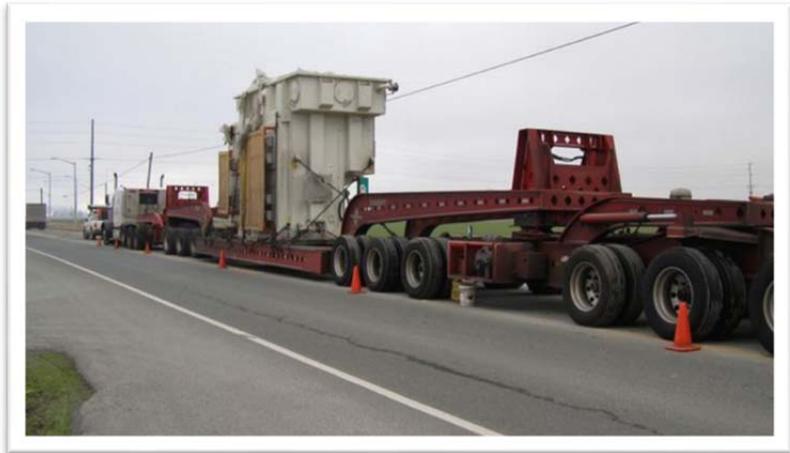
***An unpermitted overweight load that was ticketed after crossing the North Fork Bridge***

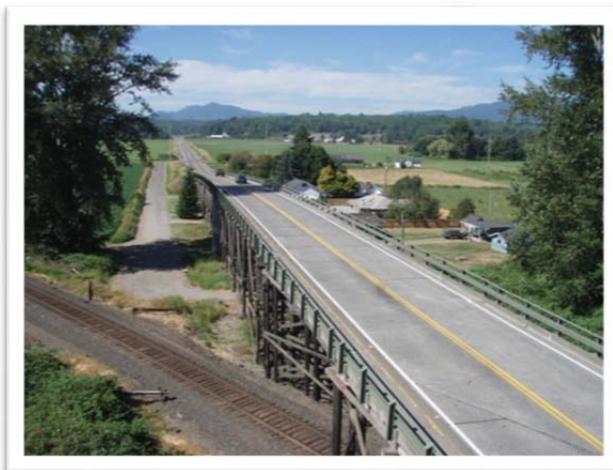
***Burlington Northern Overpass on Old Highway 99***

- Burlington Northern Overpass #40111
  - Structurally deficient, timber structure is deteriorating.
  - Functionally obsolete, does not meet the geometry standard of the road system.
  - Skagit County has secured \$12-million in Federal funding, \$4-million from other sources, and active pursuing multiple avenues for additional funding.
  - Design is complete with a total project cost estimate of \$19-million. Construction is planned for this summer.

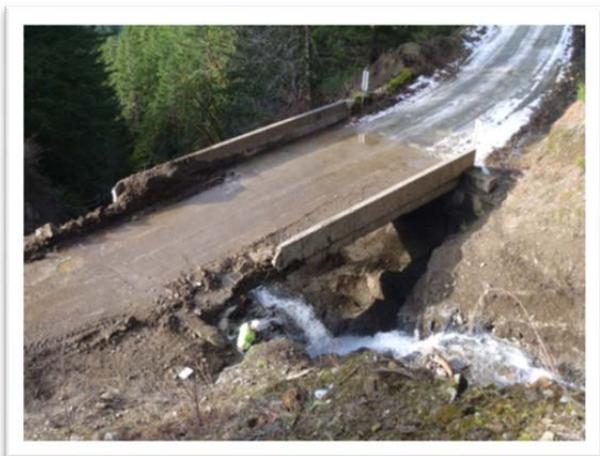
- Cascade River Road at Hard Creek #40076
  - The Hard Creek Bridge experienced heavy damage during a rock slide, reducing it to one lane
  - Skagit County received funding from Federal Highways to replace the existing structure with one that will more easily pass debris limiting future damage
  - This work is in cooperation with Federal Highways Administration and the US Forest Service
  - Construction is scheduled to begin in Spring of 2016

***Damage to Hard Creek Bridge after rockslide***

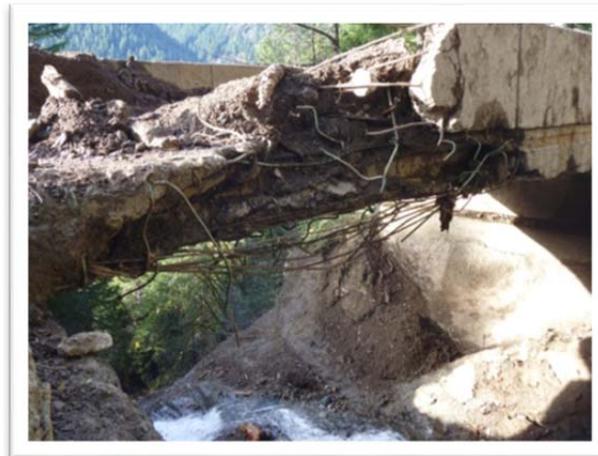
***Section loss on girder with exposed rebar***

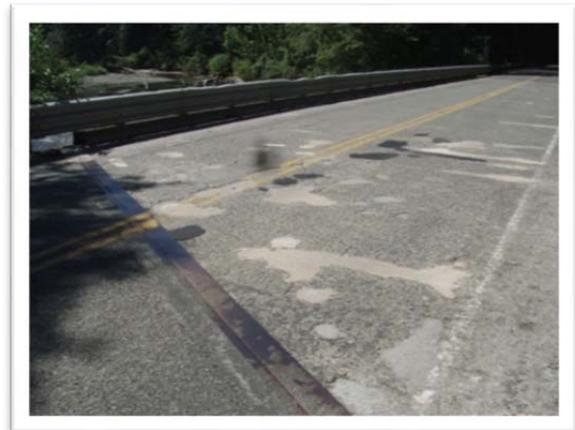
- Finney Creek Bridge on South Skagit Highway #40089
  - The bridge deck is deteriorating due to age and wear resulting in spalling and exposed rebar
  - BRAC awarded Skagit County \$342,000 in Federal funding to resurface the deck and level the approaches.
  - Work is scheduled to begin this summer of 2016.

***Deck patching on South Skagit Highway's  
Finney Creek Bridge***

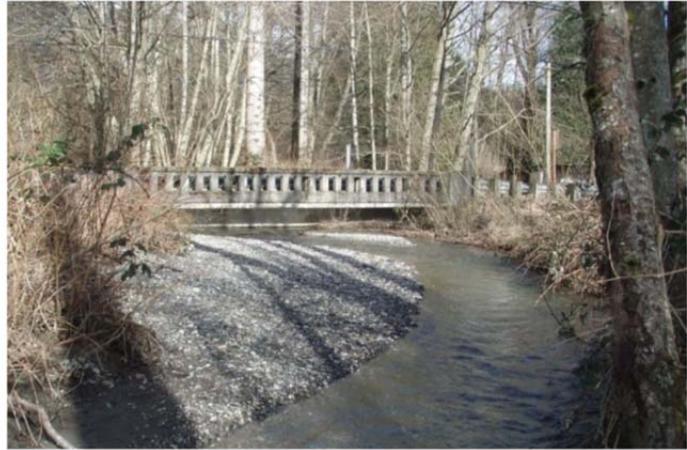
*Lyman Hamilton Highway at Childs Creek*

County staff is pursuing short term and longer term solutions to sediment aggradation at the Lyman Hamilton Highway bridge over Childs Creek. In the short term, the County is seeking permits for in-stream sediment removals to improve conveyance and reduce flood risk to properties impacted by backwatering. For a long term solution, the County is pursuing the acquisition of land adjacent to Childs Creek that could serve as a future sediment management site.

The County completed 100 cubic yards of sediment removal during the 2014 and 2015 allowable work windows. As mitigation, the County completed a Type, Size, and Location study to determine the costs of bridge replacement. These values ranged from \$2.6 million to \$2.9 million. The County also completed an alternatives analysis and conceptual design of the proposed sediment management project.

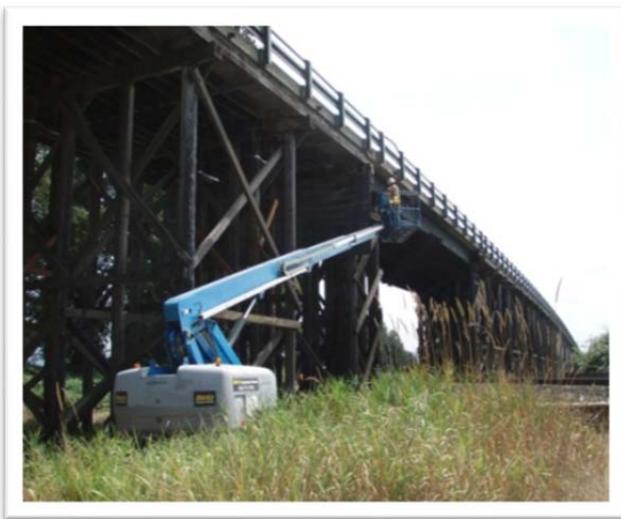
*Inspection of the BN Overpass main span pier cap.*

Interim and repair inspections are made every 6 months or sooner to check the temporary shoring and the repaired pier caps, ensuring the safety of the users. Most recently in 2014, under the direction of our contracted bridge engineer, David Shearer, a high strength epoxy application was injected into the pier caps under the mainspan to strengthen the timber and prevent further rotting and crushing from occurring. A recent inspection showed the epoxy injections holding well and no further crushing has occurred.
