June 12, 2026
Report No.: 26-040 – Revision 1

RE: Preliminary Geologic Hazard Site Assessment, 12790 Marine Drive, Anacortes, Washington
Parcel P68272

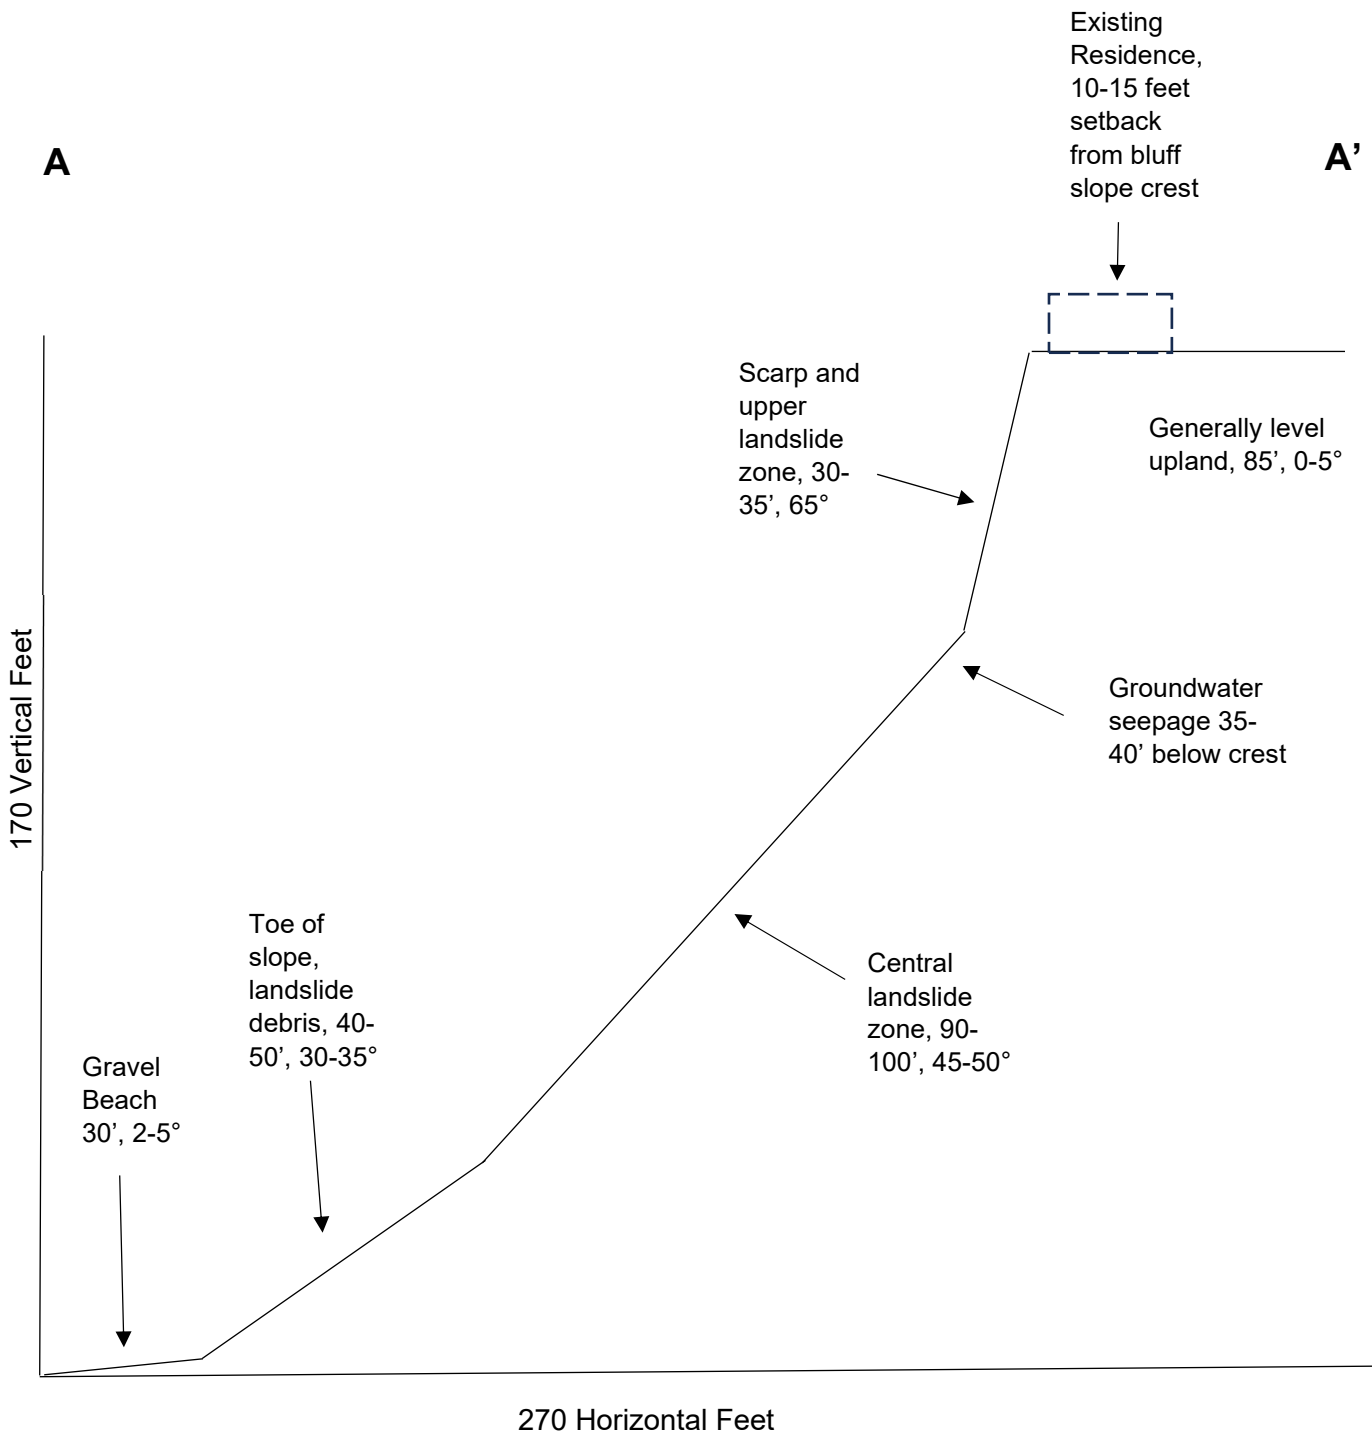
the slope face. Slope angles of 45 to 50 degrees over approximately 90 to 100 slope feet were documented in the central area of the slide. The toe of the bluff was measured at about 35 degrees for 40 to 50 slope feet and extended down to the contact with the natural gravel beach. Landslide debris, displaced vegetation and lumber from the staircase were observed at the toe of the bluff. It appears that high tide reaches the toe of the bluff and can be destabilizing the toe of the slope from below. The horizontal extent of the landslide includes the majority of the property width north to south. It was not evident that the landslide reached neighboring properties to the north and south, although access was limited beyond the deck area because of steep slopes and vegetation. Groundwater daylighting on the slope face was observed at about 40 vertical feet below the slope crest as light seepage.

Figure 4: Schematic cross section A-A' profile facing N. Data is based on field hand measurements in conjunction with CalTopo™ mapping software. Locations are approximate and should not be used for construction.

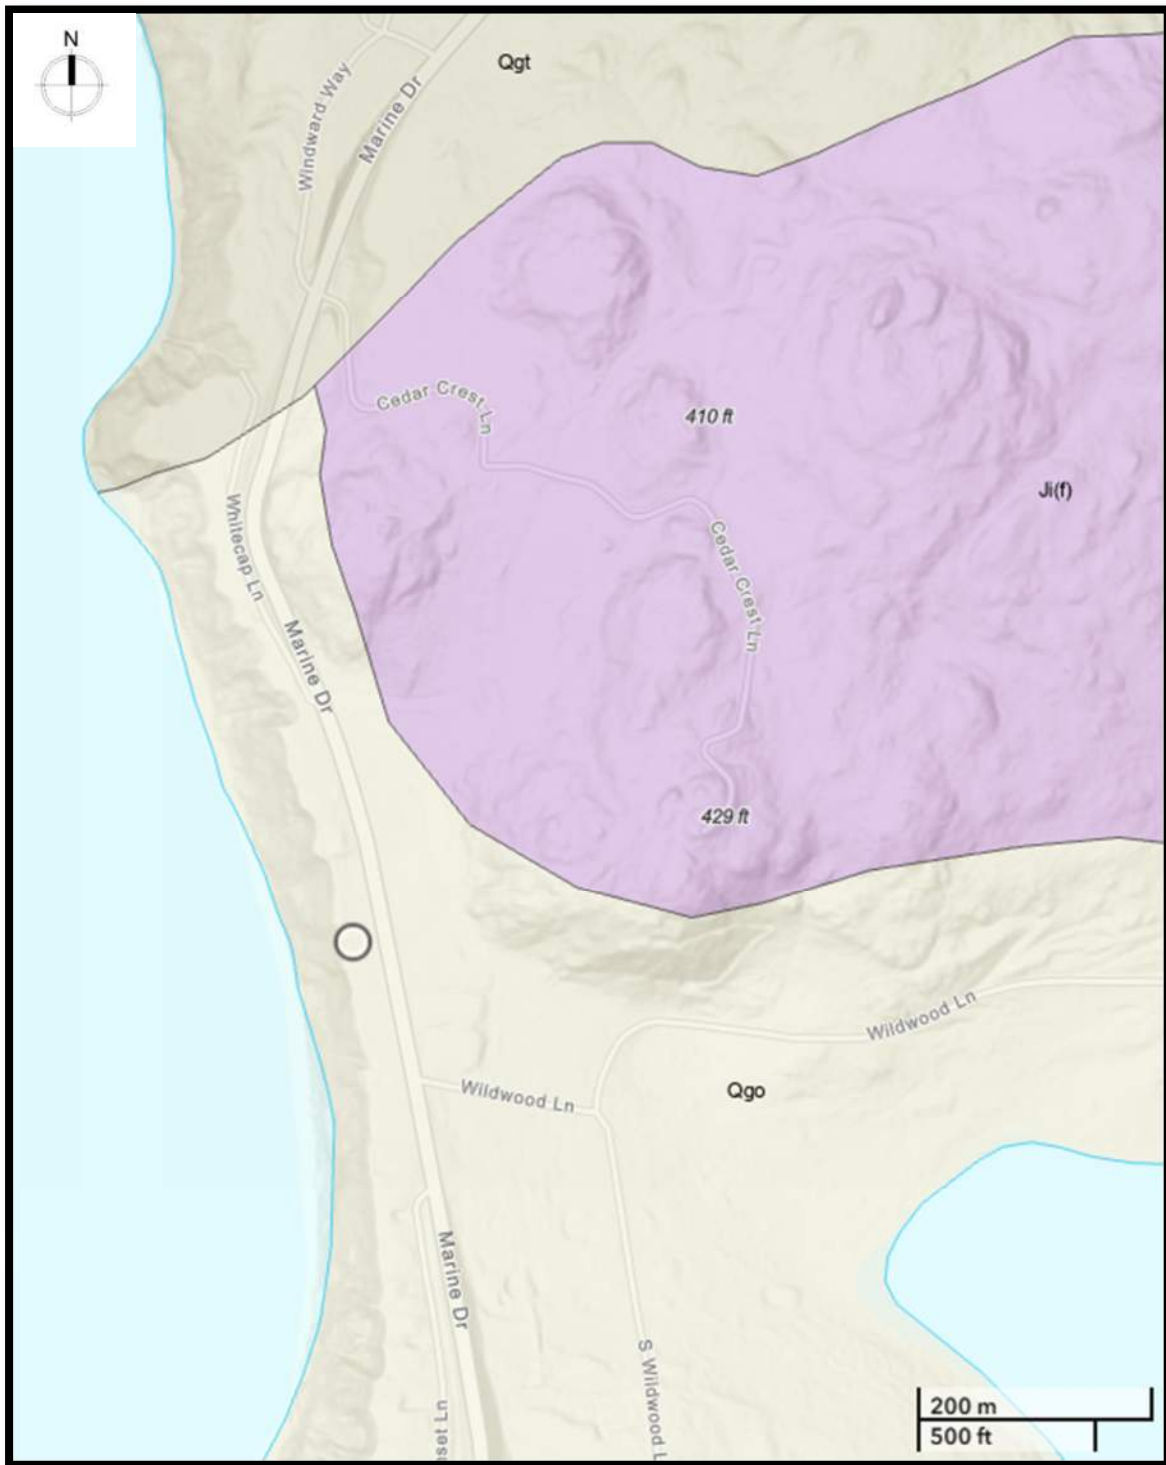
The *Geologic Information Portal* maps the bluff slopes and vicinity as Pleistocene nonmarine recessional glacial outwash (Unit Qgo). The unit is described as *sand and pebble to cobble gravel; local lenses of silt; loose; mostly fluvial; includes deltaic deposits and may contain small exposures of compact ice-contact deposits*. This unit extends to the east, toward Lake Erie and north and south of the subject property along Marine Drive. To the north of Unit Qgo, Pleistocene continental glacial till (Unit Qgt) is mapped extending generally north along Marine Drive. The unit is described as *unsorted clay, silt, sand, and gravel, in varied abundance, with scattered to abundant pebbles, cobbles, and boulders; compact; typically structureless; locally contains subordinate amounts of ice-contact deposits such as eskers, ablation till, and flow till; may locally include marine deposits*. To the northeast of the parcel, intrusive mafic and intermediate rocks of the Fidalgo Ophiolite are mapped extending to the summit of Mt Erie and beyond. This unit is described as *Jurassic tonalite (plagiogranite) sheeted dike complex with minor layered hornblende gabbro and pyroxenite* (DNR).

Figure 5: *Geologic Map* showing the mapped units Qgo, Qgt and Ji(f). The project location is shown by the black dot. Map courtesy of *Washington Geologic Information Portal*, 2026.

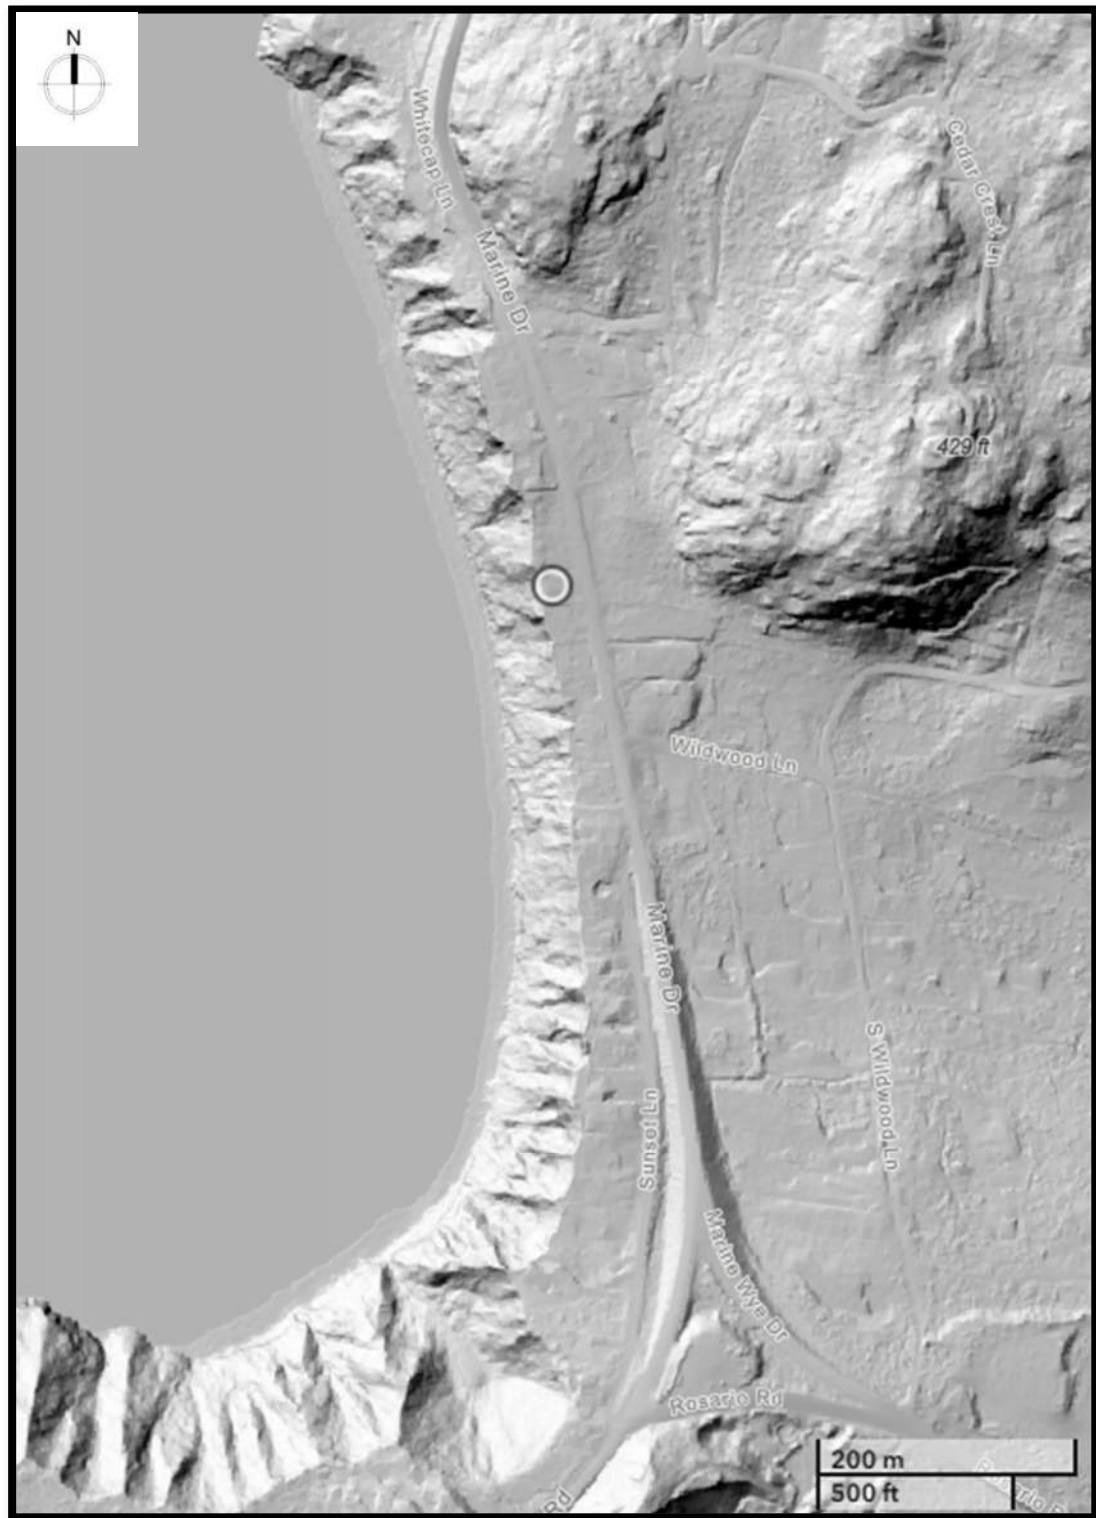
Light detection and ranging (Lidar) imagery of the site vicinity was reviewed during the research process. The 2016 Skagit County *iMap* lidar image shows scalloped ridge crests to the north and south of the subject property. The properties to the immediate south of the subject property have what appears to be a landslide footprint. The DNR lidar from 2023 shows similar bluff slope conditions along Marine Drive with better resolution. A notable scarp and probable slope failure is visible to the south of the subject site. Scalloped ridge crests and generally shallow translational landslide features are common along this coastal bluff zone.

Figure 6: *Lidar Imagery 1* showing scalloped ridge crests on the coastal bluff in the vicinity of the project site shown as the black dot. Imagery courtesy of *Washington Geologic Information Portal*, 2026.

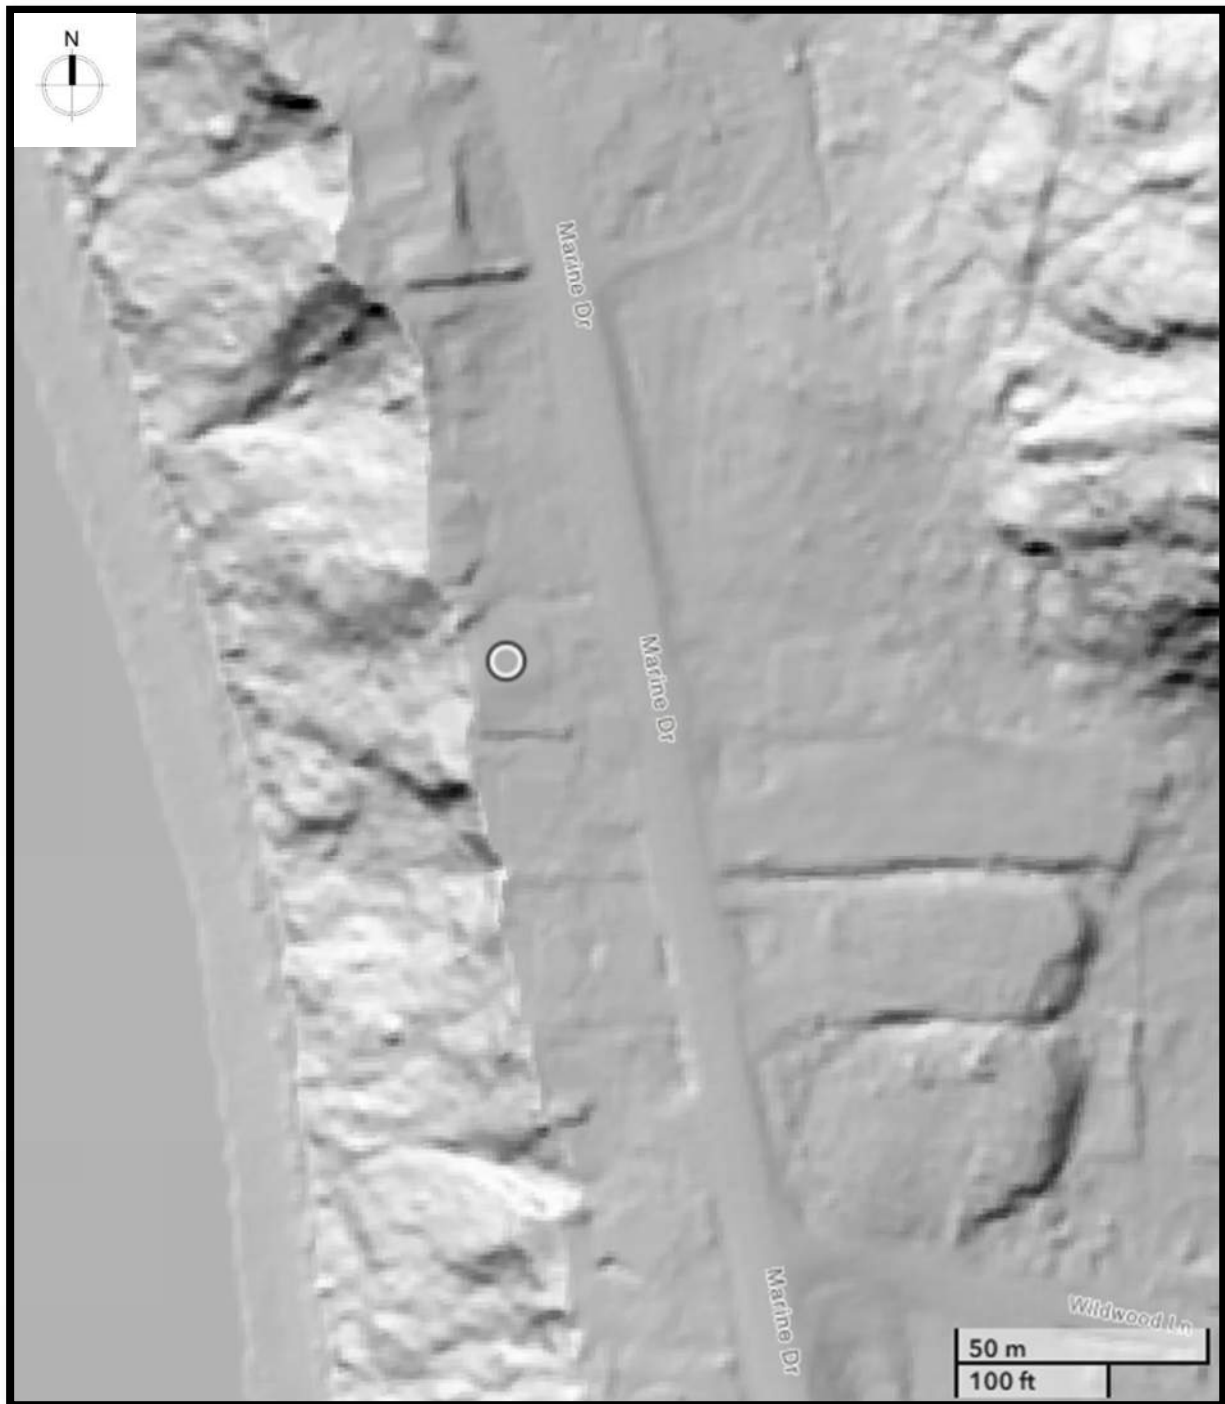
Figure 7: *Lidar Imagery 2* showing scalloped ridge crests on the coastal bluff in the immediate vicinity of the project site shown as the black dot. Imagery courtesy of *Washington Geologic Information Portal*, 2026.

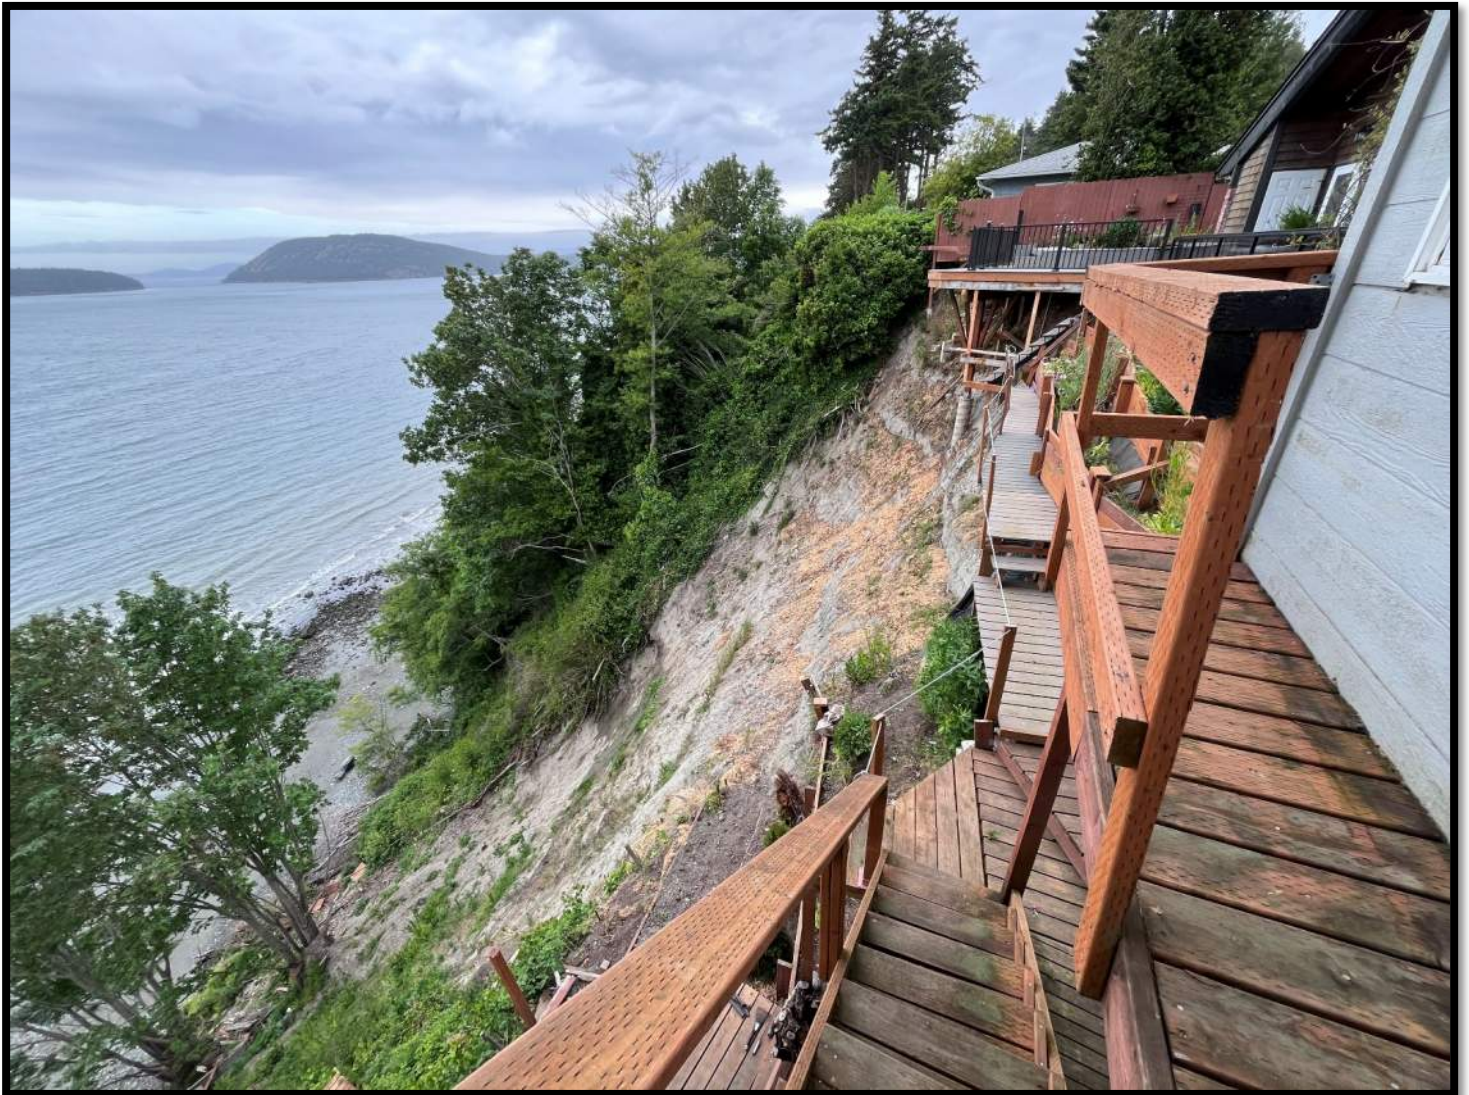
From our observations, we determined that the landslide was a shallow, concave translational debris landslide. The landslide was observed to be 70 to 80 feet wide and included the majority of the bluff height, likely about 160 vertical feet. We estimate that soils encapsulated in the failure zone were 3 to 7 feet thick vertically across most of the central and upper slope face.

Photo 1: Existing conditions at the bluff slope face showing the landslide footprint. Facing N on May 29, 2026.

- Place robust erosion control netting or matting across the entirety of the landslide footprint. A specific product that has been used successfully in slope stabilization is woven coconut fiber coir matting. We recommend a robust coir matt be selected and placed in accordance with the manufacturer's recommendations. We have attached an example of the specifications for this material in email correspondence with the client. The matting should be firmly attached to the site slopes with u-shaped, steel landscape staples that are typically 4 to 8 inches long. Overlap individual sections of fabric by at least one foot.

- Revegetate the site slopes as soon as possible following coir matt installation. We have included a DOE document titled *Vegetation Management: A Guide for Puget Sound Bluff Property Owners* (Menashe, 1993) in email correspondence with the client team. We generally recommend that low lying, deep rooting flora be selected. The planting of trees that will eventually grow tall and add significant weight to the slopes should be avoided. Hydro seeding from the upper slopes should be considered by the project team.

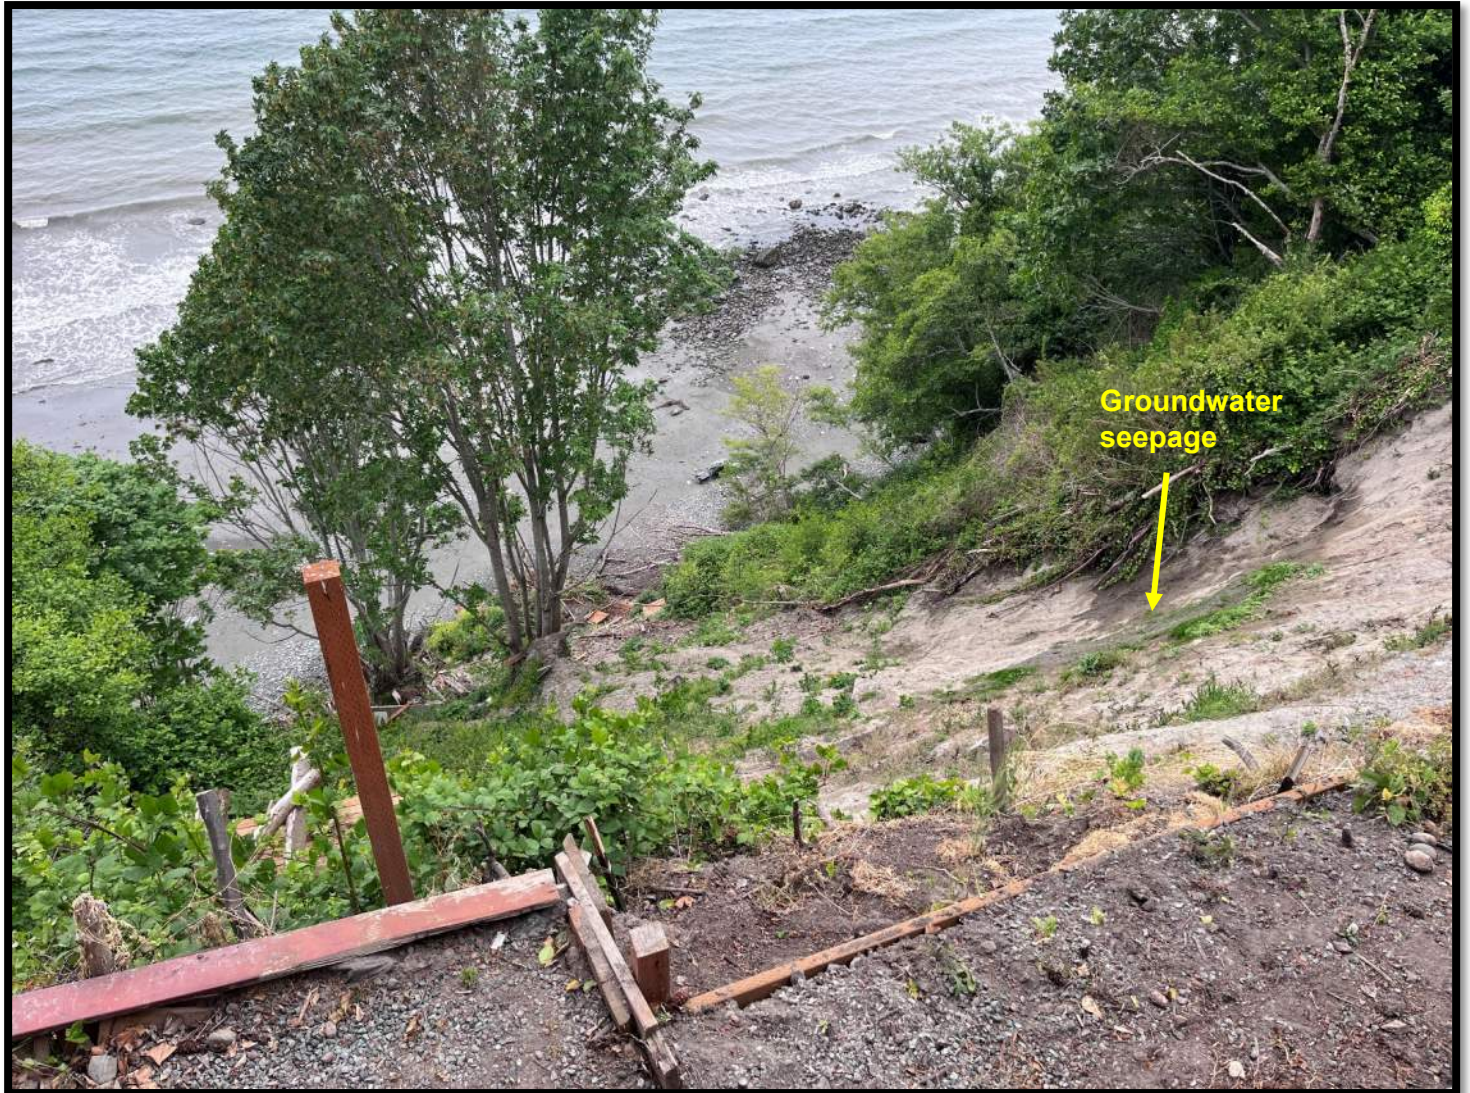
Groundwater was observed daylighting as light seepage on the slope face as noted above. We consider the site to have potential perched groundwater conditions due to relatively permeable upper slope materials overlying a low permeability horizon that likely consists of glacial till. We do not know if the observed seepage persists all

Photo 2: Existing conditions looking down the slope toward the beach area. Note seepage in upper central slope. Facing NW on May 29, 2026.

year but estimate that more seepage occurs in the winter set season. We advise that slope improvements occur in the dry summer months to avoid the potential for perched water conditions.

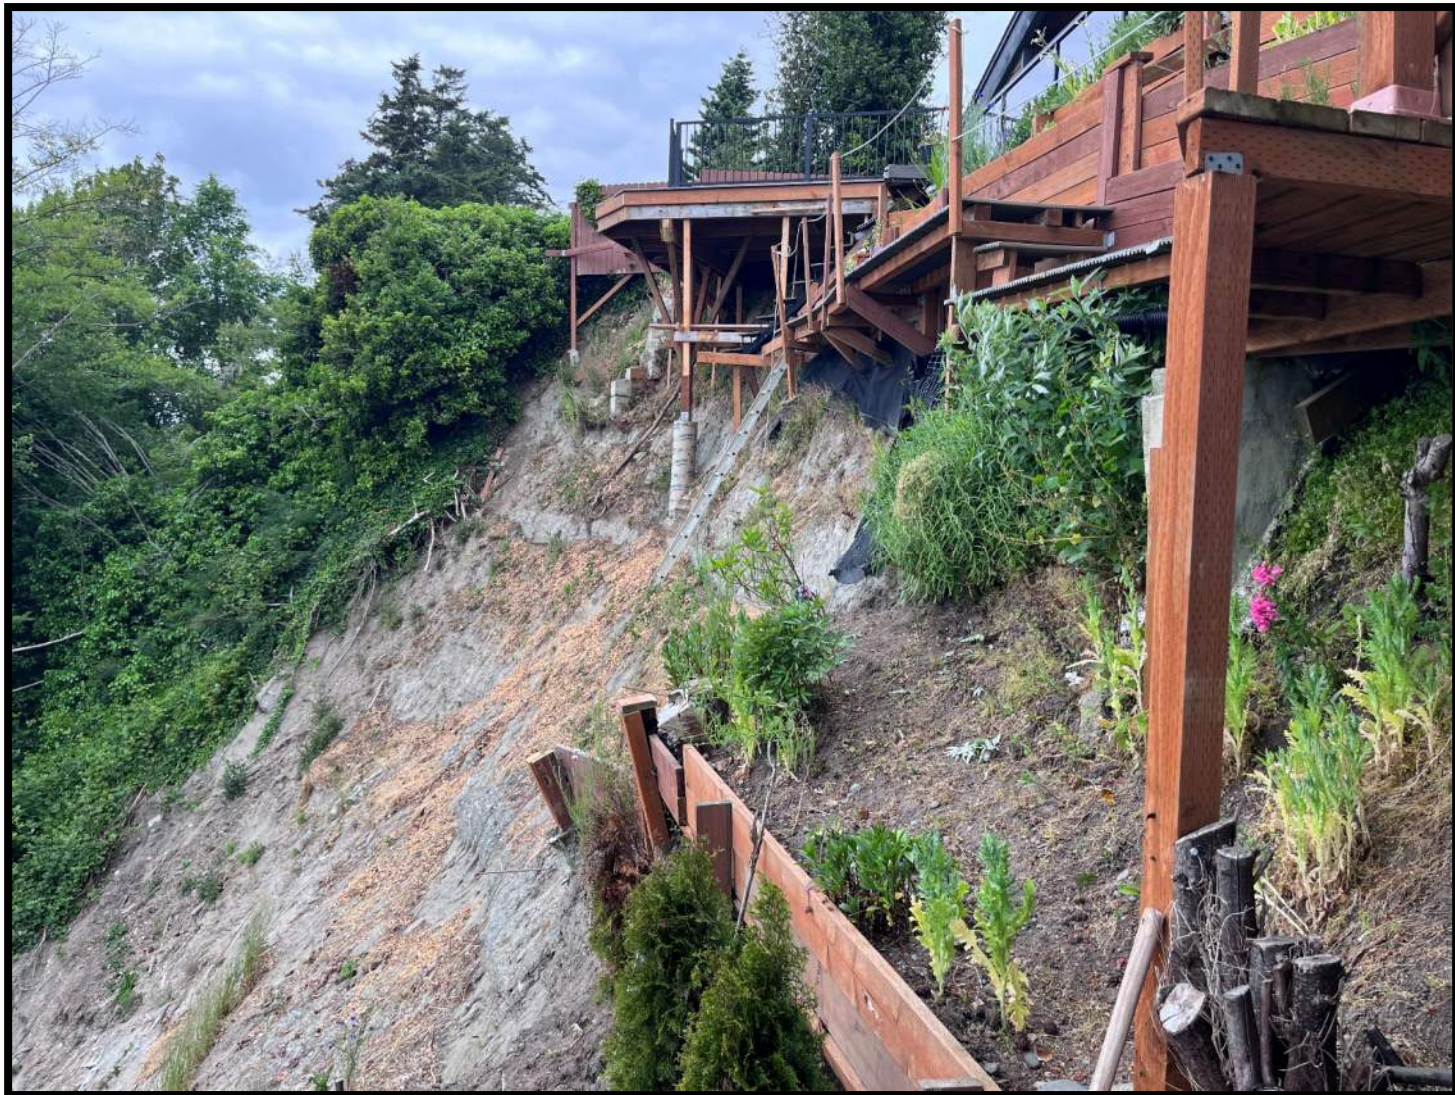
The slope conditions observed during our site visit consisted of mostly exposed glacially derived soils in an over steepened condition. The scarp at the top of the bluff was about 35 feet tall at an angle of approximately 65 degrees. Some of the staircase was intact on the south side of the scarp area, which allowed limited access to

Photo 3: Facing N showing existing conditions in the scarp area on May 29, 2026.

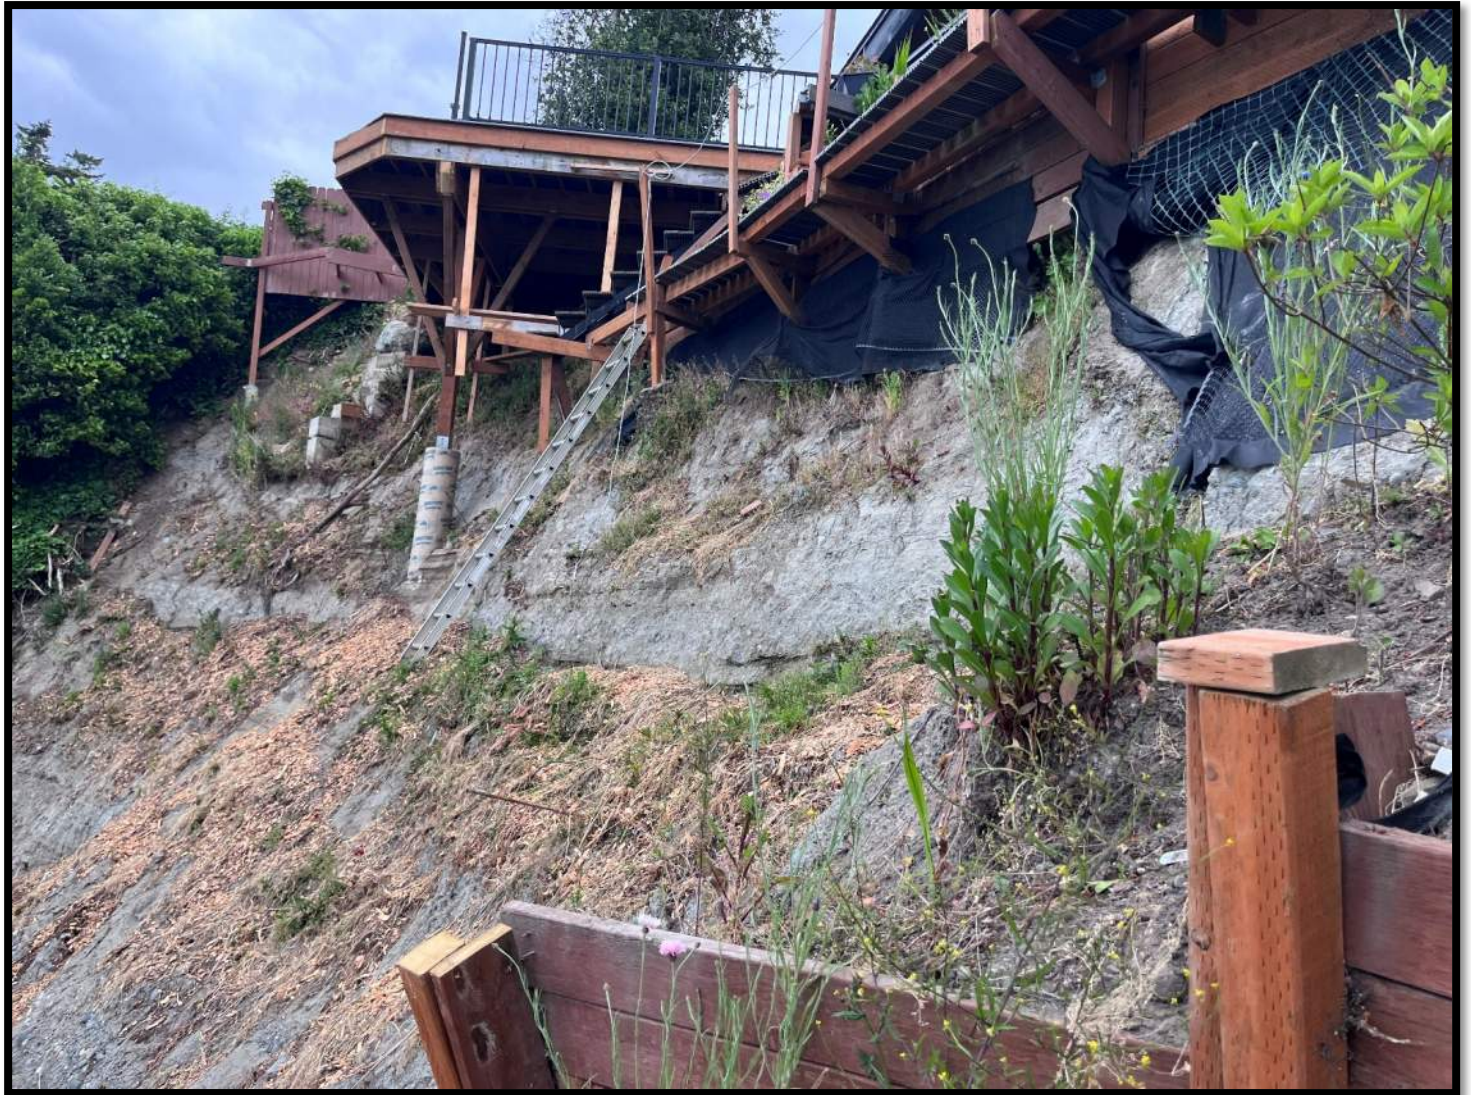
Photo 4: The north area of the scarp showing existing conditions after the landslide. Facing NE on May 29, 2026.

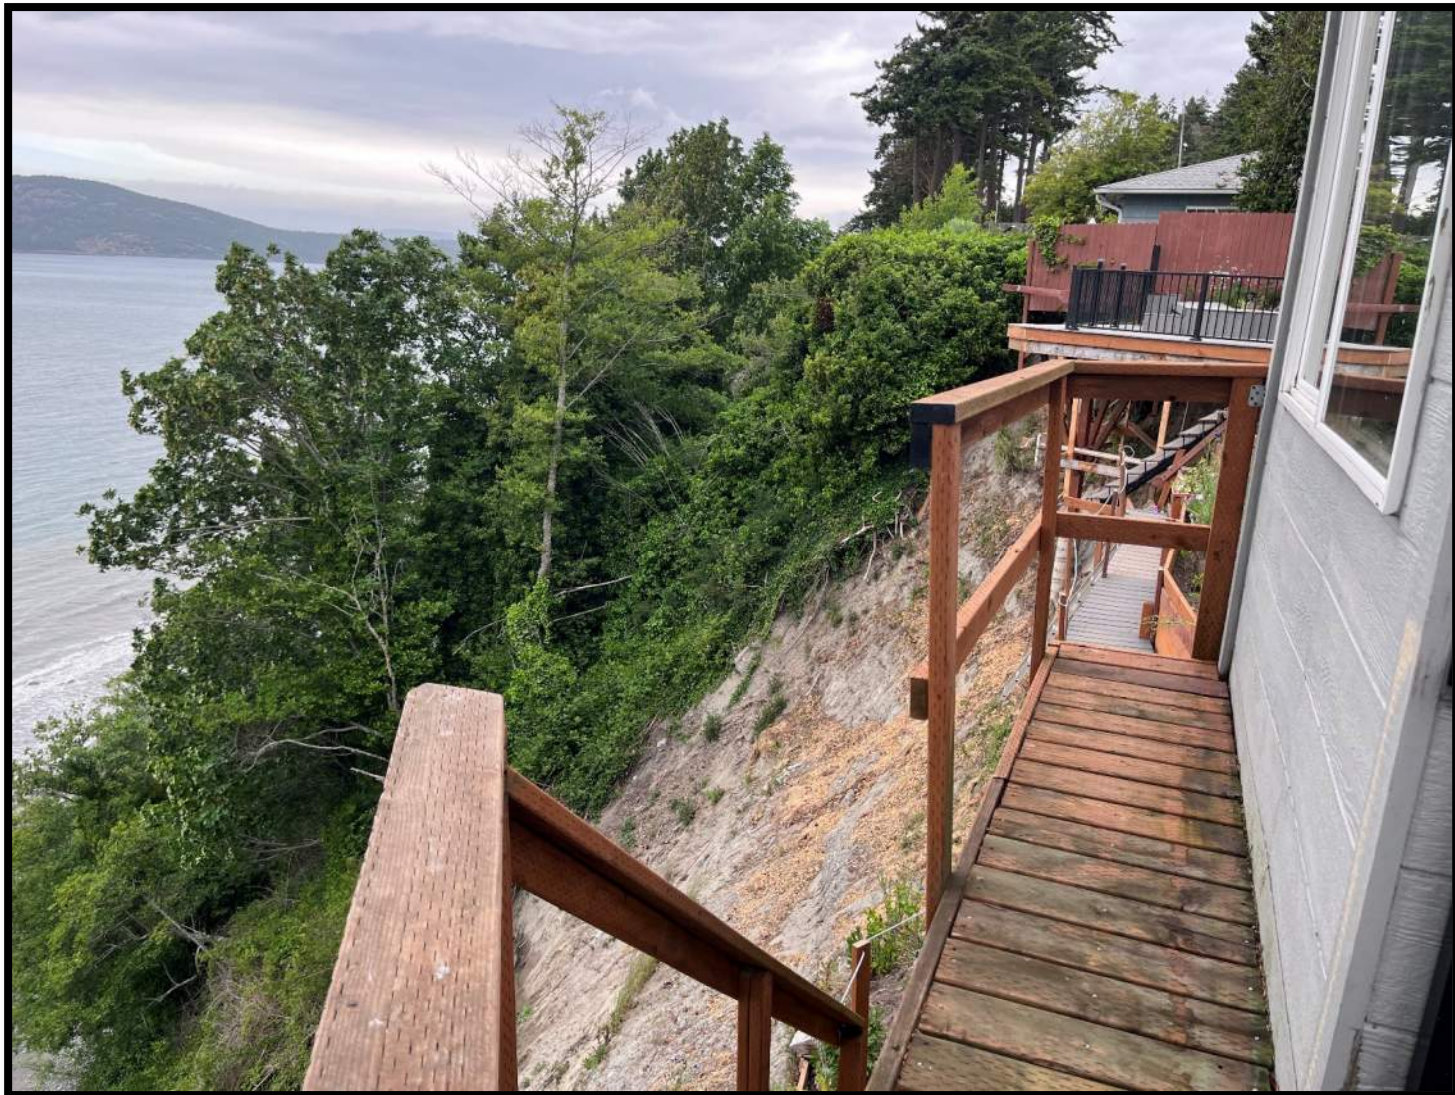
The western side of the residence includes several exterior, attached deck features at a similar elevation to the residence. There is a detached shed with viewing windows on the south side of the deck. Planter features comprise the north deck margins. Landscape planters are found downhill to the west of the residence about 10 to 15 feet below the deck elevation in the central area of the upper slope. The established deck is cantilevered out over the top of the bluff in the north and south margins. The central deck appears to be placed on existing soils. A hot tub is located centrally on the deck. The entire history of the deck construction is unknown however we presume an original-construction deck formed the western perimeter of the house and it was expanded in 2019 and was the cause for the above noted code compliance. The home site is currently set back approximately 10 to 15 feet from the crest of the bluff at the top of the recent landslide. The family indicated that the house foundation was not compromised by the landslide. No interior features of the house such as door or window function appeared to be impacted according to our conversations while on site.

Photo 5: Upper deck area adjacent to the existing residence. Facing N on May 29, 2026.
