SKAGIT COUNTY DEPARTMENT OF PUBLIC WORKS

2018 ANNUAL BRIDGE REPORT

SUBMITTED MARCH 2019

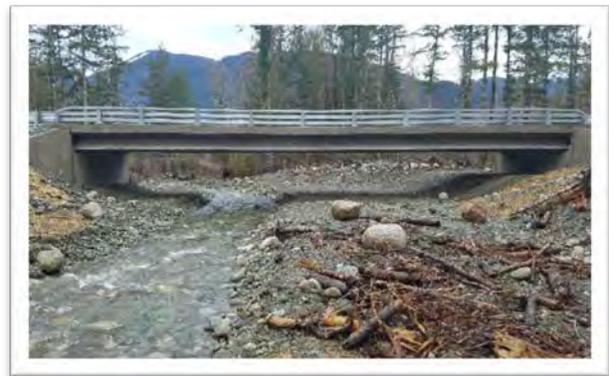
Hollow Cedar Bridge looking downstream

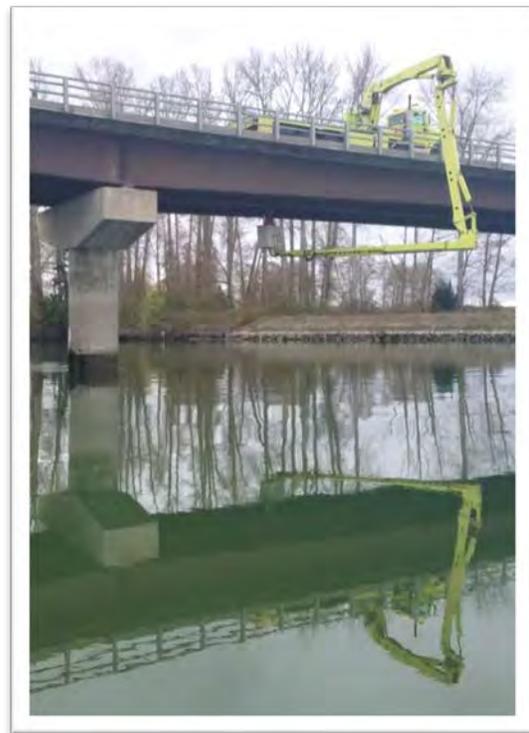
UBIT inspection on South Fork Bridge

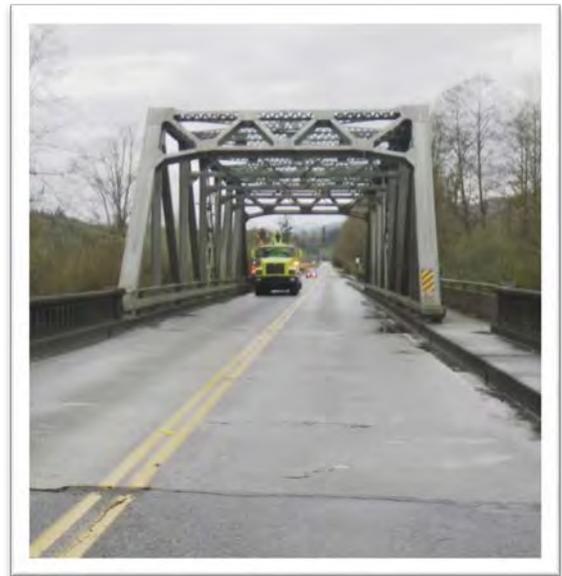
- Samish River Bridge on Old Hwy 99 #40114
 - Due to frozen rocker bearings, the bridge deck experiences compression stress which results in failing joint headers, cracks, and spalling with exposed rebar in the concrete deck

Samish River Bridge deck during inspection

- BRAC awarded Skagit County \$824,000 in Federal funding to replace the bearings, expansion joints, and resurface the deck/driving surface
 - Work is scheduled to begin in summer of 2019

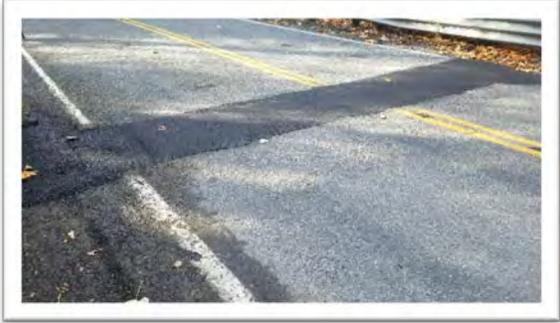
- **South Skagit Hwy at Mill Creek** – Due to lack of conveyance under the bridge, combined with a large rain event, Mill Creek began scouring the subgrade underneath and behind the west bridge abutment. The Environmental Services Team, with help from the Road District #3 crew, were able to quickly permit, excavate out the approach roadway behind the abutment, re-armor around the abutment, backfill the scoured out area, and asphalt patch the disturbed area.
-
