SKAGIT COUNTY DEPARTMENT OF PUBLIC WORKS

2022 ANNUAL BRIDGE REPORT

SUBMITTED MARCH, 2023

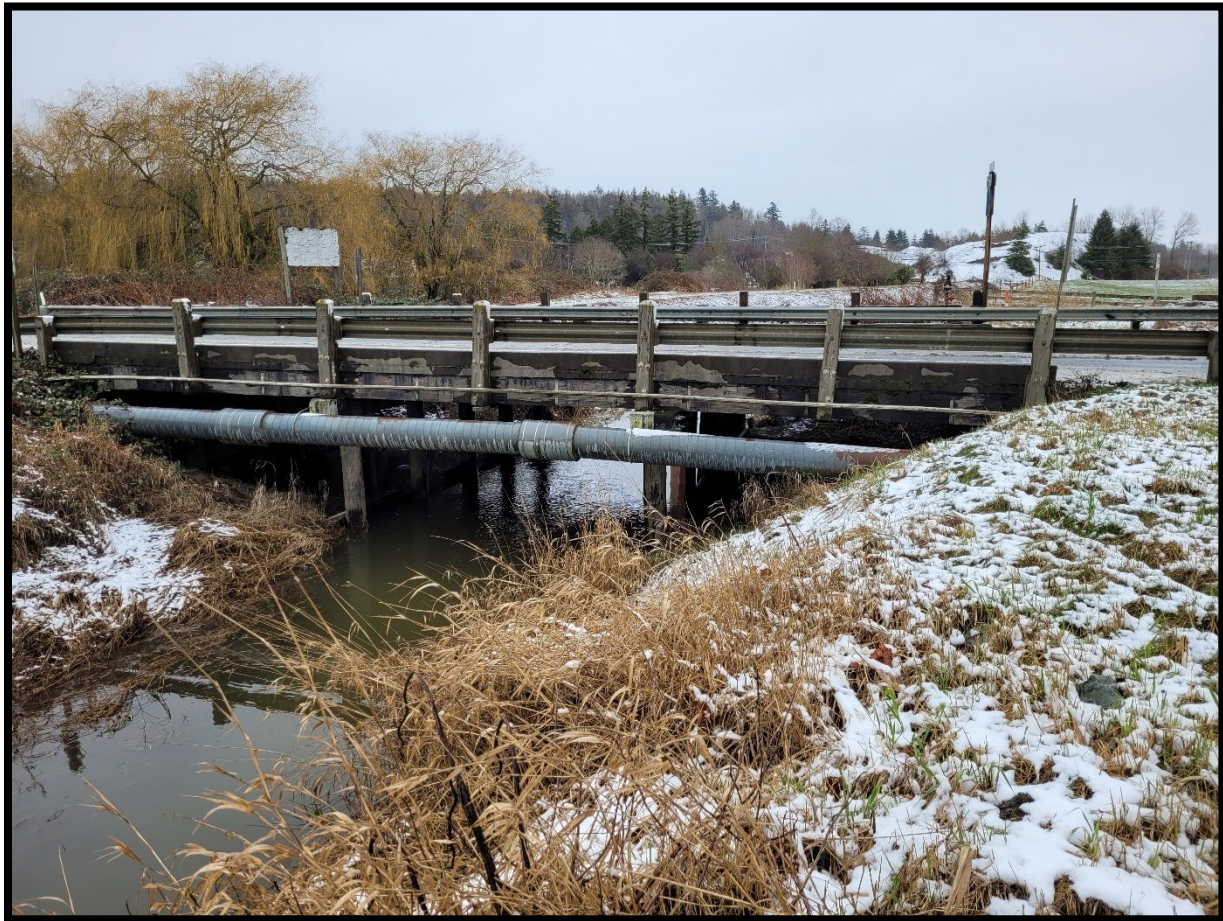
“Old Highway 99 at Thomas Creek Bridge”

Part of the original state highway, constructed in 1934, scheduled for replacement.

- **Old Highway 99 at Thomas Creek (Cover)** was awarded \$6 Million to replace the 89-year-old timber structure. The substructure of the bridge is beginning to fail and required the need for temporary shoring to keep it open to legal sized loads. The new structure will also increase conveyance as the current bridge is routinely submerged during flood events. Design is scheduled to begin later this year, construction slated for 2025-2026.

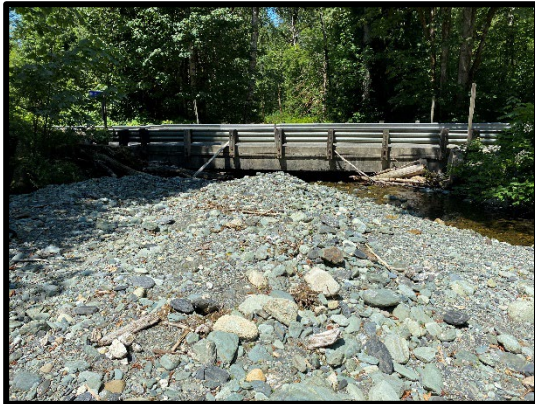
South Skagit Highway at Mill Creek Bridge #40086

Mill Creek channel upstream of bridge.

A sufficiency rating of 80.74 is still very high for a bridge but environmental processes have rendered the Mill Creek crossing useless for its intended purpose. Mill Creek has filled in with large aggregate and decreased the structures' available conveyance, causing the creek to overtop the roadway and divert the flow to the east and west of the bridge. The bridges' Waterway Adequacy has been coded a 2 (frequent overtopping of deck or roadway approaches with severe traffic delays) and therefore eligible for replacement funding. Skagit County will be seeking replacement funds in a future Call for Projects that coincides with salmon restoration funding for a basin wide solution.

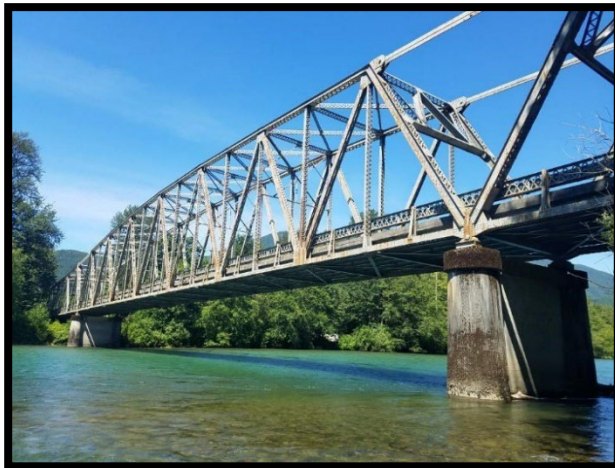
Marblemount Bridge – Skagit River

The 93-year-old steel truss, providing access from SR-20 to the North Cascade Forest Lands received **\$18.6 Million** in Federal Local Bridge Program funding to rehabilitate the structure and strengthen it to handle today's legal loads. **Construction of this project is scheduled to**

occur in 2026. The sufficiency rating dropped to 19.06 and would be posted for load restrictions, however, with the low average daily traffic, Public Works instead reduced the bridge to one-lane with signal controlled two-way traffic operation. With a one-lane configuration, legal trucks are still able to cross one at a time and can avoid a 20-Mile detour.

Rehabilitation of the structure will include cleaning and painting, replacement of damaged and/or deteriorating members of the truss, and upgrade of key members to increase the load carrying capacity of the truss system.

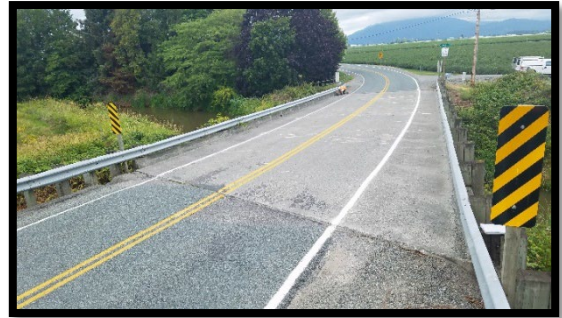
Bay View-Edison at Joe Leary Slough Bridge

The substructure and superstructure of this bridge are in very good condition (SR 84.90) but the deck is experiencing advanced deterioration and is in need of repair, currently coded a 4 (Poor). This coding of 4 makes the bridge structurally deficient and has been awarded **\$487,400** through the Federal Local Bridge Program to repair the deck, as well as the approach road fill retaining wall and existing drainage system. **Construction to begin this summer.**

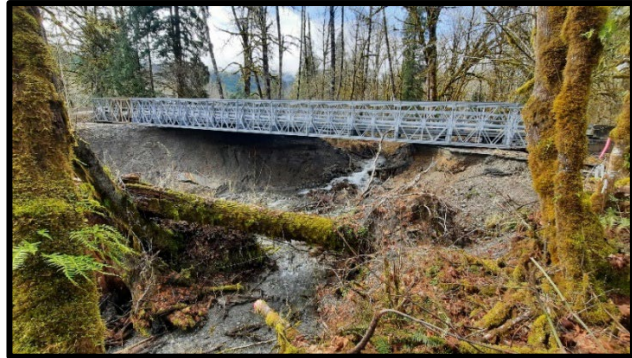
Concrete-Sauk Valley at North Osterman

The temporary bridge was installed to keep the road open while the North Osterman Creek culvert continued to fail due to storms and massive head cutting from the unpredictable migration of the Sauk River. When 100% failure was imminent, County crews sprang into action to add two more 10' sections to the bridge, increasing the overall span length to 130'. The extra span length helped protect against future head cutting and lateral scour of the creek. The temporary structure will remain until the permanent crossing is designed and ready for construction.

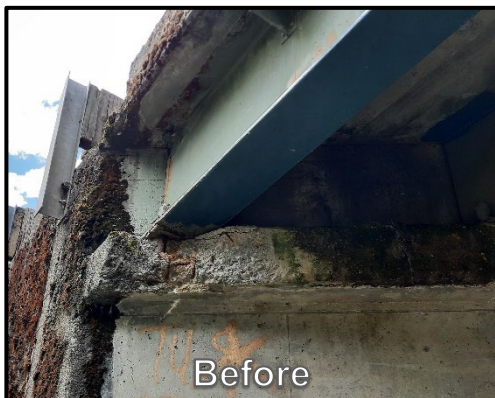
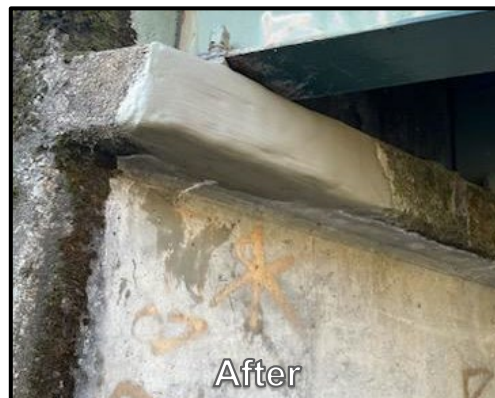
South Skagit Highway at Finney Creek #40089

During a routine inspection of this bridge, inspectors discovered a large spall in the abutment seat that had exposed rebar and one of the girder anchor bolts. Repair plans were quickly drawn up, supplies ordered, and our County Forces were able to get in and make the repairs before flood season where access would've become difficult. Repairs included cutting away the surrounding concrete, brushing away the weathered steel, construction of false work for the form, and pouring a high performance concrete patch into place.
