SKAGIT COUNTY DEPARTMENT OF PUBLIC WORKS

2023 ANNUAL BRIDGE REPORT

2023 BRIDGE REPORT

Submitted: March 2024

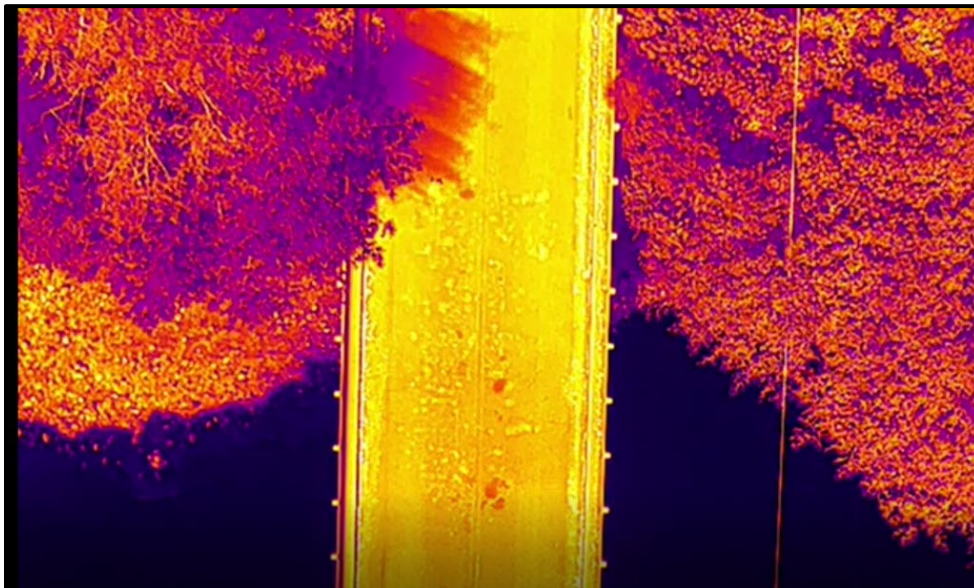
Thermal imaging of a portion of Cascade River Bridge:

The patched spalls and delamination areas heat and cool at different rates than the concrete in good condition. The bright red spots are existing patches of spalled delamination, lighter spots are delamination within the deck that will eventually spall. You can also see the impact that shadows from the trees have on the imaging.

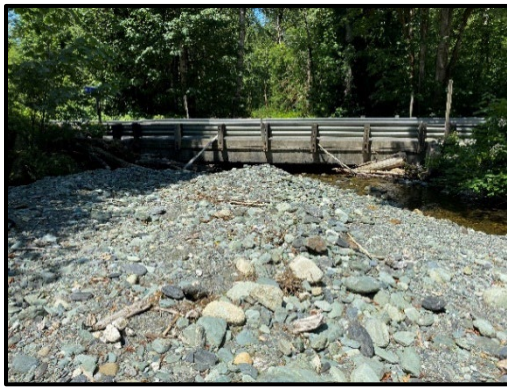
South Skagit Highway at Mill Creek Bridge #40086

Mill Creek channel upstream of bridge.

A sufficiency rating of 80.74 is still relatively high for a bridge but environmental processes have rendered the Mill Creek crossing useless for its intended purpose. Mill Creek has filled in with large aggregate and decreased the structures' available conveyance, causing the creek to overtop the roadway and divert the flow to the east and west of the bridge. The bridges' Waterway Adequacy has been coded a 2 (frequent overtopping of deck or roadway approaches with severe traffic delays) and therefore eligible for replacement funding. The County will be seeking replacement funds in a future Call for Projects (2025) that coincides with salmon restoration funding for a basin wide solution.

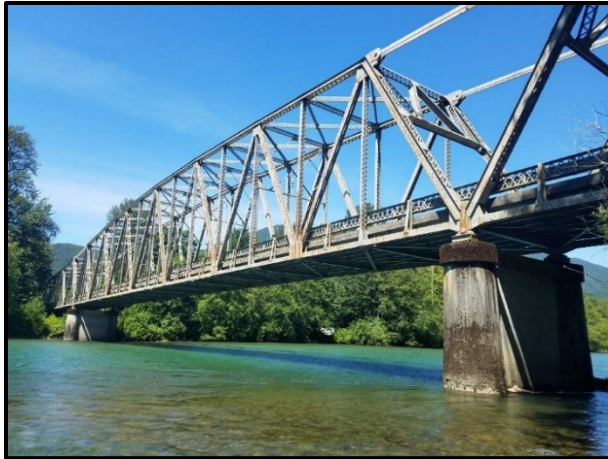
Marblemount Bridge – Skagit River

The 93-year-old steel truss, providing access from SR-20 to the North Cascade Forest Lands received **\$18.6 Million** in Federal Local Bridge Program funding to rehabilitate the structure and strengthen it to handle today's legal loads. **Construction of this project is scheduled to**

occur in summer of 2025. The sufficiency rating dropped to 19.06 and would be posted for load restrictions, however, with the low average daily traffic, Public Works instead reduced the bridge to one-lane with signal controlled two-way traffic operation. With a one-lane configuration, legal trucks are still able to cross one at a time and avoid a 20-Mile detour.

Rehabilitation of the structure will include cleaning and painting, replacement of damaged and/or deteriorating members of the truss, and upgrade key members to increase the load carrying capacity of the truss system.

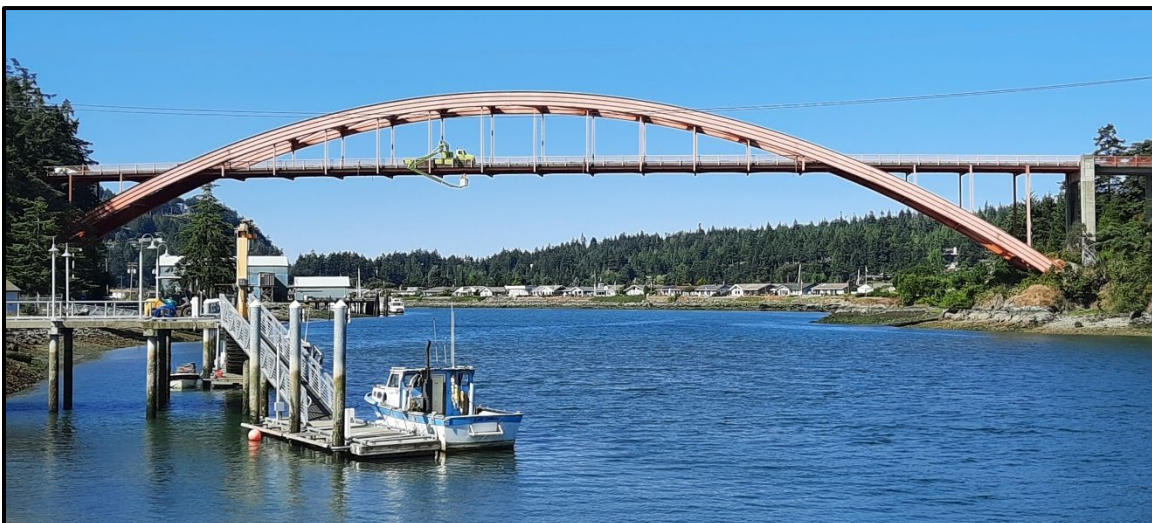
Although **Rainbow Bridge #40039** (below) does not meet any of the eligibility requirements for rehabilitation funding, the bridge has numerous repair needs and could use a cleaning and fresh coat of paint. County staff will continue to look for ways to fund these items and hopefully strengthen the bridge so that the current load restrictions can be removed.

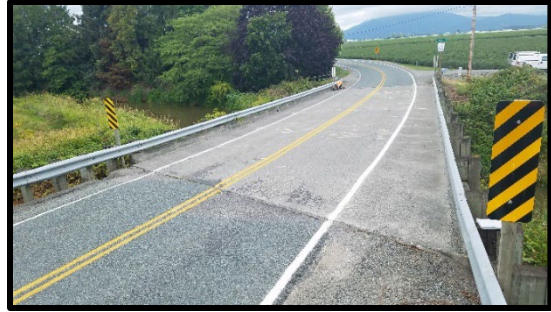
Bay View-Edison at Joe Leary Slough Bridge

The substructure and superstructure of this bridge are in very good condition (SR 84.90) but the deck is experiencing advanced deterioration and is in need of repair, currently coded a 4 (Poor). This coding of 4 makes the bridge structurally deficient and has been awarded **\$657,200** through the Federal Local Bridge Program to repair the deck, as well as the approach road fill retaining wall and existing drainage system. **Construction to begin this spring.**

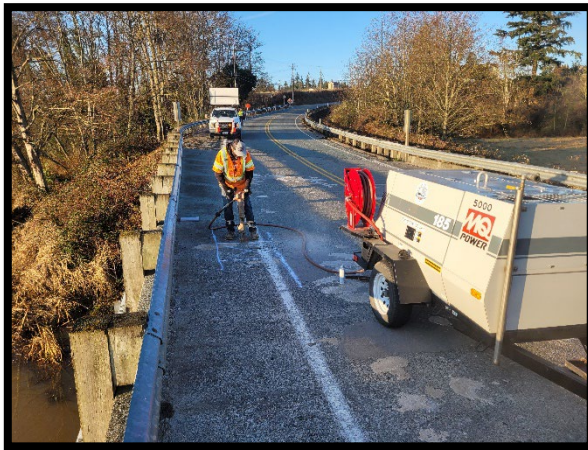
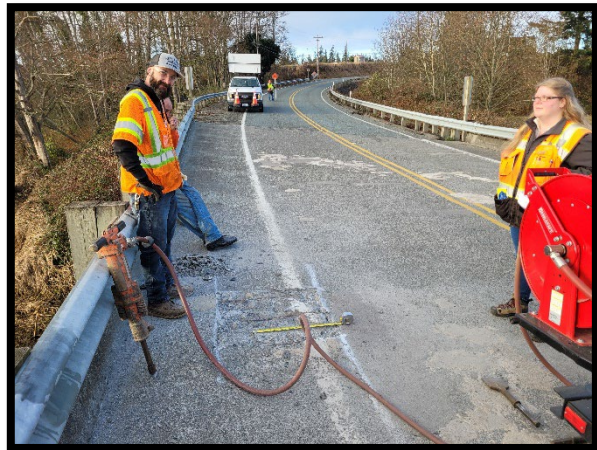
Bay View-Edison at Joe Leary Slough Bridge – jackhammer used to expose rebar for measuring and spacing, some of the information that went into the deck rehab project.
