## SKAGIT COUNTY DEPARTMENT OF PUBLIC WORKS

# 2024 ANNUAL BRIDGE REPORT

**SUBMITTED MARCH, 2025**

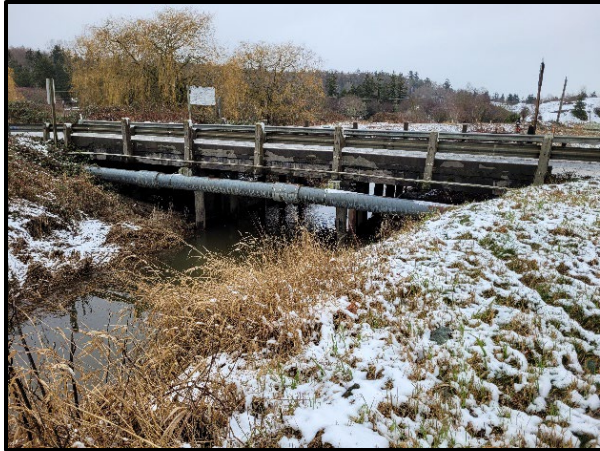
❖ **Old Highway 99 at Thomas Creek** was awarded \$6 Million to replace the 90-year-old timber structure. The substructure of the bridge is failing, requiring temporary shoring to keep it open to legal loads. The new structure will also enhance creek conveyance as the current bridge is routinely submerged during larger flood events. KPFF, Inc. was selected as the design consultant with construction currently scheduled for summer of 2026.

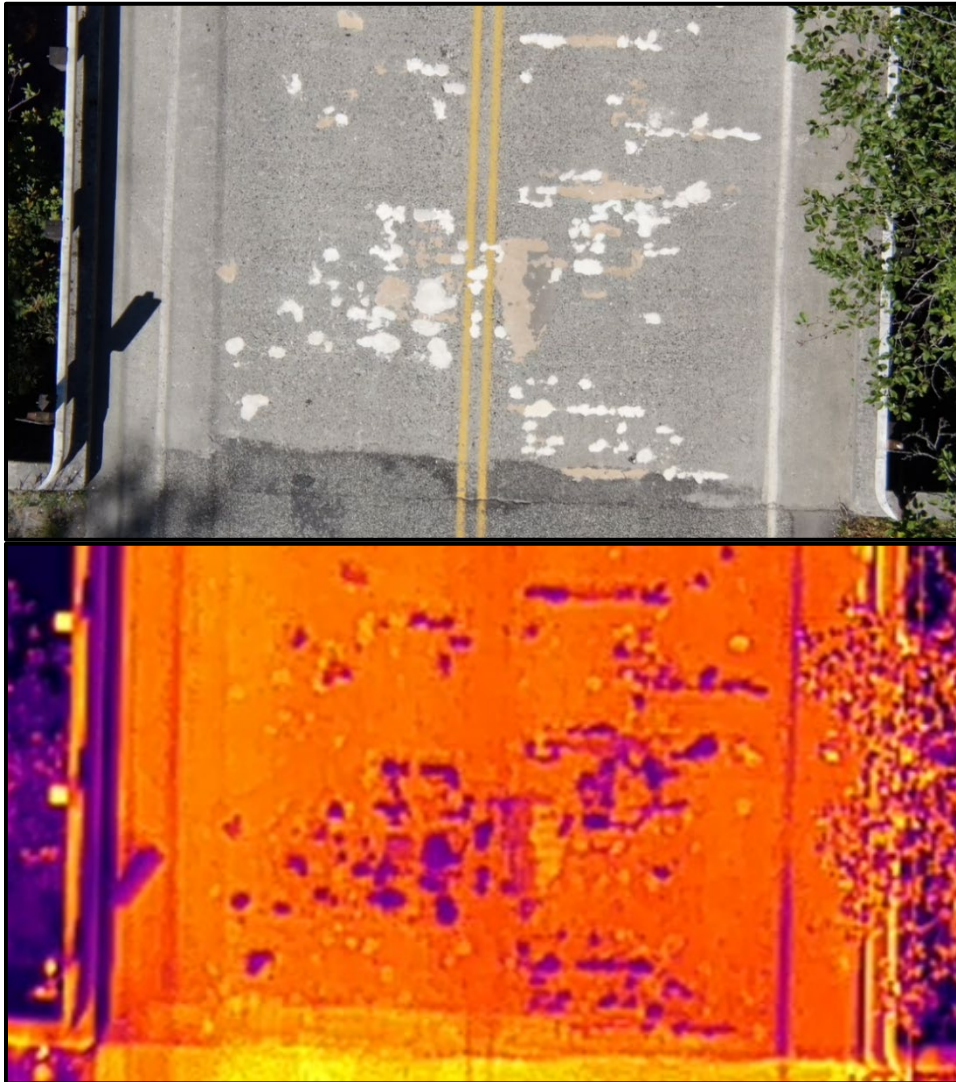
Thermal imaging of a portion of Lake Cavanaugh Road at Pilchuck Creek Bridge:

The patched spalls and delamination areas heat and cool at different rates than the concrete in good condition. The existing patches of spalled delamination (top photo) show up in the thermal imaging (bottom photo) as dark red spots. The lighter yellow spots indicate delamination in the concrete that will eventually spall and need additional patching.

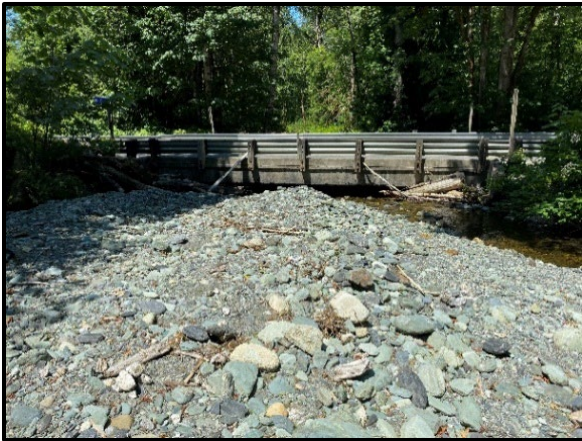
#### **South Skagit Highway at Mill Creek Bridge #40086**

Mill Creek channel upstream of bridge.

Environmental processes have rendered the Mill Creek crossing inadequate for its intended purpose. Mill Creek, located in an alluvial fan, has filled in with large aggregate and decreased the structures' available conveyance, causing the creek to overtop the roadway during the most minor rainfall events. Currently, the channel diverts flow to the east of the bridge and joins with Savage Creek, reducing salmonid habitat. The bridges' Waterway Adequacy has been coded a 2 (frequent overtopping of deck or roadway approaches with severe traffic delays) and therefore eligible for replacement funding. The County will be seeking replacement funds in this year's Call for Projects (April) that coincides with salmon restoration funding for a basin-wide solution.

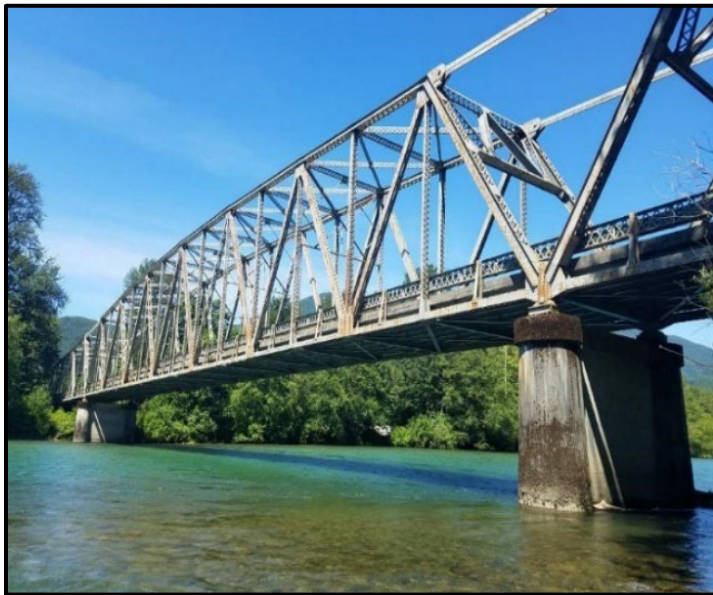
Marblemount Bridge – Skagit River

The structure would be posted for load restrictions based upon its current rating, however, considering the low average daily traffic, Public Works elected to reduce the bridge to one-lane with signal controlled two-way traffic operation. With a one-lane configuration, legal trucks are allowed to cross one-at-a-time to avoid a 20-mile detour.

Rehabilitation of the structure will include cleaning and painting, replacement of damaged and/or deteriorating members of the truss and upgrading key members to increase the load carrying capacity of the truss system.

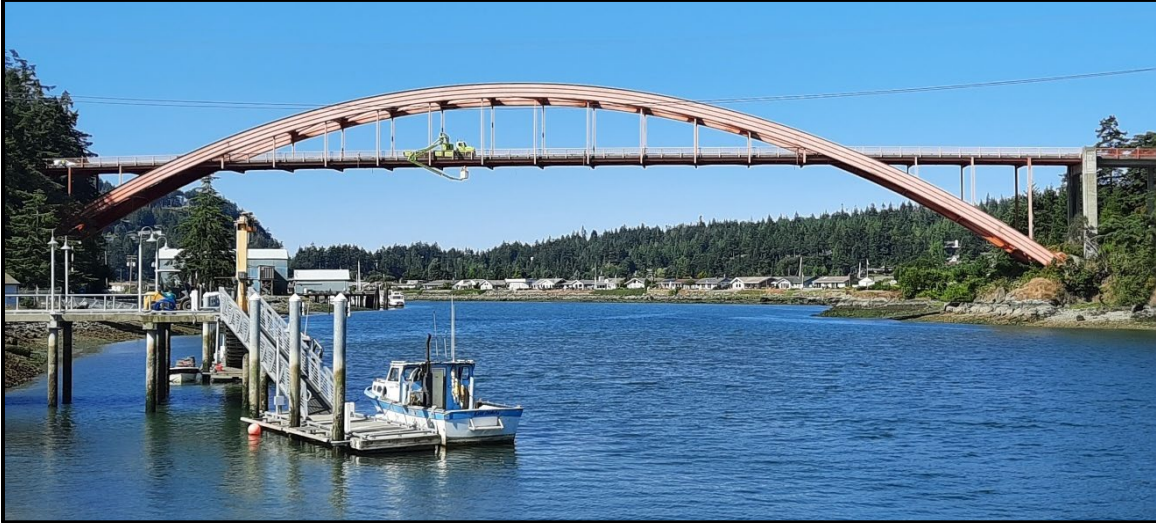
Although **Rainbow Bridge #40039** (below) does not meet the eligibility requirements for rehabilitation funding, and although the paint/protective coating has faded considerably,

it is still rated in fair condition. However, the bridge has multiple repair needs so preventative maintenance funding could be an option to pursue and then be combined with a cleaning and painting effort. County staff will continue to look for ways to fund these items and hopefully strengthen the bridge so that the current load restrictions can be removed.

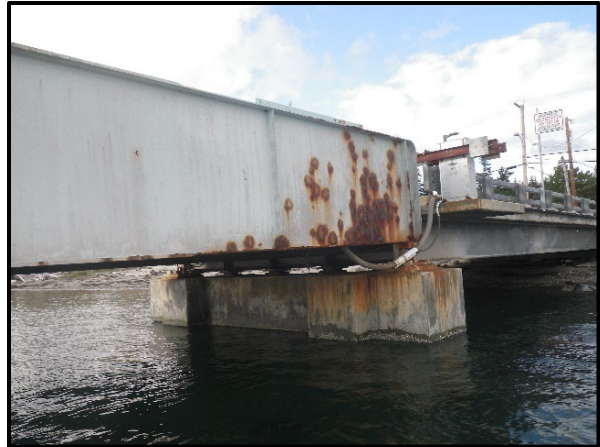
Painting of steel structures is not only for aesthetic purposes, but it also provides a protective coating to prevent corrosion. The **Guemes Island Ferry Dock #40153** (right) and Anacortes Ferry Dock #40154 are currently the only structures in our inventory with documented paint deterioration eligible for grant funding. Within a saltwater environment, the protective coatings on these steel structures are essential and must be addressed before further deterioration occurs. County staff will be applying for the Federal Local Bridge Program in April for paint and preventative maintenance to address numerous repair needs for both docks.

M/V Guemes Ferry Anacortes Terminal – Transfer Span

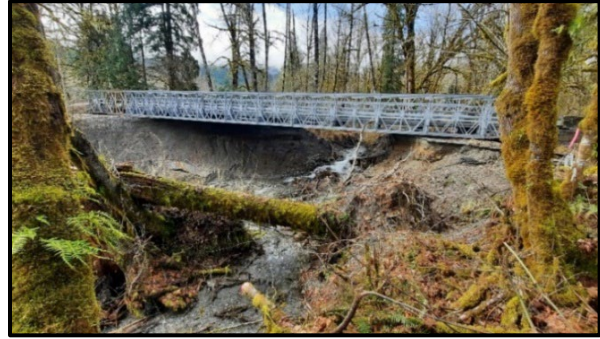
The temporary bridge was installed to maintain regionwide access when the culvert at North Osterman Creek failed due to storms and massive head cutting from the unpredictable geomorphology of the nearby Sauk River. Due to the bridge's lack of substructure, it is considered scour critical and has a Scour Plan of Action in place directing County staff to monitor site conditions during rainfall events. Recently, County forces successfully permitted and installed Super Sacks, filled with river rock, along the banks of Osterman Creek to prevent further channel migration towards the ends of the bridge. The temporary structure will remain until the permanent crossing is designed and ready for construction. This crossing was submitted for FEMA funding and recently received more than \$770,000 in FEMA funding to begin design of a new bridge. Once the design is complete, the County will submit the estimated construction cost to FEMA to secure additional funding.

Temporary Bridge over North Osterman Creek, looking upstream.

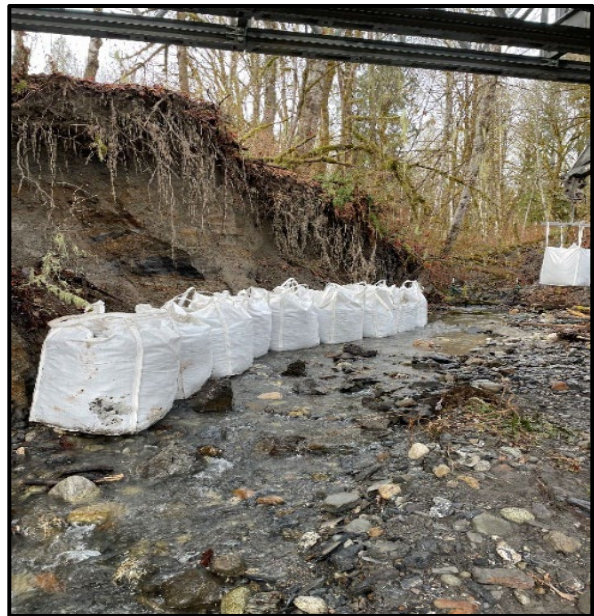
Super-sacks filled with stream gravel are placed to armor bank and slow down channel migration.

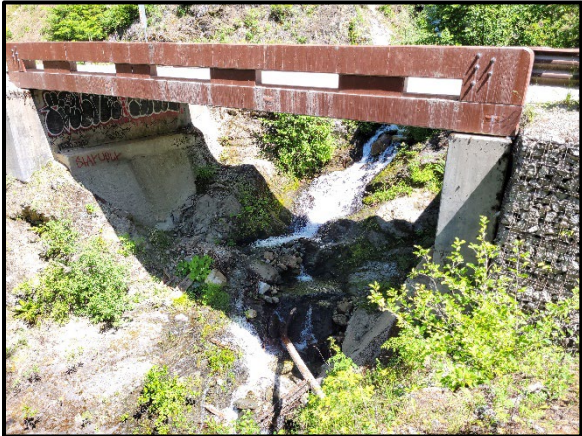
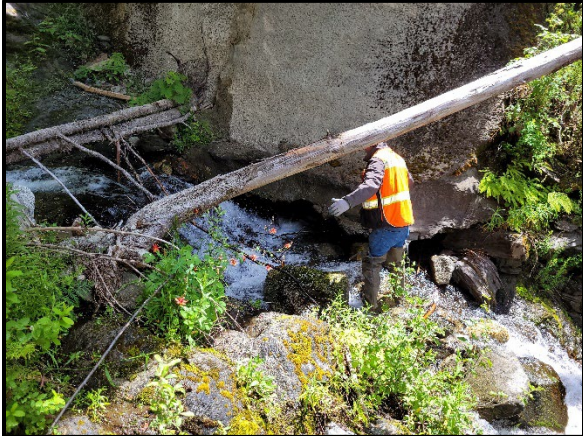
Hard Creek Bridge on Cascade River Road experienced some scour along the eastern bank that is undermining the road base retaining wall. A temporary patch was installed by County crews in November to prevent further erosion. A permanent solution will be constructed in summer of 2025.

Cascade River Road at Hard Creek Bridge, looking north, upstream.

Scoured channel bank undermining retaining wall along east bank.
