October 17, 2018
Job No. 18-0669

Skagit County Public Works
1800 Continental Place
Mount Vernon, WA 98273

Re: Geotechnical Engineering Report
Road Failure Investigation
North Shore Drive
Lake Cavanaugh, Washington

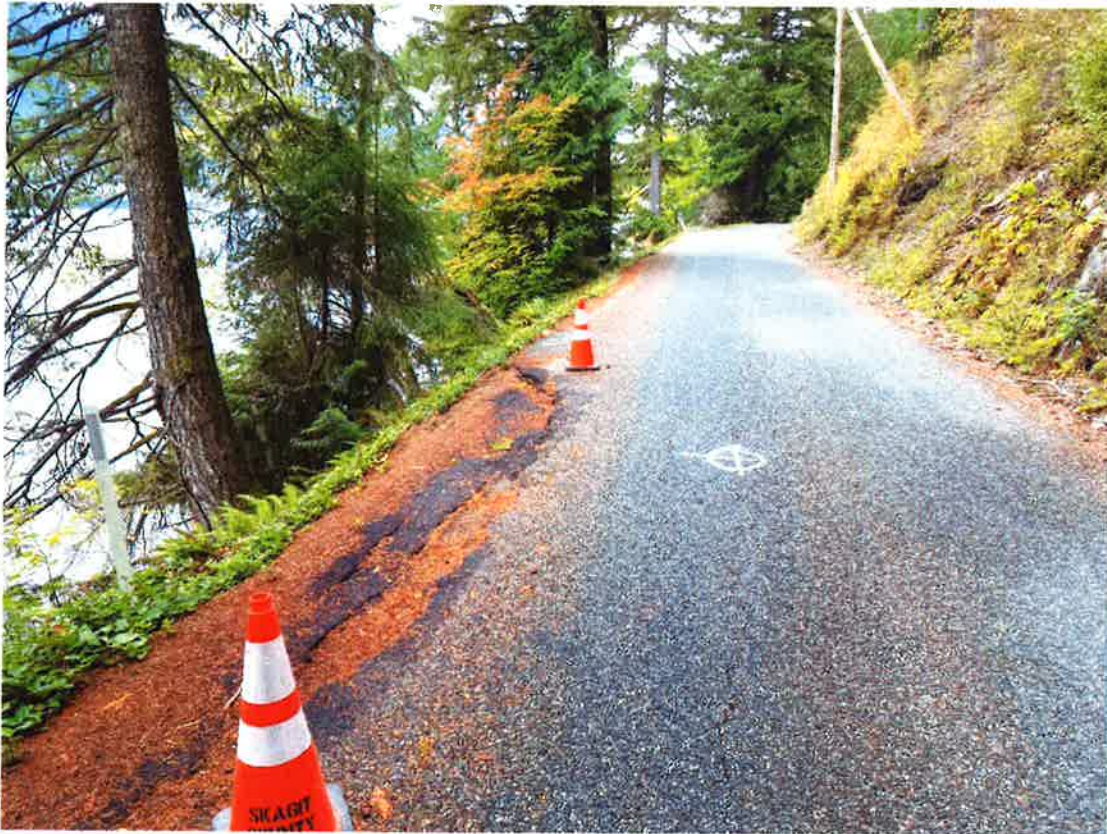
At Slide 1 on the western portion of the project site, the roadway has experienced localized soil slumping and subsequent asphalt cracking over an approximately 40-foot long crescent-shaped area paralleling the roadway (Photo1). It is unknown to GTS how

long the displacement has been occurring. The area has been patched with asphalt and crack sealed on at least two occasions historically, based on our visual observations. Surface rupture estimates include 2 to 3 inches of vertical subsidence and horizontal offset toward the lake shore. Immediately below the area of concern, we observed slope angles generally over 40 degrees. Wave undercutting from assumed winter storms and high water was observed across this location, with 2 to 3 feet of horizontal wave induced erosion into the soil at the base of the slope. Pistol-butted trees with exposed roots were common at this location, displaying evidence of downslope soil displacement and material removal by wave action on the shoreline. Exposed bedrock slopes were observed on the uphill side of the project site. No formal drainage controls were observed at this location.

Photo 1: View facing west along Slide 1 location showing existing conditions.

- Continued filling and/or asphalt patching of slumping areas. Slide 1 and Slide 3 would be most suited to this technique, while Slide 2 is likely to require more significant means to complete a temporary repair as the slide zone is more extensive. However, as addressed above, new fill material and pavement repairs can add mass above the generally loose, existing fill soils, thus contributing to continuing displacement at the roadway level.
- Removal of failing pavement sections and recompaction or replacement of existing fill with new structural fill at localized areas should be considered. The placement of 4 to 6-inch quarry spalls from the lake margin up to the road as temporary bank reinforcement, along with spot fill and pavement repairs as needed should also be examined by the project team.

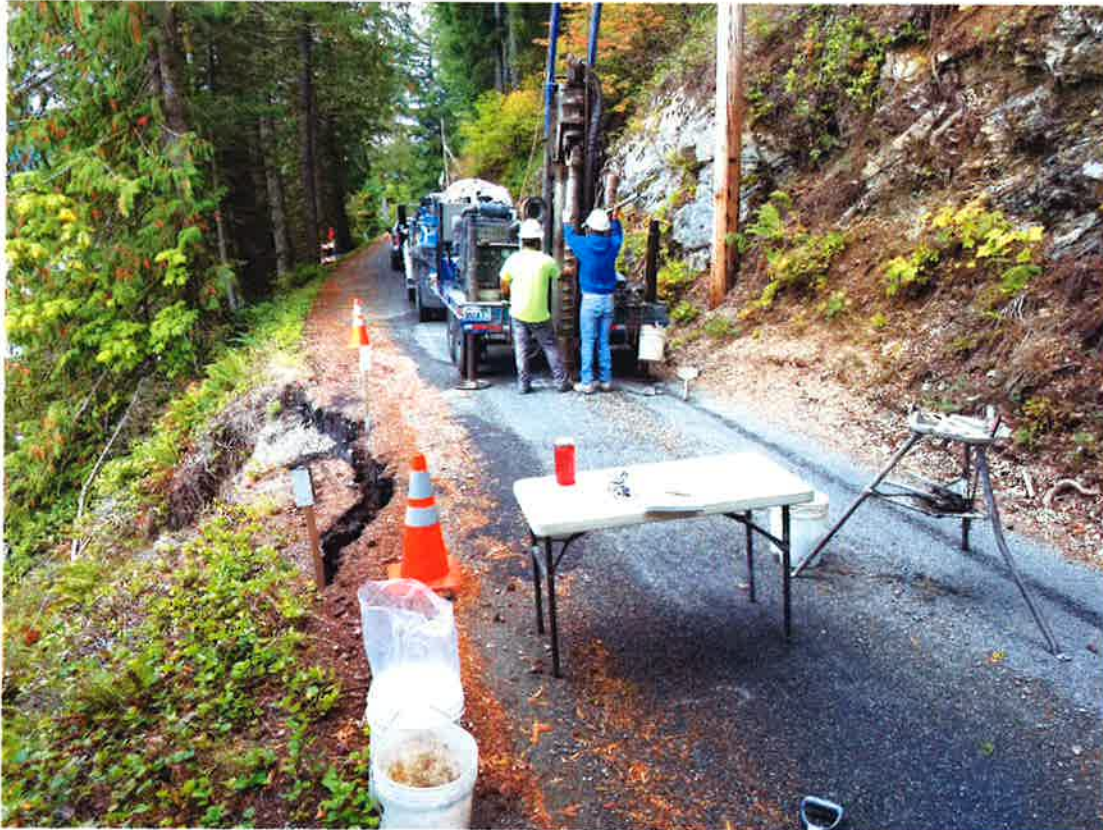
The Slide 2 location presents the most significant roadway damage at the project site and extends over about 40 linear feet of the project area (Photo 2). Up to 8 inches or more of vertical and 6 to 15 inches of horizontal displacement was observed on slump blocks below the roadway during our primary field work. Two additional soil blocks were observed well below the roadway at or near the lake level. Slough features in this area included fill soil blocks and portions of the roadway asphalt. At least two dead 1 to 1.5-foot diameter alder trees were observed at the base of the slope adjacent to the slide area that had fallen toward the lake side during mass movement activities. We also noted during the primary field work that the displacement appeared to be advancing

since our earlier visit on September 10th, 2018, although no formal measurements were established. The asphalt roadway in this location had a thickness of up to one foot at the south road margin, indicating the location had experienced displacement and asphalt patching at multiple occurrences prior to our study. Below the site along the lake shore, narrow exposures of bedrock were observed at lake level, along with live trees out of vertical growth position. The bank below the roadway was measured at over 50 degrees. Wave scouring from assumed winter weather events and high-water levels had undercut the existing soils in varying proportions. No surface or subsurface engineered drainage controls were observed at this location.

Photo 2: Slide 2 location existing conditions and drilling team, facing west.

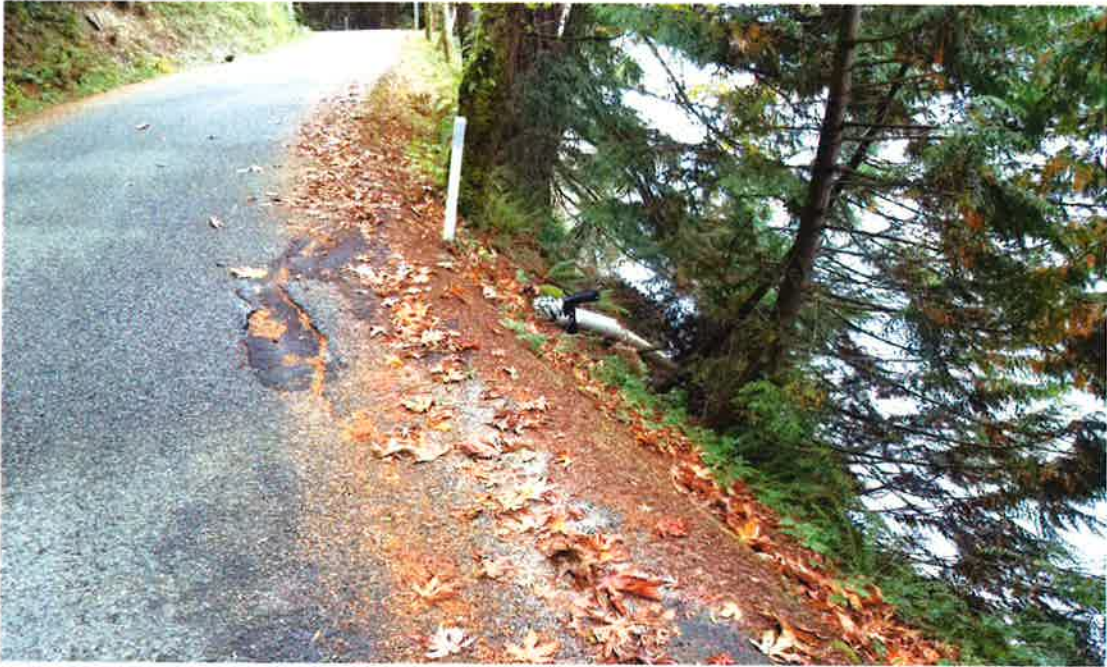
The Slide 3 location extends over an approximately 30-foot linear section of the south side of the roadway (Photo 3) and marks the eastern limits of the project area with significant damage. The asphalt has visible displacement with 1 to 2 inches of horizontal and vertical offset. Patching with additional asphalt and crack sealing was evident on visual observation, extending up to 3 feet to the north from the south road edge. The bank below the roadway was estimated at over 40 degrees and contained pistol-butted trees generally not in vertical growth position. Wave undercutting and subsequent soil erosion at the lake level was evident at this location (Photo 4). Engineered drainage controls of unknown age were observed adjacent to the slide location. The corrugated metal culvert crossing under the road from a catch basin on the north side of the road to the bank on the south side of the road was connected to an apparently custom-made

PVC pipe structure that was intended to transport stormwater to the lake level. GTS did not observe the drainage system in operation due to dry conditions.

Photo 3: Slide 3 location showing existing conditions, including storm drain system in upper-center of picture. Facing east.

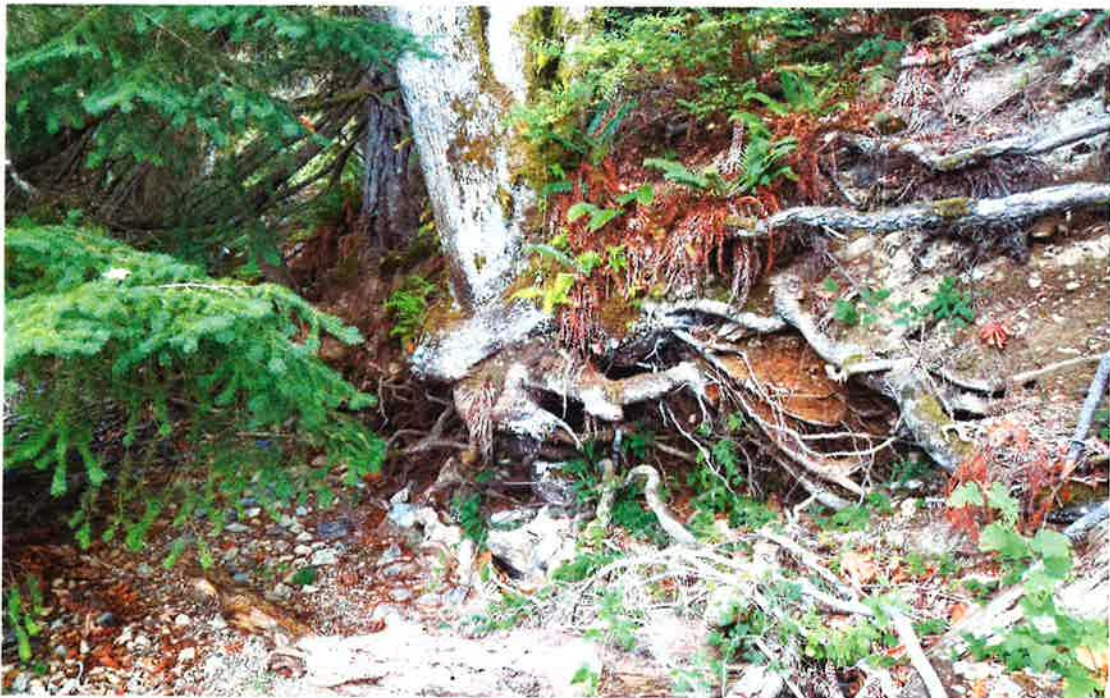
Photo 4: Conditions along the lakeshore adjacent to Slide 3 showing wave undercutting, road bank over steepening and erosion scour features. Facing northwest.

2. Undercutting by wave action during elevated lake water levels or during storm events has caused moderate to severe erosion of the soils at the base of the slope directly above the lake. Several locations were noted with 2 to 5 feet of horizontal scouring toward the roadway from the present lake level near the failure zones. Erosion over time at the toe of the slope has led to an oversteepened and undercut road bank with tree roots and other vegetation enduring as the primary containment of the remaining soils.
