## **Car/Passenger Ferry M/V "Guemes"**

***Condition and Value Survey***

**Survey No. 2019-0753**

**Date of Survey: March 4 & 14, 2019**

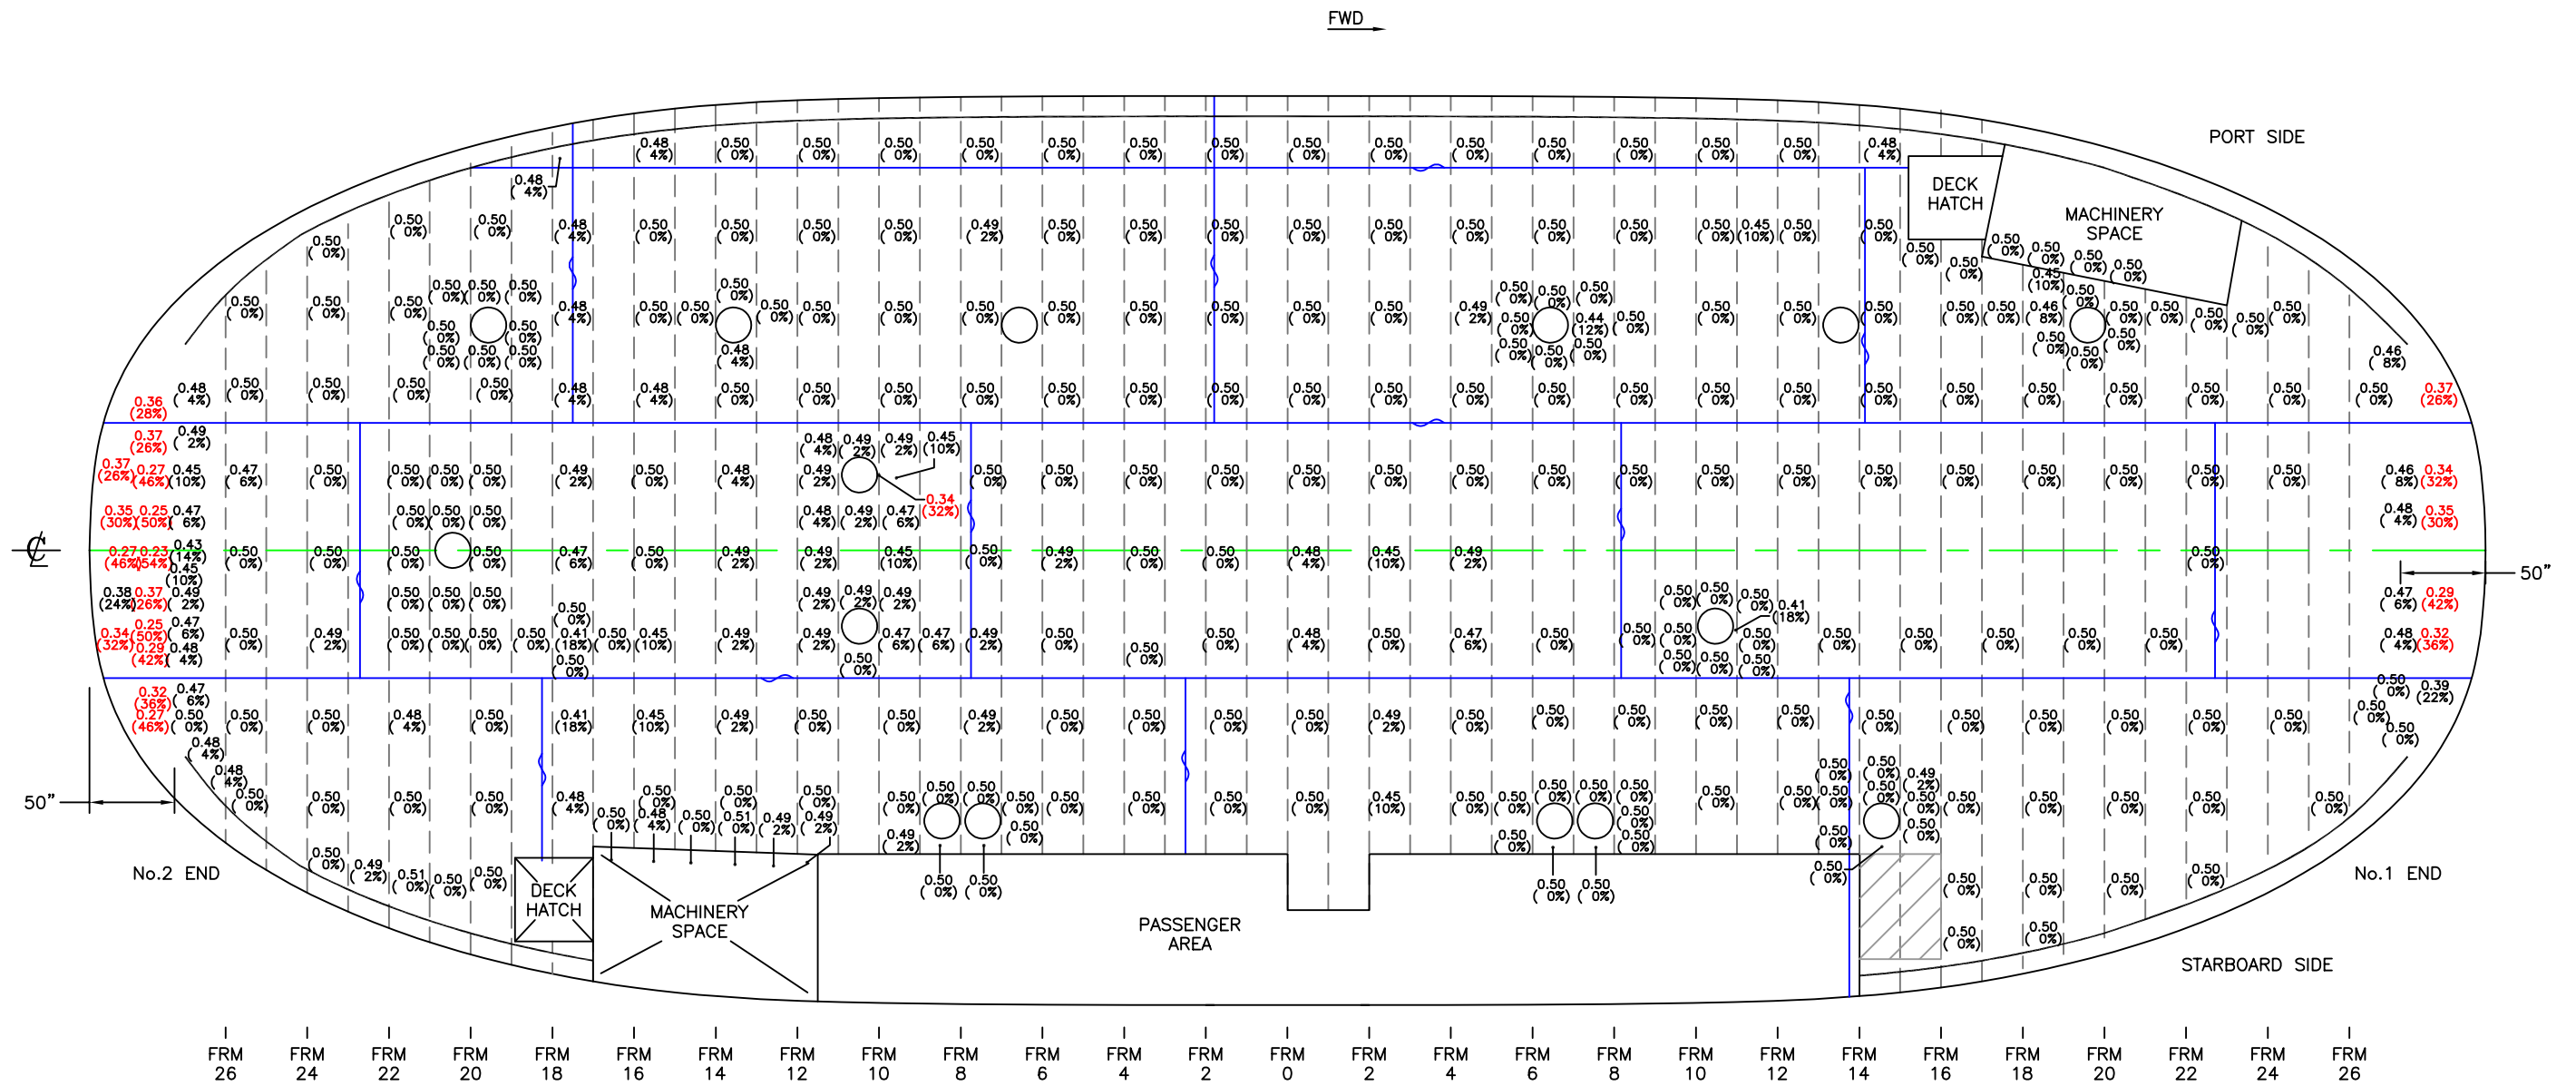
**MAIN DECK PLATING**

Butts and seams appeared satisfactory with no significant wastage. Approximately 50" of wasted deck plate on each end apron were being cropped and renewed at the time of survey. This area was identified on the 2019 gauging report and is subject to normal heavy wear due to ramp and traffic loads. Deck coatings and non-skid were in the process of being renewed at the time of survey (Reference dry-docking report)

NOTE:  
 MAIN DECK PLATING .50"  
 RED = EXCESSIVE WASTAGE (25% AND GREATER).  
 = RAMP.

- Crop and renew four [4] wasted fuel tank sounding tubes.
- Crop and renew 5' 8" x 12' 6" x 1/2" plate in main deck apron in way of No. 1 and No. 2 car ramp areas
- No. 1 and No. 2 Z-drive hull mounting brackets found with fractures-v-out and reweld.

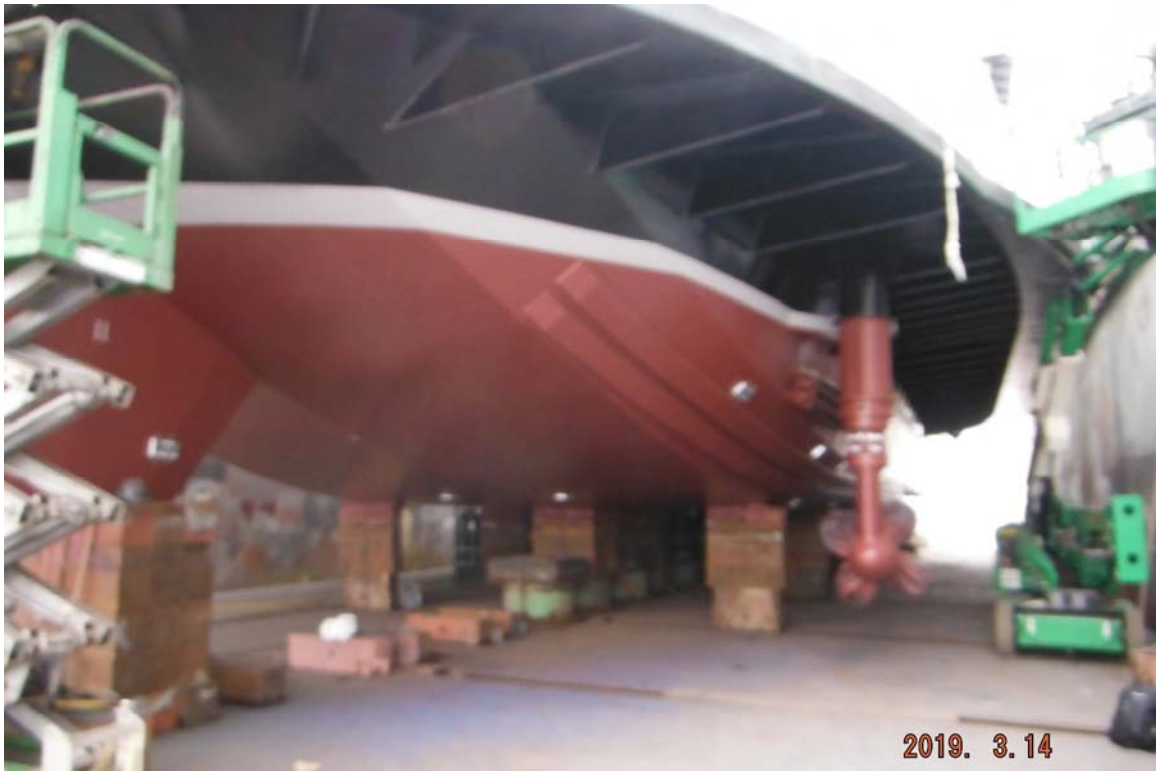
Butts and seams appeared satisfactory with no significant wastage. Hull plating found fair with light washboarding between frames, particularly in areas that are subject to wheelwash from the Z-drive propulsion---No. 1 end port, No. 2 end starboard. Coatings and zincs renewed (reference dry-docking report).

Photo No. 1  
No. 1 end looking aft port side

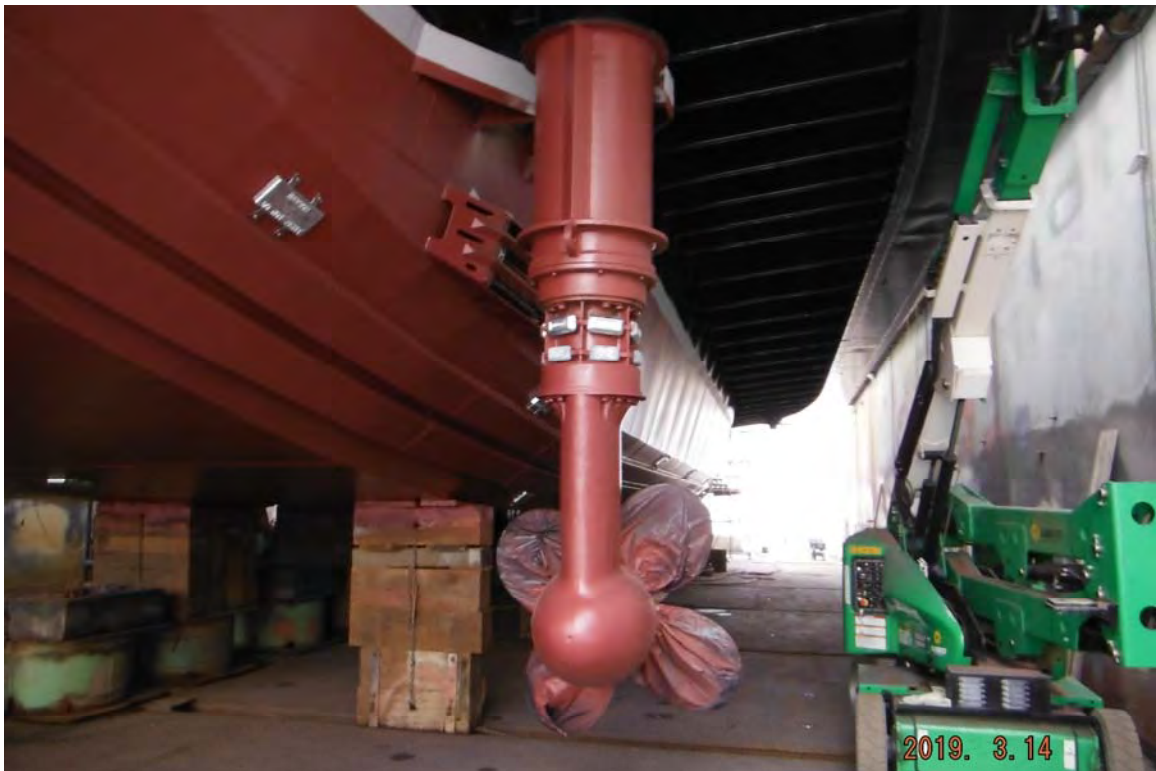
Photo No. 2  
No. 1 end Z-drive Unit

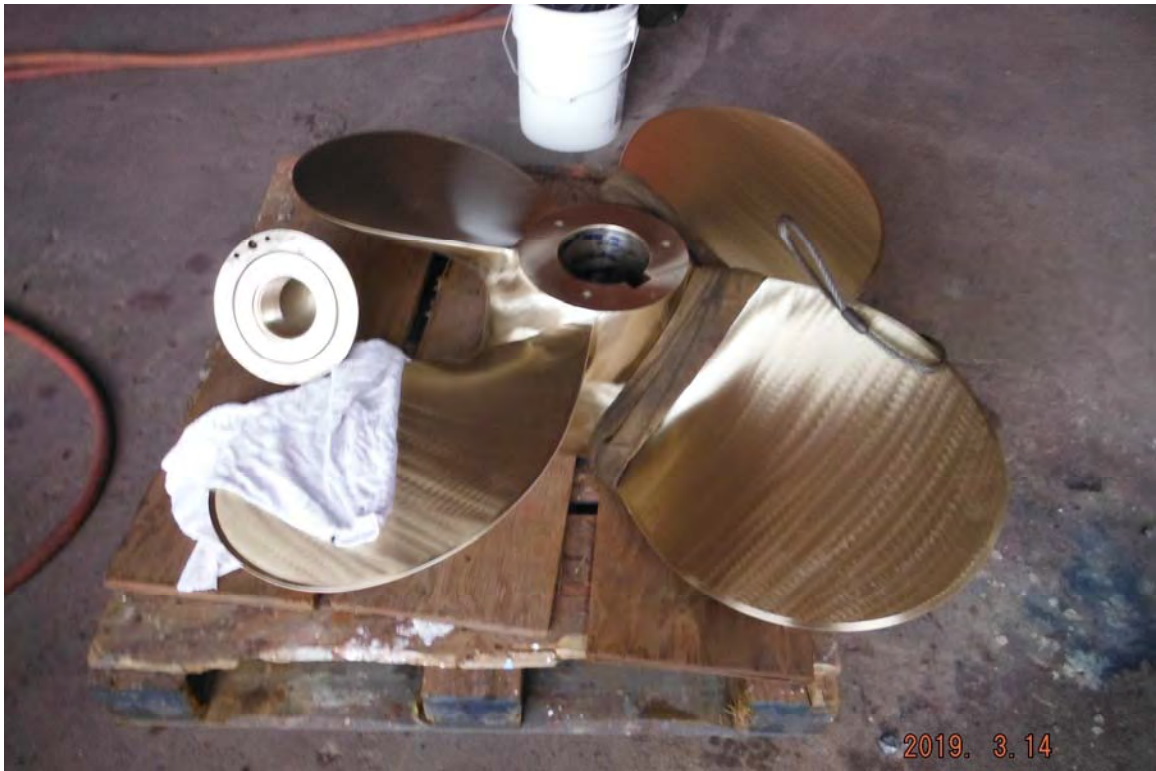
Number: Two [2]  
 Blades: Four [4]  
 Diameter: 52"  
 Pitch: 36"  
 Manufacturer: Kruger & Sons  
 Material: Bronze  
 Condition: Good, Inspected and polished 2019 dry-dock

Photo No. 3  
Refurbished propeller

- Inspect propellers
- No. 1 propeller removed and replaced.
- No. 1 propeller seal replaced
- No. 2 propeller seal replaced

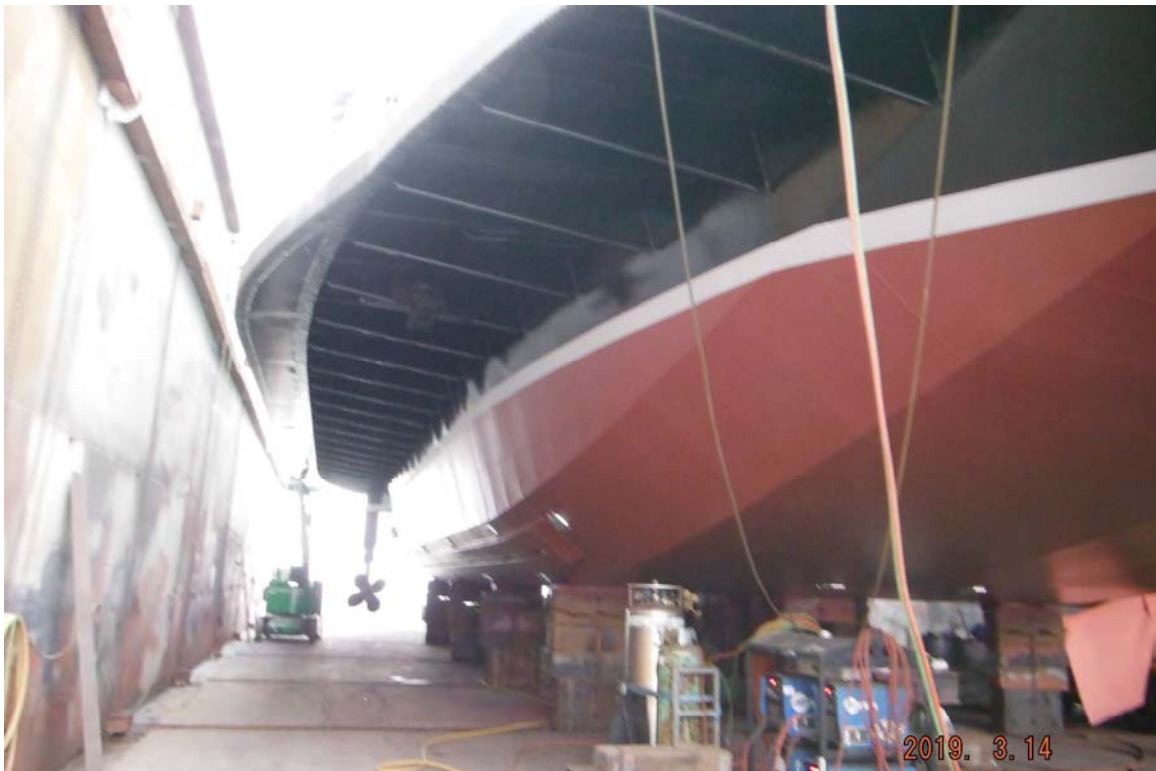
Photo No. 4  
No. 2 end looking forward port side

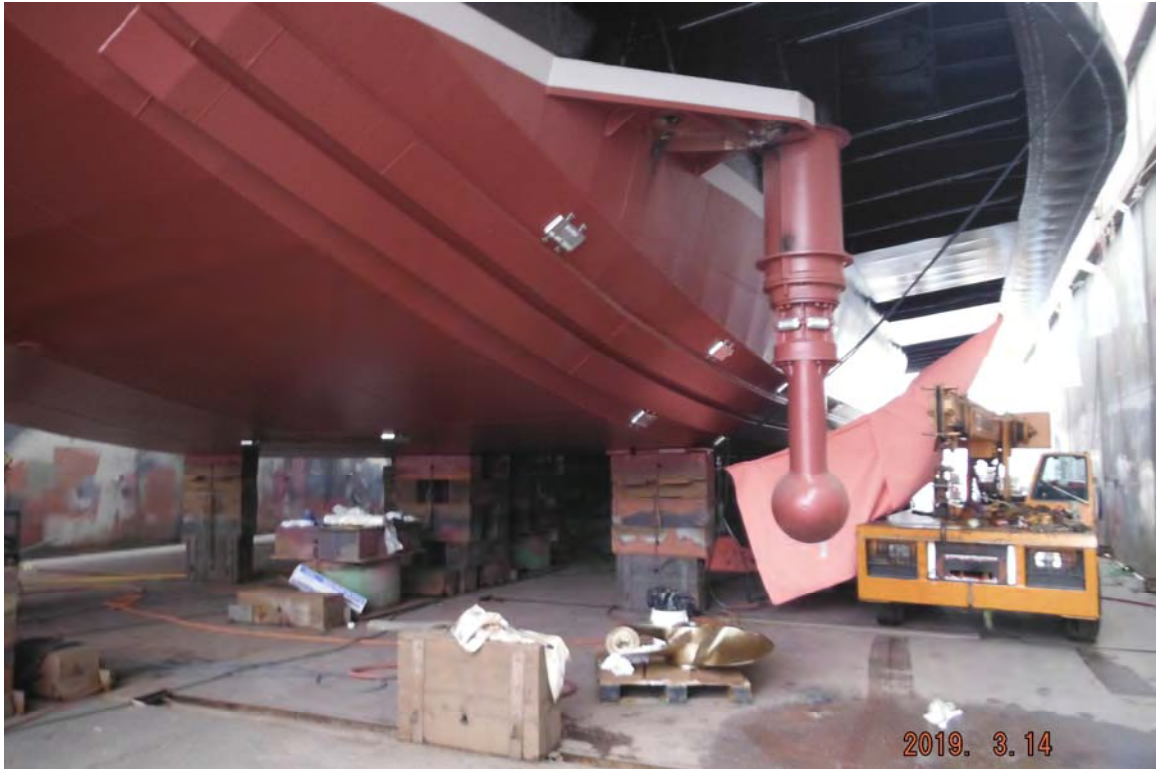
Photo No. 5  
No. 2 end looking forward starboard side

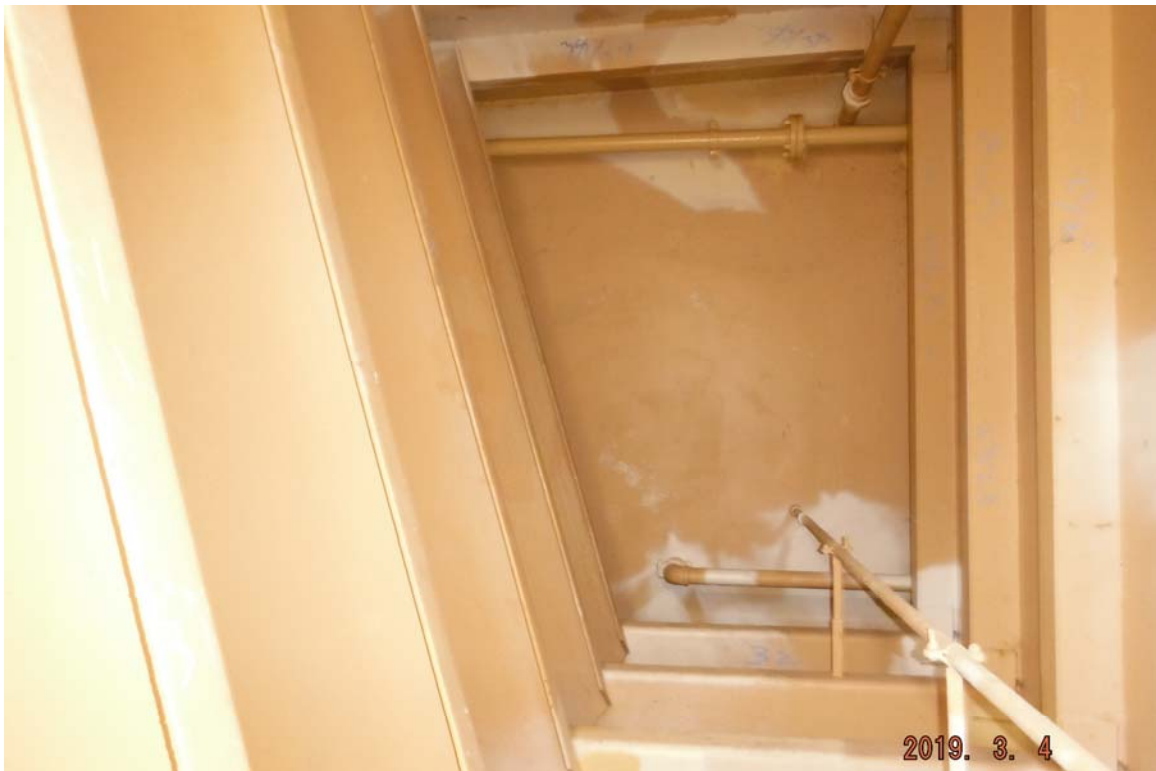
Photo No. 6  
Interior void, representative sample of internal coatings

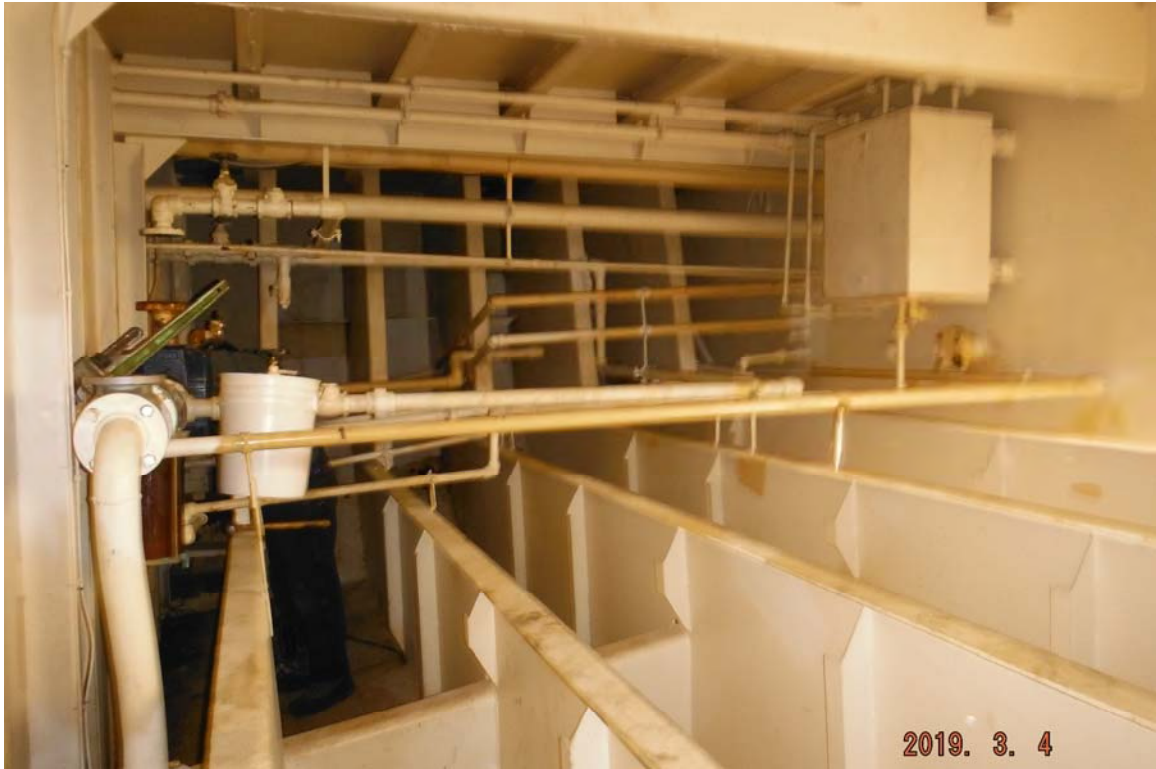
Photo No. 7  
Interior void, representative sample of internal coatings

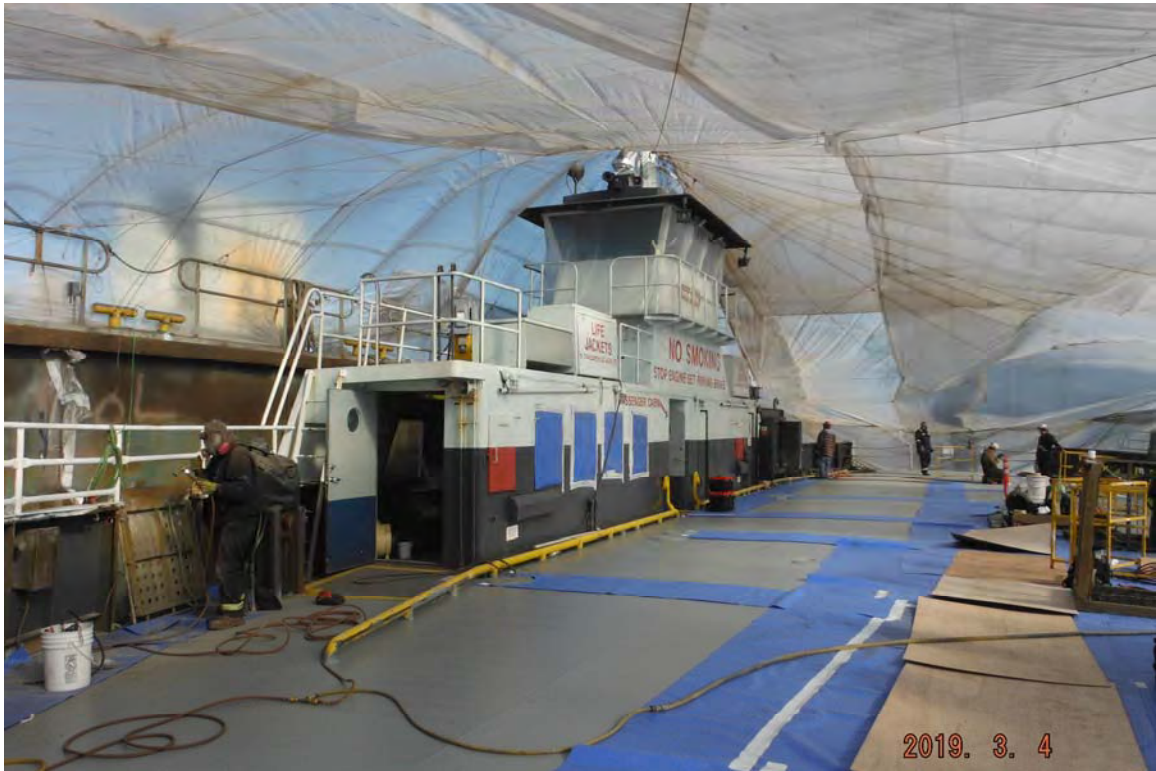
Photo No. 8  
Main deck looking aft from No. 1 end

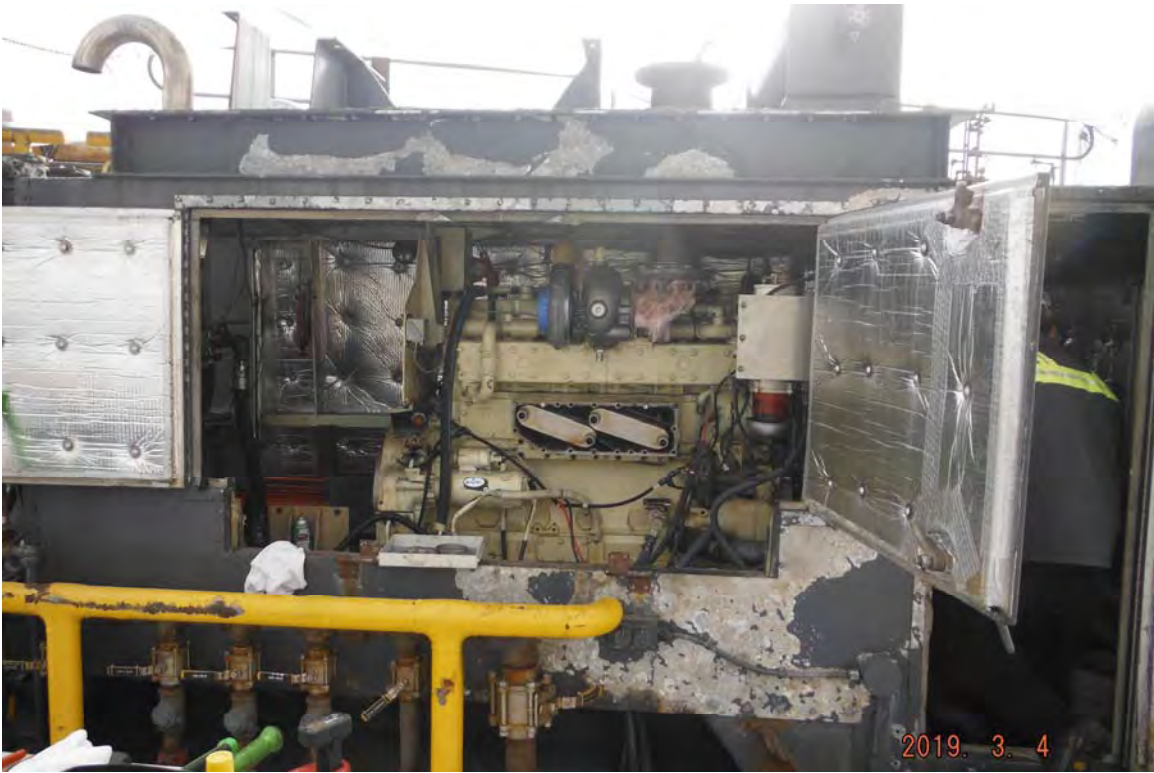
Photo No. 9  
Main engine and compartment

- No. 1 and No. 2 Reduction gears removed, overhauled by 3<sup>rd</sup> party and reinstalled
- Auxiliary Generator removed, overhauled by 3<sup>rd</sup> party and reinstalled
  - New head gasket
  - New oil cooler
- Main Engines
  - Flush cooling system with fresh water
  - Engine No. 1
    - Replace FW pump and drive
    - Clean and replace aftercooler core
    - Replace fuel pump
  - Engine No. 2
    - Replace all heads
    - Replace turbocharger
    - Clean and replace aftercooler core
    - Replace fuel pump
    - Replace FW pump

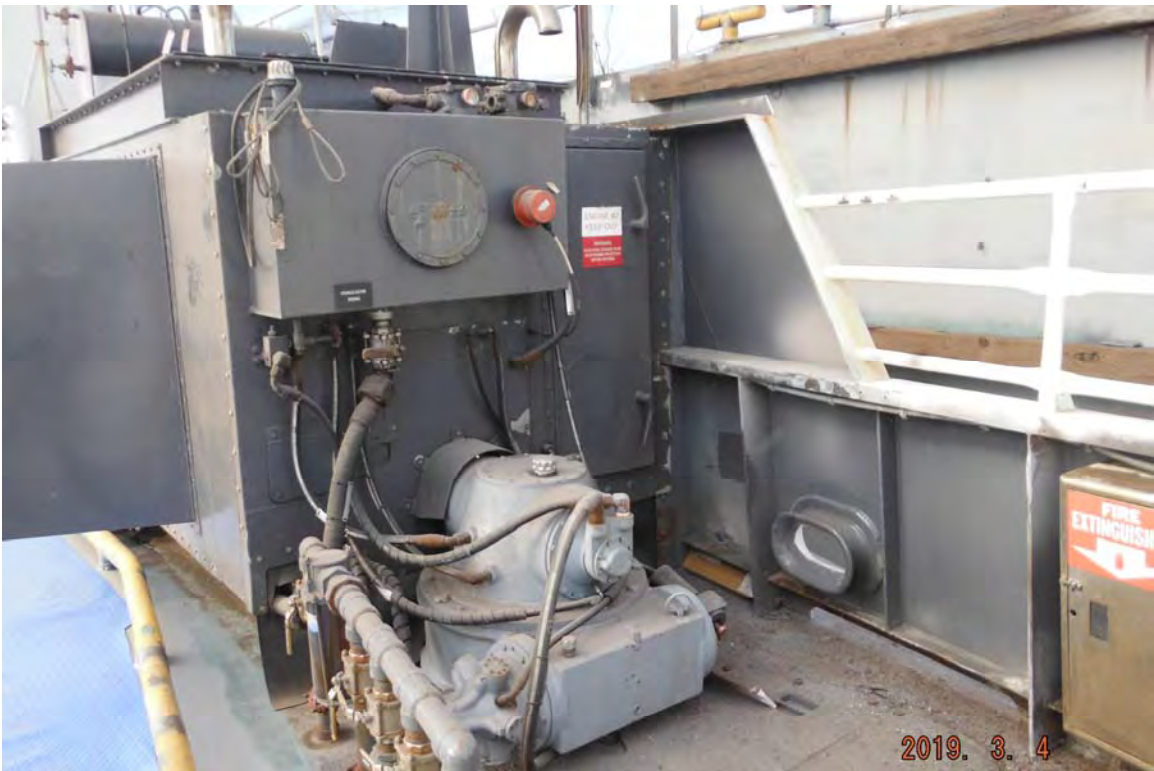
Photo No. 10  
Z-drive assembly, upper unit

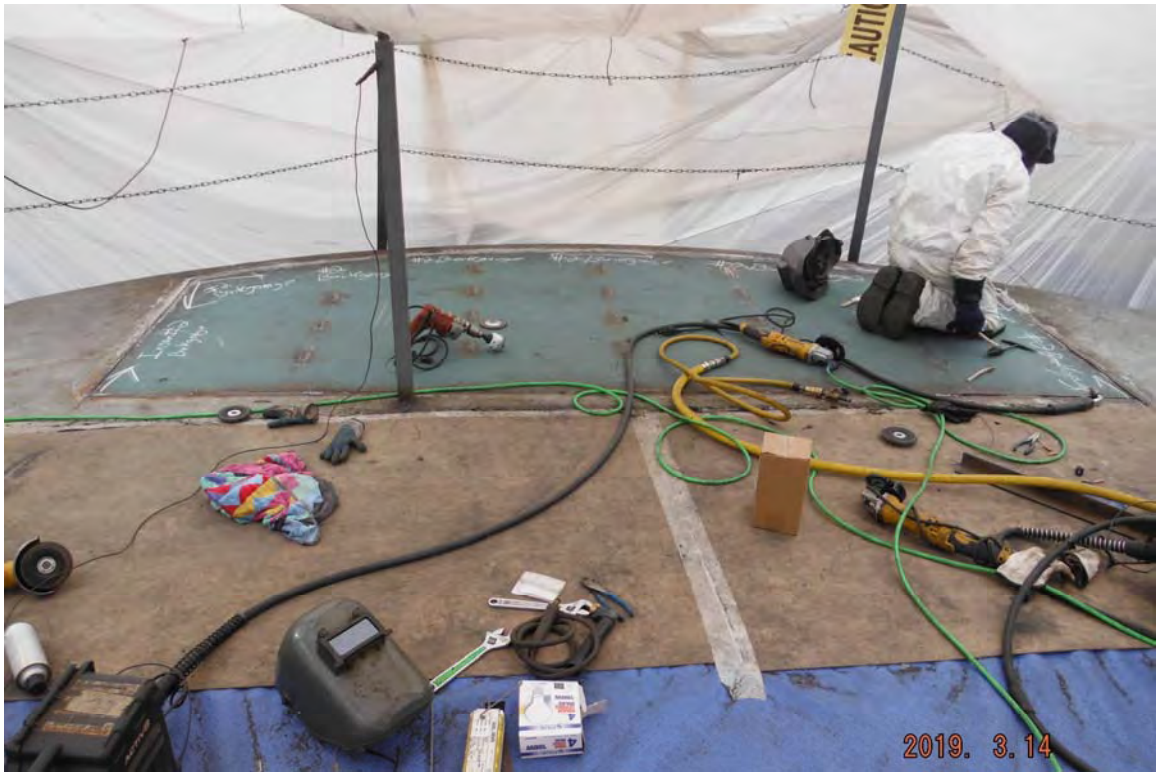
Photo No. 11  
Main deck apron showing new insert

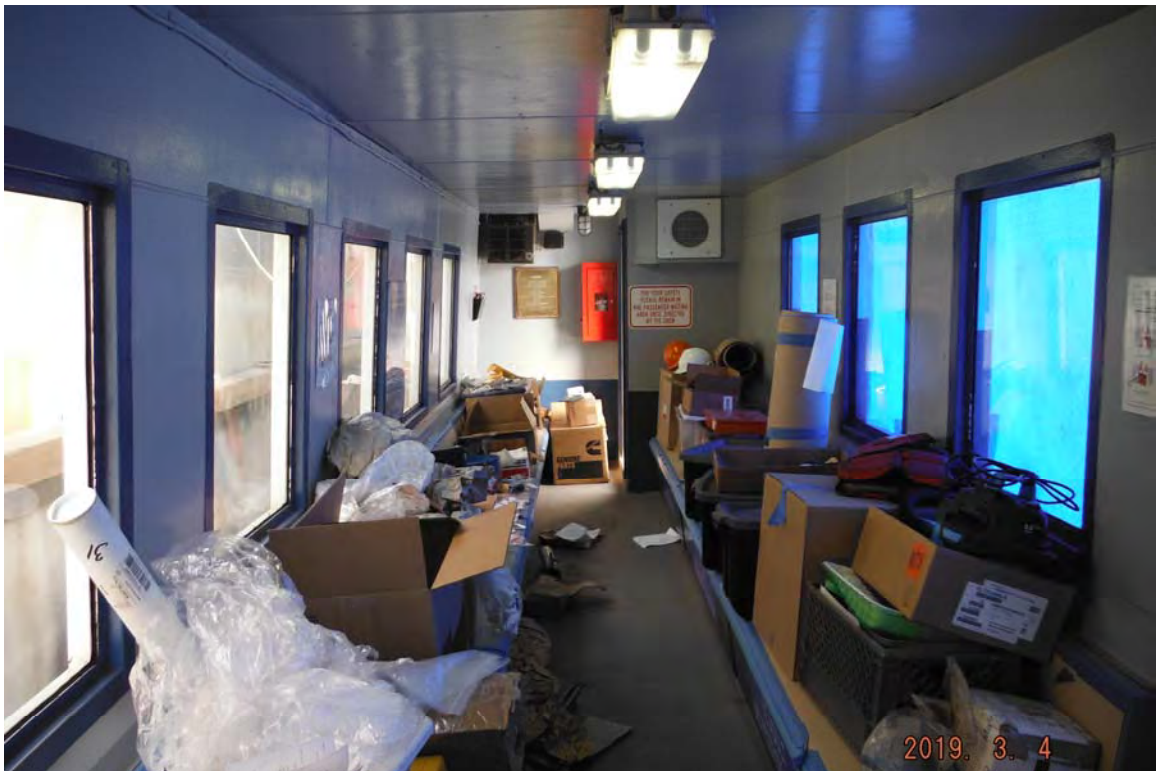
The main deck passenger lounge is accessed from the No. 1 end and deck side and can accommodate twenty-eight [28] walk-on passengers. It is outfitted with electric heat, bench seats, lifesaving and firefighting equipment. The crew's day room is electric heated, has wood cabinet with laminate counter and single basin stainless sink forward, chairs and laminate table.

Photo No. 12  
Passenger Lounge

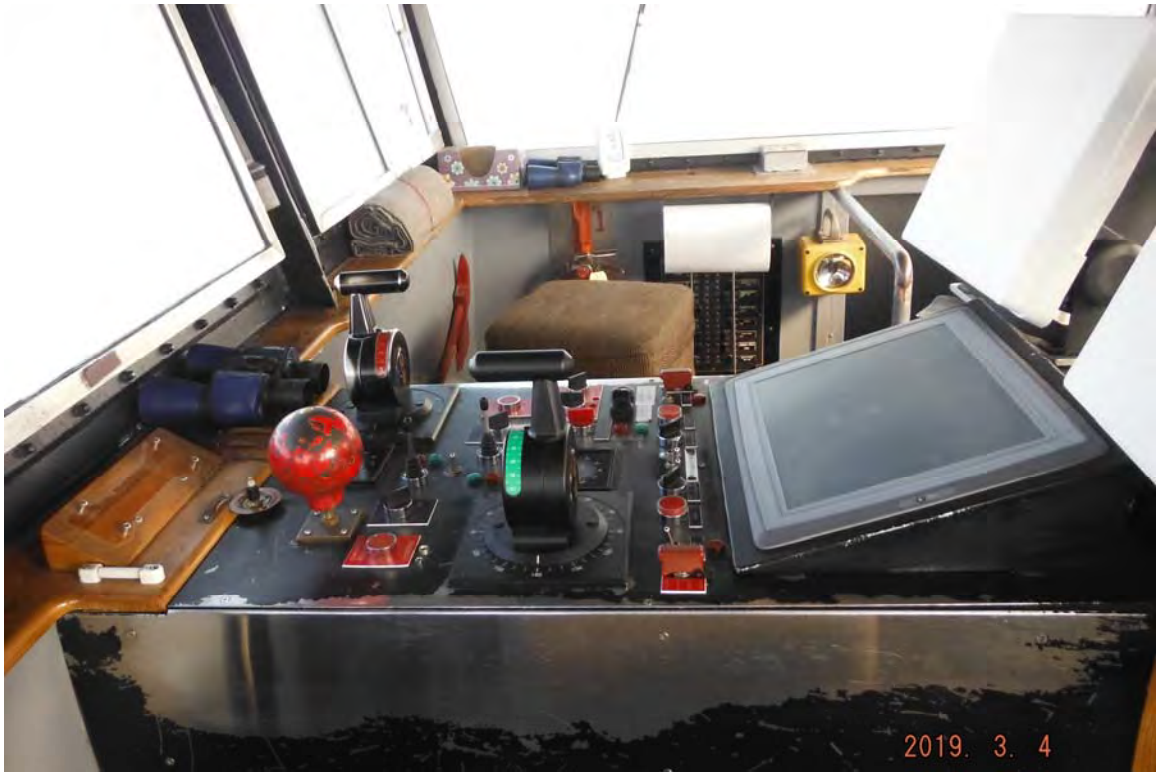
Photo No. 13  
Pilothouse Control Console
