# MARINE SURVEY

## REPORT No. CMS-17-4185

### M/V "GUEMES"

## Condition & Valuation Report

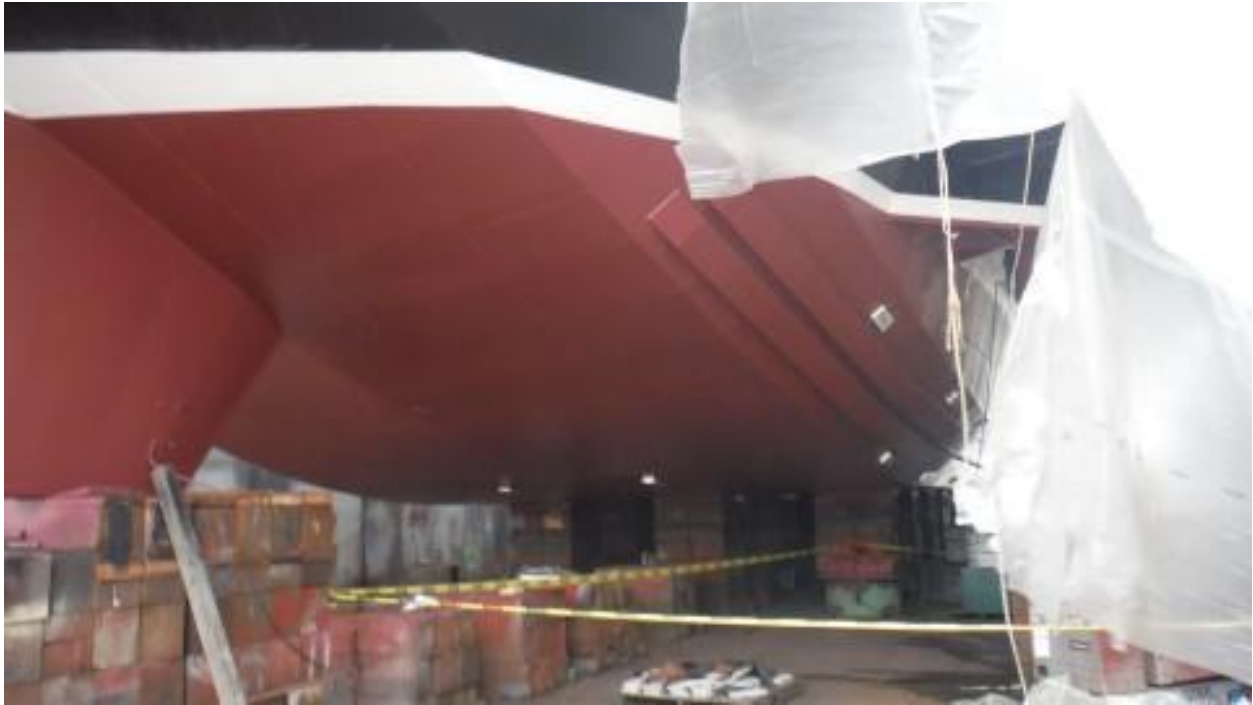
Detail of Bottom ,Starboard Side End #2

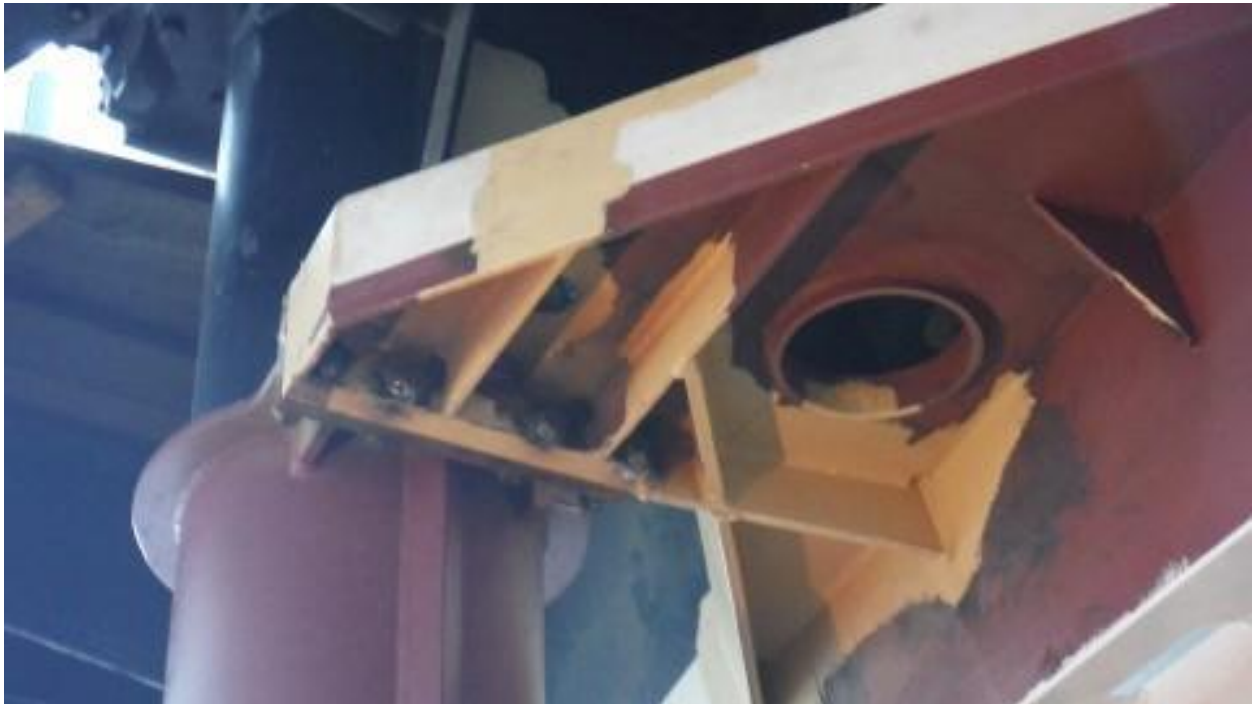
Photo showing outboard leg attachment to hull side.

- i. Maintain current navigation charts, Coast Pilot, Light List, Tide and Current Tables.
  - j. Maintain EPIRB and hydrostatic release (NOT APPLICABLE).
2. Maintain a close watch on thruster foundations for stress fractures in area of outdrive pin locations and hull attachment area.
3. Return repaired magnetic compass to vessel.
4. Swing repaired compass and provide compass deviation card.
5. Clean and re-stow vessel prior to return to service.

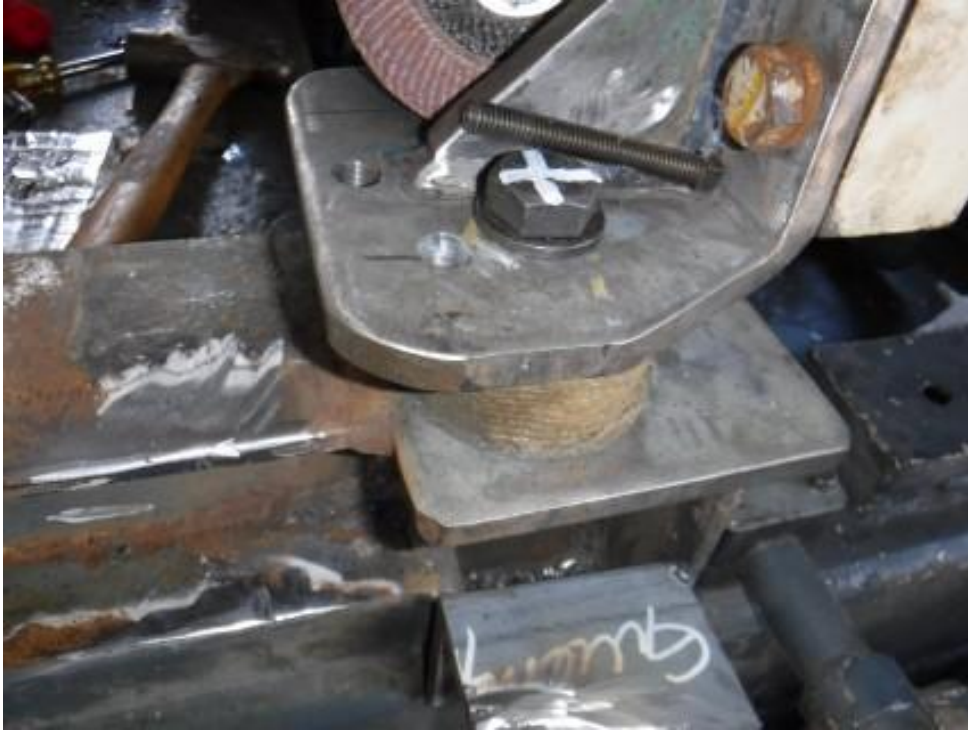
Detail of Vibracon propulsion engine mount

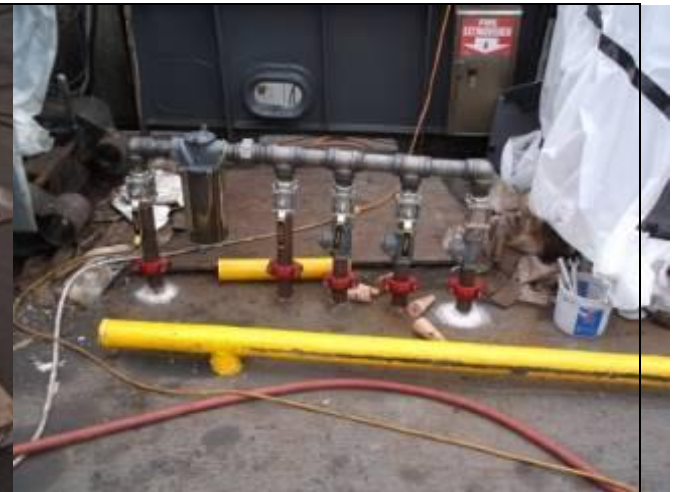
**06 New Bilge Washdown Manifold**

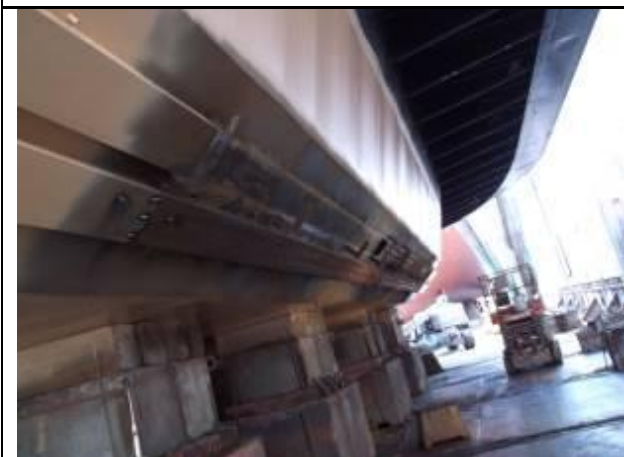
**Bottom:** Bottom found to generally be without indents and/or set-ins or repairs worthy of notation except for port side chine plate renewal 4-ft X 32-ft X 3/8-in; Bottom is protected by 16-zinc anodes on each side of bottom and 8-smaller zinc anodes on each azimuthing drive collar; Bottom is coated to 6-ft 6-in draft with antifouling coating.

**27 New Starboard Chine Plate**

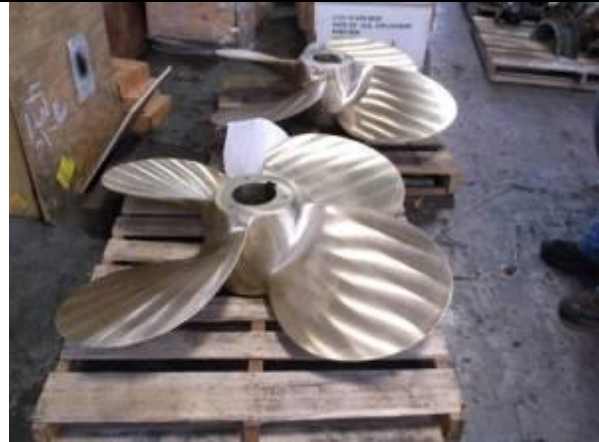
**30 Reconditioned Propellers**
