TECHNICAL MEMORANDUM

Date: May 24, 2010

From: Simon Page, Anchor QEA, LLC

Re: Lake McMurray Lake Level and Beaver Control Improvement Needs Evaluation Services

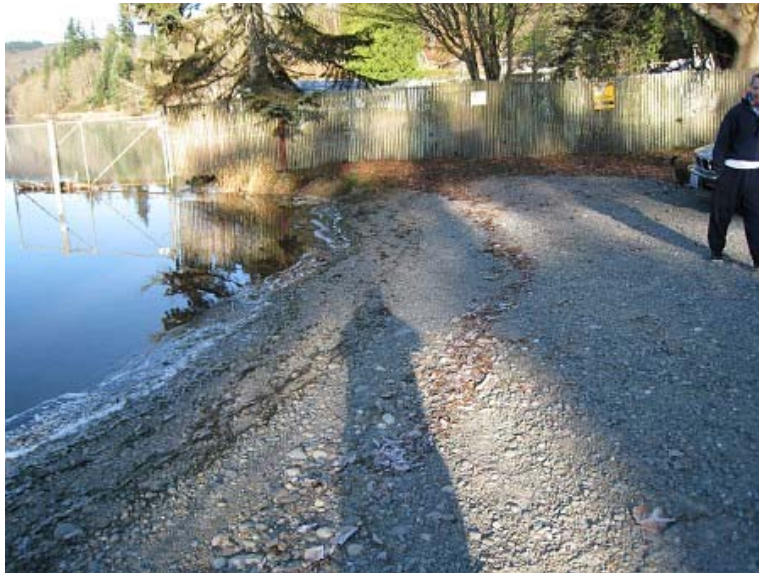
Because neighbors had recently reported rapidly rising waters, the County staff gage at the boat launch was visited for evidence of high water marks. Photo 1 shows a clear debris line about 0.7 foot above the staff gage's current water level read of 227.9 local datum (231.66 NAVD88; high water was approximately 232.36).

December 9, 2009 Lake Level and High Water Debris Line

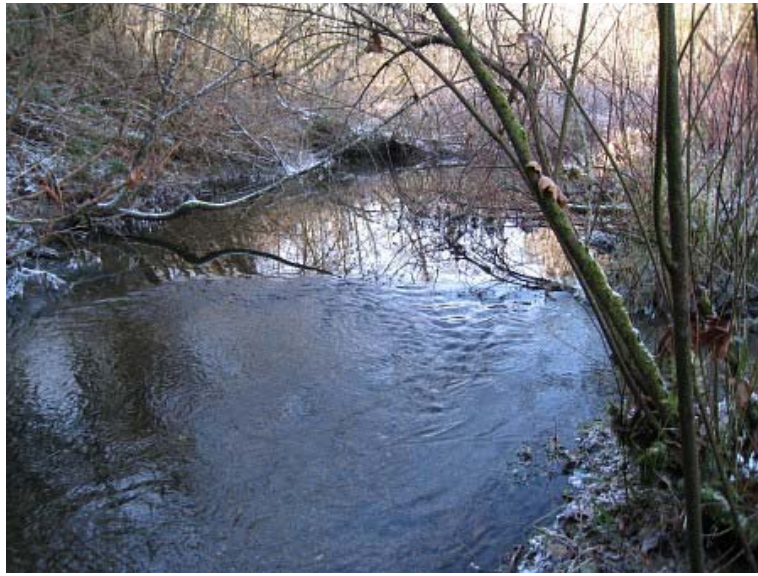
Photo 2

As previously mentioned, about 500 feet of the channel was waded from the culverts downstream during the December 2009 creek survey. Water was found to be 2 to 3 feet deep for the first 200 feet until a gravel bar was encountered that created a riffle (Photos 2 and 3).

Gravel Bar and Riffle 200 feet Downstream of McMurray Shore Drive Culverts

- Remove the gravel bar downstream of the McMurray Shore Drive culverts and maintain the channel
- For limited vegetation maintenance to maintain open water channels between existing open water areas in the outlet channel, in order to take advantage of downstream channel improvements
- To either adjust or remove the beaver deceivers (Exhibit 1)

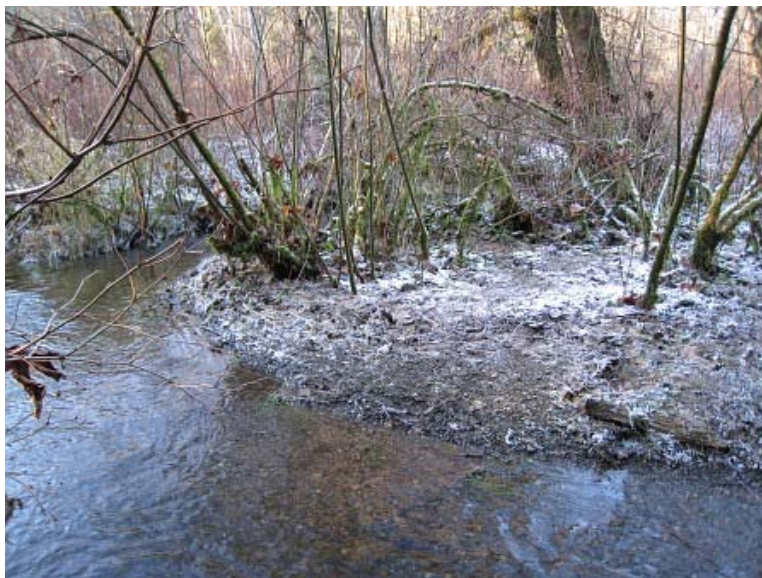
Photo 3

Gravel Deposits 200 feet Downstream of McMurray Shore Drive Culverts

This gravel deposit is located at the mouth of an unnamed tributary that enters Lake Creek from the west. The gravel deposit is relatively recent as appears to have buried the existing vegetation and there was limited new growth of the surface (Photos 3 and 4).

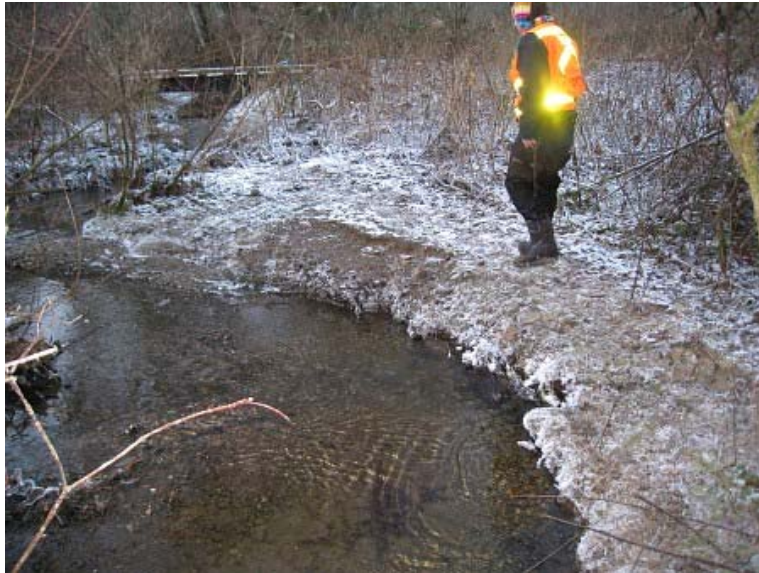
Gravel Deposits on the Floodplain Upstream of Confluence, December 2009

Photo 4 also shows that active erosion of the gravel deposit. Photo 5 shows the same location as Photo 2 in August 2009. Photo 6 shows the tributary looking downstream from the foot bridge in August 2009. Photo 7 shows a scour hole at the downstream end of the tributary culvert under SR 9.

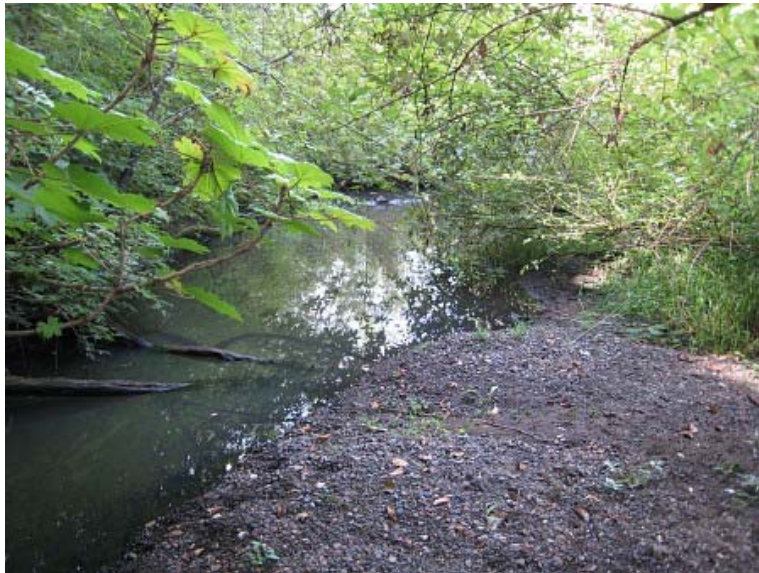
Photo 5

Mouth of Tributary with Lake Creek, August 2009

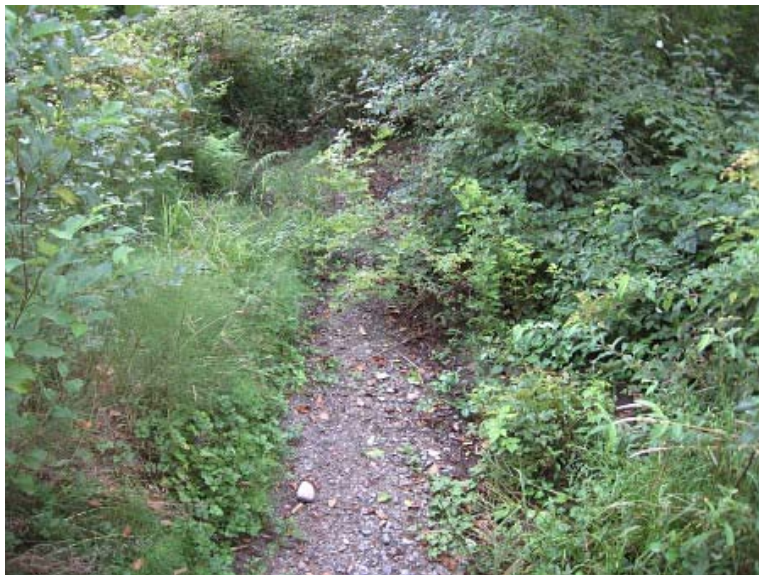
Photo 6

Tributary Channel Downstream from Foot Bridge, August 2009

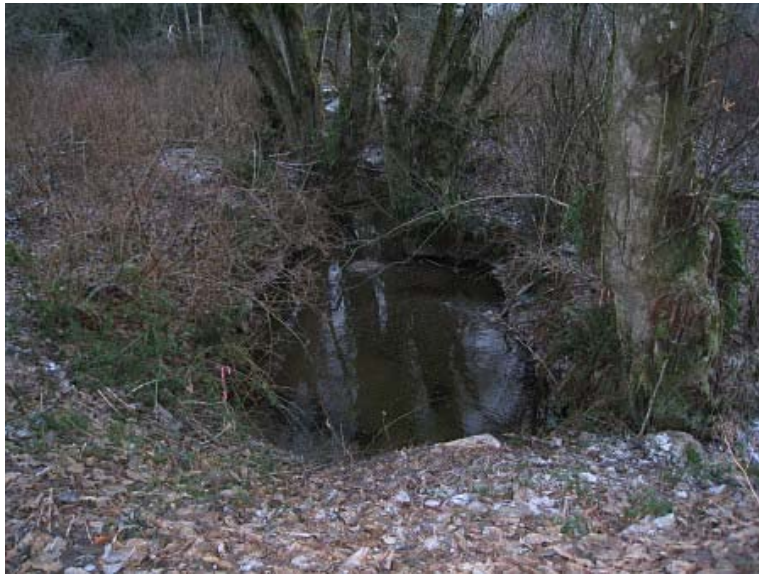
Photo 7

Scour at Outlet of SR 9 Culvert, December 2009
