# Memorandum

To: Karina Siliverstova, Skagit County Public Works  
From: Colin Butler, PE & Jeff Johnson, PE, Watershed Science & Engineering  
Date: September 17, 2021  
Re: Lake Campbell Outlet Investigation Summary of Findings

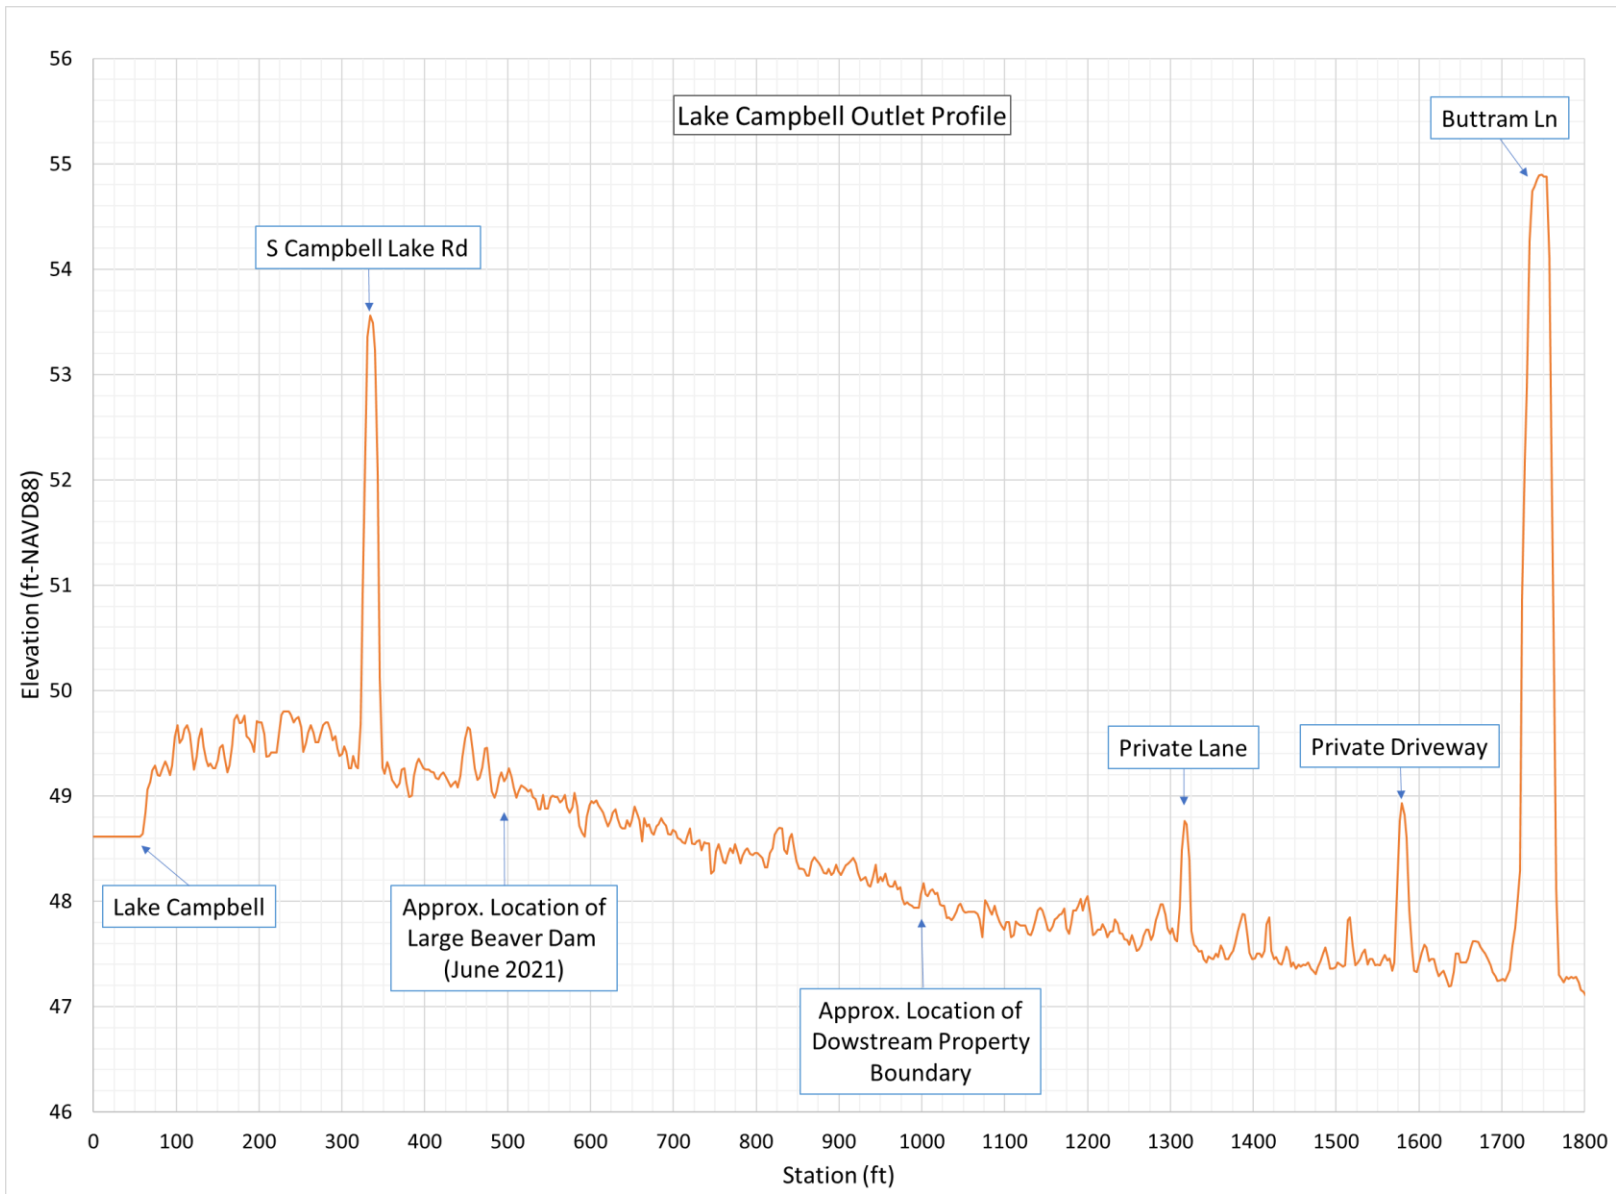
Figure 2 – Longitudinal profile of Lake Campbell outlet with key locations identified (Based on 2016 LiDAR)

Prior to the site inspection, WSE reviewed the outlet channel profile to identify features that may impact channel conveyance. The profile (Figure 2) was created from the North Puget USGS LiDAR data collected in 2016, which was the best available elevation data for this area. The profile reveals that the reach between Lake Campbell and Buttram Lane has a relatively flat slope and therefore may have reduced capacity due to factors such as surface roughness and channel blockage, so WSE focused the investigation on this reach. Downstream from Buttram Lane, the channel slope steepens which increases conveyance and reduces backwater impacts. As a result, WSE determined that the reach below Buttram Lane was likely not contributing to increased water levels at Lake Campbell.

The reach between the lake and Buttram Lane contains a beaver dam and two private driveway crossings. The two driveways have relatively small culverts according to County records (WSE did not examine the culverts due to property access limitations), but the roadway crests are low based on LiDAR elevations and easily overtopped during floods as confirmed by County photos. This likely limits the impact the driveways and their culverts have on upstream water levels. Buttram Lane is elevated on a high fill which does not overtop and could contribute to increased lake levels, but a 7-foot diameter culvert was installed in 2006 to reduce upstream flooding and accommodate fish passage (see Figure 3). The large capacity of the culvert indicates that Buttram Lane is likely not contributing significantly to increased water levels at Lake Campbell.

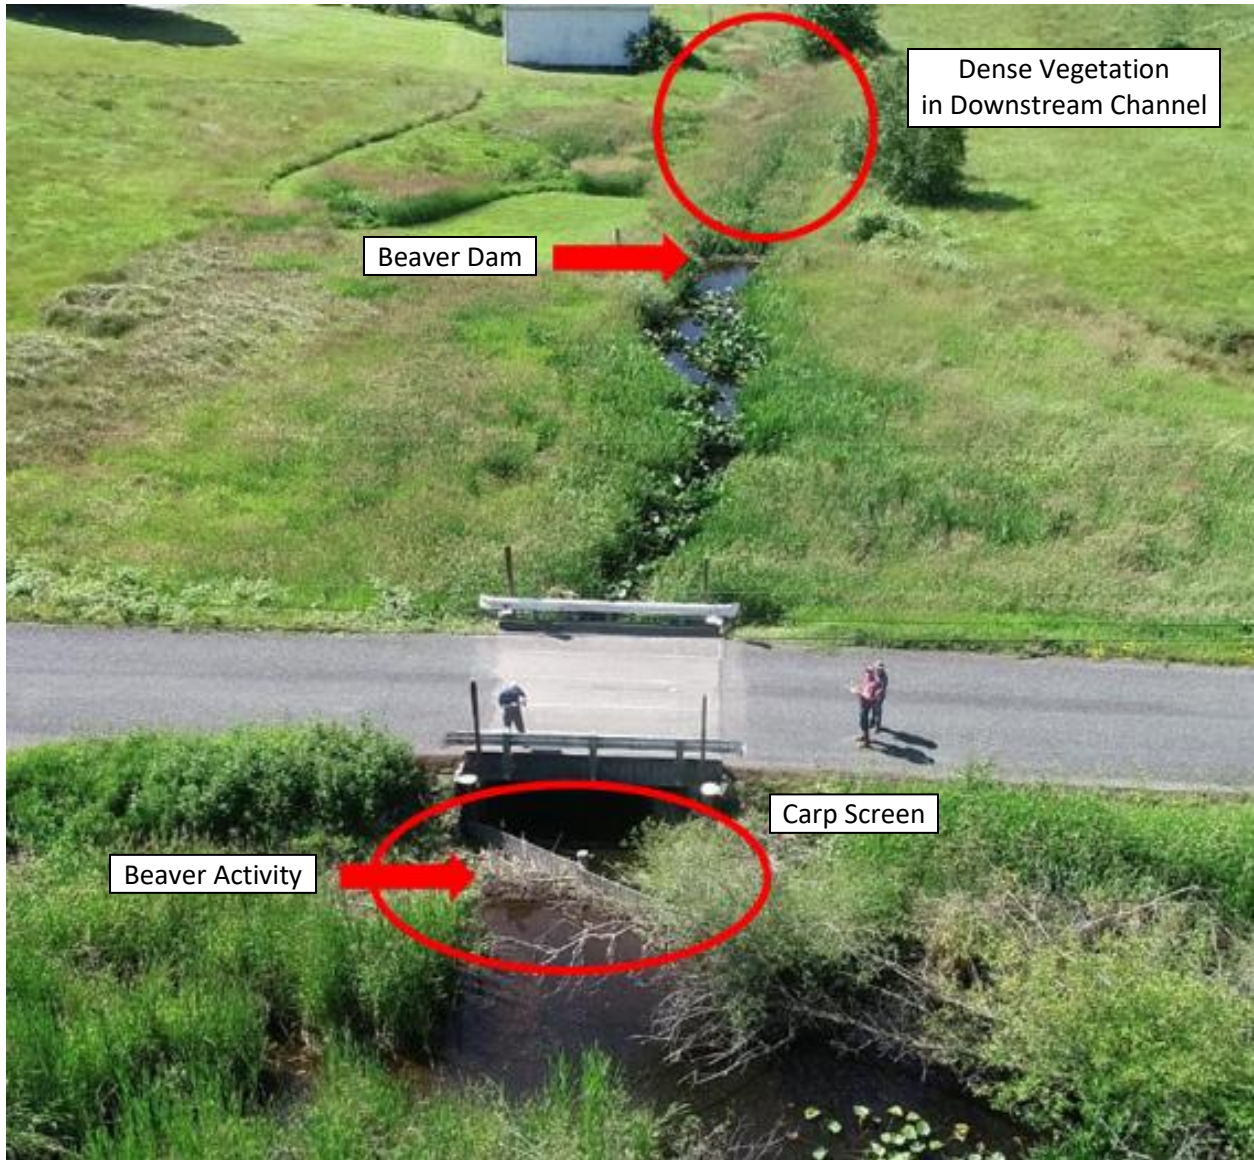
Figure 4 – Features likely affecting outlet channel capacity and therefore lake levels (Photo taken June 17, 2021)

- Carp screen upstream of the South Lake Campbell Road bridge combined with mud and debris that beavers had packed along the upstream side of the screen prior to the County's relocation of the screen
- Beaver dam located approximately 150 feet downstream from the bridge
- Dense vegetation in the channel downstream from of the beaver dam

The features are identified in Figure 4, and their effects on channel capacity are described below. The highwater photos used to describe the effects were provided by the County.

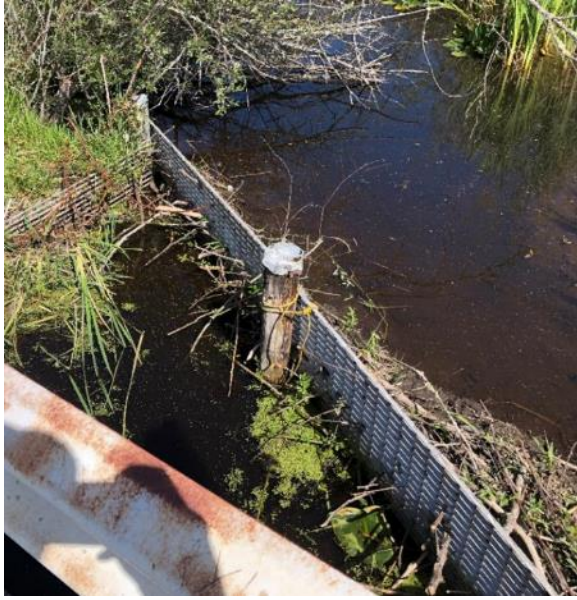
**Photo 1 – Carp Screen during low flow (June 17, 2021)**

Photo 1 show the carp screen during low flow with mud and debris packed along the upstream side as a result of beaver activity. Photo 2 reveals that during the January 2020 highwater event, the drop in water surface elevation across the screen was only a few inches. This suggests that the screen and beaver activity on the screen have some influence on lake levels at this flow, but it is important to note that water levels in the channel downstream would still be high even without the screen and beaver activity. If the screen and associated beaver activity were the sole features responsible, we would expect to see lower water levels in the downstream channel and a much larger drop in the water surface over the screen. Therefore, the carp screen and associated beaver activity are not the only factors affecting lake levels; additional downstream factors are also responsible.

- Beaver dam removal and/or management
- Channel restoration and/or vegetation management
- Carp screen relocation and/or modification

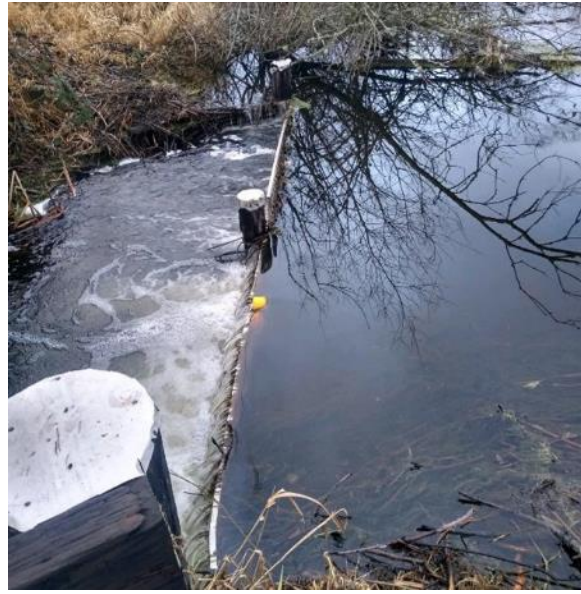
**Photo 2 – Carp screen during highwater (Jan. 25, 2020)**

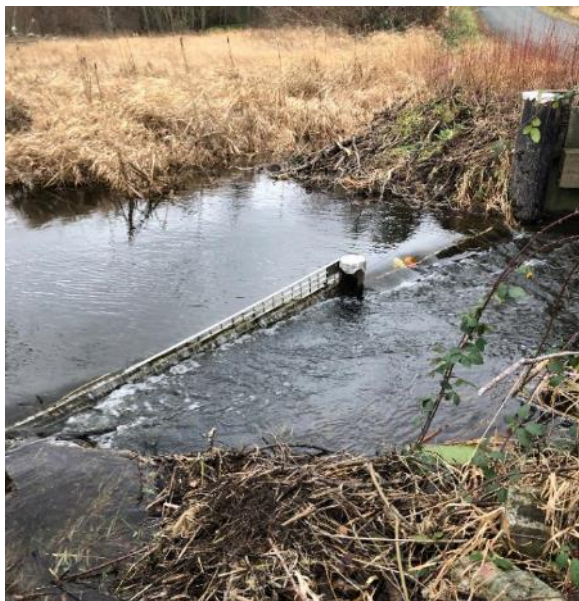
**Photo 3 – Carp screen during highwater (Jan. 5, 2021)**

Photo 3 shows the carp screen during a highwater event that occurred on January 5, 2021. There is almost no drop in the water surface over the carp screen during this event. Photo 4 shows the channel downstream from the road during the same event. Ripples on the water surface in the photo indicate that the water levels are high enough for water to actively flow over the submerged downstream beaver dam. However, the capacity of the channel is significantly impacted by the beaver dam and the thick vegetation in the channel. This evidence indicates that the channel downstream from the carp screen is having a significant influence on lake levels.

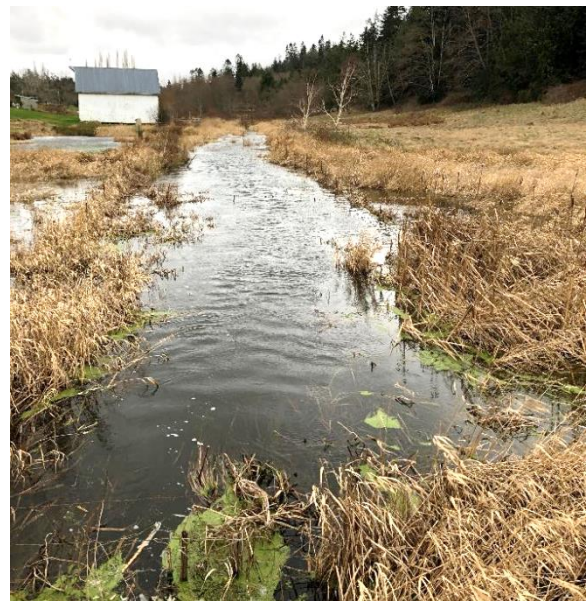
**Photo 4 – Downstream channel (Jan. 5, 2021)**

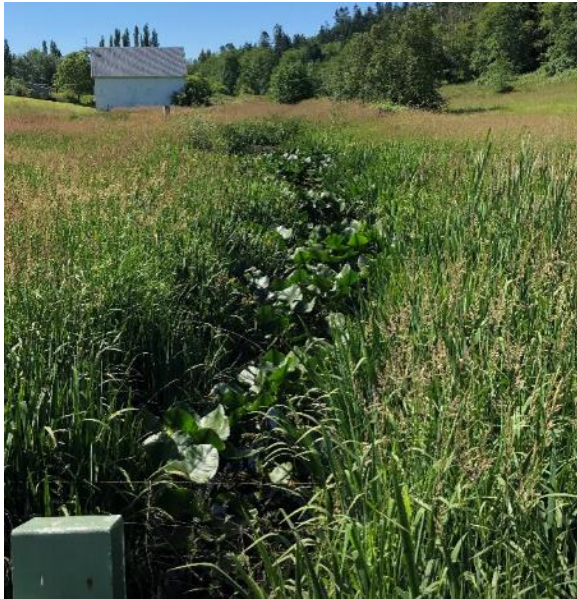
**Photo 5 – Downstream channel on June 17, 2021 (Photographer oriented looking downstream)**

These photos show that vegetation is more dense during the summer (Photo 5) than during the previous winter (Photo 6). The channel remained fairly open at higher water levels during the January 25, 2020 event as shown in Photo 6. This section of the channel was dredged years ago by the landowner's father-in-law. As a result, it is wider and deeper than the channel further downstream, and the vegetation has not yet regrown to the extent that it has further downstream. The water in Photo 6 does not show obvious signs of movement, likely due to the beaver dam at the downstream end of this reach and a more densely vegetated channel below this reach.

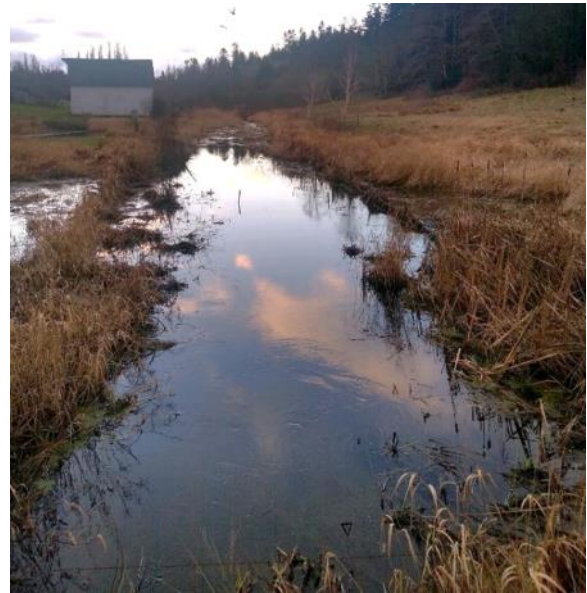
**Photo 6 – Downstream channel during highwater on Jan. 25, 2021 (Same orientation as Photo 5)**

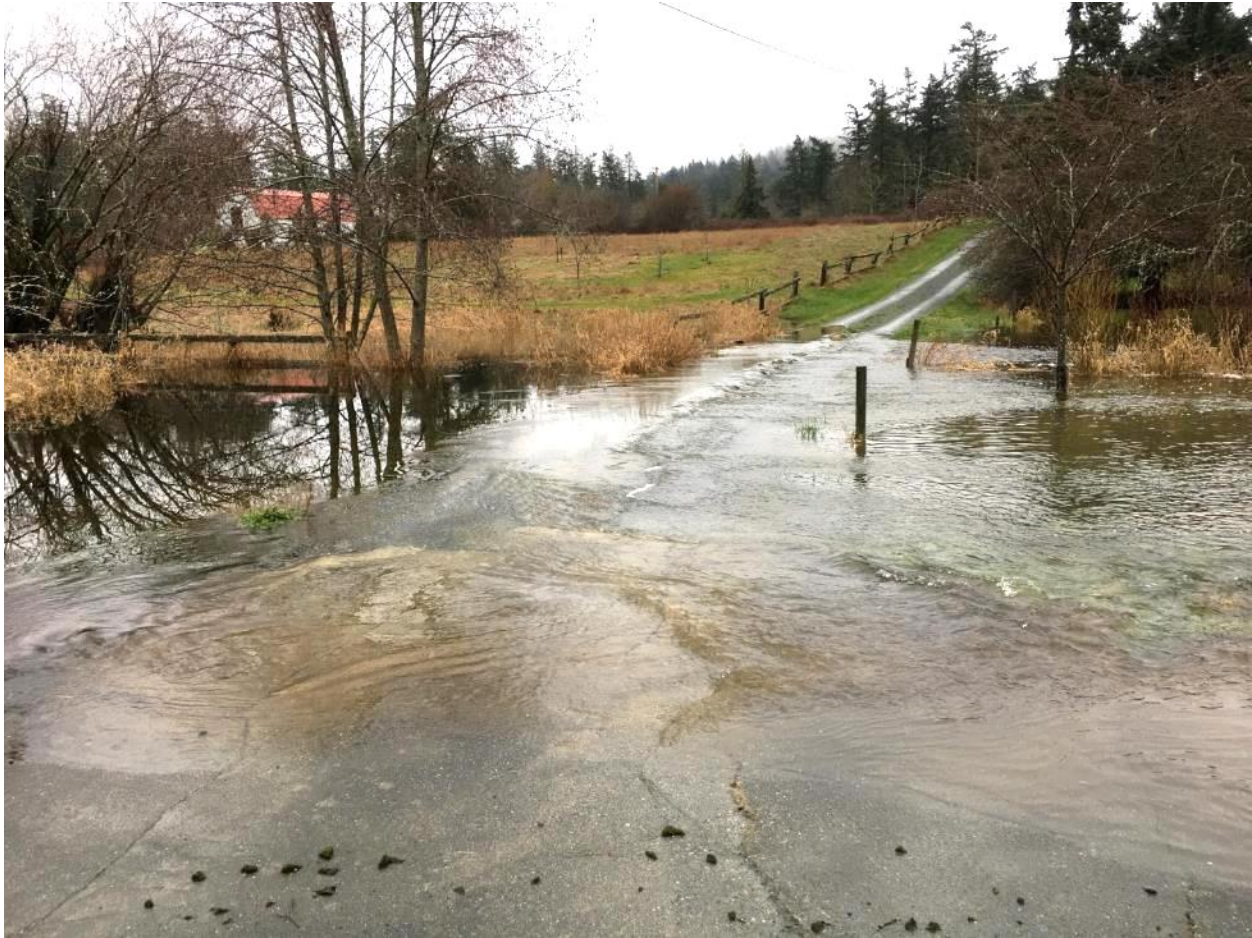
**Photo 7 – Shallow flooding over private driveway upstream of Buttram Lane (February 2020)**

Photo 7 shows water overtopping one of the private driveway crossings upstream of Buttram Lane during a highwater event in February 2020. This driveway may have some influence on upstream water levels as was alluded to in the Channel Profile discussion, but we can't determine the magnitude of its impact without additional data.
