## Stormwater Facility Background and Inspection Report

Location: 44510 Concrete Sauk Valley Rd., Concrete, WA. 98237  
Parcel number: P70969  
Owner: Skagit County  
Inspection date: 6/13/18  
Report Update: 9/20/22

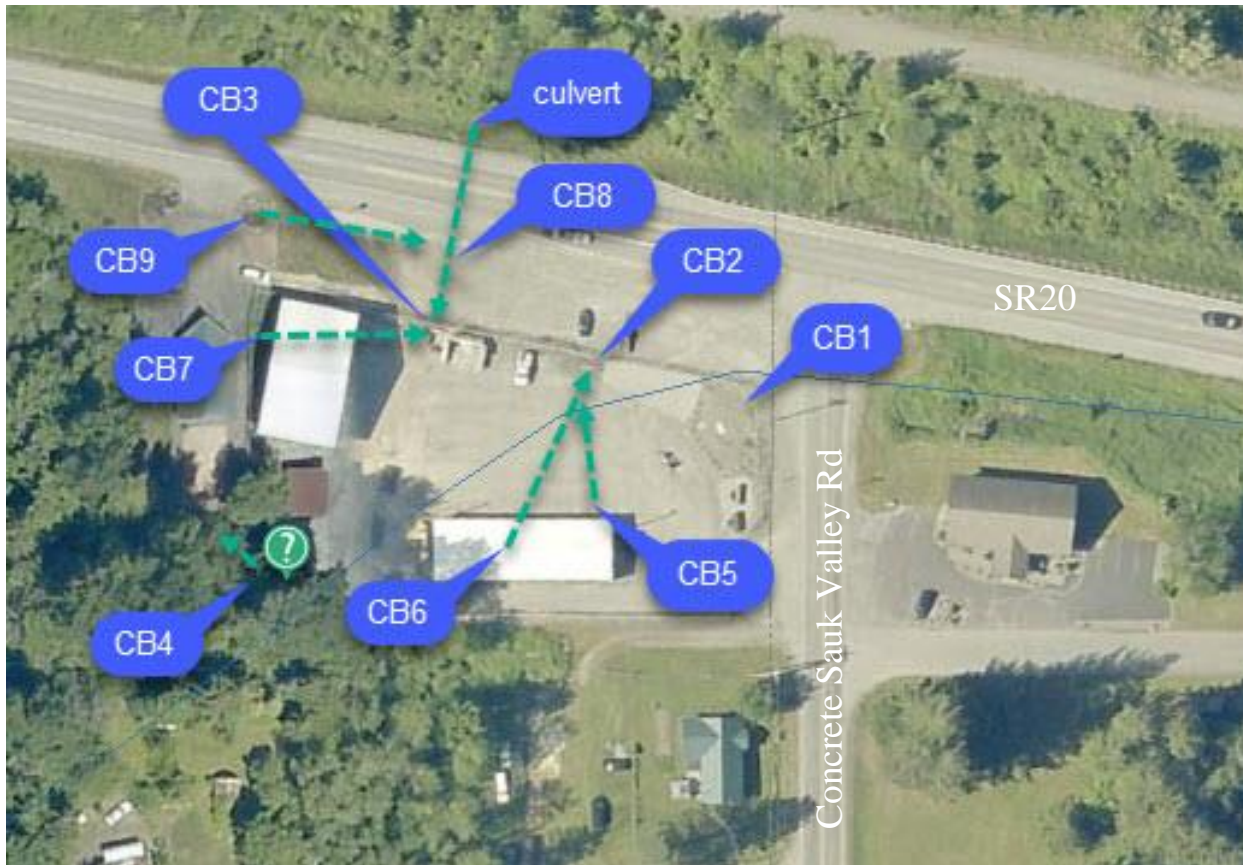
Stormwater for the site at P70969 is managed through seven catch basins within the parcel (Figure 2). The site also receives stormwater from external sources, including the ditches north and south of State Route 20 (SR20). The north ditch flows through a cross-culvert underneath SR20 into CB8 before entering the county's site and the south ditch flows eastward into CB8 before entering the county's site. All stormwater captured onsite discharges to Lorenzan Creek. The portion of Lorenzan Creek that crosses the property is enclosed in a 30" concrete culvert that runs under the site for approximately 278'. The stream flows west, entering a culvert just before crossing Concrete Sauk Valley Road and daylighting approximately 20 feet west of the property boundary toward the southwestern corner of the parcel. This culvert is documented by Washington Department of Fish and Wildlife (WDFW) as a barrier to fish passage at both the inlet and outlet (*WDFW Fish Passage, GR18 surveyed by WDFW 5/2018*).

**Figure 2.** Approximate locations of catch basins. Blue line represents the approximate location of Lorenzan Creek (see remarks for Fig. 1) and the green arrows represent stormwater paths. A question mark is assigned to CB4 because it is constructed with a downturn pipe (presumed to function as an oil-water separator), which is suspected to discharge directly into Lorenzan Creek (cannot be confirmed at this time).

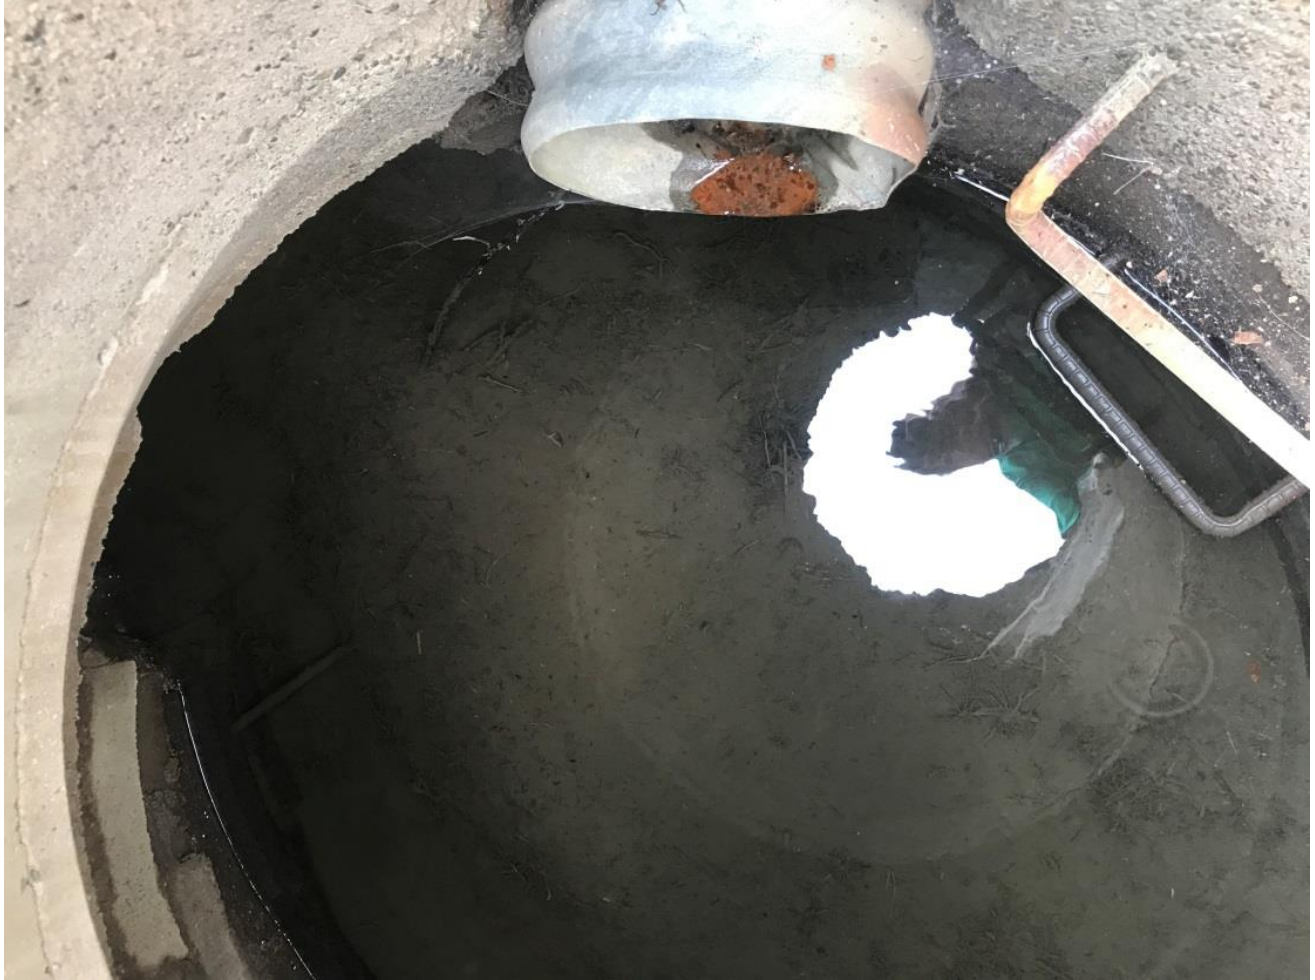
All sediment deposits in the CBs are presumed to be a combination of transport by Lorenzan Creek and stormwater runoff. Inspection notes from June 13, 2018 indicated that CB1 accumulated at least six inches of sediment along the catch basin walls. There was little to no sediment in the path between the inlet and outlet pipes (flow of Lorenzan Creek). CB2 contained at least 12 inches of sediment evenly distributed across the bottom and CB3 had at least 18 inches of sediment evenly distributed across the bottom. All CBs are approximately six feet in diameter.

Both CB2 and CB3 contained sediment build-up at the inlet and outlet points of the structure that covered more than 50% of the pipe opening. Ecology standards require CBs to be cleaned when they exceed 60%, measured from the bottom of the sump to the invert of the lowest pipe. Therefore, these CBs exceeded the standard and required maintenance.

**Figure 3.** CB3 with the lid off revealing the artificial stream bed. Sediment depth is  $\geq 18''$ . The metal pipe discharges stormwater from CB7.

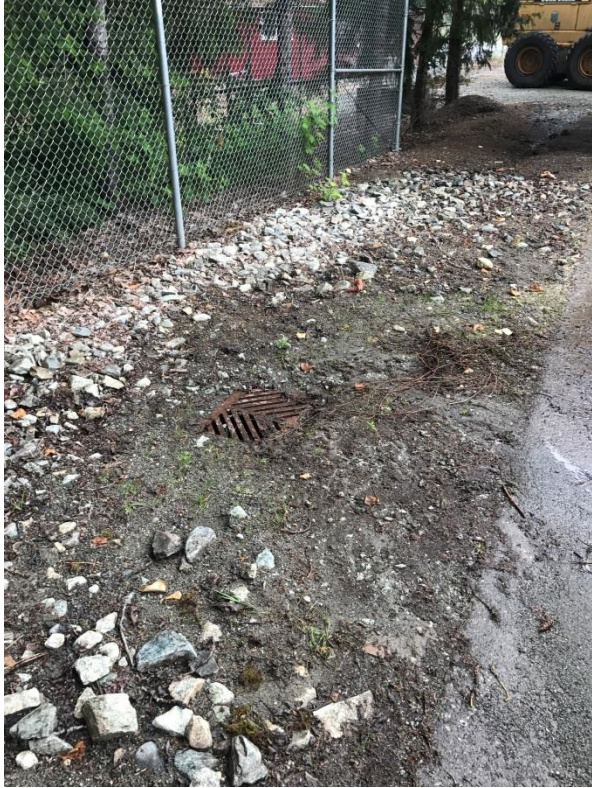
CB4 is located at the edge of a washout station; functionality and conveyance are currently unknown (Figure 4). When stormwater staff inspected CB4, the sump was almost completely full of sediment. A request was submitted for CB4 to be cleaned. Unfortunately, the stormwater inspector was not able to be present during the cleaning to observe and identify internal structures. A subsequent observation to determine conveyance was precluded by turbid water in CB4. Based on communication with the maintenance staff, CB4's outlet conveys stormwater west into Lorenzan Creek. The outlet pipe is a 90-degree downturn pipe that is suspected function as an oil-water separator. No inlet pipe has been identified in CB4.

**Figure 4.** CB4, known as the washout station

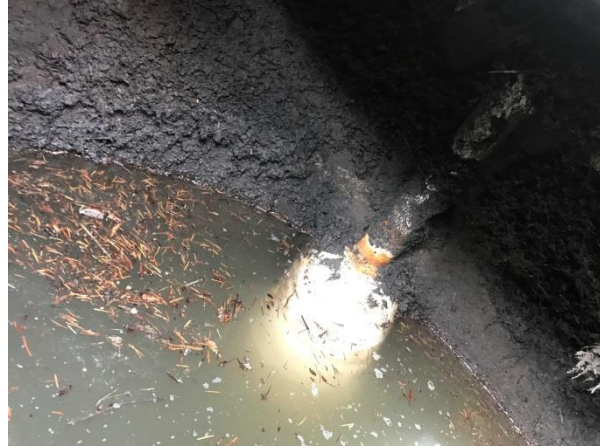
**Figure 5.** Possible oil-water separator within CB4.

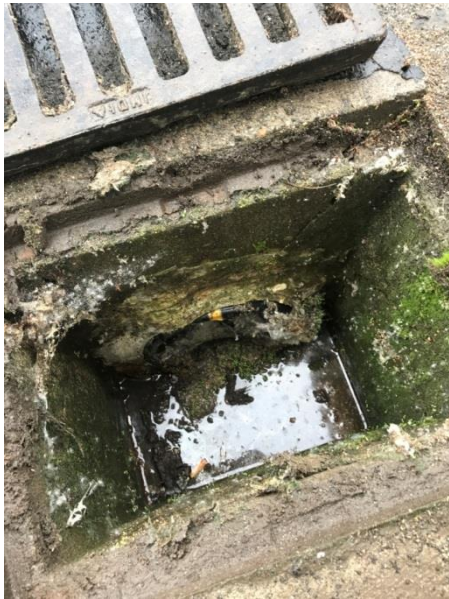
There are two small CBs that drain stormwater from the equipment shop and discharge directly to CB2 (Figures 6, 7, 8 & 9). CB5 is situated just outside the main entrance on the NE corner of the building and CB6 is located inside the equipment shop in a garage stall.

**Figure 6.** CB5 with lid removed.

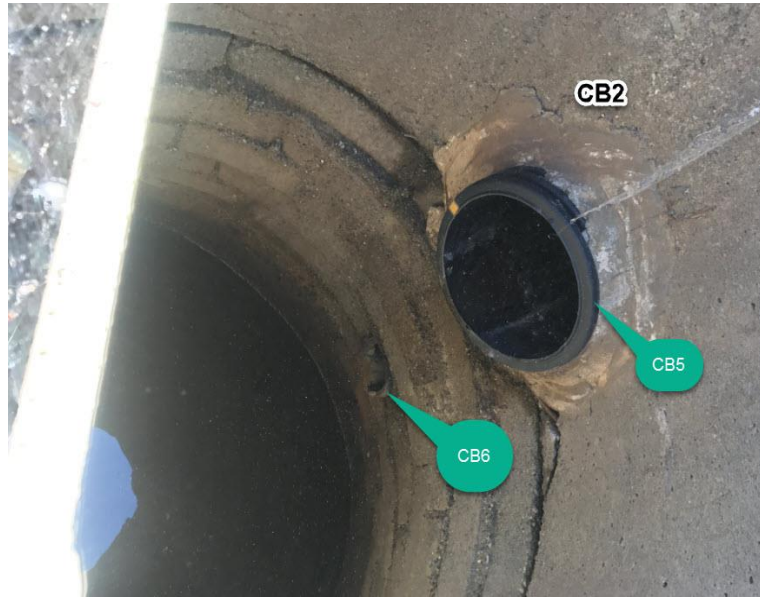
**Figure 7.** CB2 with origins of inlet pipes identified.

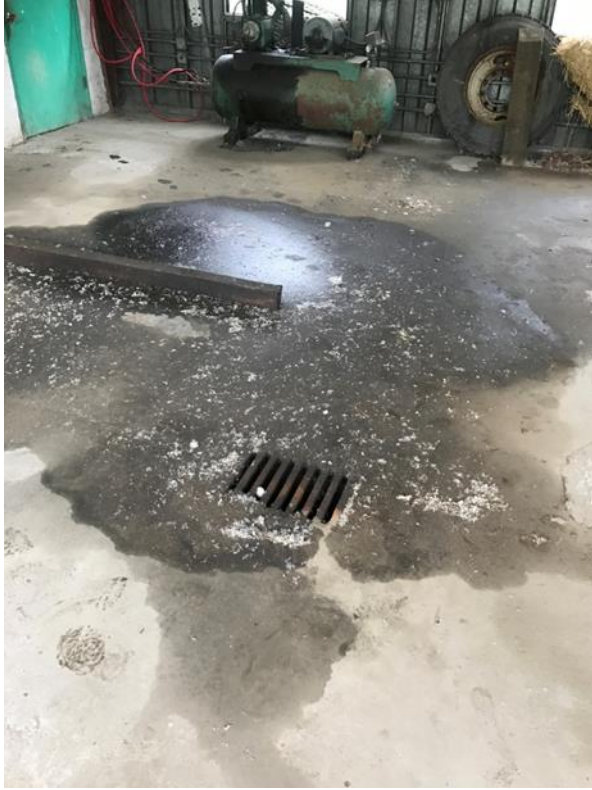
**Figure 8.** CB6 located in the equipment shop.

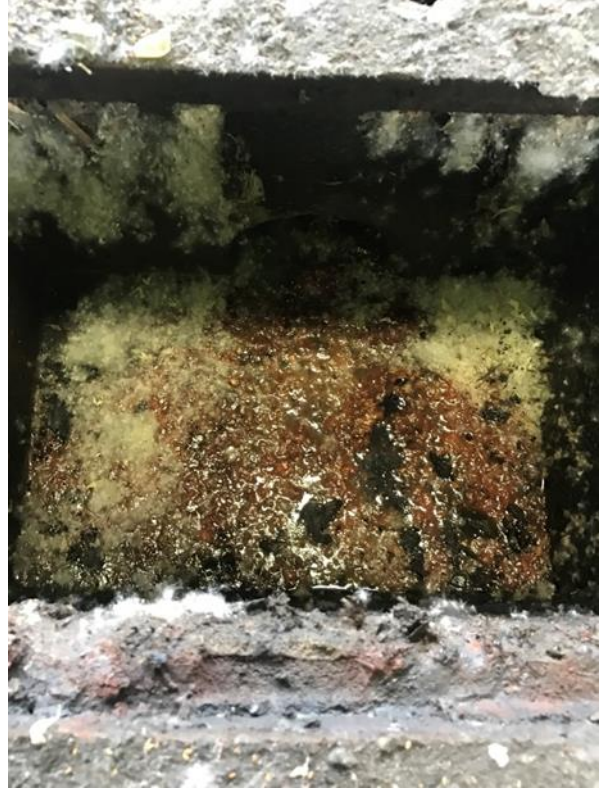
**Figure 9.** CB6 with lid removed.

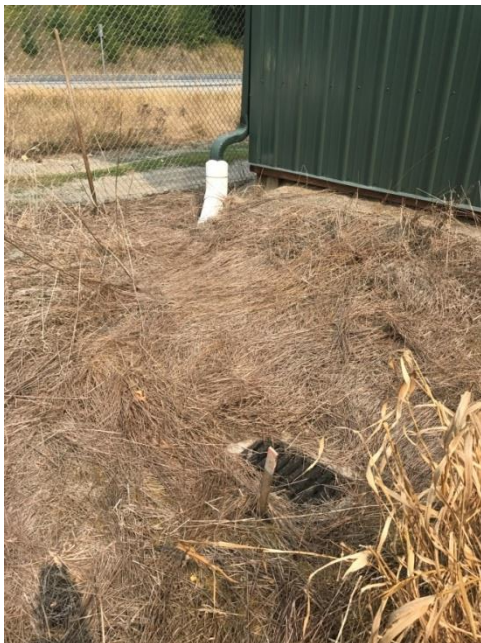
Lastly, CB7 receives stormwater from the roof drains of the larger pole building located on the northwest corner of the parcel (Figure 10). Stormwater from CB7 flows to CB3, where it discharges to Lorenzan Creek.

**Figure 10.** CB7 and one of two roof drains connected to CB7.

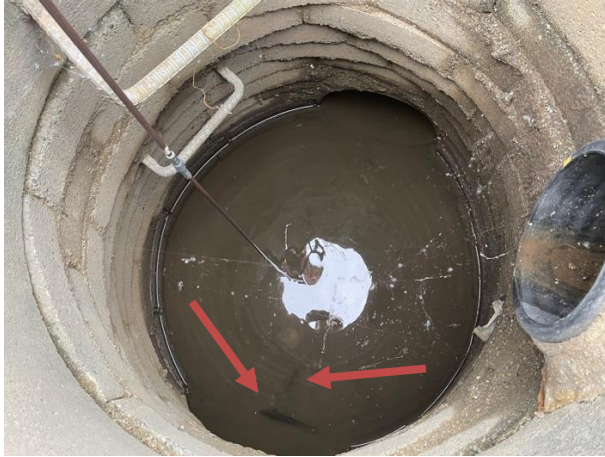
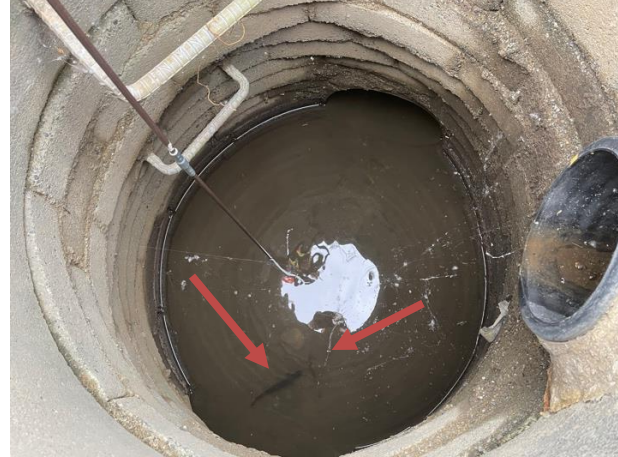
In 2023, SCPW stormwater staff documented fish presence in CB2 (Figures 11 & 12) and CB3 (no available photo). These observations were made while conducting the annual stormwater facilities inspection.

**Figure 11.** Two unidentified salmon in CB2 – June 2023. **Figure 12.** Two unidentified salmon in CB2 – June 2023.
