WSDOT Local Programs
Federal Local Bridge Program
Project Application

STRUCTURE ID	BRIDGE NUMBER	BRIDGE NAME
08228800	40070	SKAGIT RIVER MARBLEMOUNT
_____	_____	_____
_____	_____	_____
_____	_____	_____
_____	_____	_____
_____	_____	_____

The project consists of rehabilitating deficient elements of the 92 year old structure, including gusset plate replacement, cleaning and painting of the bridge, sealing and caulking of pack rust, expansion joint replacement, bearing repair, structural steel repair, and approach railing replacement.

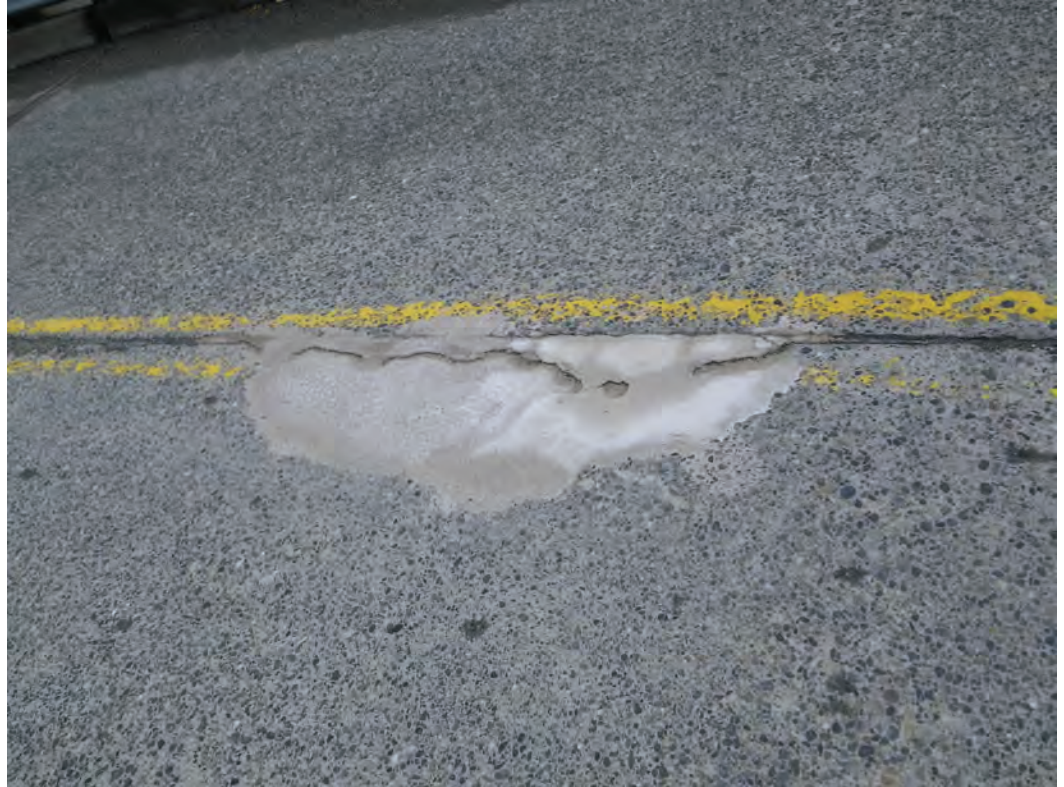
SI-37

13	Deck surface over the approach spans is worn in the wheel lines. Span 1 has a 5 ft. x 20" patch near midspan and a 6" x 12" spall near Pier 2. See photos #37 and #38. REPAIR #12708. Span 5 has an 8 sq. ft. patch in the eastbound lane.
35	Soffit has a few transverse hairline cracks scattered throughout with some rust staining, and several areas of shallow delamination and spalling at the floor beams exposing rusty flanges. See photo #5 (typical). Panel 5, between Stringers A and B, there is a 1 ft. diameter patch and a 16" diameter spall around patch near Floorbeam 5. Panel 7, near Floor Beam 7, there is a spall 6" x 10" x 3" deep between Stringers E and F. Panel 18, there are rock pockets with exposed rebar between Stringers C and D.

13 Bridge Deck Surface
Photo Type: G - General
Orientation: SE
Date: 3/25/2014
Repairs:
Span 1 has a 5 ft. patch at the centerline.

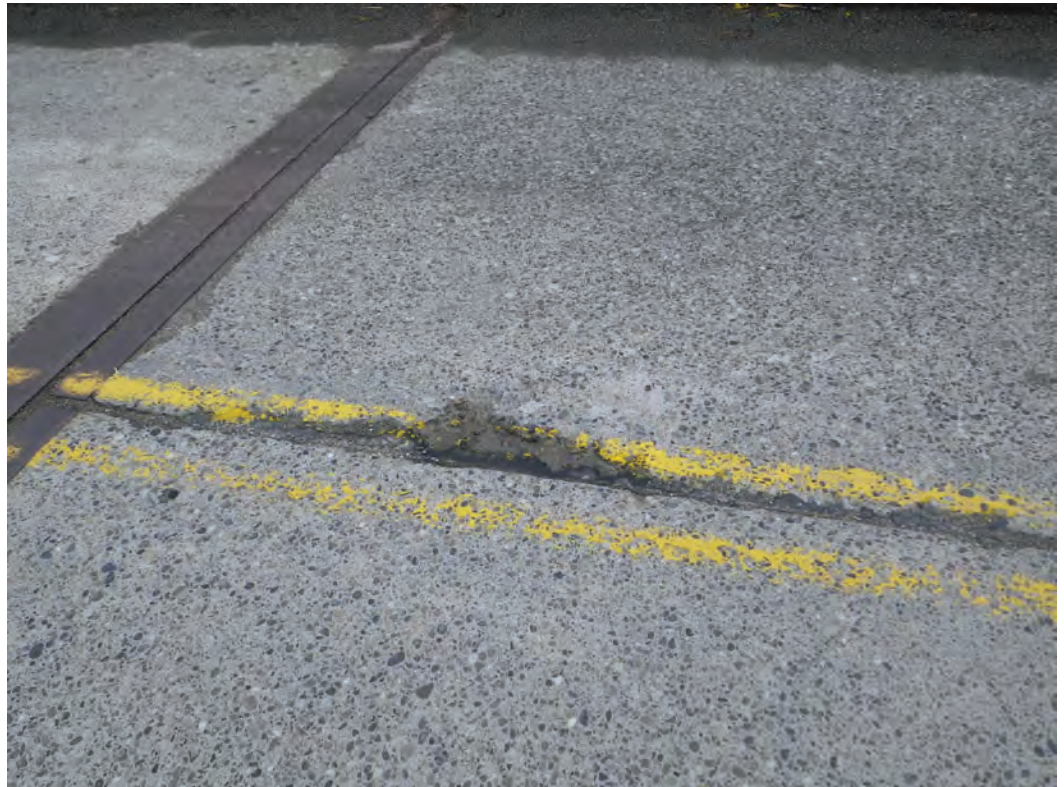
SI-38

13 Bridge Deck Surface
Photo Type: R - Repair
Orientation: S
Date: 3/25/2014
Repairs: 12708
Span 1 spall near Pier 2.

Repair No	Pr	R	Repair Descriptions	Noted	Maint	Verified
12703	0	J	Replace split spacer block at northeast corner.	3/17/2010		
12705	1	B	Remove debris from upstream face of Pier 4. (This is a recurrent problem, consider the installation of a shark or debris deflector).	3/14/2012		
12707	1	J	Repair or replace the 20 ft. length of damaged guardrail at the northwest corner.	3/25/2014		
12708	1	B	Remove loose or spalled concrete from the spalled deck surface over Span 1. Clean and paint any exposed rebar and patch with an approved material.	3/25/2014		
12711	1	B	Bottom chords of both north and south trusses have a few areas of debris that inhibits inspection (areas are primarily over land at ends of truss spans). Clean debris from bottom chords prior to next scheduled UBIT inspection in 3/2022 (majority of debris can be seen and maybe accessed from deck).	3/4/2020		
12712	1	J	Remove loose ACP and patch pothole at east abument joint in the eastbound lane.	3/4/2020

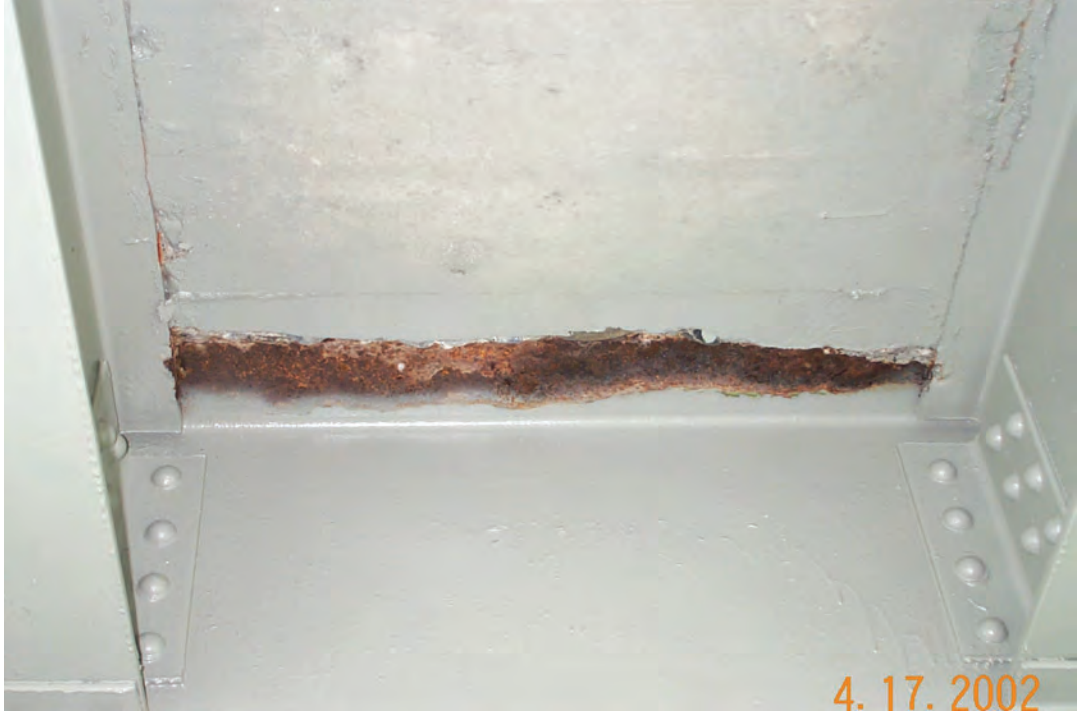
SI-5

35 Soffit
 Photo Type: G - General
 Orientation: UP
 Date: 4/17/2002
 Repairs:
 Span 3 Floorbeam 16 corrosion between Stringers E and F.

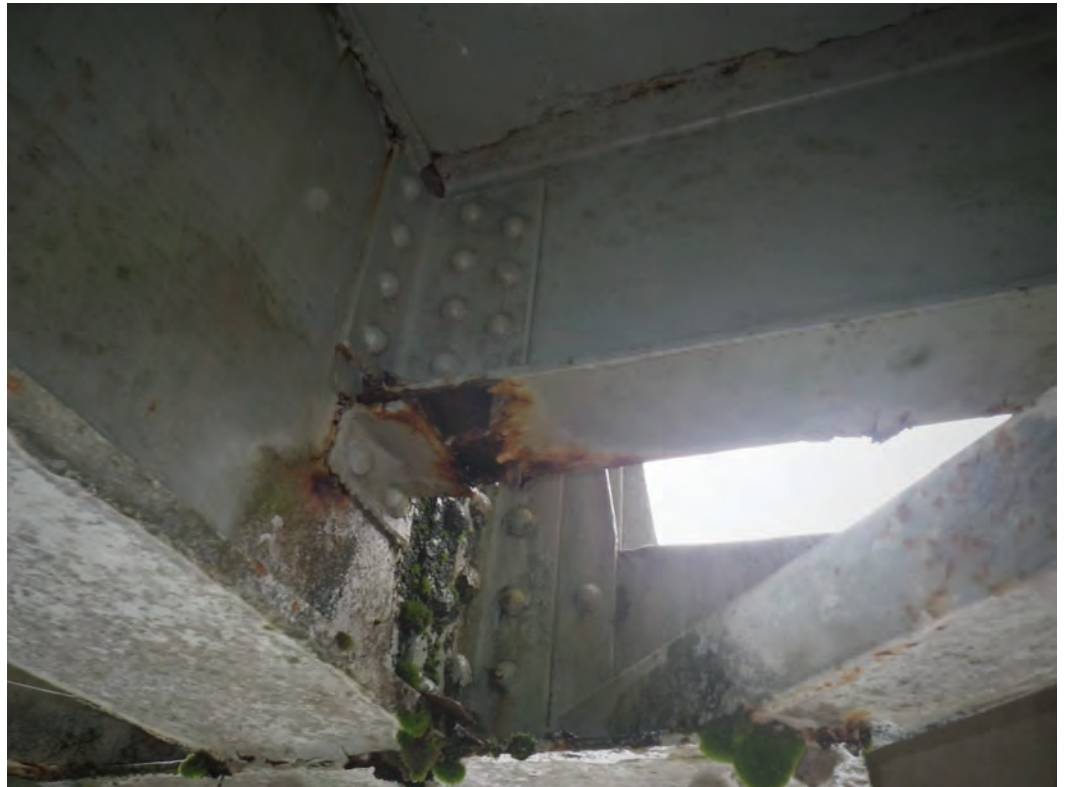
SI-44

Stringer 10G top flange (at Floorbeam 9) and Stringer 11G top flange (at Floorbeam 10) each have a 6" diameter rust scallop. REPAIR #12714.
 Stringer 13G bottom flange (at Floorbeam 13) has laminar rust with approximately 10% section loss at erection angle seat. See photo #44. REPAIR #12714.
 Stringer 14G bottom flange (at Floorbeam 13) and Stringer 15G bottom flange (at Floorbeam 14) each are bent up 1" over a 12" length near the floorbeam connections.
 Stringer 24G bottom flange (near Floorbeam 23) has laminar rust over 12" with approximately 10% section loss. See photo #45. REPAIR #12714.
 Stringer 28C bottom flange near Floorbeam 28, is bent upward 1".</p> |

113 Steel Stringer
 Photo Type: G - General
 Orientation: SE
 Date: 3/4/2020
 Repairs: 12714
 Stringer 13G bottom flange (at Floorbeam 13) has laminar rust at erection angle seat.

12714	2	B	Remove rust, apply rust inhibitor and touch-up paint the stringers at the following locations: Stringer 10G top flange (at Floorbeam 9). Stringer 11G top flange (at Floorbeam 10). Stringer 13G bottom flange (at Floorbeam 13) at erection angle seat. Stringer 24G bottom flange (near Floorbeam 23).	3/4/2020		
12715	2	B	Replace missing nut at Truss span Bearing 2A at the southwest corner for the masonry plate and tighten loose nut at the southeast corner.	3/4/2020		
12716	1	J	Install signage for Load Restrictions	10/13/2020

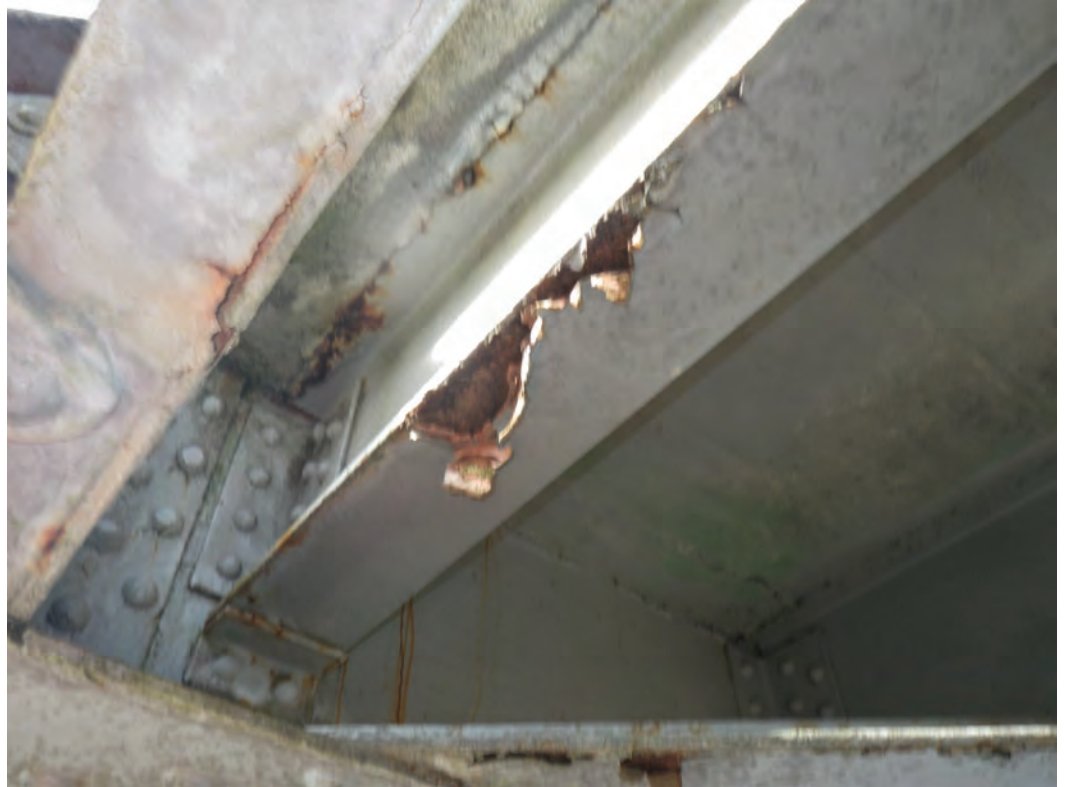
Stringer 24G bottom flange (near Floorbeam 23) has laminar rust.

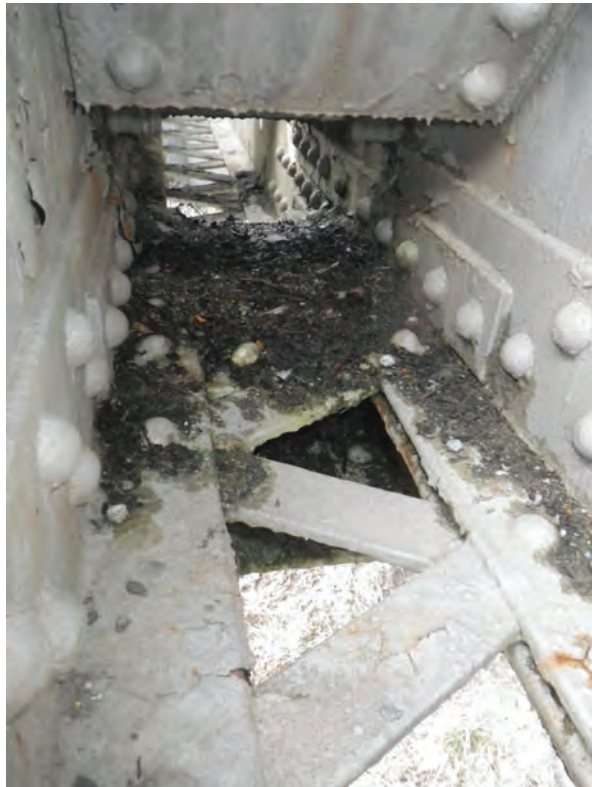
SI-42

Debris on bottom chord at L26 to L27 south truss at panel point L26S.

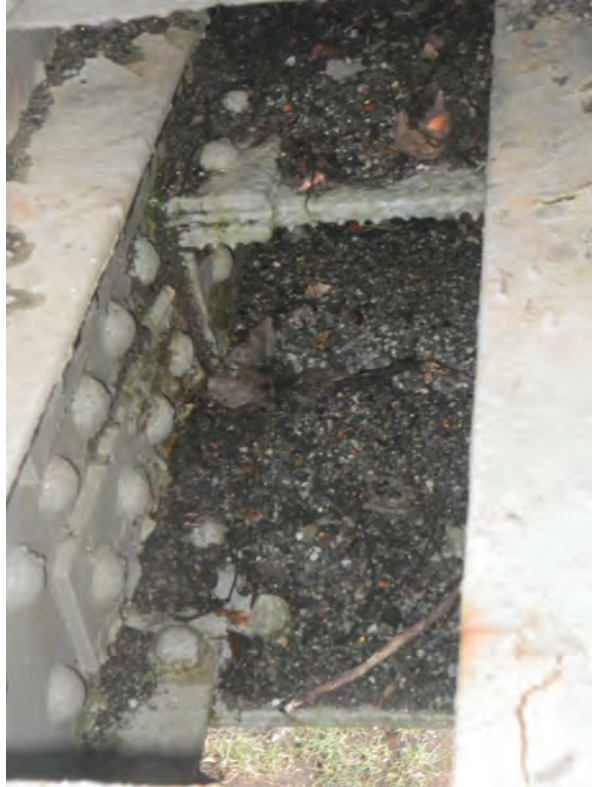
SI-43

126 Steel Thru Truss
Photo Type: R - Repair
Orientation: DN
Date: 3/4/2020
Repairs: 12711
Debris on bottom chord at L25 to L26
south truss at panel point L26S.

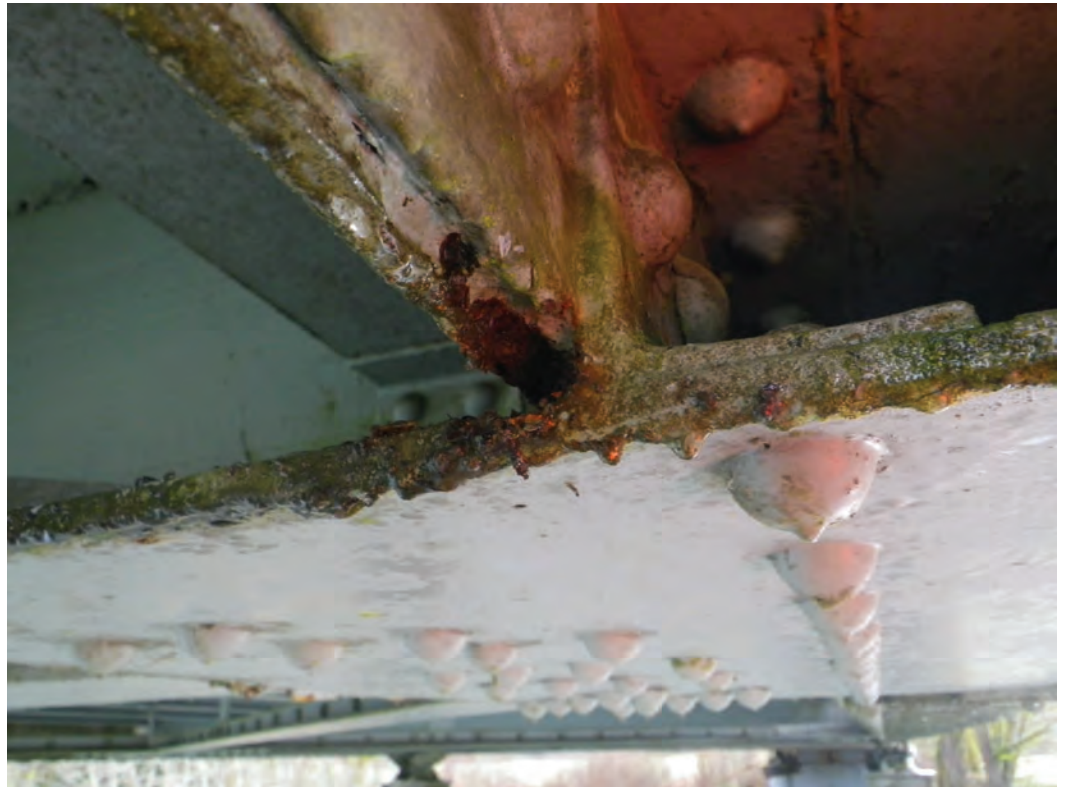
SI-30

126 Steel Thru Truss
Photo Type: G - General
Orientation: E
Date: 3/25/2014
Repairs:
L20 South bottom edge of interior gusset plate is corroded to a knife edge.

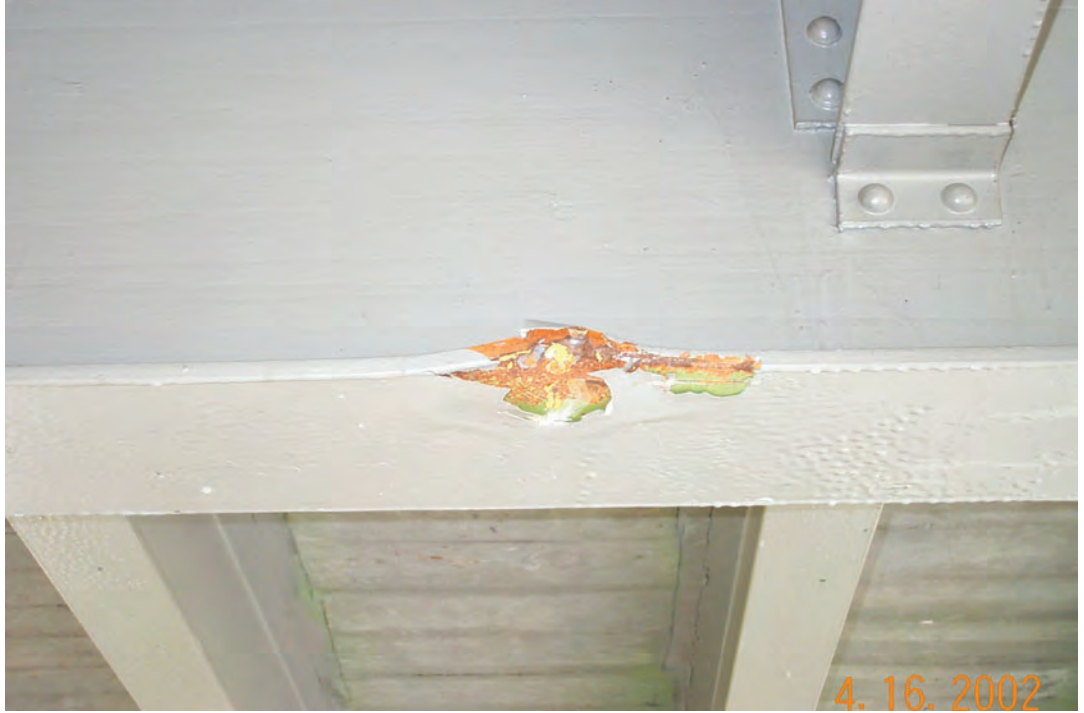
MI-4

152 Steel Floorbeam
Photo Type: G - General
Orientation: E
Date: 4/17/2002
Repairs:
Damaged Floorbeam 28.

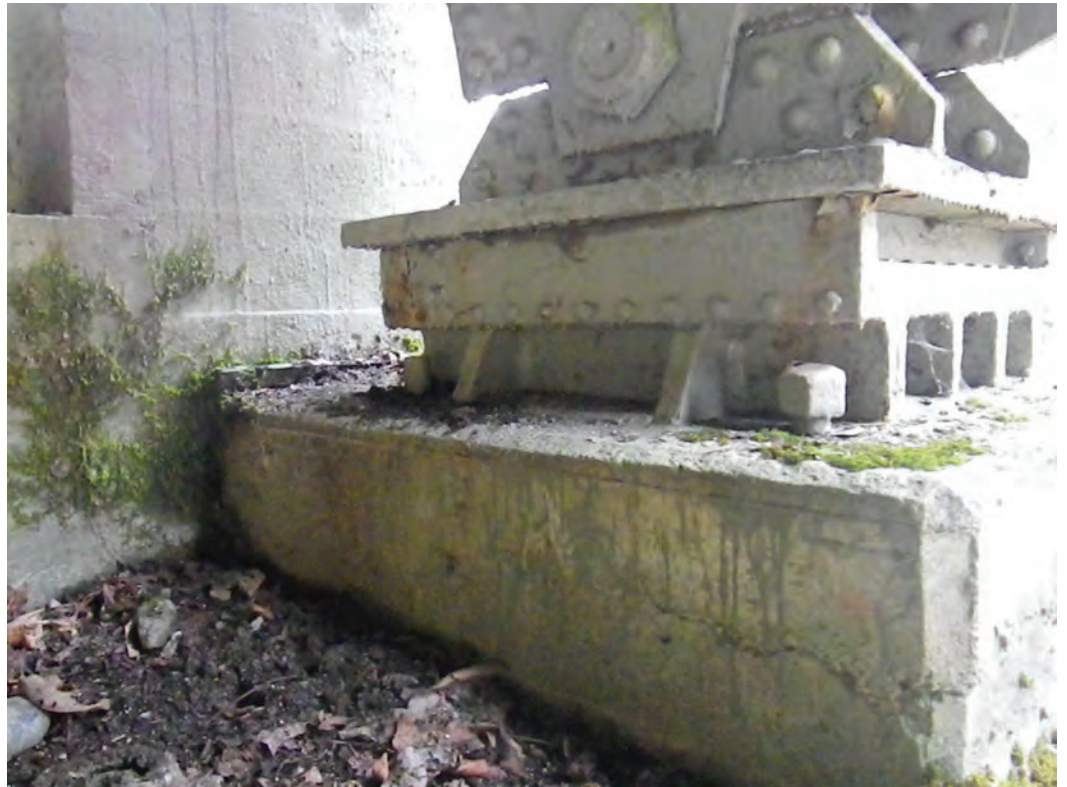
SI-33

In several locations lock nuts at the masonry plates have laminar rust blossoms with up to 1/16" section loss, most notable at Bearings 2A and 2C.
 Truss span Bearing 2A is missing a nut at the southwest corner for the masonry plate and has a loose nut at the southeast corner. See photo #33. REPAIR #12715.</p> |

311 Moveable Bearing (roller, sliding, etc)
Photo Type: G - General
Orientation: NW
Date: 3/25/2014
Repairs: 12715
Bearing 2A for the truss span has a missing nut at the SW corner and the nut is not engaged at the SE corner.

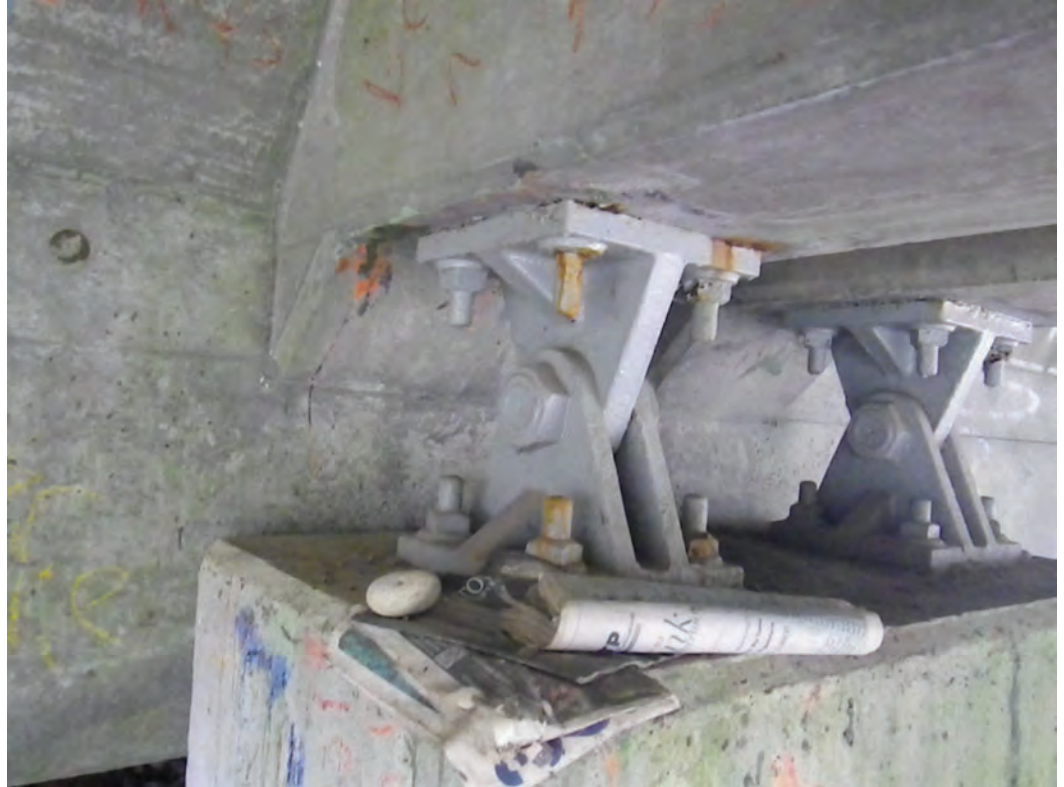
SI-34

Bearing 1A has a loose nut at the bottom SE corner.
 Bearing 1C has a missing nut the top SE corner. See photo #34 (typical).
 Bearing 1D has a missing nut at the top NE corner and bottom NW corner.</p> |

313 Fixed Bearing
Photo Type: G - General
Orientation: NW
Date: 3/25/2014
Repairs:
Bearing 1C is missing a nut at the top southeast corner.

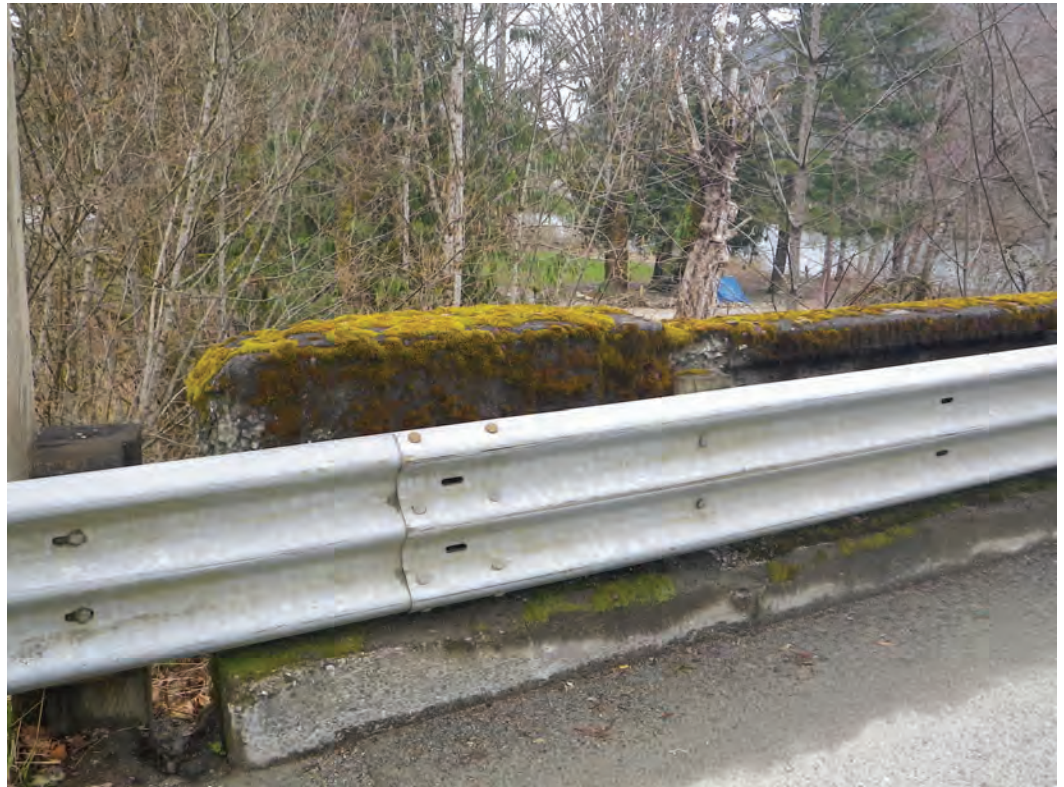
SI-36

- 330 Metal bridge rail consists of thrie-beam rail retrofitted to the original concrete baluster rail.
- 331 Concrete bridge rails over the approach spans are covered with moss. The top rails are cracked, exfoliated and spalled up to 3" deep. The posts are cracked and delaminating. The heaviest deterioration is in the north rails. See photo #36.

331 Concrete Bridge Railing
Photo Type: G - General
Orientation: N
Date: 3/25/2014
Repairs:
Concrete bridge rails are cracked, exfoliated and spalled in areas. Northwest rail is shown.

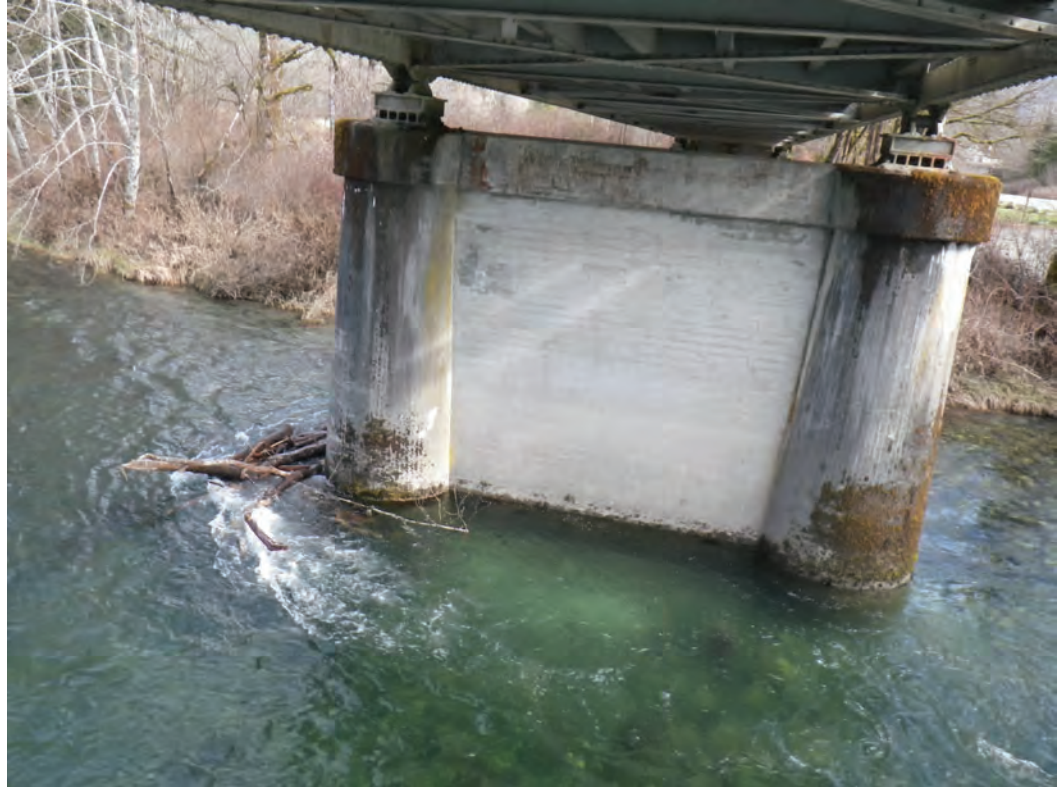
SI-41

- 355 Damaged, broken and missing rivets are present in the truss members. See element 126.
- 357 Pack rust in stringers. See element 113.
- 361 Skagit River flows north to south below Spans 2, 3 and 4. Tops of footings at Piers 3 and 4 have been exposed in the past. Pier 4 is beginning to re-accumulate debris. See photo #41. REPAIR #12705.

361 Scour
Photo Type: R - Repair
Orientation: E
Date: 3/4/2020
Repairs: 12705
Pier 4 upstream nose is accumulating debris.

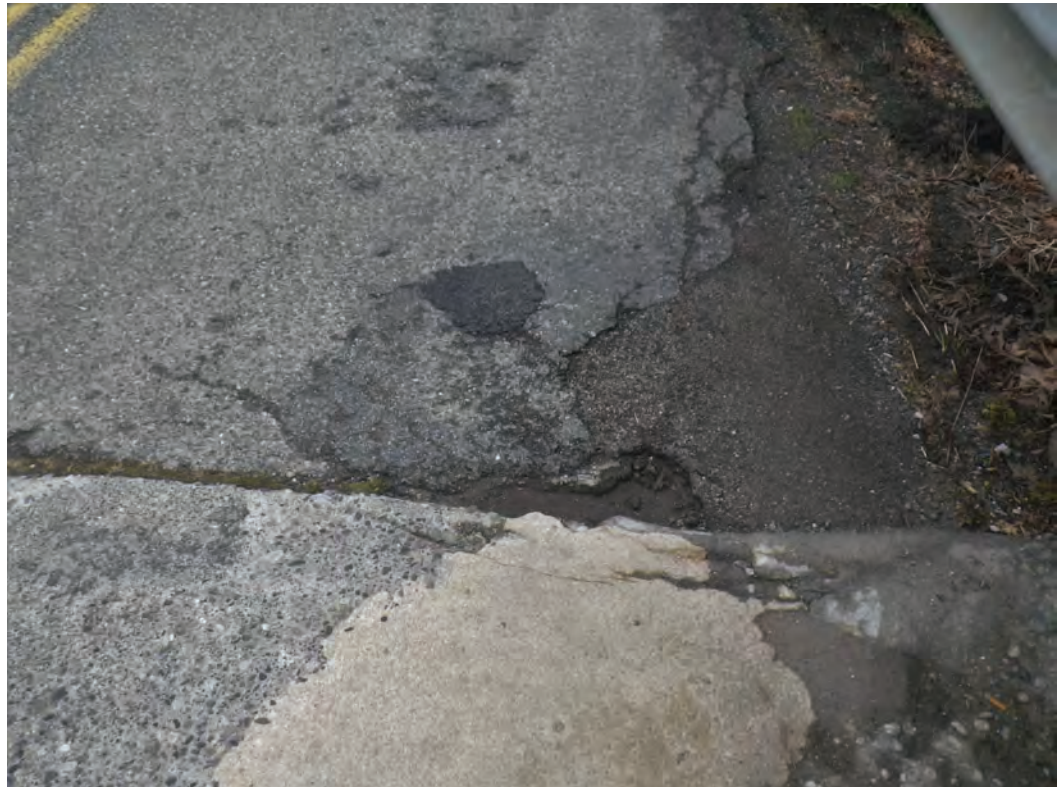
SI-46

- 400 Asphalt butt joints at abutments are not sawcut and sealed. East abutment joint has approximately 4 ft. of total patches and a 2 ft. x 8" x 1" deep pothole in the eastbound lane. See photo #46. REPAIR #12712.

400 Asphalt Butt Joint Seal
Photo Type: J - Reg Road Maint
Orientation: E
Date: 3/4/2020
Repairs: 12712
East abutment joint has a pothole in the eastbound lane.

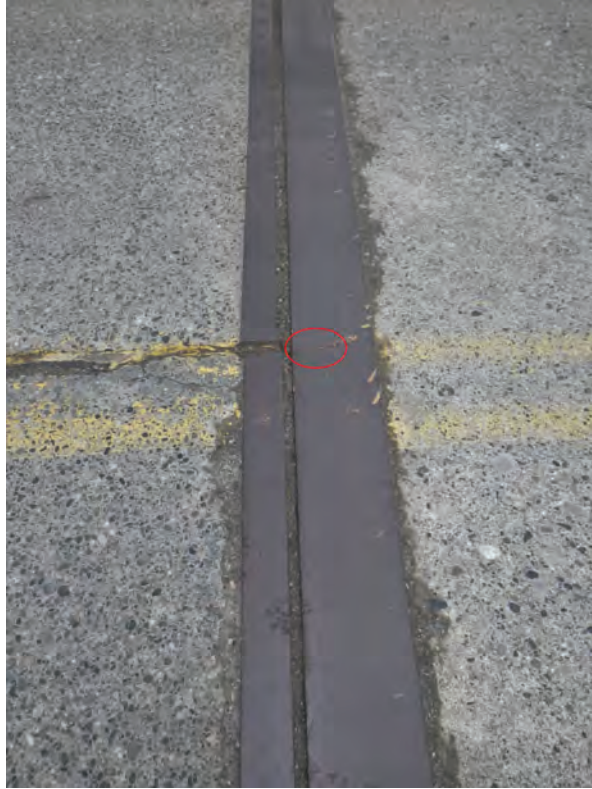
SI-47

- 408 Steel sliding plate joints are full of debris. West joint has a 6" crack in the east steel header at centerline. See photo #47.

408 Steel Sliding Plate
Photo Type: G - General
Orientation: N
Date: 3/4/2020
Repairs:
West joint has a 6" crack in the east steel header at centerline. Note: offset of joint at centerline for joint measurements.

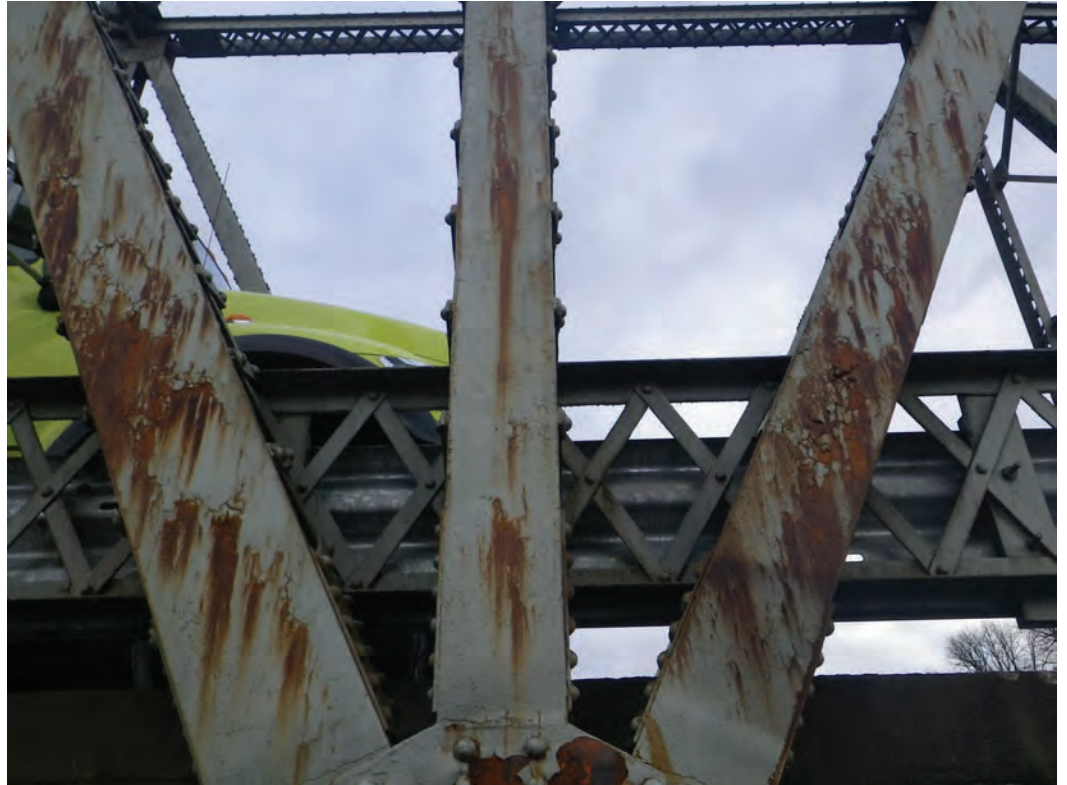
SI-29

Year	West Joint	East Joint	Temp (F)	Time
2020	1-1/2"	1-1/2"	40 °	11:00
2018	1-1/2"	1-7/8"	40 °	11:00
2016	1-1/2"	1-5/8"	47 °	10:00
- 904 Paint system is chalky with wide spread cracking, areas of heavy peeling and exposed primer. There is rust staining in some locations that is associated with areas of cracked and bubbled paint that is exposing metal substrate, heaviest on the south face of members. See photos #28 and #29.

904 Paint
Photo Type: G - General
Orientation: N
Date: 3/25/2014
Repairs:
Wide spread paint cracking with heavy rust staining.

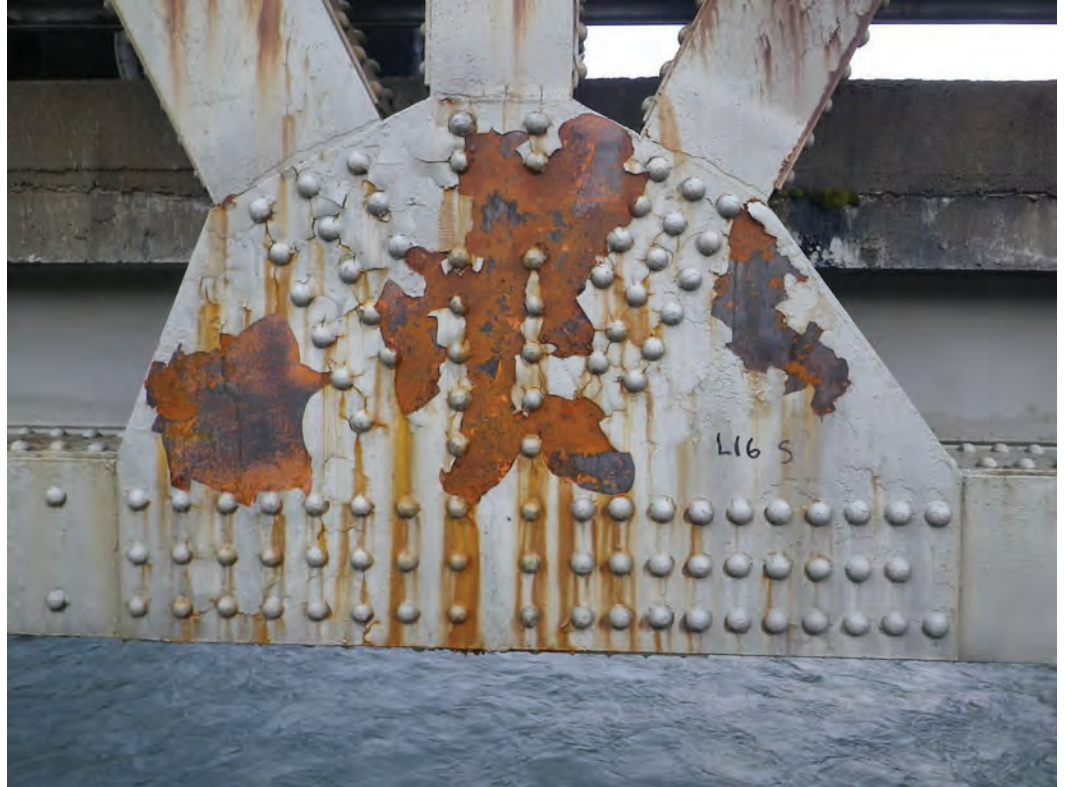
Peeling paint with surface rust and wide spread rust staining.

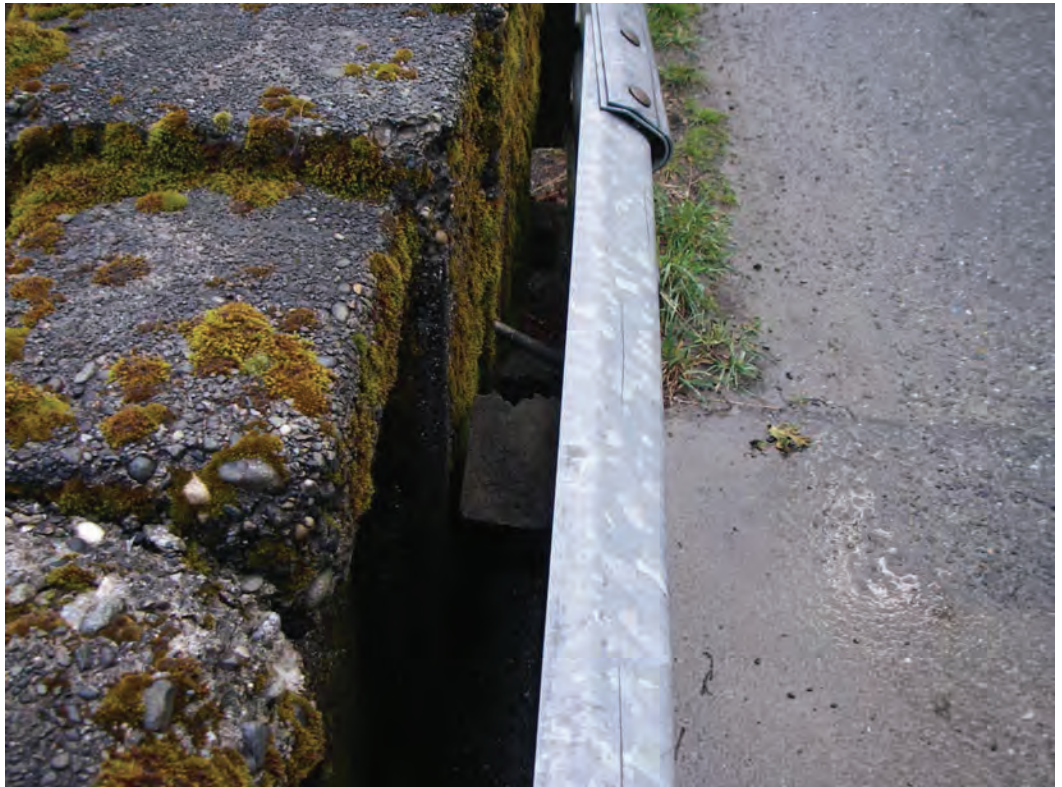
SI-19

- 1680 Piers are supported by timber piles.
- 1685 Northeast transition has minor impact damage and a split spacer block. See photo #19. REPAIR #12703.
- 1686 Guardrail has minor traffic damage at the southwest corner. Northwest guardrail has traffic impact over a 20 ft. length. See photo #35. REPAIR #12707.

1685 Transitions
Photo Type: J - Reg Road Maint
Orientation: E
Date: 3/17/2010
Repairs: 12703
Split spacer block at northeast corner.

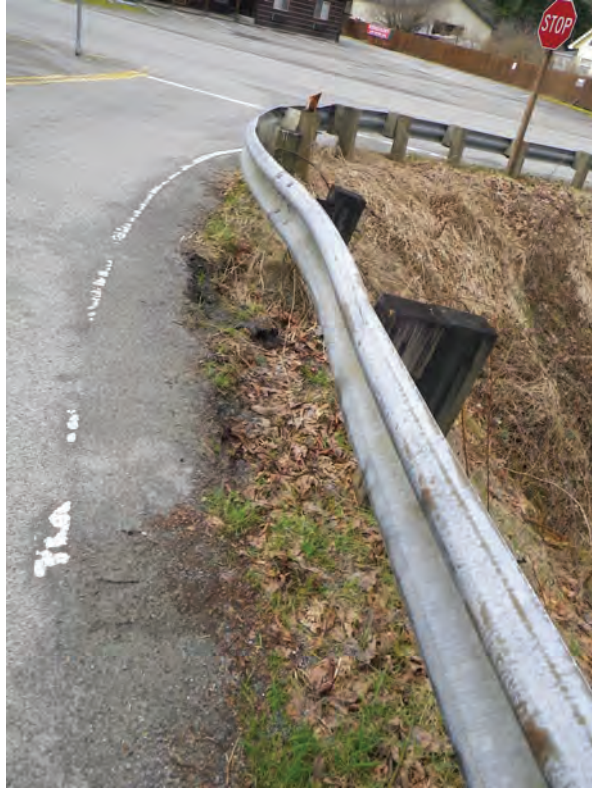
Guardrail at the northwest corner has traffic impact damage over a 20 ft.
