Table 1
ACM Sample Analytical Results
700 South 2nd Street, Mt. Vernon, WA
Skagit County Facilities

SKAGIT COUNTY
 ADMINISTRATION BUILDING
 PROSECUTOR OFFICE T.I.
 700 S. SECOND STREET
 MOUNT VERNON, WA 98273

SHEET TITLE:
 THIRD FLR. NORTH DEMO PLAN

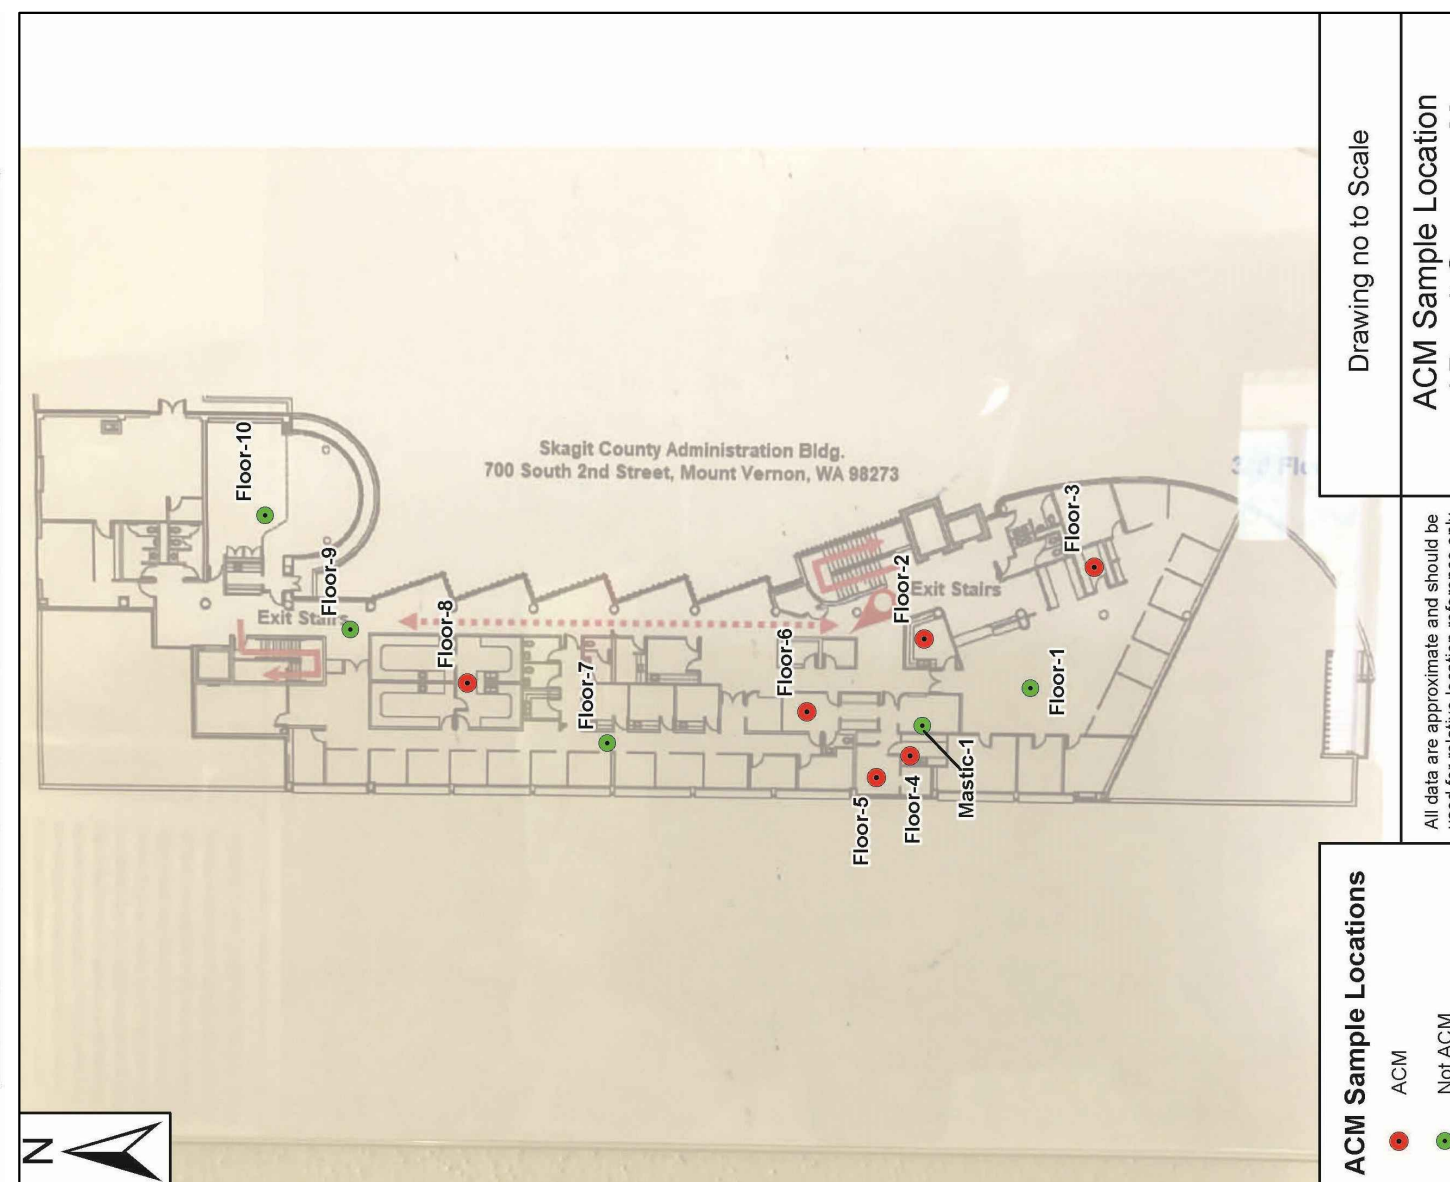
Sample ID	Date	Sample Location and Description	Analytical Result (%) ¹	Designation
<i>Samples listed in the order collected. Started at the southern end of Floor #3 in the Health Department offices.</i>				
Floor-1	5/30/2024	Collected from carpet and mastic material located near the middle of the floor inside the Health Department offices (south end of floor).	ND	Not ACM
Floor-2	5/30/2024	Collected from tan 12" x 12" floor tiles located in Work room #357. The asbestos was identified in the black asphaltic mastic (Layer 2 of 2).	5% Chrysotile	ACM
Floor-3	5/30/2024	Collected from tan 12" x 12" floor tiles located in File Storage Room #375. The asbestos was identified in the black asphaltic mastic (Layer 2 of 2).	4% Chrysotile	ACM
Floor-4	5/30/2024	Collected from tan sheet vinyl flooring located in the 'darkroom' #353. The asbestos was identified in the yellow vinyl material (Layer 1 of 3).	2% Chrysotile	ACM

Floor-5	5/30/2024	Collected from beige sheet vinyl material located in Room #352 in front of the radiator. The asbestos was identified in the yellow vinyl material (Layer 1 of 3).	2% Chrysotile	ACM
Floor-6	5/30/2024	Collected from 12" x 12" floor tiles located in the exam room #332 (similar to the other two 12" x 12" tile samples). The asbestos was identified in the black asphaltic mastic (Layer 2 of 2).	6% Chrysotile	ACM
Mastic-1	5/30/2024	Collected from a dark brown brittle mastic material associated with the cove base material located in the reception area.	ND	Not ACM
Floor-7	5/30/2024	Collected from carpet and mastic located in the western hallway near room #329	ND	Not ACM
Floor-8	5/30/2024	Collected from tan 12" x 12" floor tiles located in the Utility Lab Room #317. The asbestos was identified in the black asphaltic mastic (Layer 2 of 2).	5% Chrysotile	ACM
Floor-9	5/30/2024	Collected from gray-blue/brown swirl pattern sheet vinyl flooring located in the eastern hallway outside Room #314's double-doors.	ND	Not ACM

Floor-10	5/30/2024	Collected from carpet and mastic located inside Room #308.	ND	Not ACM

CONCLUSIONS
 ACM was identified in six of eleven samples collected from the third floor of the Skagit County Administration Building.
 Twelve inch by twelve inch vinyl floor tiles found throughout the floor area were identified with black asphaltic mastic that was identified as ACM. Any black asphaltic mastic discovered during remodel work should be considered ACM unless tested to verify a negative result.
 The yellow/tan sheet vinyl material found on the third floor was identified as ACM. It is advised that any yellow/tan sheet vinyl observed below carpet or sub-flooring should be considered ACM unless tested to verify a negative result.
