# Exhibit A-50: McShane haul road geological report

June 10, 2022

Re: **Proposed Grip Mine Haul Road**  
Comments Regarding Potential Geology Hazards

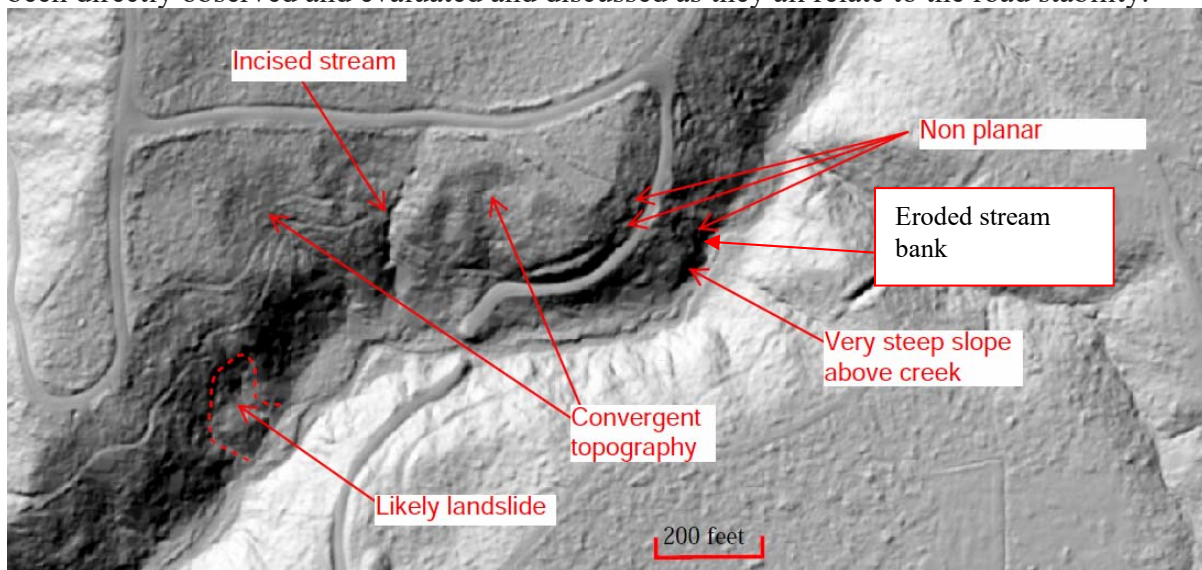
Lidar bare earth imagery is a remarkable tool for identifying landforms prior to visiting a site. My own review of the lidar identified numerous non planar features (Figure 1) that should have been directly observed and evaluated and discussed as they all relate to the road stability.

Figure 1. Lidar bare earth imagery of proposed access road and Swede Creek valley (2017 lidar via the Washington State Department of Natural Resources Lidar Portal). Note the lidar imagery predates the recent widening work on the proposed haul road.

The features indicated in Figure are all non planar features that were not recognized, discussed or analyzed in the AES report. These features are all potential landslide or erosion hazard areas that should be evaluated in more detail.

AES provides one paragraph regarding their visual slope reconnaissance. None of the features that are shown on the Figure 1 lidar are discussed or assessed. Each of the features indicated in Figure 1 and their relevance to the assessing the slope area of the proposed haul road are discussed below.

Swede Creek and stream processes along Swede Creek are never discussed. This is a significant omission in that the slopes in question are the result of Swede Creek having eroded a deep narrow steep sided valley. Lidar imagery clearly shows an active stream channel and active stream movement and evidence of recent erosion. There is a likely landslide associated with the creek a short distance down stream and what appears to be a steep stream cut slope below the proposed haul road (indicated on Figure 1) that is not mentioned or discussed. The lidar imagery shows what appears to be slope slump (a non planar feature) just above the steep stream cut slope. Further erosion at this location will undermine the slope the proposed haul road crosses. Stream erosion of the slope below the haul road is never mentioned or discussed in the report.

The convergent topography below the east-west section of the road above the slope was not addressed. These slopes are clearly not planar. What are these features? What geomorphic processes formed these features and how active are those processes? Could the road above impact the processes? Do the processes on these slopes pose a long term risk to the road?

The incised stream channel below the east-west road above the slope is never mentioned or discussed. The lidar image clearly shows this stream is a sharp feature suggesting recent active erosion. Does the road impact water flow to this feature? Does increased erosion from road drainage potentially impact the public resources down slope in Swede Creek?

No mention of changes to road drainage are made regarding the incised stream below the east-west section of the road (Figure1) as this incised stream was never observed or discussed in the report.
