SKAGIT COUNTY CRITICAL AREAS REPORT GEOLOGICALLY HAZARDOUS AREAS (SCC 14.24.400) MARBLEMOUNT QUARRY

Submitted to: Chuck Nylund
Kiewit Infrastructure Company

January 15, 2019

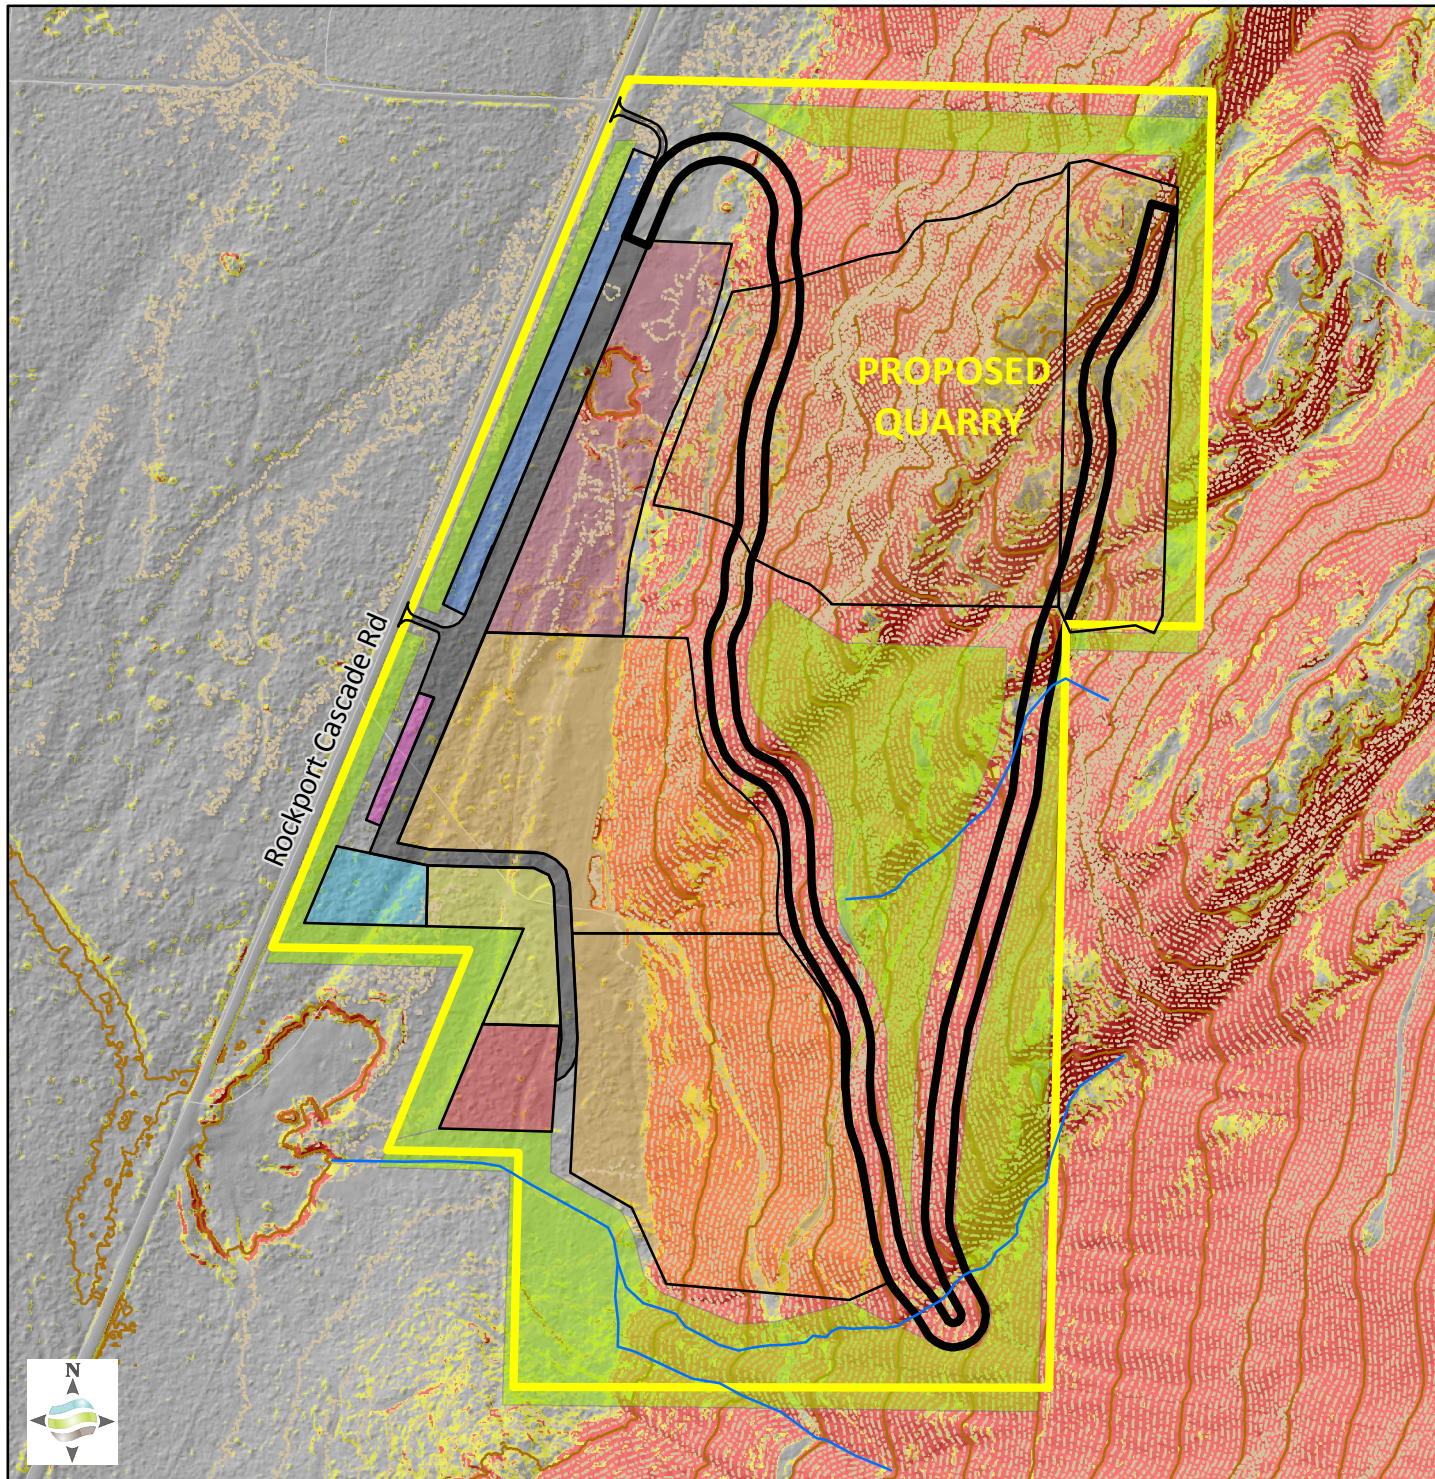
FIGURE 2
 Marblemount Quarry
 Geologically Hazardous Areas

In summary, the site consists of two distinct geomorphic conditions: natural, steep bedrock foothill topography, including cliffs with talus, and a low gradient Holocene alluvial terrace (**Figure 2**). The site ranges from sparsely vegetated to densely vegetated. A forest fire in ~1998 burnt most of the timber on the foothills in the project vicinity and young timber stands are reestablishing in the burnt areas. The alluvial terrace has been historically logged and cleared and is sparsely vegetated. Two small watercourses flow down the steep topographic areas and infiltrate into the alluvial terrace east of the proposed quarry. A proposed access road will cross these watercourses. No seeps or flowing streams were observed in the area where quarrying is proposed. The proposed mining will take place within the steep bedrock while the quarry operations will primarily take place within the alluvial terrace. The access road will cross steep slopes to access the east, upper portions of the subject site. The steep slopes were generally found to be bedrock with shallow soils, colluvium, and talus. The steep bedrock cliffs and slopes create the potential for geologically hazardous areas. The presence of talus indicates that rockfall processes occur intermittently at this site. Talus ranges in size from small particulate to boulders in excess of 10-foot in diameter. No evidence in the field or in the desktop analysis revealed any historic deep-seated landslide occurrence within the subject site.

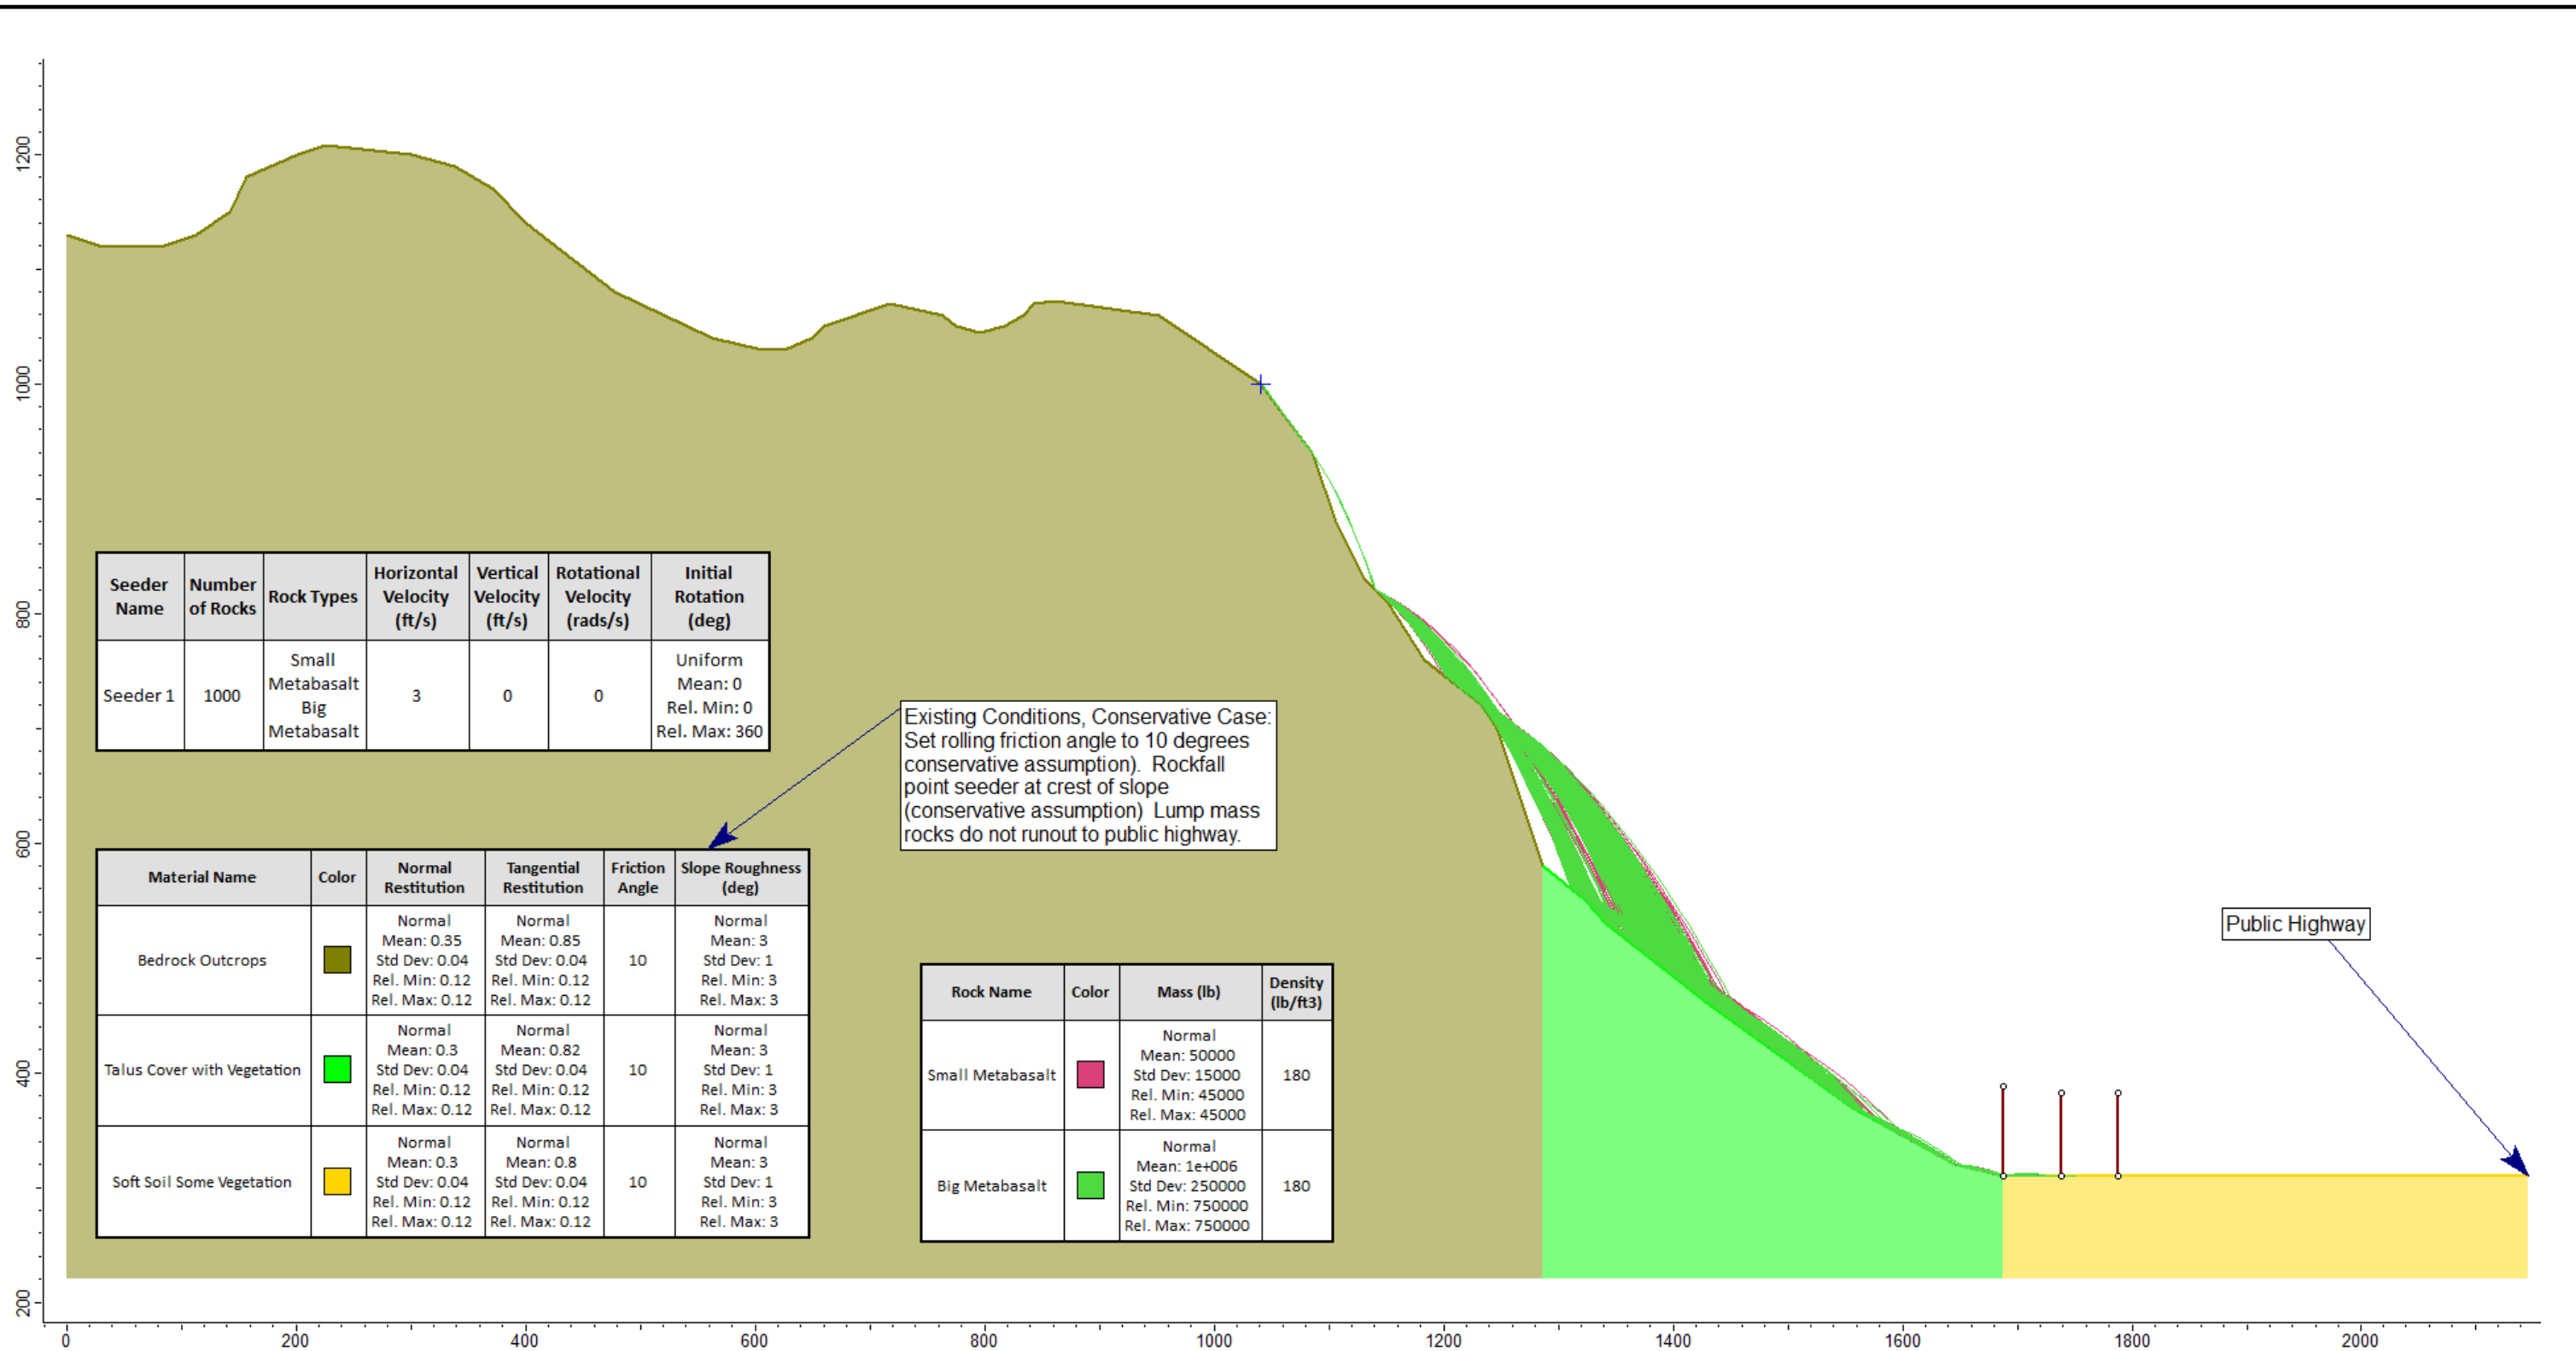
Existing Conditions, Conservative Case:
Set rolling friction angle to 10 degrees
(conservative assumption). Rockfall
point seeder at crest of slope
(conservative assumption) Lump mass
rocks do not runout to public highway.
