FINAL FLOOD REDUCTION INVESTIGATION FOR LAKE McMURRAY, HULL DRIVE & HULL ROAD

Prepared for:
Skagit County Public Works
1800 Continental Place
Mount Vernon, WA 98273

Prepared by:
  **WATERSHED**
SCIENCE & ENGINEERING
506 2nd Avenue, Suite 2700
Seattle, WA 98104
206-521-3000

January 7, 2021

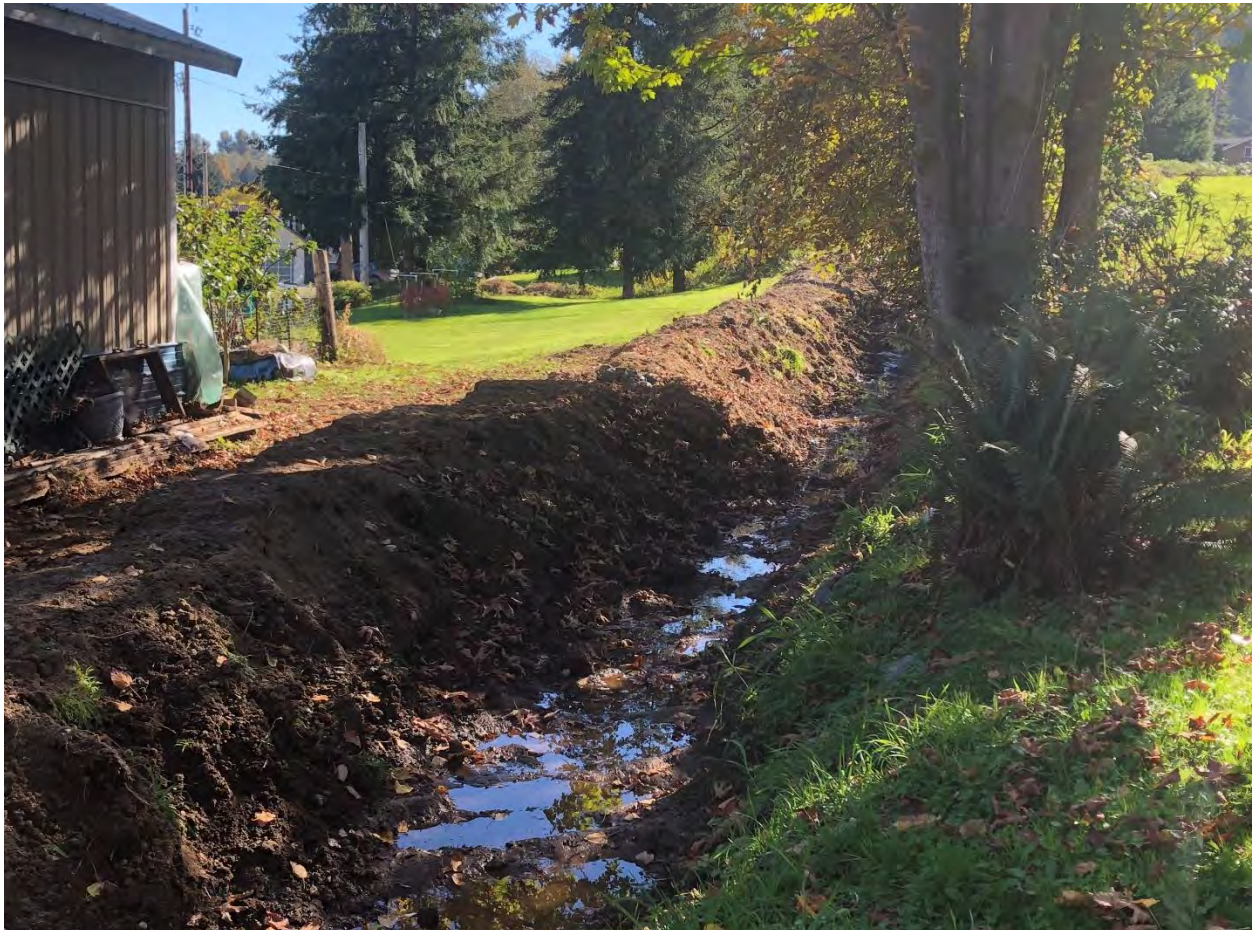
Following a flood in 2018, the section of the unnamed stream upstream from Hull Drive was dredged and the spoils used to build a small flood containment berm along the right bank (Photo 4). This was completed by one or more private property owners, not the County. The hydraulic model indicates that the berm and channel currently contain the 100-year flood except at the inlet to the Hull Drive culvert. The capacity of this dredged section is already decreasing due to sediment deposition and vegetation growth. Periodic maintenance dredging and vegetation removal will be required to preserve channel capacity to prevent overtopping of the earthen berm. If the berm overtops, erosion on the landward side of the berm could cause the berm to fail, sending focused flow toward Hull Road and multiple lake front properties.

Photo 4. Unnamed tributary channel leading to Hull Drive shortly after it was dredged and the spoils placed to form a small berm along the east bank. (Photo provided by County, October 15, 2018).

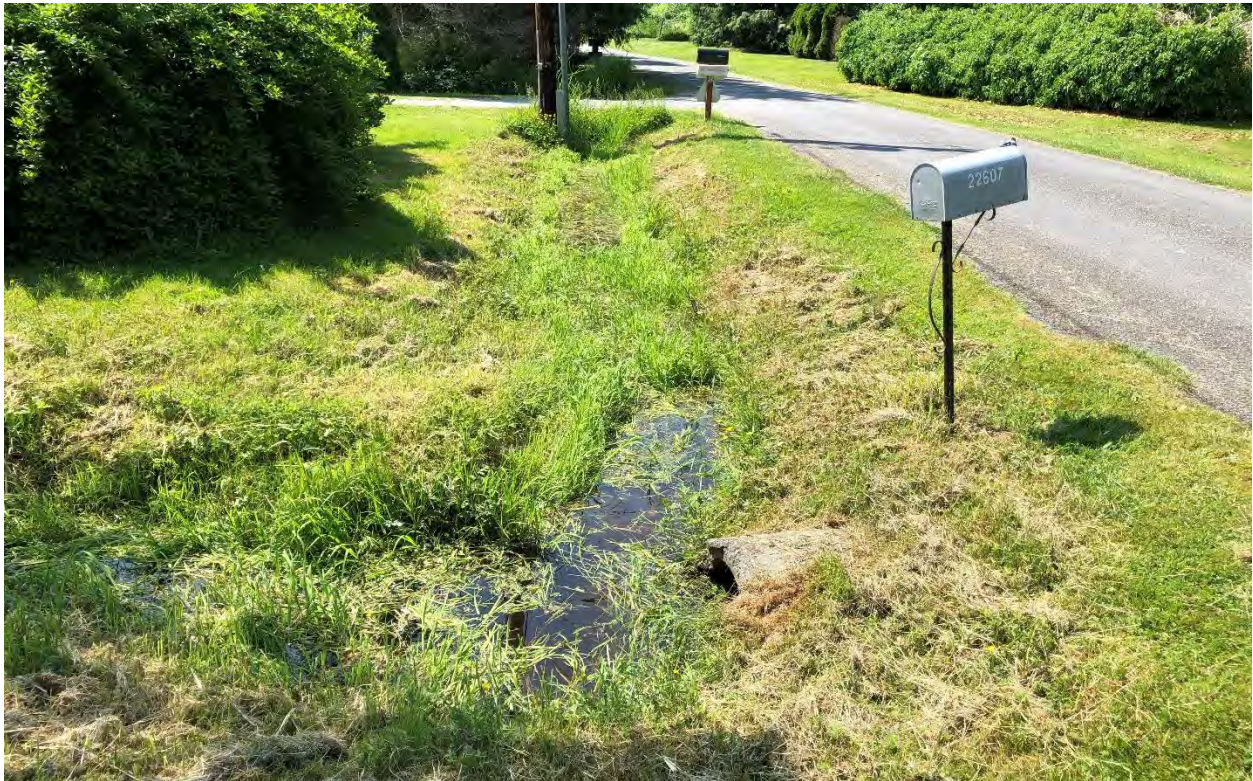
The stream channel between Hull Road and the lake is choked with vegetation and sediment which has reduced its ability to convey water to the lake. This has elevated water levels at the outlet of the Hull Road culvert which in-turn forces a portion of the water exiting the culvert to enter and flow south in the road side ditch shown in Photo 6. The ditch does not have the capacity to contain the total flow and water spills through low spots along the east side of the ditch and floods several lake front properties (Figures 6 to 9).

Photo 6. Viewing upstream (south) along the Hull Road ditch. The culvert near the mail box is the culvert that carries the stream under Hull Road. The stream exits the left side of the photo (May 30, 2019).

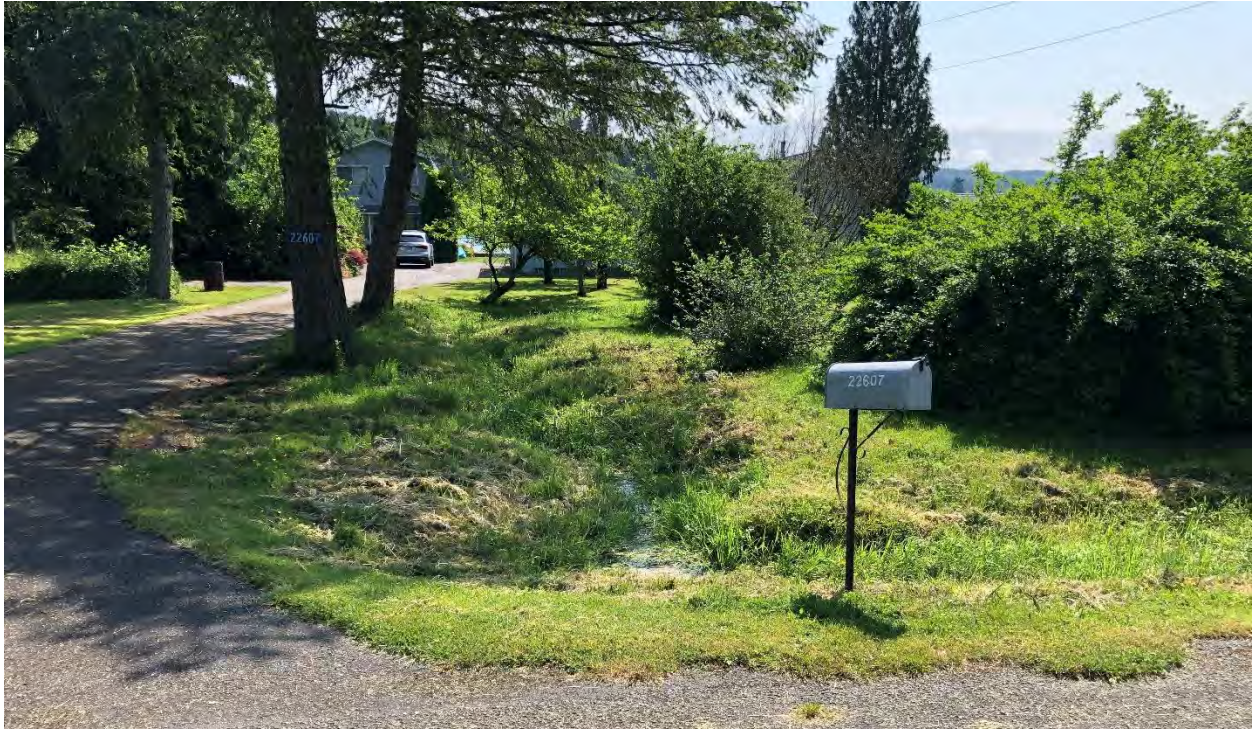
The channel between Hull Road and the lake was choked with grass and sediment (Photos 7 and 8). Fortunately, flooding along both properties has been limited due in part to the limited capacity of the Hull Road and abandoned railroad berm culverts (Photos 9 and 10). Flooding caused by the high lake level has been the primary problem for both properties (Figures 6 to 9). This channel segment will need to be cleaned periodically to maintain capacity to prevent flooding, regardless of whether the culverts under Hull Road or the abandoned railroad berm are enlarged.

Photo 7. Viewing downstream (east) from Hull Road along the stream channel that leads to Lake McMurray. The roadside ditch exits the right side of the photo (May 30, 2019).

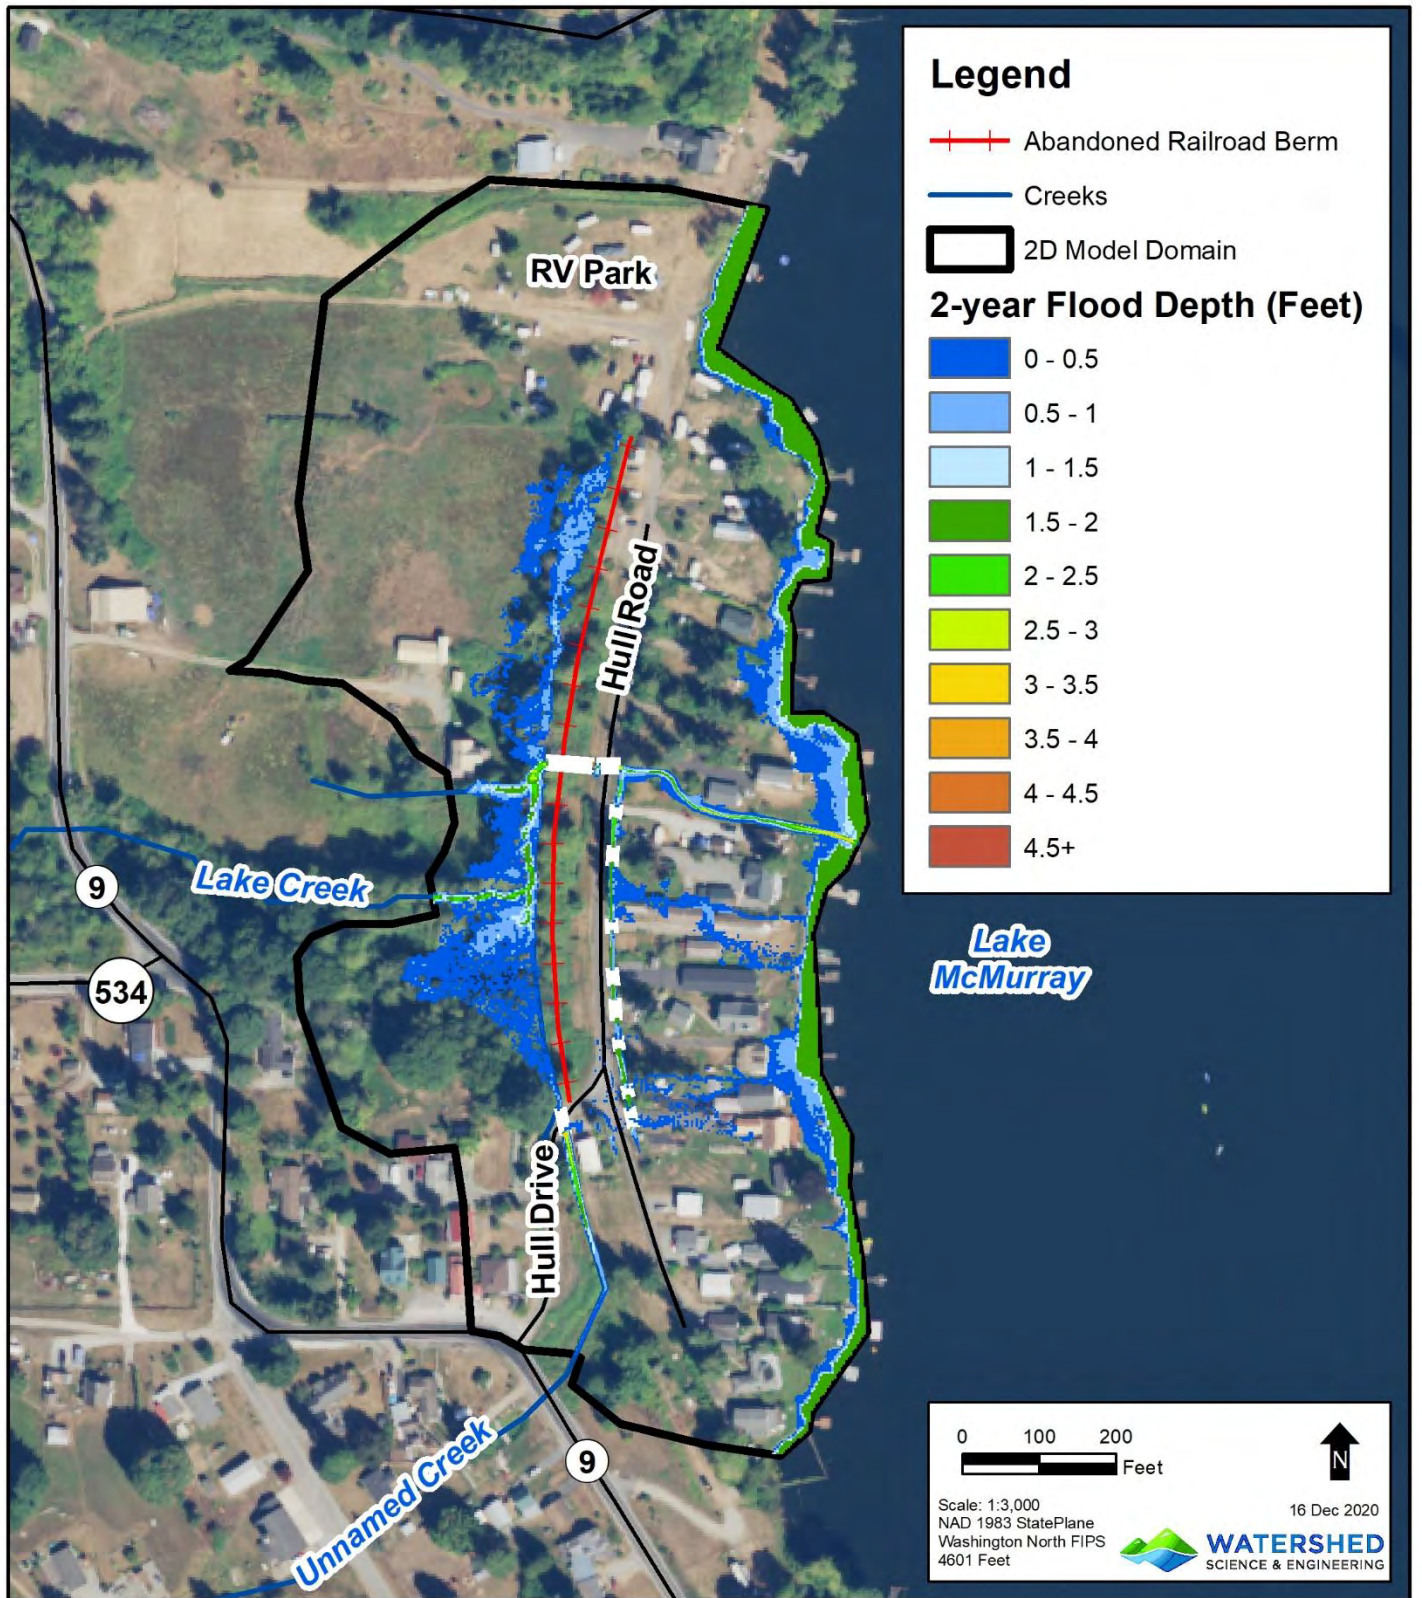
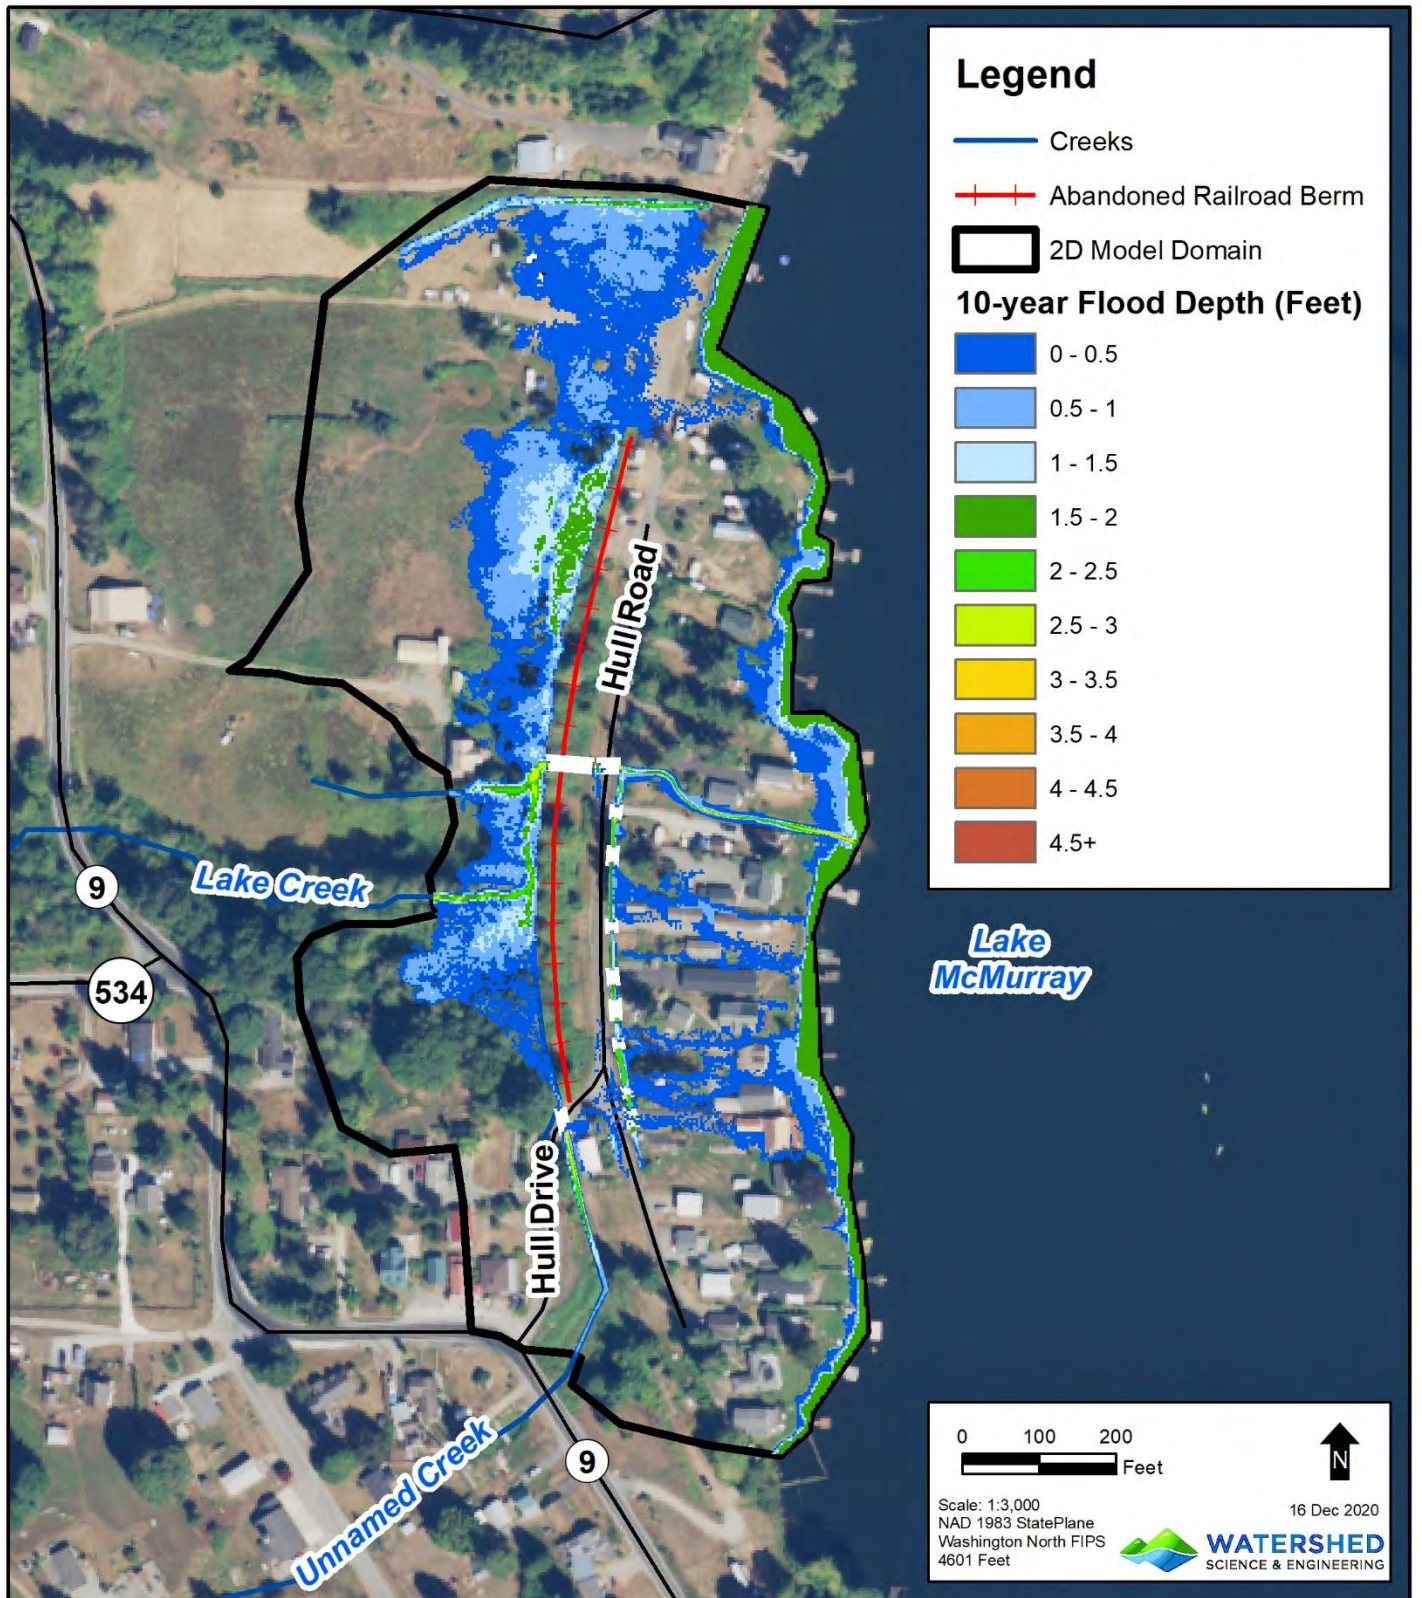
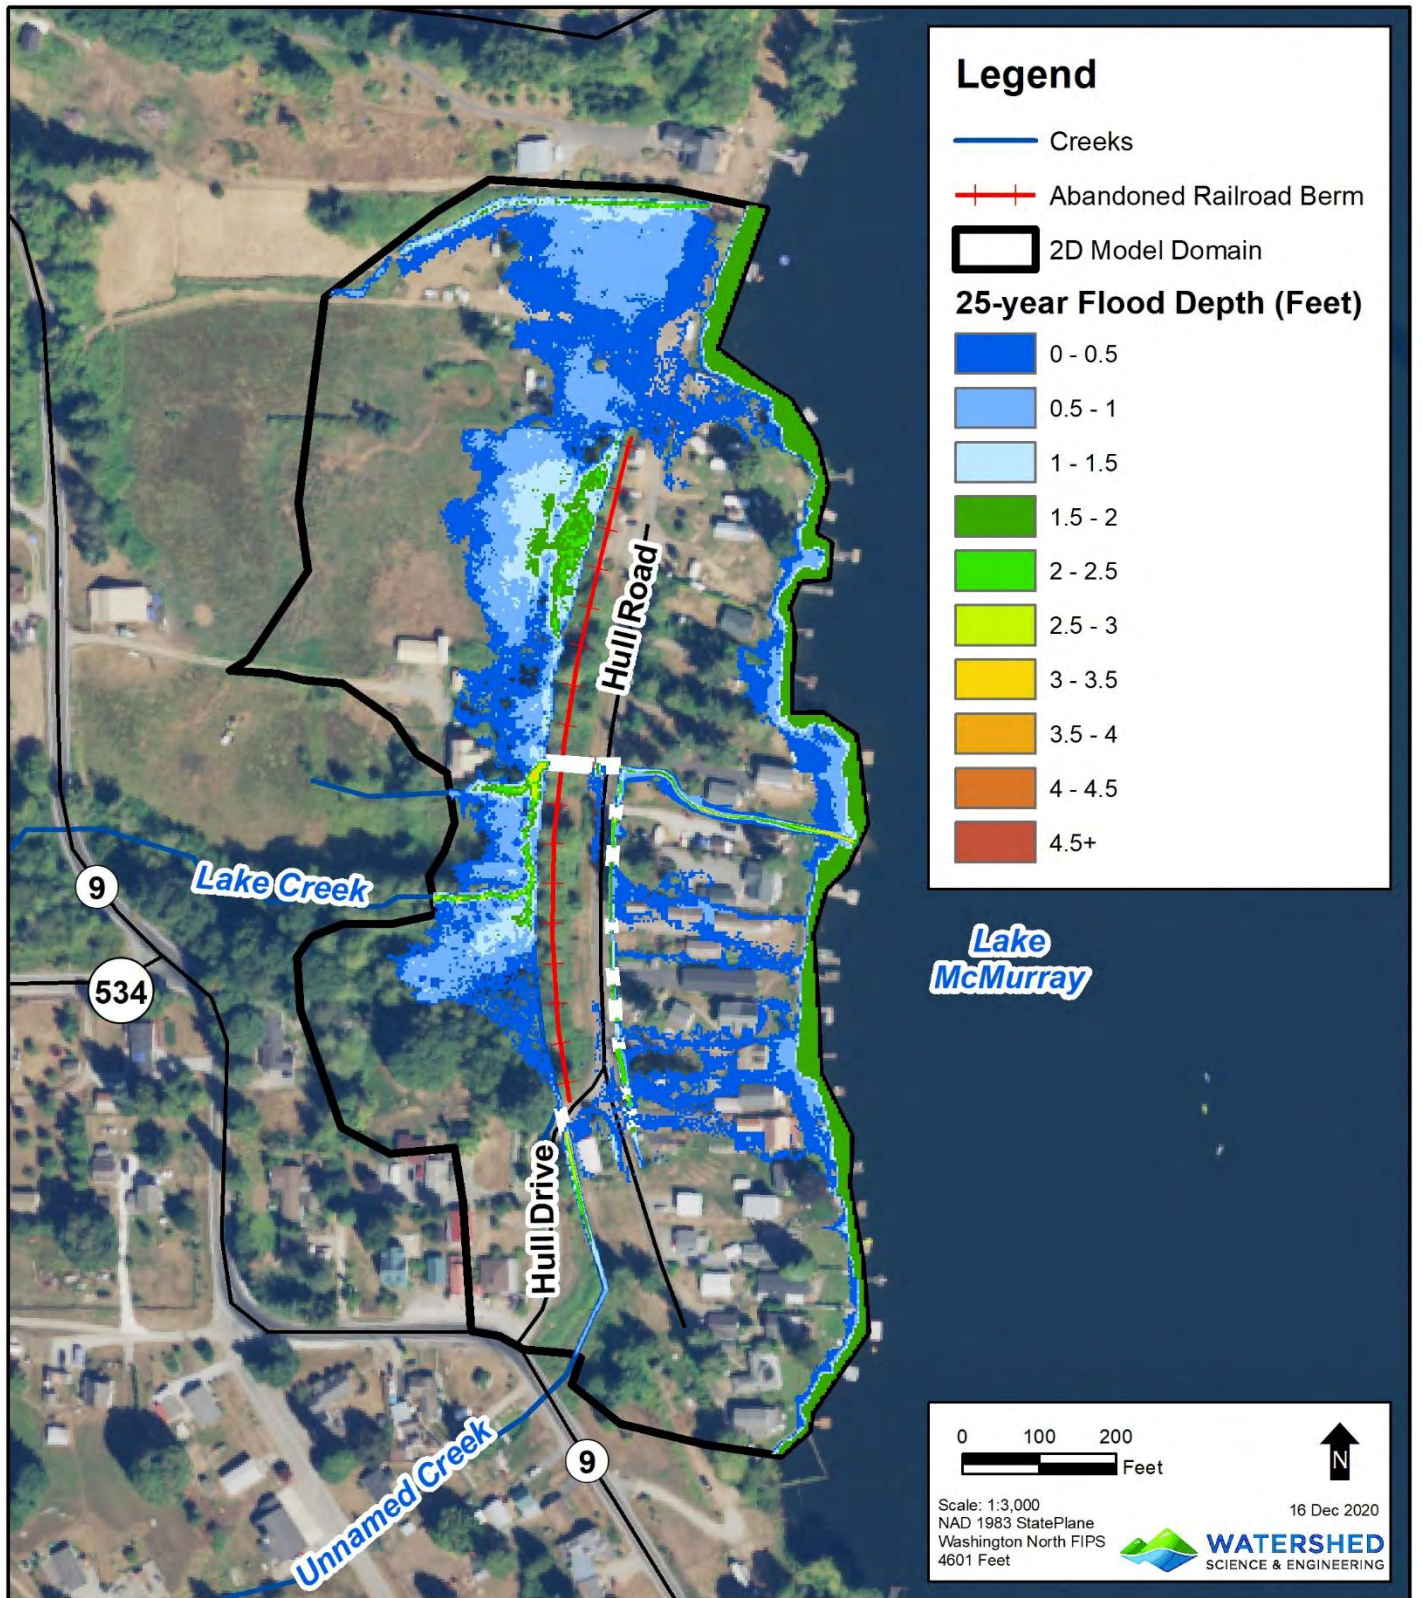
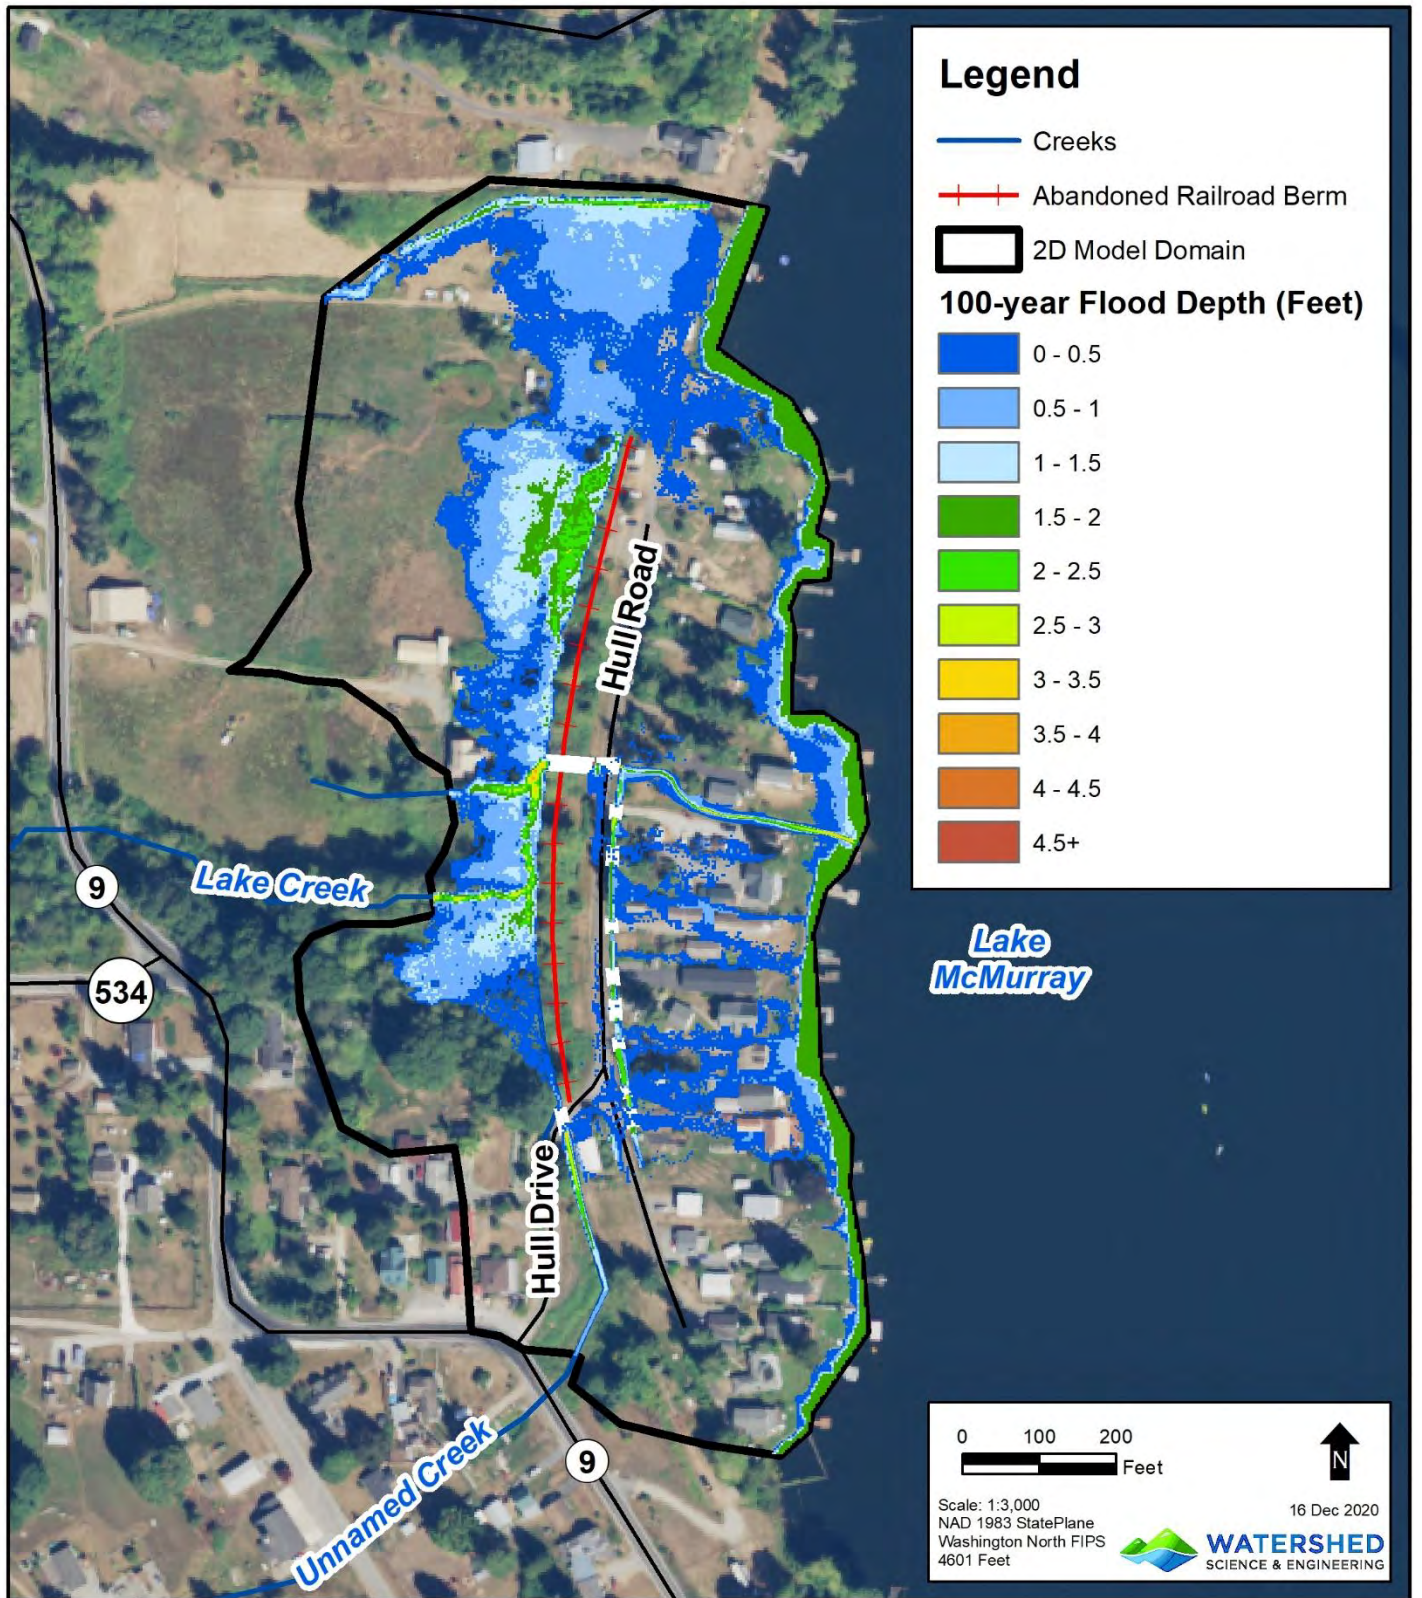
The HEC-RAS 2D hydraulic model was used to estimate flood depths and inundation limits for existing conditions for the four flood events, 2-, 10-, 25-, and 100-year floods. Model results, illustrated in Figures 6 to 9, combined with personal observations from landowners, reveal that there are six distinct flood problems within the project area:

Figure 6. Existing Conditions 2-year Flood Depth with High Lake Level (Elevation 232.8 ft).

Figure 7. Existing Conditions 10-year Flood Depth with High Lake Level (Elevation 232.8 ft).

Figure 8. Existing Conditions 25-year Flood Depth with High Lake Level (Elevation 232.8 ft).

Figure 9. Existing Conditions 100-year Flood Depth with High Lake Level (Elevation 232.8 ft).

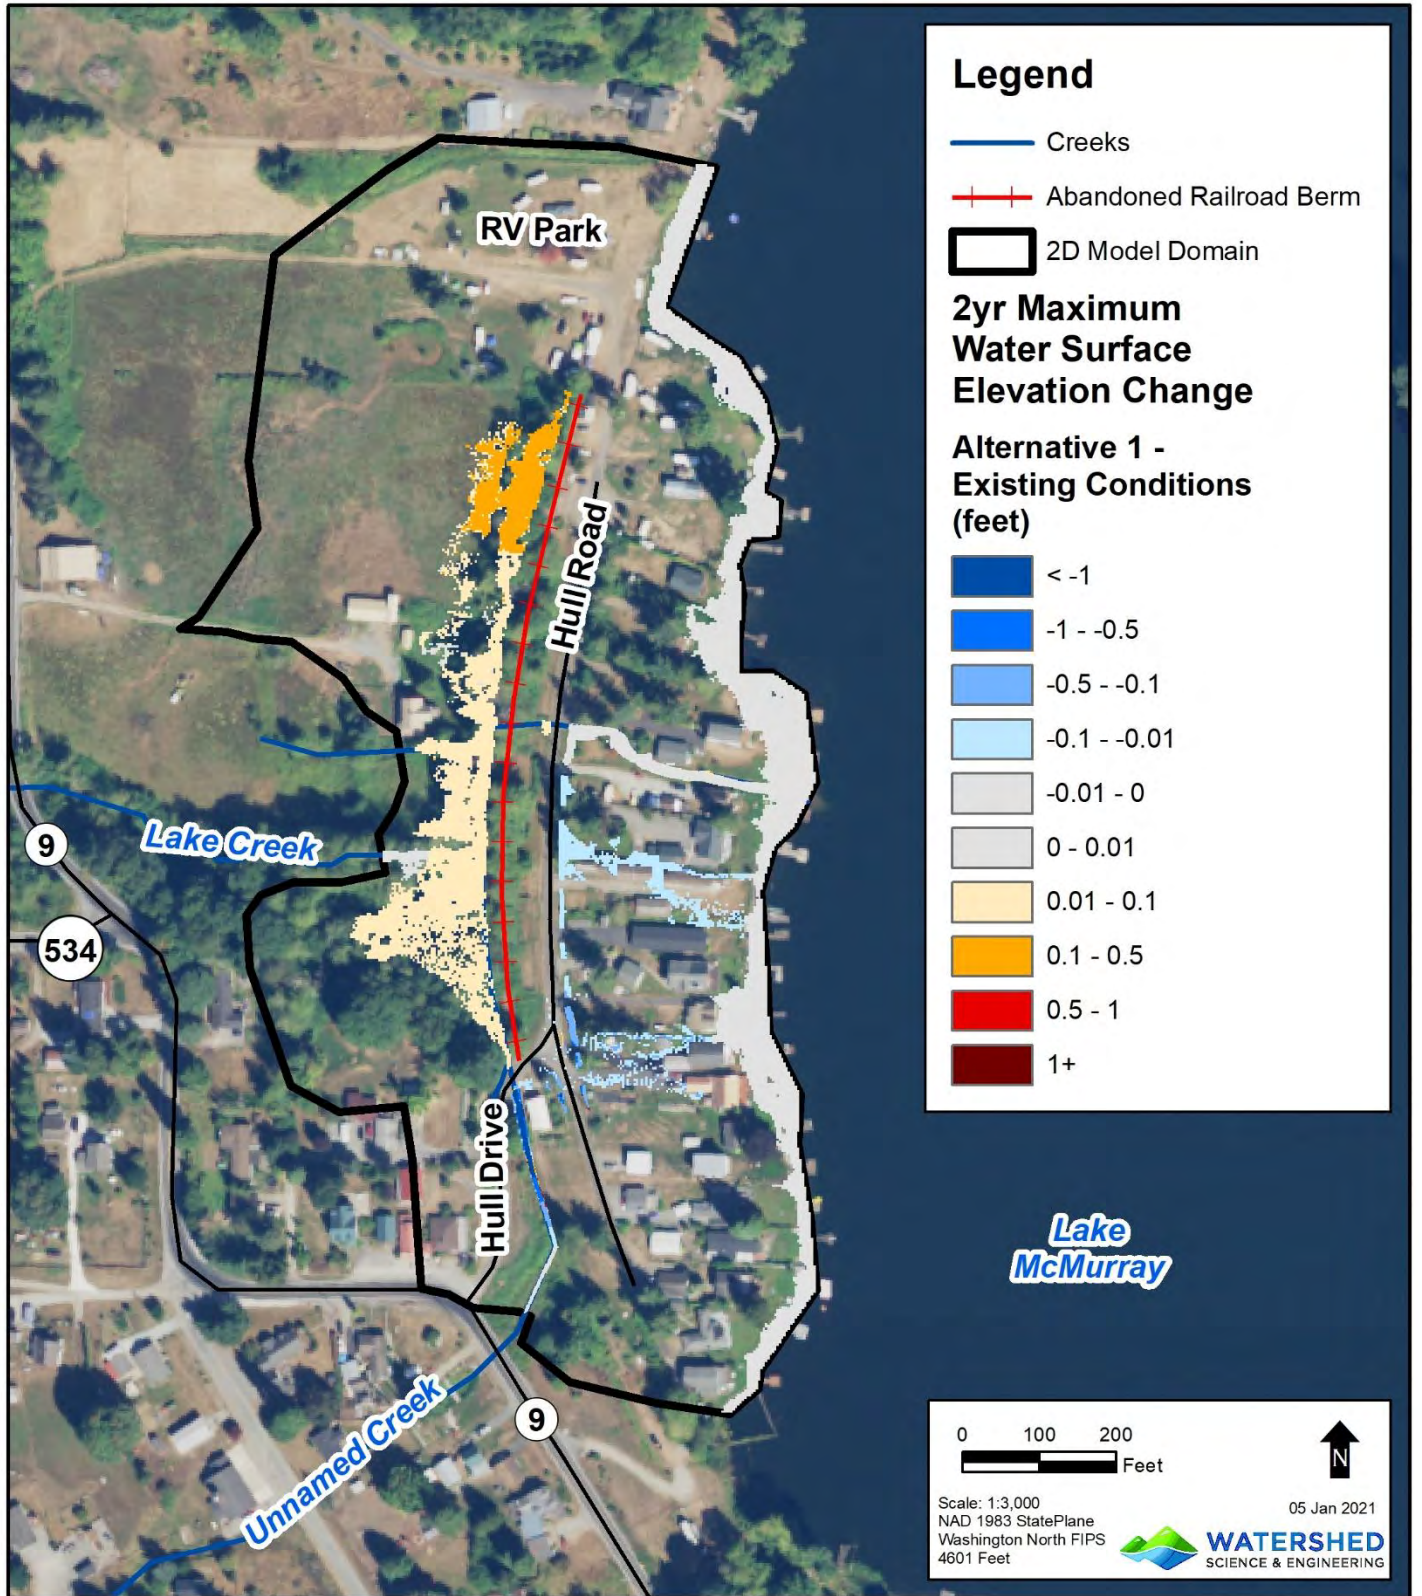
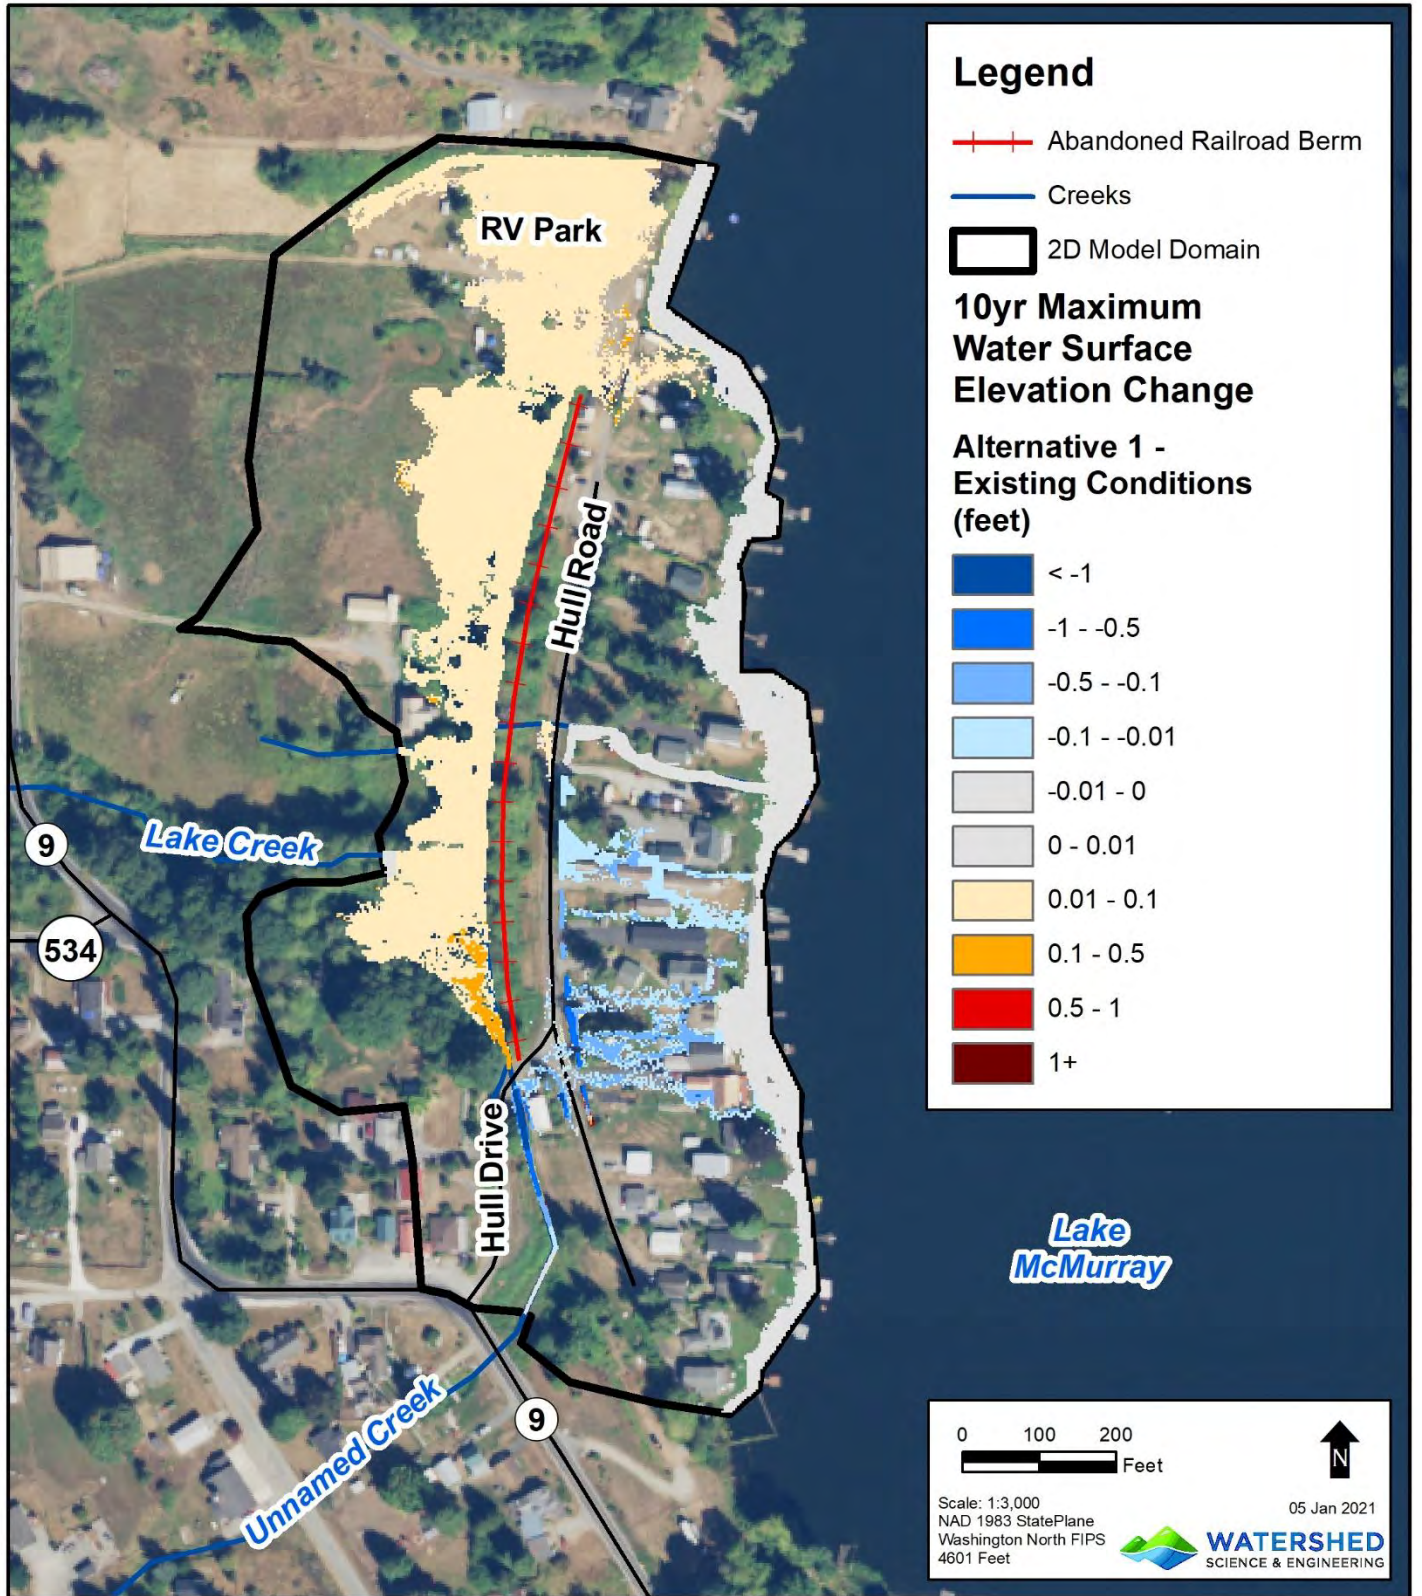
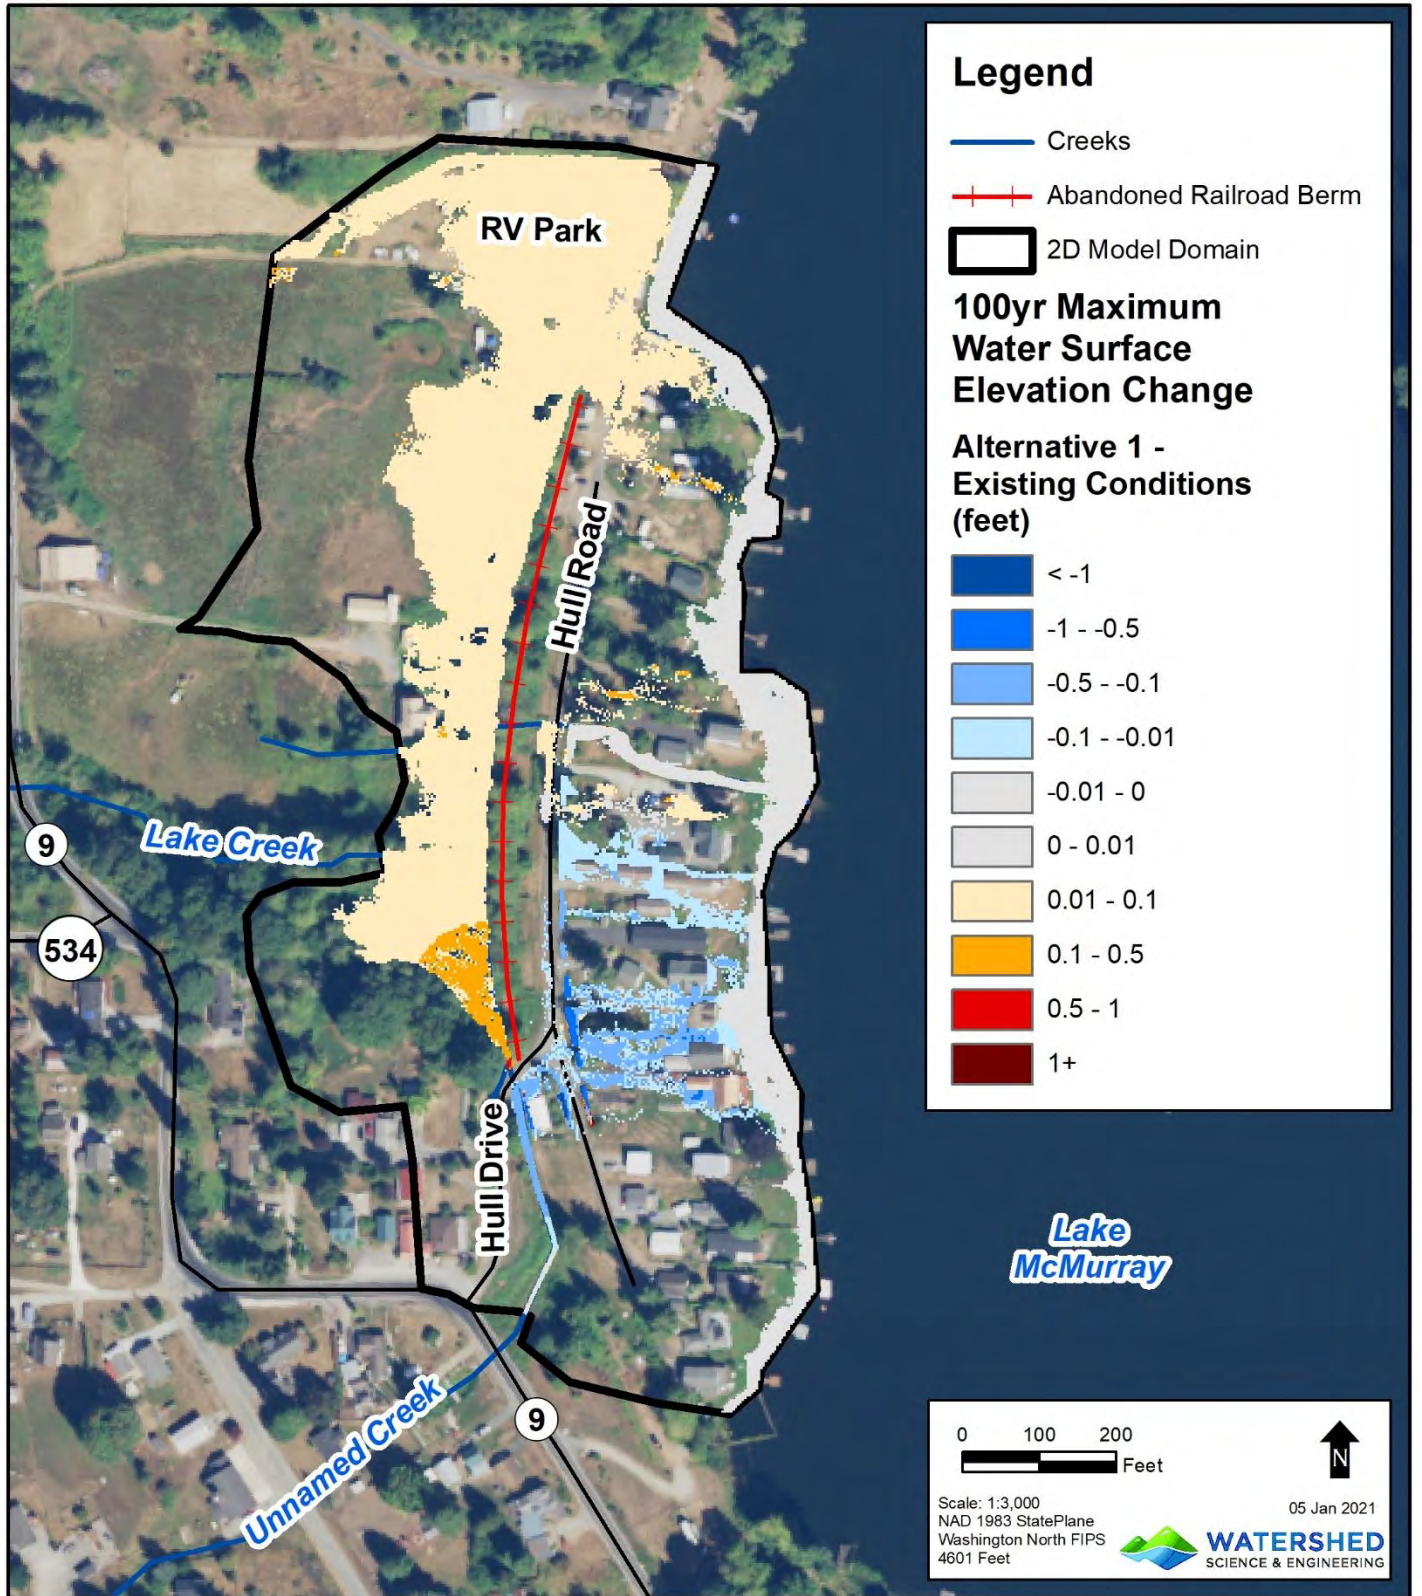
A larger culvert will increase flows to the ponded area upstream of the abandoned railroad berm. Figures 13, 14, and 15 show the change in maximum 2-, 10-, and 100-year water surface elevations, respectively, caused by increasing the size of the Hull Drive culvert and taking no other action, as predicted by the HEC-RAS model. The largest rise of 0.3 feet will occur at the outlet of the upsized Hull Drive culvert in the 10-year event and 0.5 feet in the 100-year event. The increase in water surface elevation in the 10- and 100-year events diminishes as water flows to the north. Maximum increases to water surface elevation near the home located just upstream of the abandoned railroad culverts is approximately 0.12 feet during the 10-year event and 0.13 feet during the 100-year event. During the 2-year event the largest increase of 0.11 feet will occur at the north end of the ponded section near the RV park. Near the house located west of the railroad berm the maximum increase in water surface elevation during the 2-year event will be approximately 0.04 feet.

Figure 13. 2-year Flood Water Surface Elevation Change Alternative 1 vs. Existing Conditions.

Figure 14. 10-year Flood Water Surface Elevation Change Alternative 1 vs. Existing Conditions.

Figure 15. 100-year Flood Water Surface Elevation Change Alternative 1 vs. Existing Conditions.

Increasing the size of the culvert under Hull Drive from the existing 12-inch CMP to a 24-inch RCP (Reinforced Concrete Pipe) will stop most floods from overtopping the right bank at the culvert inlet and flowing down Hull Drive to flood multiple lake front properties. Figures 10, 11, and 12 compare the 2-, 10- and 100-year flood limits for Alternative 1 to those for existing conditions. The blue shading in the figures shows areas that the model predicts will no longer flood. The figures reveal that water no longer overtops the right (east) bank at the culvert inlet. Stopping the spill eliminates flooding of both Hull Drive and Hull Road as well as flooding on four lake front properties. The analysis assumes the culvert entrance remains open and does not clog with sediment or woody debris.

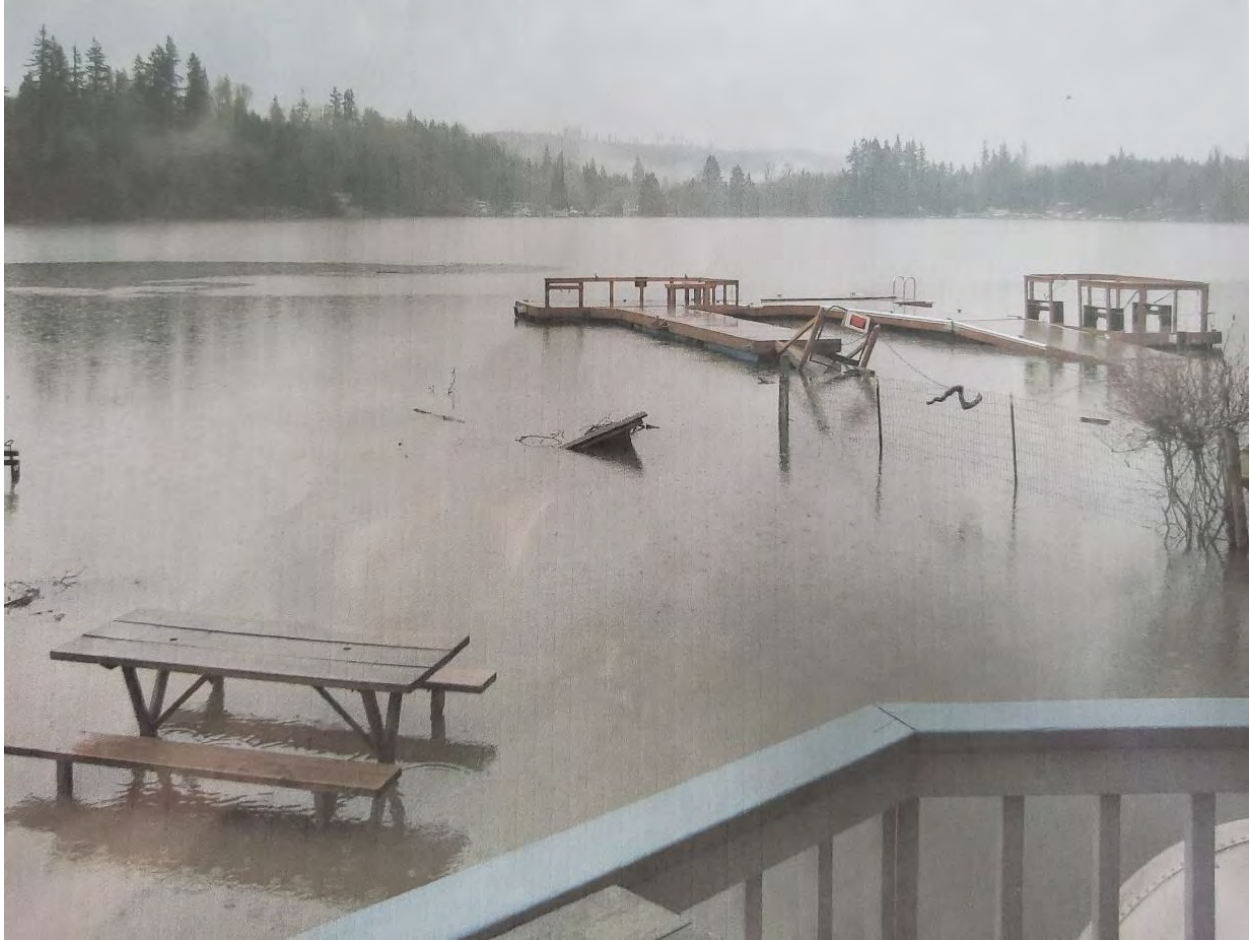
Photo 4. Winter flooding caused by high lake levels. Photo is viewing south from the home that is located immediately south of where Lake Creek joins Lake McMurray. (Photo provided to County by landowner, date unknown).

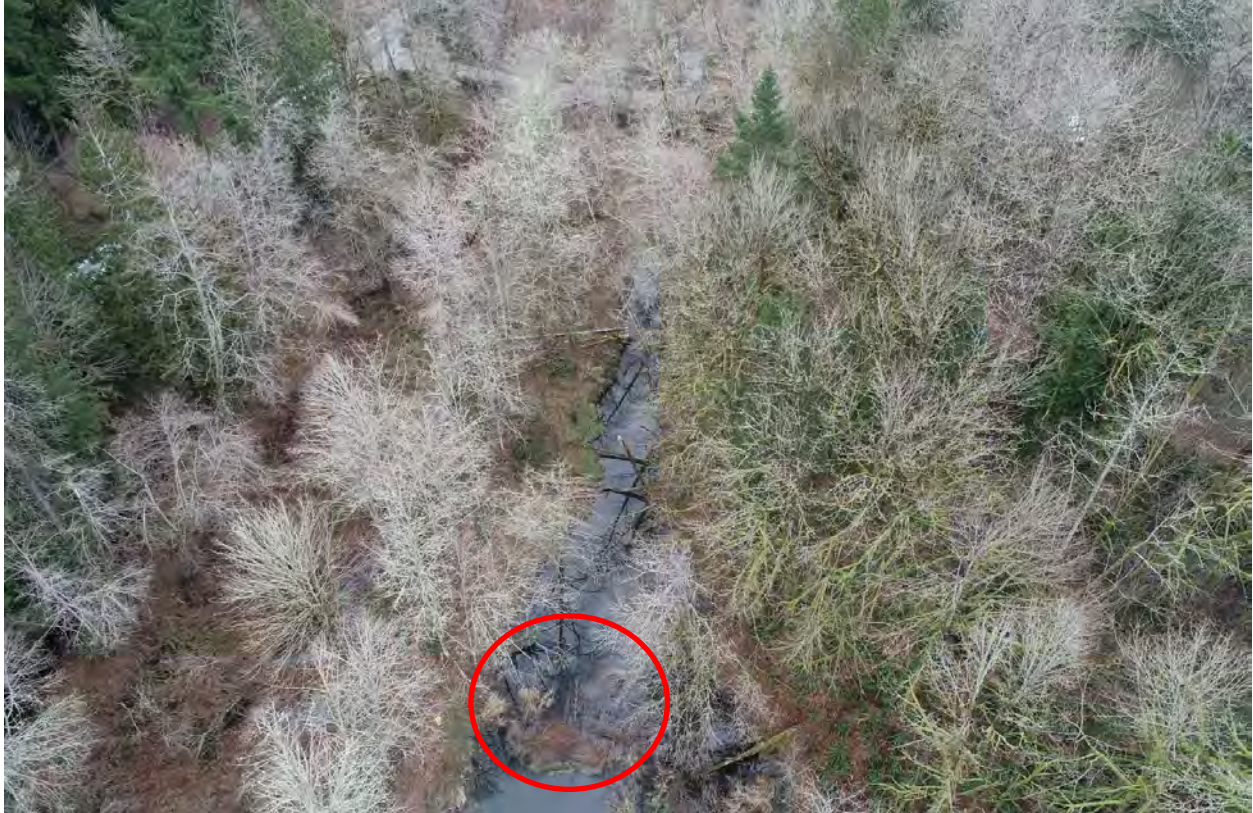
Downstream from the northern most beaver dam (Photo 9) the channel is open and generally free from obstructions except for a few fallen trees (Photo 10). It is possible beaver dams may have existed in the reach in the past, but we did not see current evidence of any.

Photo 9. Beaver dam and beaver diver (circled in red) located near Station 1200 in Figure 2 (March 10, 2020).
