FINAL FLOOD REDUCTION INVESTIGATION FOR LAKE McMURRAY, HULL DRIVE & HULL ROAD

Prepared for:
Skagit County Public Works
1800 Continental Place
Mount Vernon, WA 98273

Prepared by:
  **WATERSHED**
SCIENCE & ENGINEERING
506 2nd Avenue, Suite 2700
Seattle, WA 98104
206-521-3000

January 7, 2021

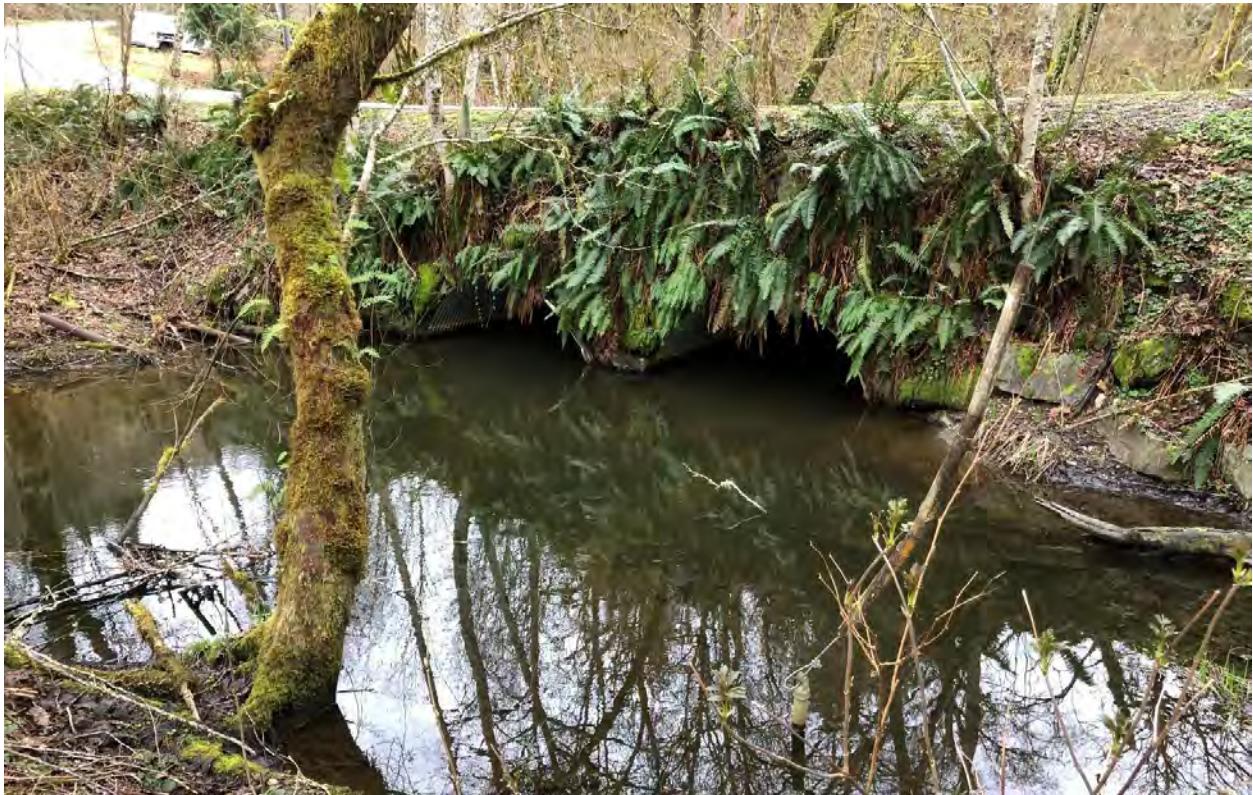
Photo 12. Outlet of existing dual culverts under McMurray Shore Drive.

At McMurray Shore Drive ponded water was observed upstream, inside, and immediately downstream from the culverts indicating that the culverts were not obstructing flow on the day of the site visit; rather, something downstream from the road was causing the water to pond (Photo).

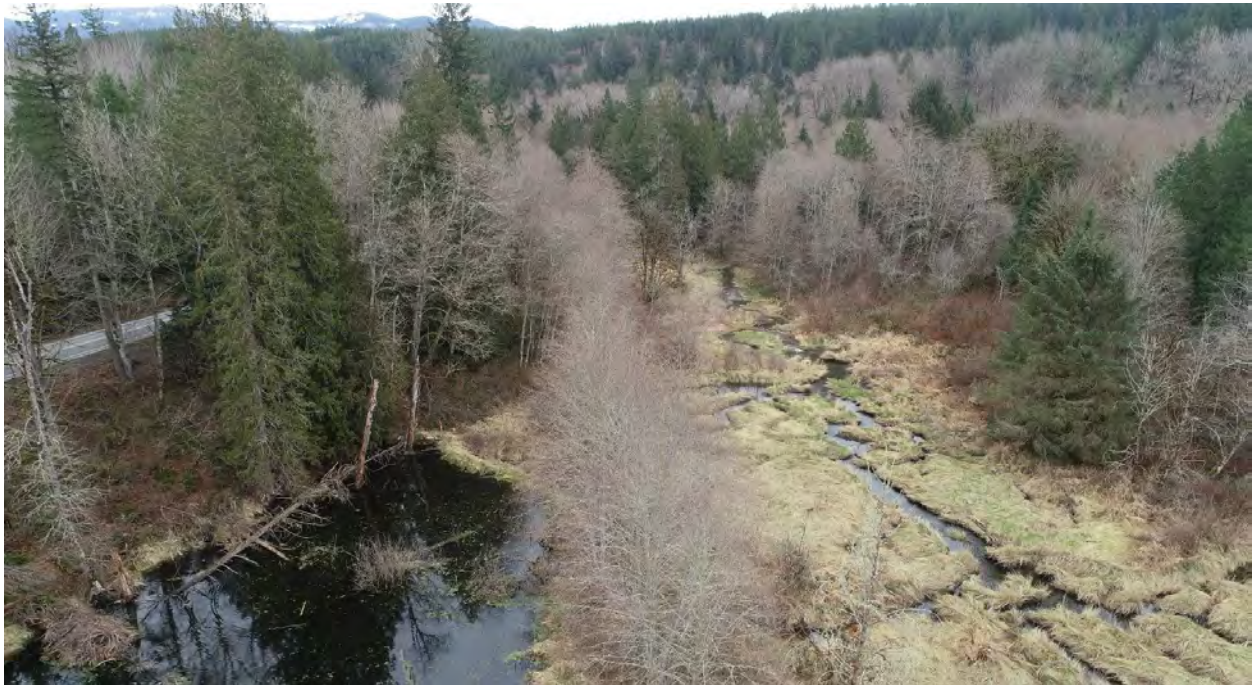
Downstream from the unnamed tributary, Lake Creek meanders through a valley floor covered with thick vegetation. Throughout the reach there is evidence of beaver activity but no significant dams until station 3,700 feet. Here there is a large beaver dam to the left (northwest) of the primary railroad berm. The dam is not obstructing the outlet channel because it is on the opposite side of the berm from the stream.

Photo 9. Active beaver dam approximately 3,700 feet downstream of Lake McMurray (March 10, 2020). The primary railroad berm is covered with trees in the center of the photograph. Lake Creek is in the right side of the photo.

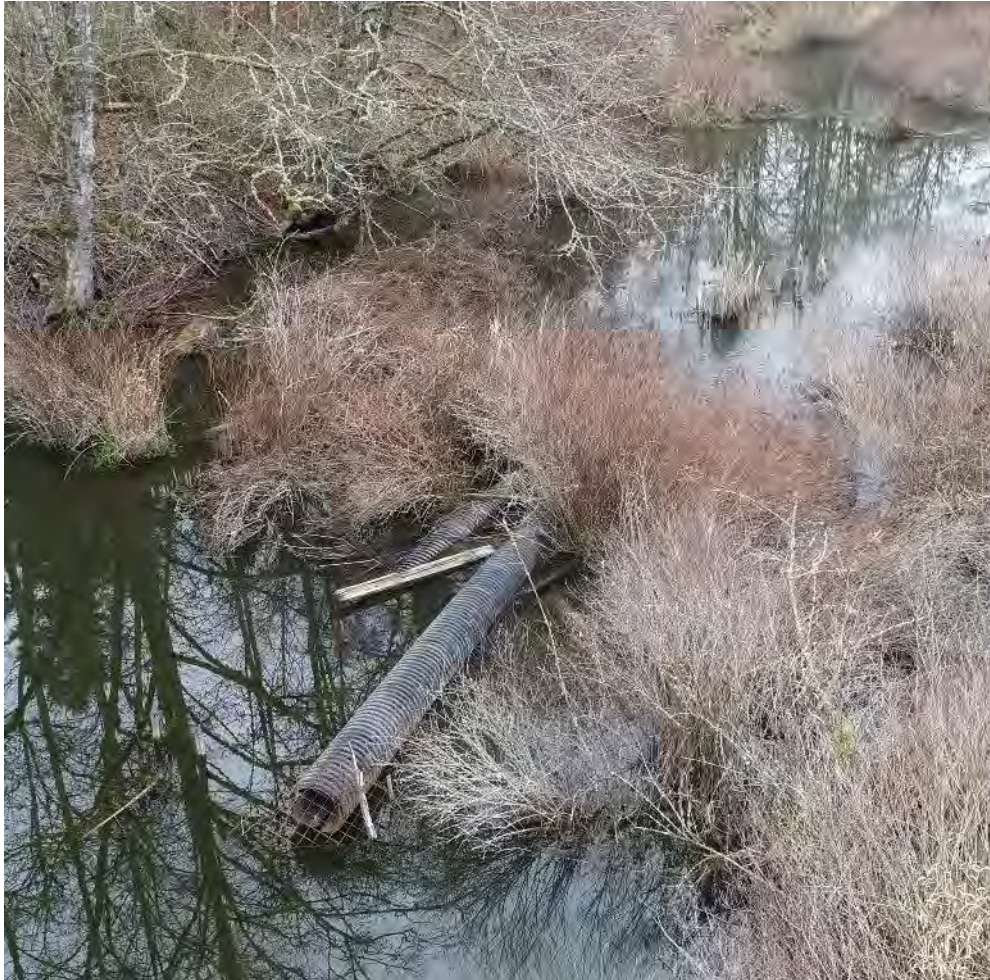
Photo 1. Example of beaver deceiver in disrepair located upstream of McMurray Shore Drive. (March 10, 2020).
