RE-EVALUATION OF THE MAGNITUDE OF HISTORIC FLOODS ON THE SKAGIT RIVER NEAR CONCRETE DRAFT REPORT

OCTOBER 2008

northwest hydraulic consultants

28 October 2008

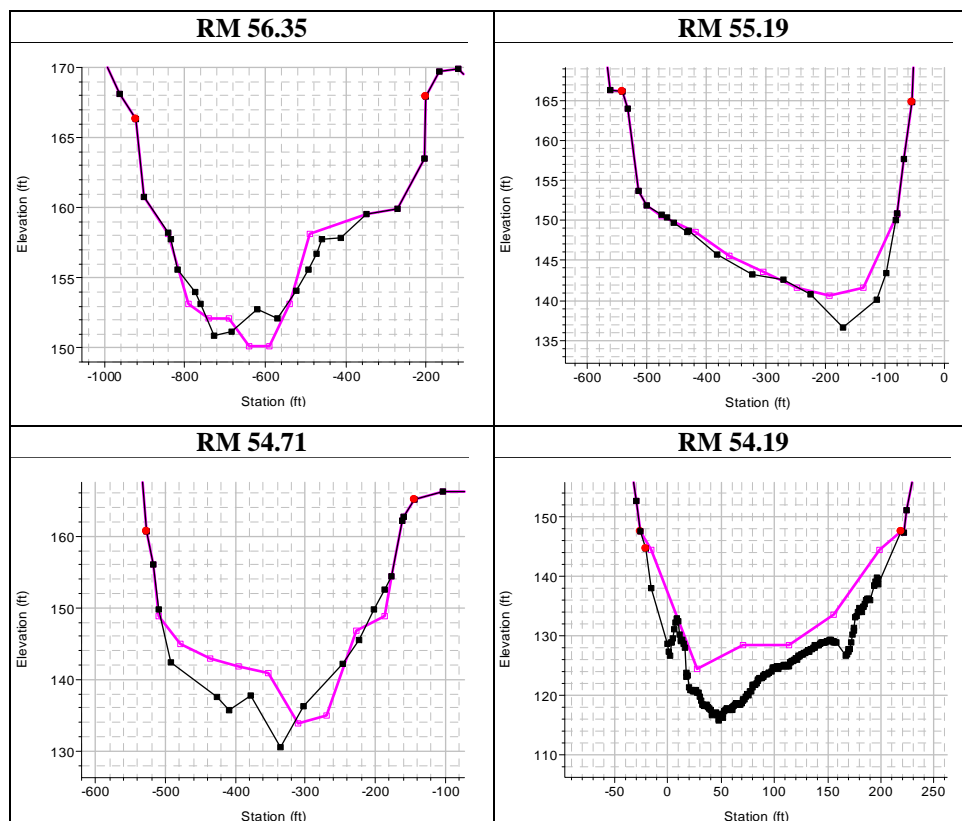
Figure 5. Comparison of Cross-Section Geometry Between 1911 (pink) and 2003 (black).

Selected in-channel cross-sections from the 1911 survey are compared with cross-sections from the current condition HEC-RAS model in Figure 5, and the thalweg profile from 1911 is compared against that from the current condition HEC-RAS model in Figure 6. The comparison shows relatively small differences in channel geometry between 1911 and the present. The channel in the current condition model is on average about 4 feet deeper than in 1911 over much of the reach between The Dalles and the confluence with the Baker River. Below The Dalles to RM 53.1, differences are not as consistent. In general, the current condition channel below The Dalles is somewhat deeper than the 1911 channel, except between RM 53.3 and RM 53.94 where the 1911 channel is locally deeper.

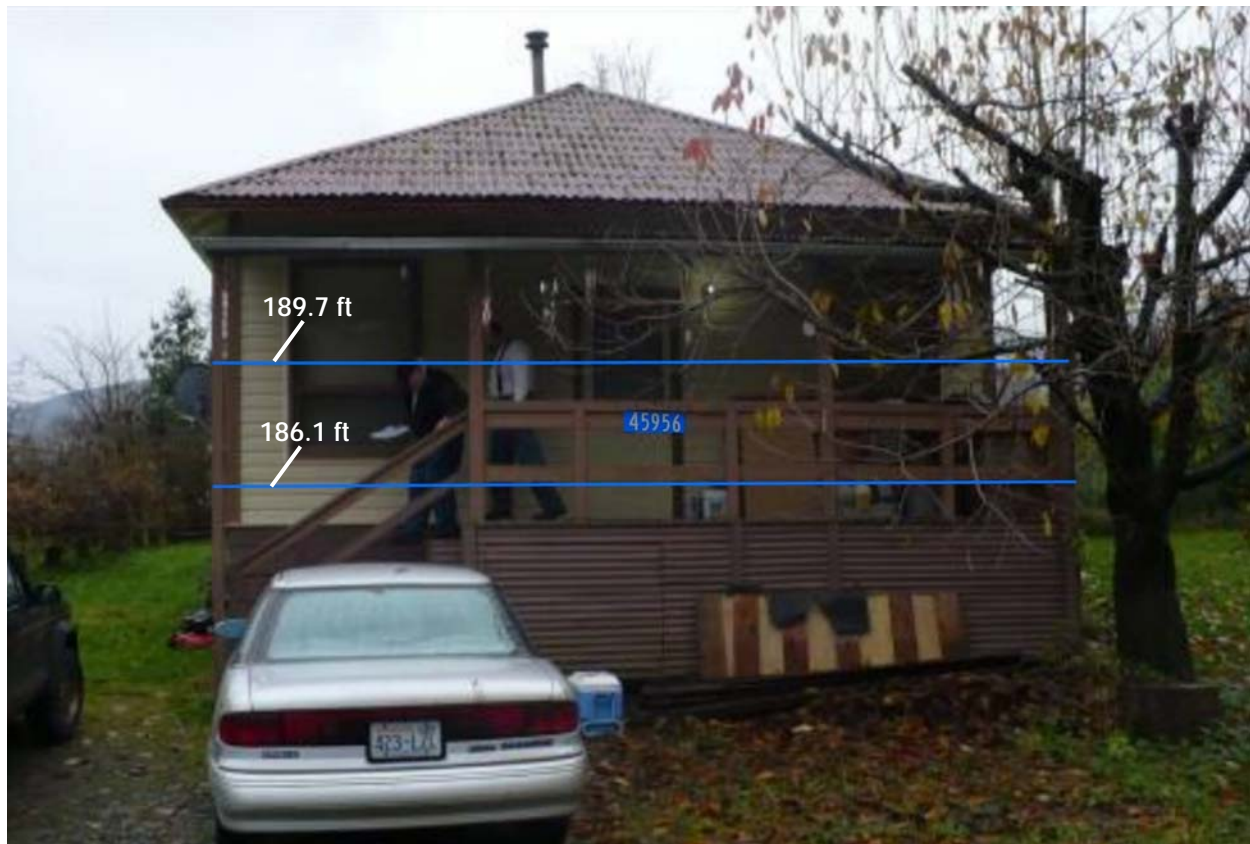
Figure 10. 45956 Albert Street.

The lowest existing residence dating from 1921 that has been identified in the Crofoot Addition is 45956 Albert Street, with a finished floor elevation of 184.93 feet NGVD 1929⁴. It is possible that other lower residences existed in 1921 that have since been demolished, or otherwise modified, but we have no way of either identifying such residences or of determining their elevations. Assuming the maximum reported depth of water of 14 inches was above the finished floor level at 45956 Albert Street, gives a maximum December 1921 water surface elevation in the Crofoot Addition of at most 186.1 ft. The only house dating from 1921 in East Concrete for which we have a finished floor elevation is 46335 Forest Place at 186.61 ft. Visually, this house appears to be one of the lowest, if not the lowest, house dating from 1921 in East Concrete. From the FIS (Federal Emergency Management Agency, 1989), the head loss between Crofoot and East Concrete is roughly 0.5 feet at a discharge of 226,000 cfs (the currently published 1921 peak discharge is 228,000 cfs), which would put the water level at 46335 Forest Place essentially at the finished floor level. This seems inconsistent with the statement in the Concrete Herald article that the “*waters also crept up around some of the dwellings in East Concrete*”, so the estimated 1921 peak water level of 186.1 ft. in the Crofoot Addition is probably high. Nevertheless, we have taken the estimate of 186.1 ft NGVD 1929 as the best estimate of high water level in the Crofoot Addition in the December 1921 flood and the basis for estimating the December 1921 peak discharge in Section 3.0 of this report.

the currently published value of 228,000 cfs. A somewhat conservative¹⁰ HEC-RAS model relying on current channel geometry produces simulated water surface elevations in the Crofoot Addition ranging from 189.7 to 190.8 ft at a discharge of 228,000 cfs for the combinations of model parameters bracketing their probable actual values (see Table 3). Based on the Concrete Herald report, the maximum water level in the Crofoot Addition during the 1921 flood was at most 186.1 ft. These water levels are shown in Figure 10 superimposed on a photograph of the lowest existing house in the Crofoot Addition dating from 1921 (45956 Albert Street).
