Resource Significance

Natural Resources

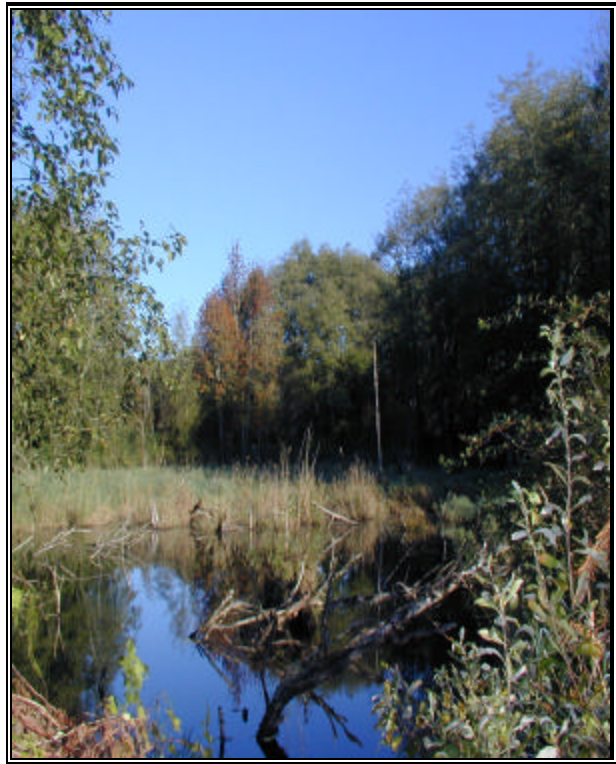
Beaver pond & associated wetlands, tributary of Hansen Creek
