**REPORT  
ENVIRONMENTAL SITE ASSESSMENT  
PHASE I**

**3DH AGGREGATES SURFACE MINE  
SKAGIT COUNTY PARCELS P44865 AND P126694  
ROCKPORT, WASHINGTON**

October 7, 2013

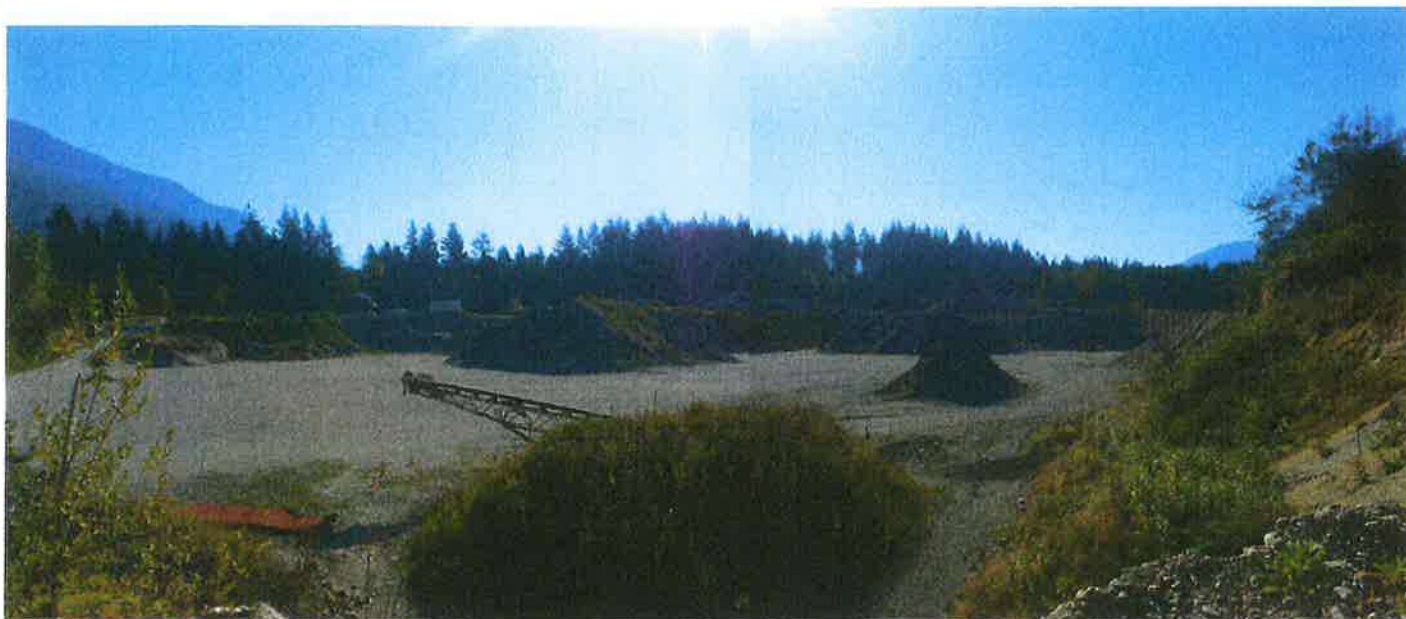
**Figure 4.** View of the property looking southeast from the top of the dike.

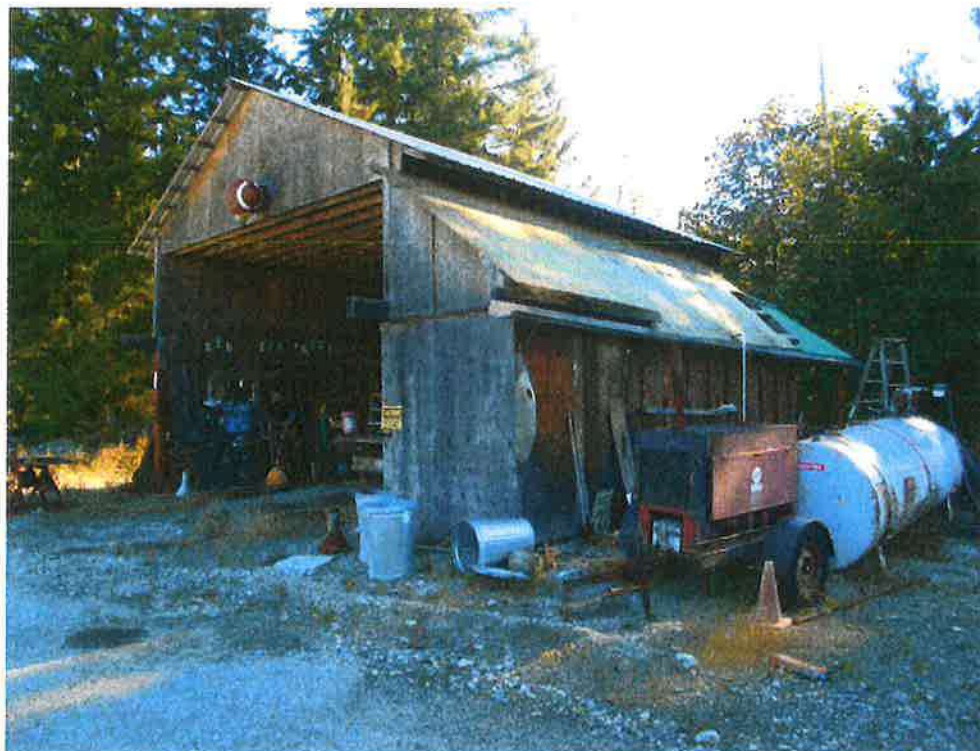
One equipment storage and repair building is located in the northeastern portion of the site. The building is constructed of wood over a gravel floor. The building is utilized for storage of tools and parts for equipment repair. Some hydrocarbon staining was observed on the floor of the building.

Two full, unlabeled 55-gallon drums are located north of the equipment shed. One 1,000-gallon diesel fuel AST is located along the south side of the equipment shed. No indications of staining or releases were observed around the fuel tank area.

**Figure 5.** View of the equipment storage and repair building along northeastern property boundary. The 1,000-gallon diesel AST is located along the south side of the building (right side of photo)

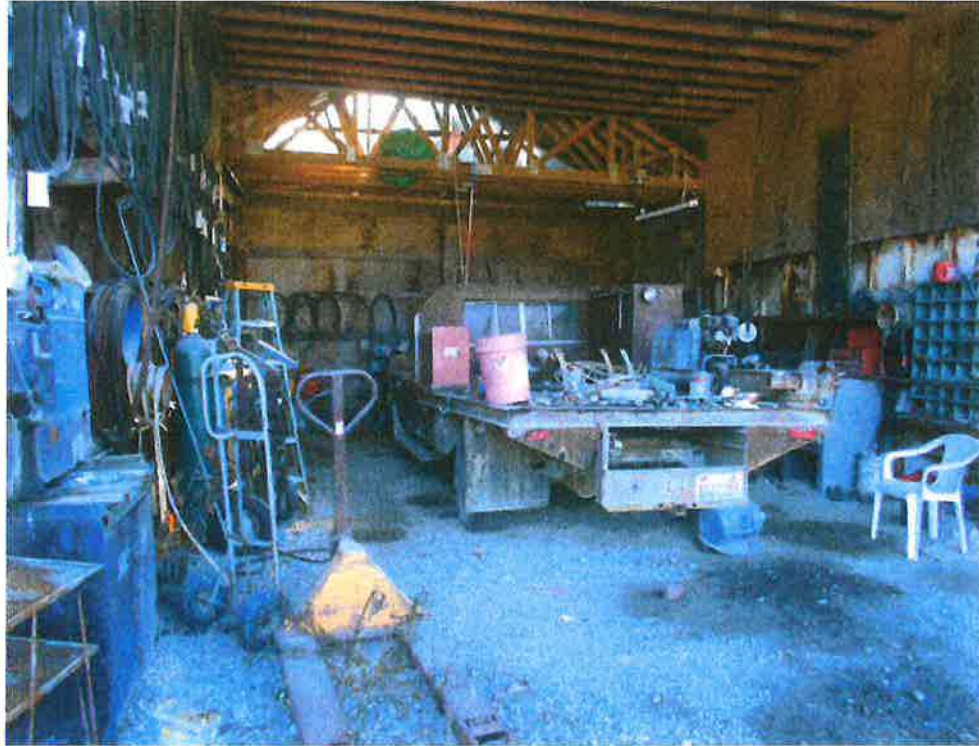
A fluid storage shed is attached to the north side of the building. Three 55-gallon drums of new and used motor oil and hydraulic oil, and multiple 2.5 gallon containers of motor oil are stored within the shed. Some spills were noted on the floor of the shed; but only a small stained area was observed on the gravel around the entrance to the storage.

**Figure 6.** Interior of the equipment/repair building.

Some staining was observed on the ground surface in the repair area. We recommend that best management practices be instituted at the site so that all spills and drips are immediately cleaned up. In addition, a floor could be placed beneath the repair area to provide a barrier between the repair activity and the ground. Two unlabeled 55-gallon drums are currently being stored on the ground surface, north of the repair building. We recommend that all drums be stored under cover and within secondary containment. Waste materials should be removed and disposed of properly.

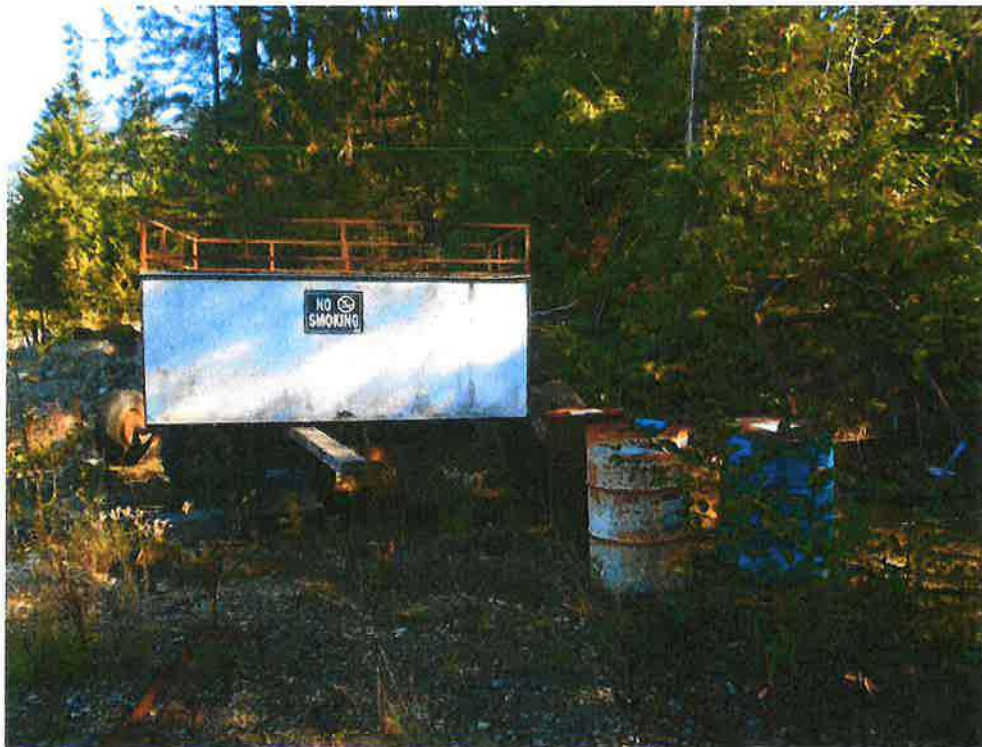
**Figure 7.** Two drums stored north of equipment building. We recommend the drums get removed and properly disposed.

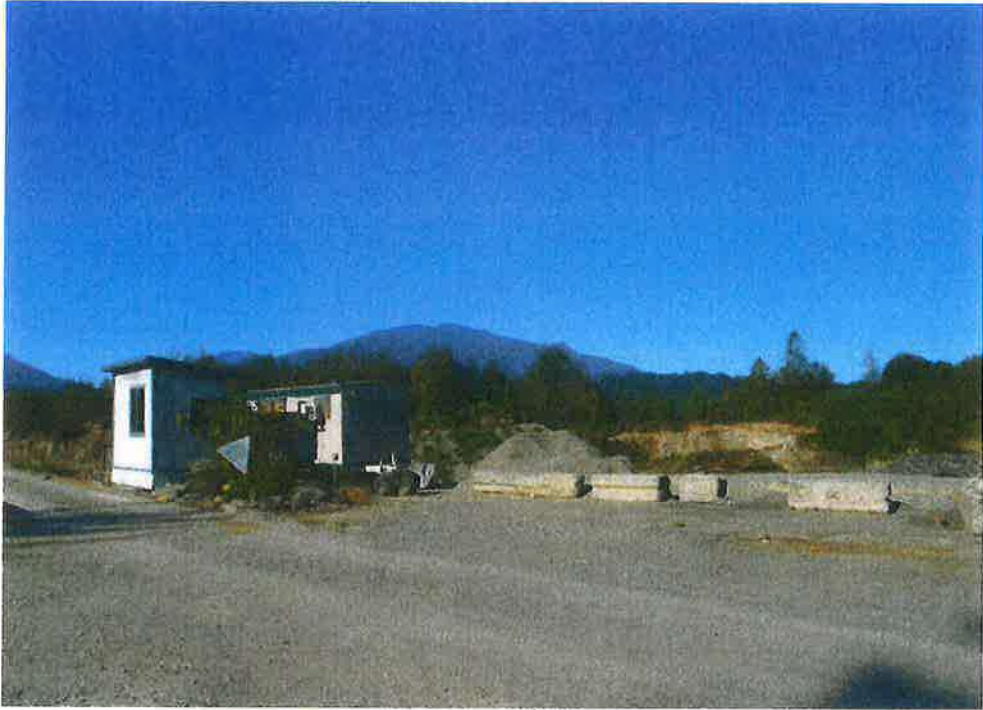
A small scale house structure and a mobile office are located adjacent to the truck scale, southwest of the equipment storage building. The scale house has electricity.

**Figure 8.** Scale, scale house, and mobile office.

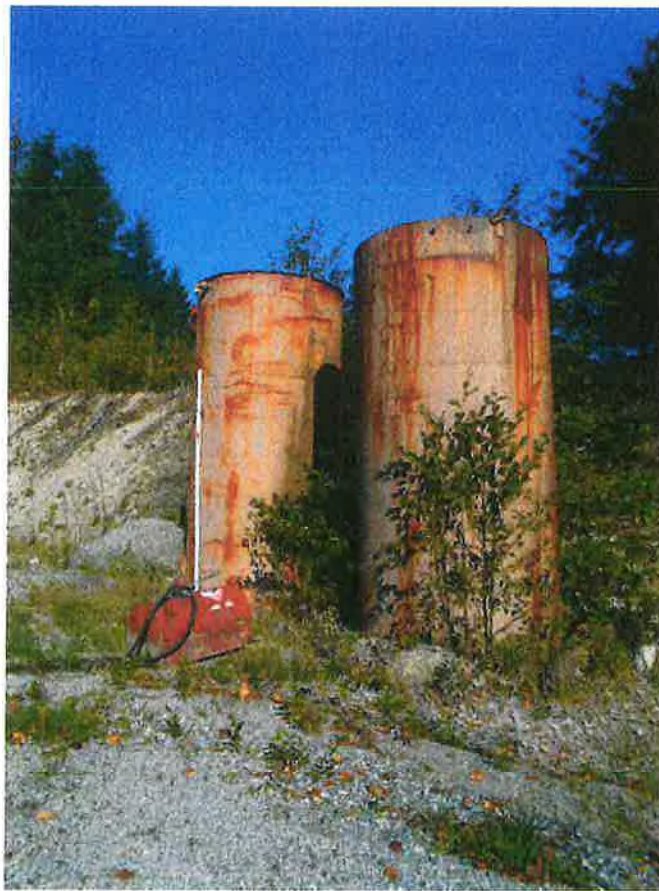
Three metal above ground storage tanks (AST) are located along the northern property boundary. The tanks are used to store water, according to Mr. Johnny Rock, a long time employee of the pit. An empty 55-gallon AST is located adjacent to the two large metal water tanks. No staining was observed around the AST.

**Figure 9.** Water tanks and 55-gallon diesel AST along northern boundary.

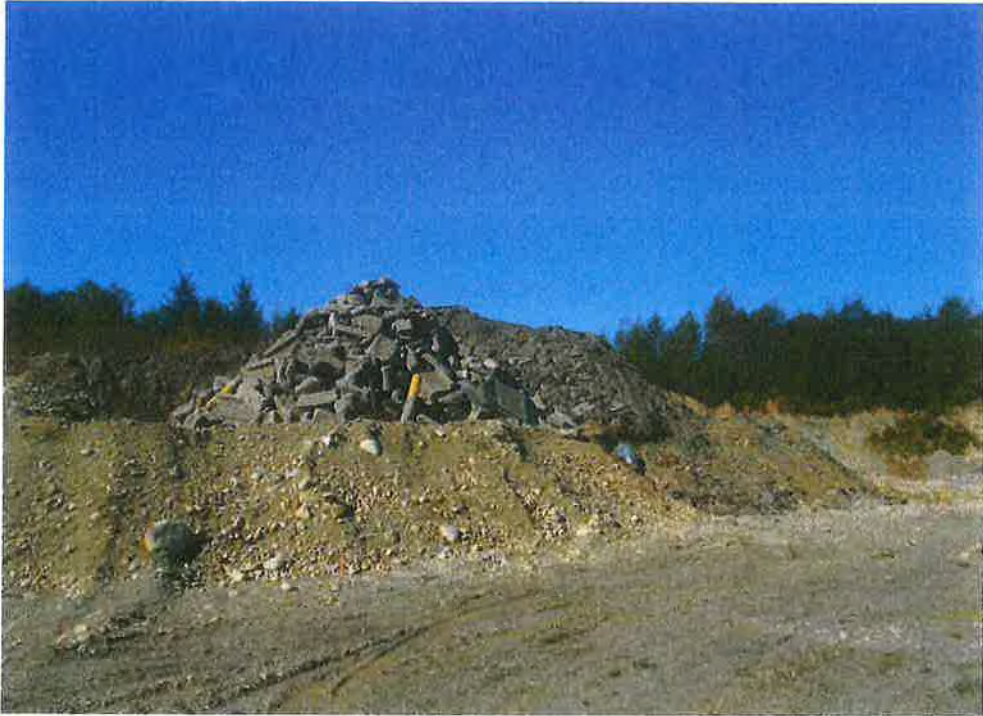
A few large piles of asphalt and concrete are located throughout the northern portion of the site. No other debris was noted in the piles.

**Figure 10.** Piles of asphalt and concrete being stored onsite for future crushing and recycling.

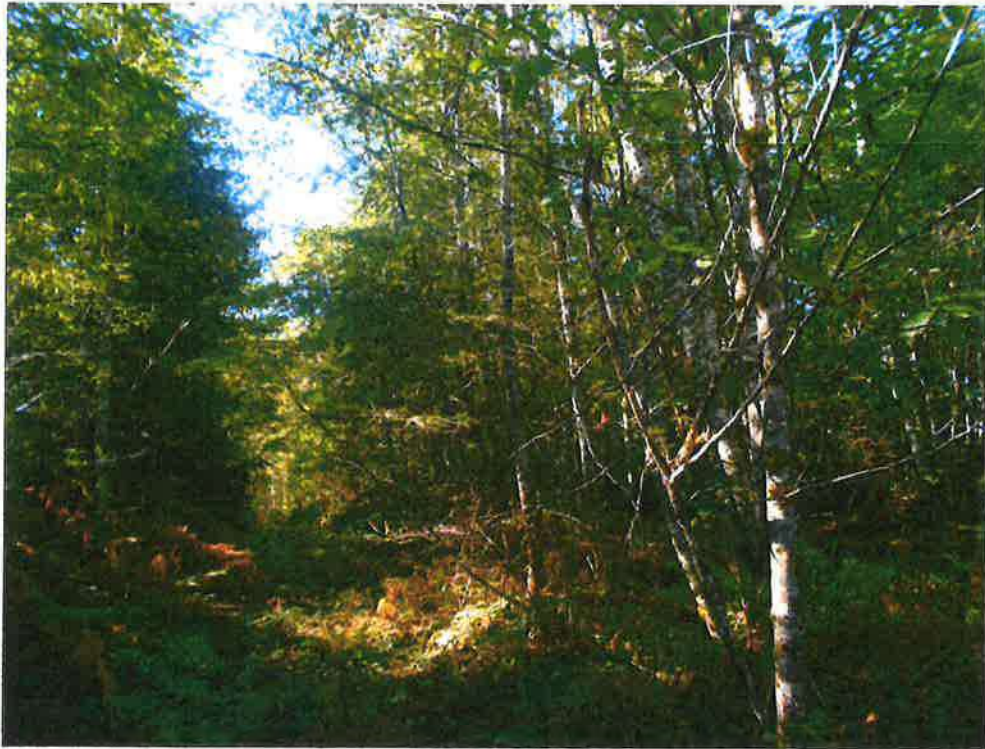
The remainder of the site is covered by young forest. One former roadway extends south through the central portion of the site. No indications of debris or dumping were observed within the forested portions of the site.

**Figure 11.** View of the forest in the central and southern portions of the site.

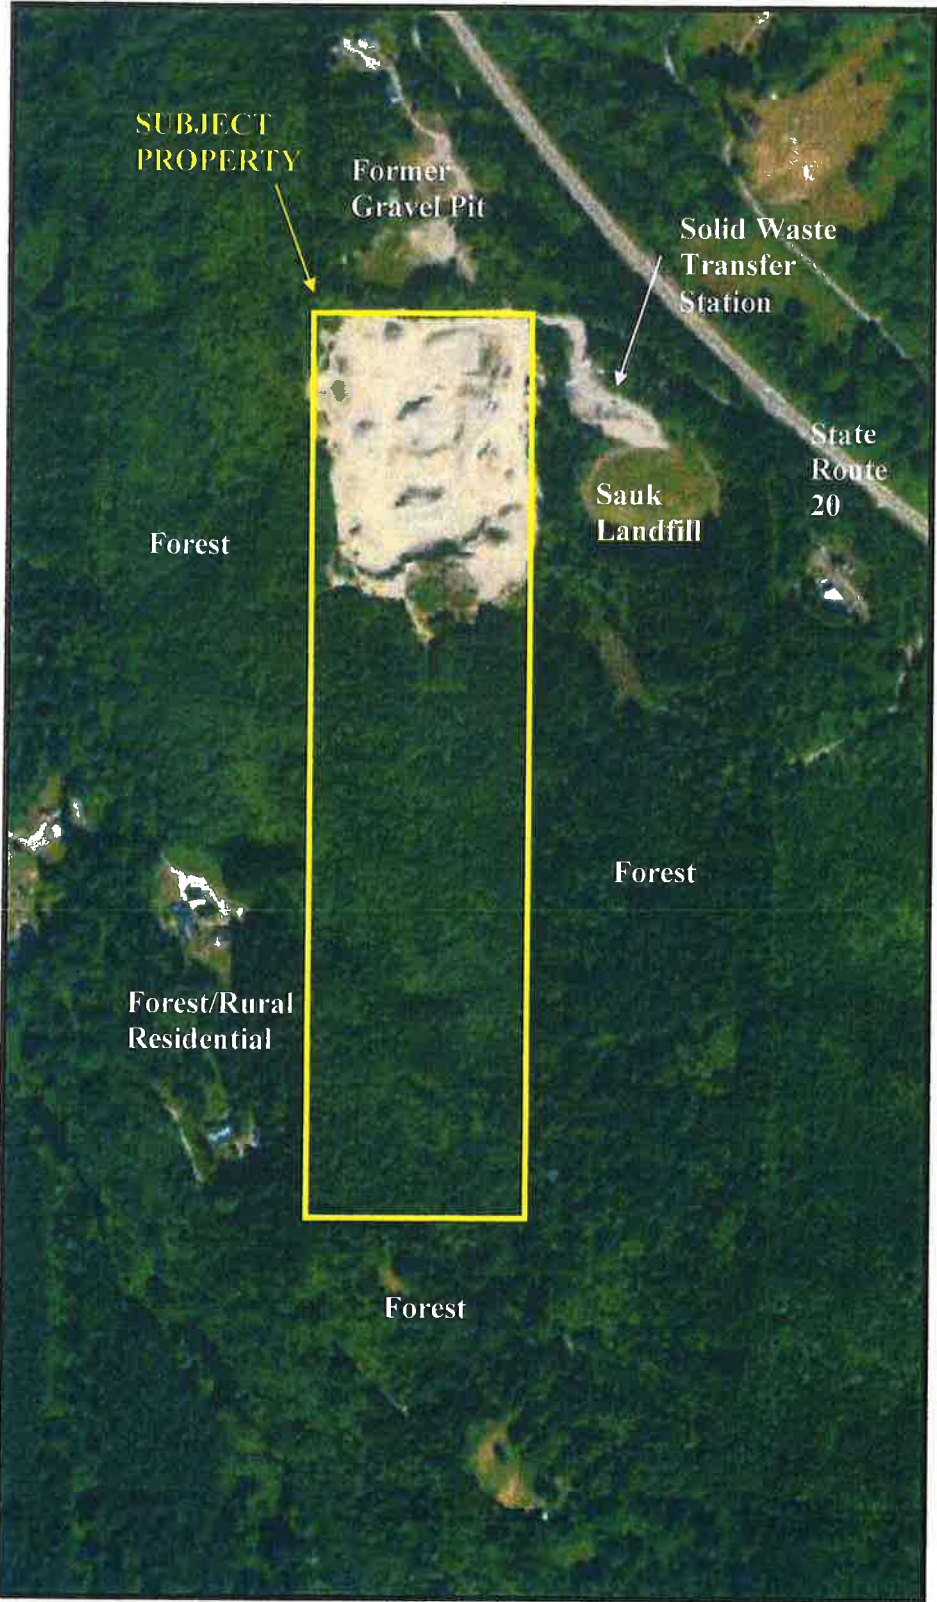
Figure 2. Aerial photograph of subject property and vicinity (GoogleEarth, 2011).

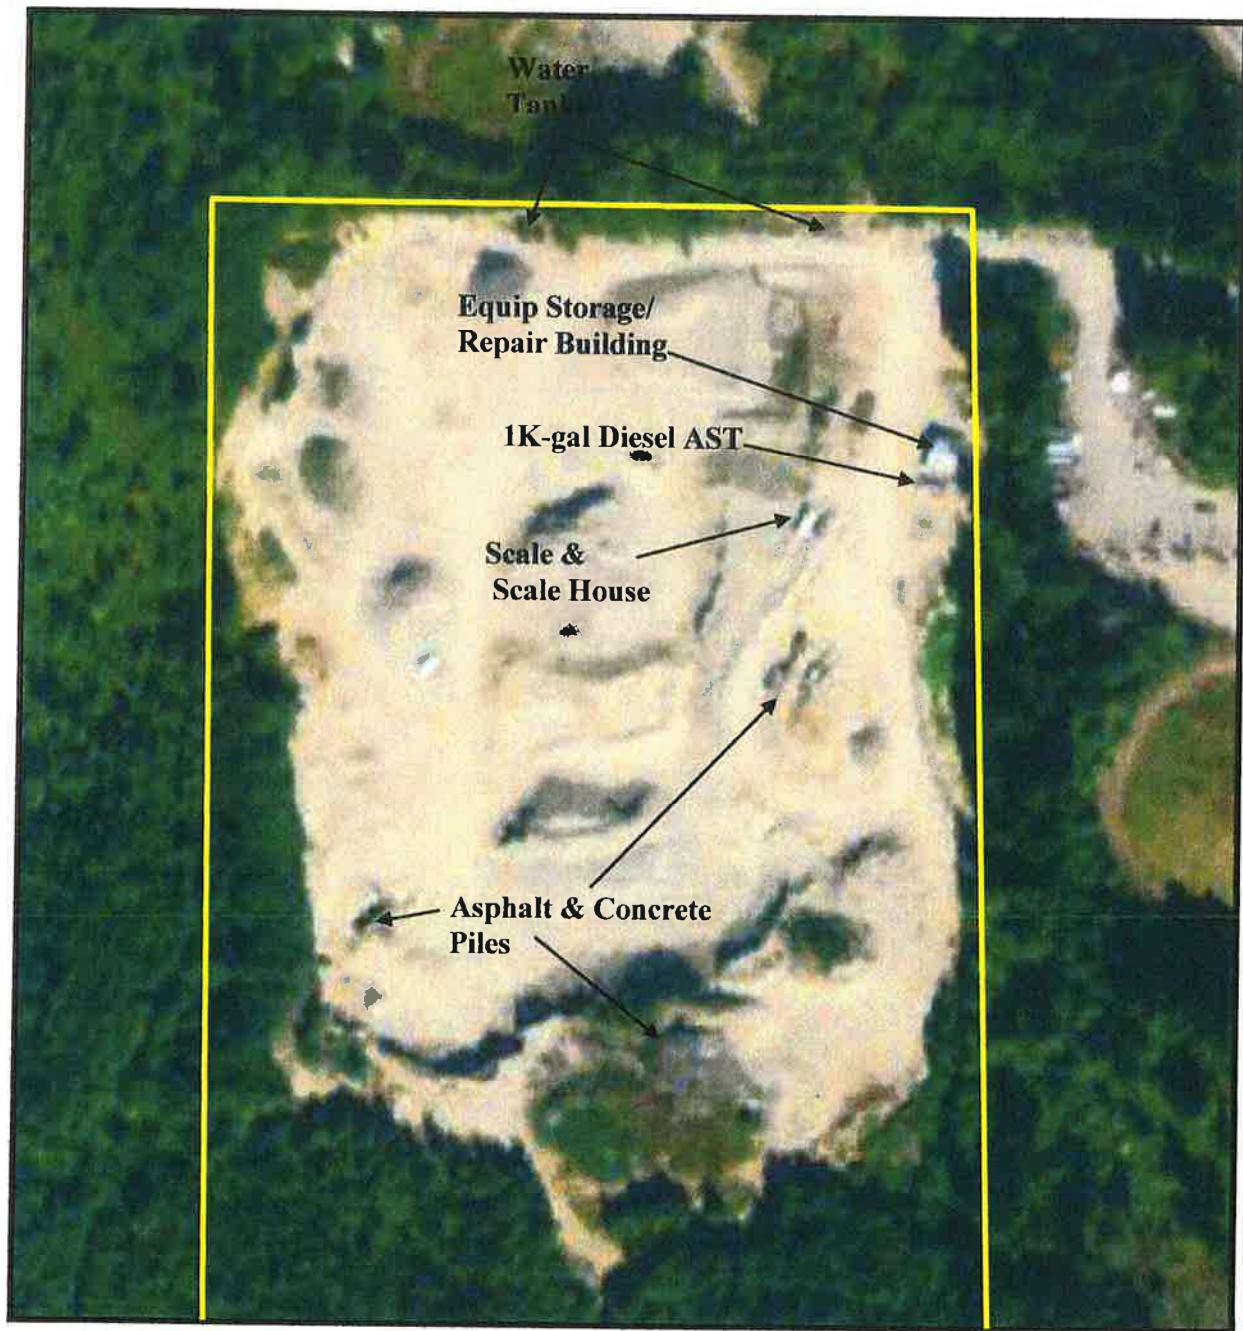
**Figure 3.** Close-up of the northern portion of the subject property (Google Earth, 2011)

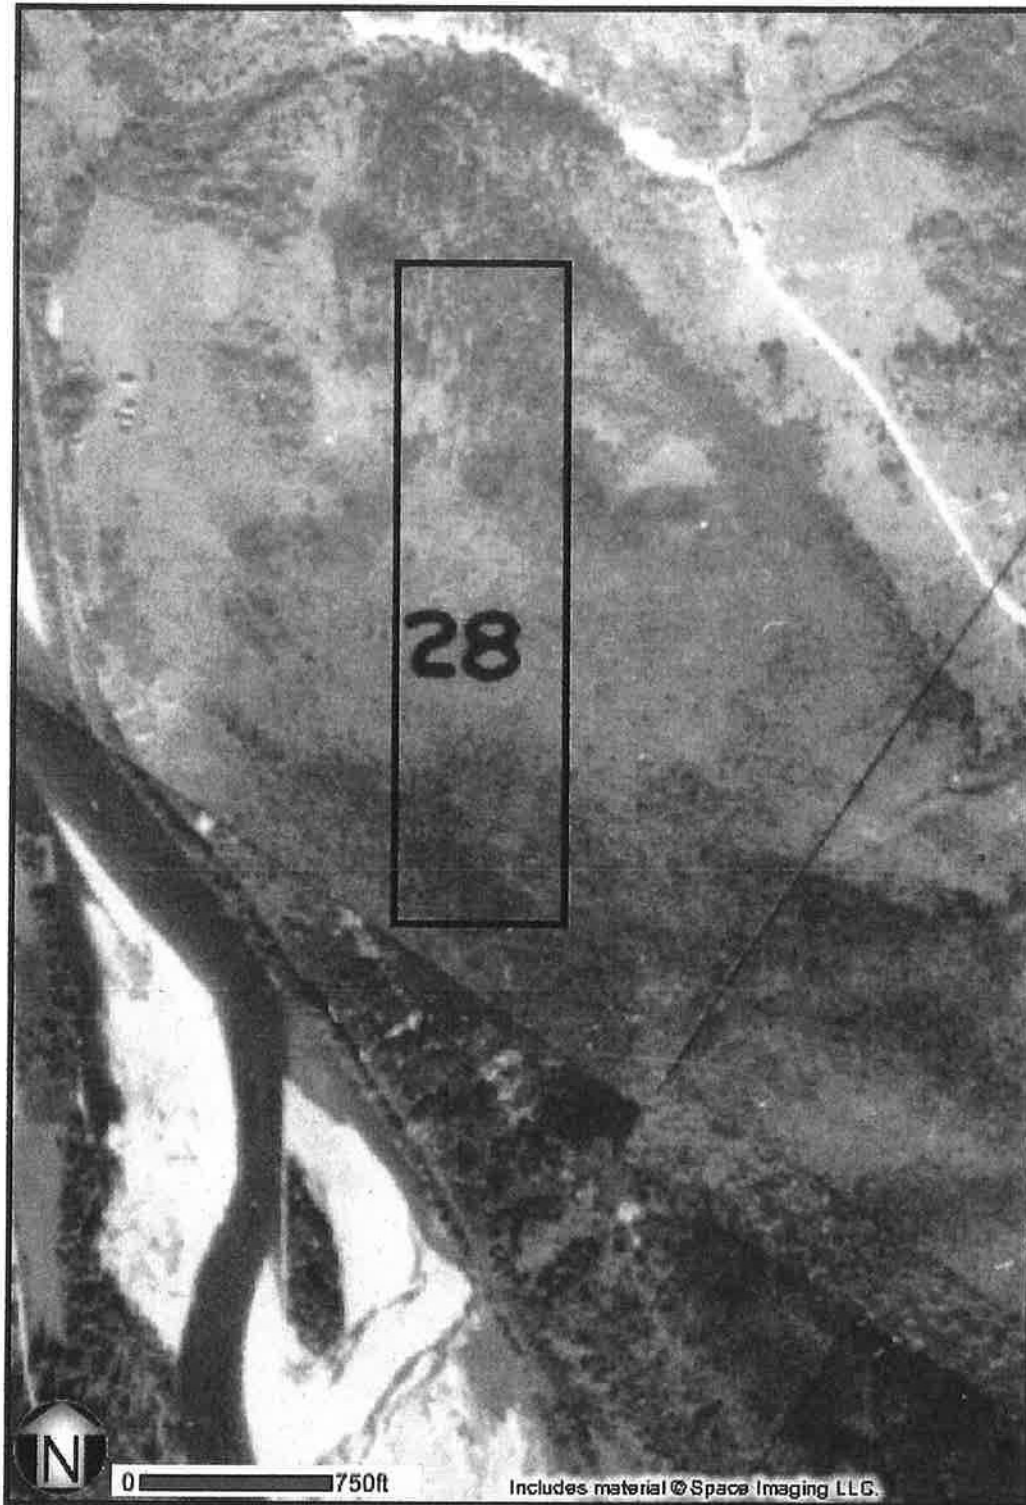
**1937 Historic Aerial Photograph**  
(location is approximate)

Forest covered the property from at least 1937 through the mid 1990s. The forest on the site in 1937 was thin over the central and southern portions of the site and may indicate an early forest harvest from the site. Forest was cleared from the site again in the mid-late 1990s. The site was permitted as a sand and gravel mine in 1978; however removal of sand and gravel did not began on the site until the late 1990s or early 2000s. Since mining began, approximately 12 acres of land in the northern portion of the site have been disturbed.

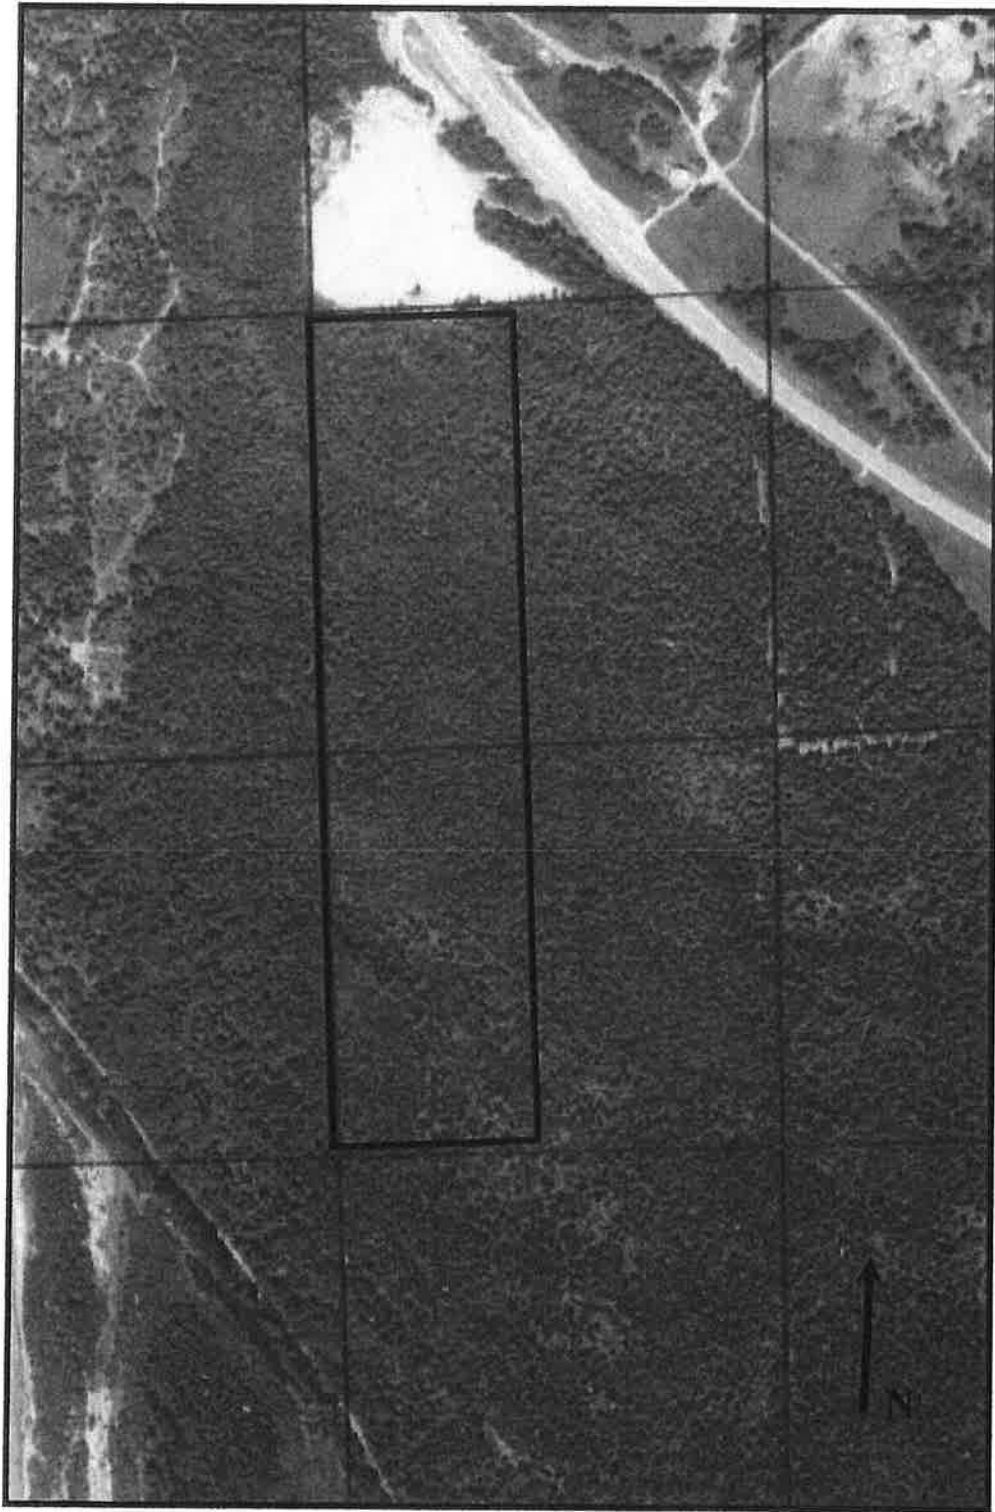
1969 Historic Aerial Photograph

*North:* Forest bound the site to the north in 1937. The land was cleared of trees and a gravel mine was operating on the site by 1969. The site was less active by 1978 with some vegetation in the former mining areas. Vegetation has continued to cover more of the site since 1978.
