# **ENVIRONMENTAL REVIEW RECORD**

# **UPPER SKAGIT INDIAN TRIBE**

# BOW HILL FEE TO TRUST APPLICATION AND RESORT EXPANSION

September 9, 2010

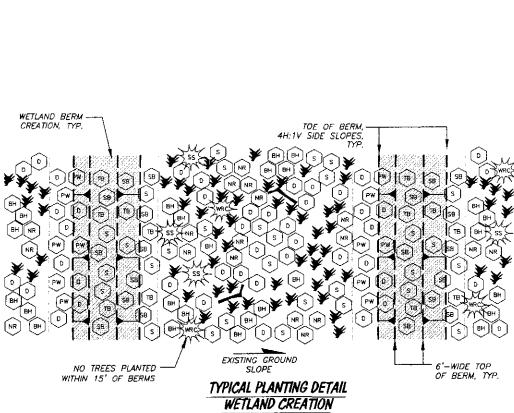
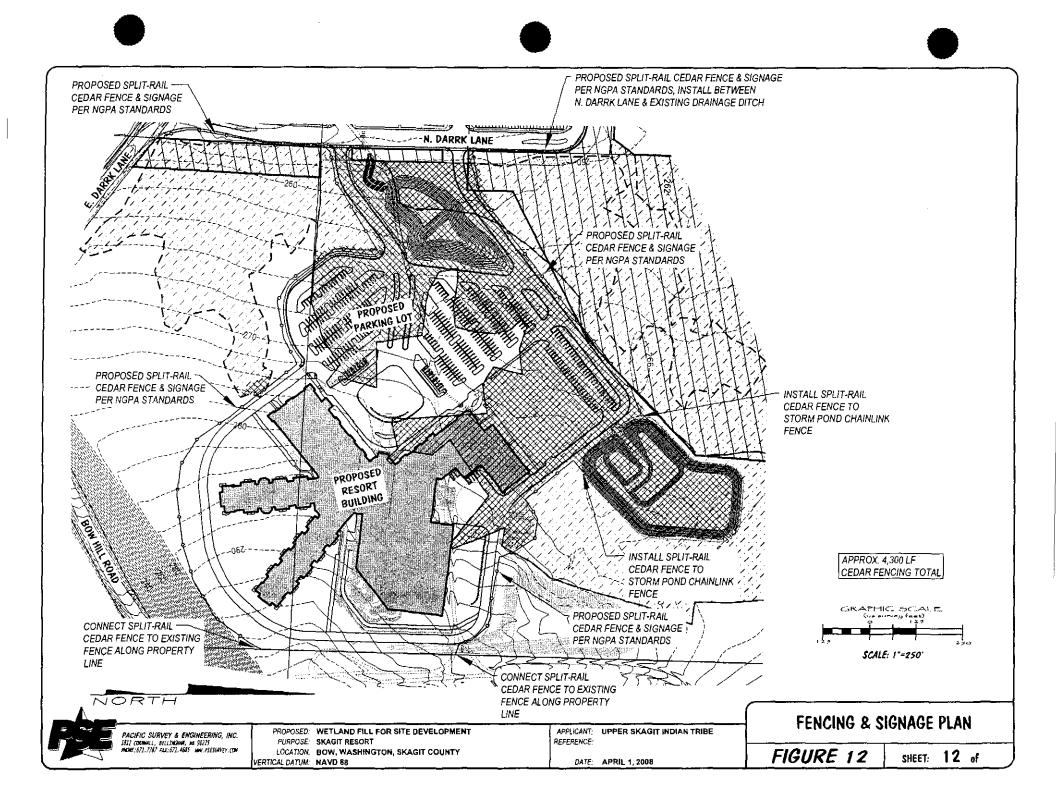
RECOMMENDED PLANTING DETAIL						
SYMBOL	SPECIES	(FEET O.C.)	MINIMUM	APPROXIMATE QUANTITY		
	TREES					
July July	Sitka spruce (Picea sitchensis)	20'	24"			
WRCH	Wester Red Cedar (Thuja plicata)	20'	24"			
	SHRUBS					
ВН	Black Hawthorn (Crataegus douglasii)	2 to 5'	1 gal. **			
NR	Nootka Rose (Rosa nutkana)	2 to 5' *	1 gal. **			
D	Red Osier Dogwood (Cornus sericea)	2 to 5'	1 gal. **			
58	Salmonberry (Rubus spectabilis)	2 to 5'	1 gal. **	· · · · · · · · · · · · · · · · · · ·		
6	Snowberry (Symphoricarpos albus)	2 to 5' *	1 gal. **			
PW	Pacific Willow (Salix lasíandra)	2 to 5'	1 gal. **			
TB	Twinberry (Lonicera involucrata)	2 to 5'	1 gal. **			
	EMERGENTS					
¥	Daggerleaf Rush (Juncus ensifolius)	6"	bareroot ***			
¥	Sawbeak Sedge (Carex stipata)	6"	bareroot ***			
¥	Slough Sedge (Carex obnupta)	6"	bareroot ***	· · · · · · · · · · · · · · · · · · ·		
	MISCELLANEOUS					
	Log		12' to 15' long			
		1	( I

CONCEPTIAL	PLANTING PLAN
PACIFIC SURVEY & ENGINEERING, INC.	PROPOSED: WETLAND FILL FOR SITE DEVELOPMENT	APPLICANT: UPPER SKAGIT INDIAN TRIBE		
1812 COMMUL, BELLINGHAM, MA 58225 MOME-621,2207 FAX-671,4885 MMH,PSESURVEY.COM	PURPOSE: SKAGIT RESORT LOCATION: BOW, WASHINGTON, SKAGIT COUNTY VERTICAL DATUM: NAVD 88	REFERENCE: DATE: APRIL 1, 2008	FIGURE 11	SHEET: 11 of

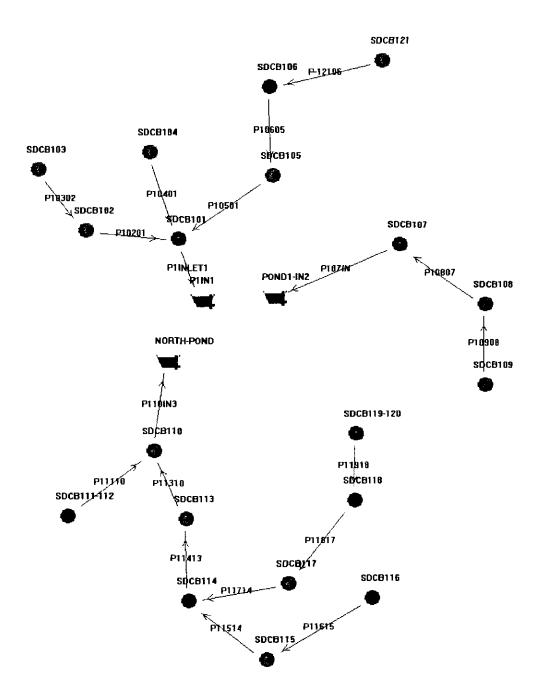
Figure 8.10a: Pond 1 Layout For Conveyance Computer Modeling

To simulate full pond conditions, the conveyance calculations assume a tail water elevation of 257.00. Design rim elevations for each catch basin are provided in the "Max El (ft)" column. The 100-year water surface elevation in each catch basin is provided in the "HW Loss Elev (ft)"

Based on the results of the computer modeling, each pipe in the Pond 1 network is sized to adequately convey the anticipated stormwater flows. Also, rim elevations for each catch basin are higher than the maximum anticipated water level in each catch basin.

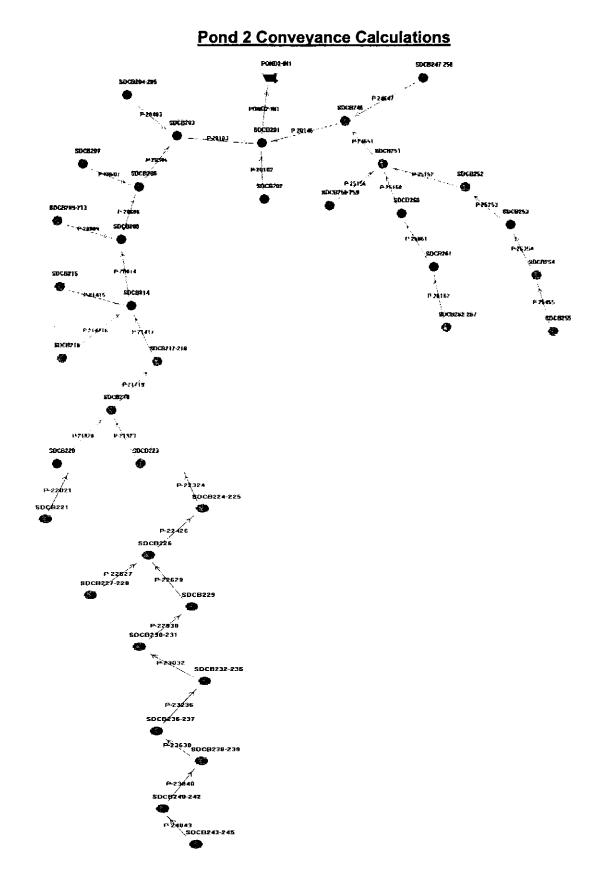
Figure 8.10b: Pond 2 Layout For Conveyance Computer Modeling

To simulate full pond conditions, the conveyance calculations assume a tail water elevation of 262.50. Design rim elevations for each catch basin are provided in the "Max El (ft)" column. The 100-year water surface elevation in each catch basin is provided in the "HW Loss Elev (ft)"

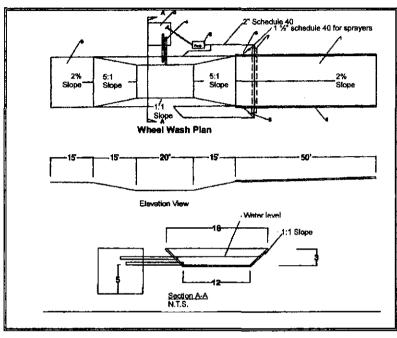
Figure 4.3 Wheel Wash

Use a low clearance truck to test the wheel wash before paving. Either belly dump or lowboy will work well to test clearance.
	Keep the water level from 12 to 14 inches deep to avoid damage to true hubs and filling the truck tongues with water.
	Midpoint spray nozzles are only needed in extremely muddy condition
	Wheel wash systems should be designed with a small grade change, 6 12 inches for a 10-foot-wide pond, to allow sediment to flow to the low side of pond to help prevent re-suspension of sediment. A drainpipe w a 2- to 3-foot riser should be installed on the low side of the pond to al for easy cleaning and refilling. Polymers may be used to promote coagulation and flocculation in a closed-loop system. Polyacrylamide (PAM) added to the wheel wash water at a rate of 0.25 - 0.5 pounds per 1,000 gallons of water increases effectiveness and reduces cleanup tim If PAM is already being used for dust or erosion control and is being applied by a water truck, the same truck can be used to change the was water.

Maintenance	The wheel wash should start out the day with fresh water.
Standards	The wash water should be changed a minimum of once per day. On large earthwork jobs where more than 10-20 trucks per hour are expected, the wash water will need to be changed more often.
	Wheel wash or tire bath wastewater shall be discharged to a separate o site treatment system, such as closed-loop recirculation or land application, or to the sanitary sewer with proper local sewer district approval.

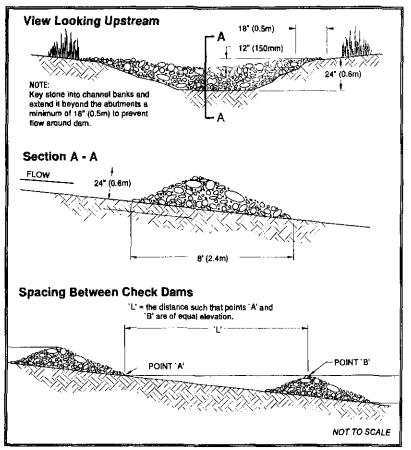
Figure 4.13 – Check Dams

Purpose	Triangular silt dikes may be used as check dams, for perimeter protection for temporary soil stockpile protection, for drop inlet protection, or as a temporary interceptor dike.
Conditions of use	May be used in place of straw bales for temporary check dams in ditches of any dimension.
	<ul> <li>May be used on soil or pavement with adhesive or staples.</li> </ul>
	<ul> <li>TSDs have been used to huild temporary:</li> </ul>
	<ol> <li>sediment ponds;</li> <li>diversion ditches;</li> <li>concrete wash out facilities;</li> <li>curbing;</li> <li>water bars;</li> <li>level spreaders; and,</li> <li>berms.</li> </ol>
Design and	Made of urethane foam sewn into a woven geosynthetic fabric.
Installation Specifications	It is triangular, 10 inches to 14 inches high in the center, with a 20-inch to 28-inch base. A 2-foot apron extends beyond both sides of the triangle along its standard section of 7 feet. A sleeve at one end allows attachmen of additional sections as needed.

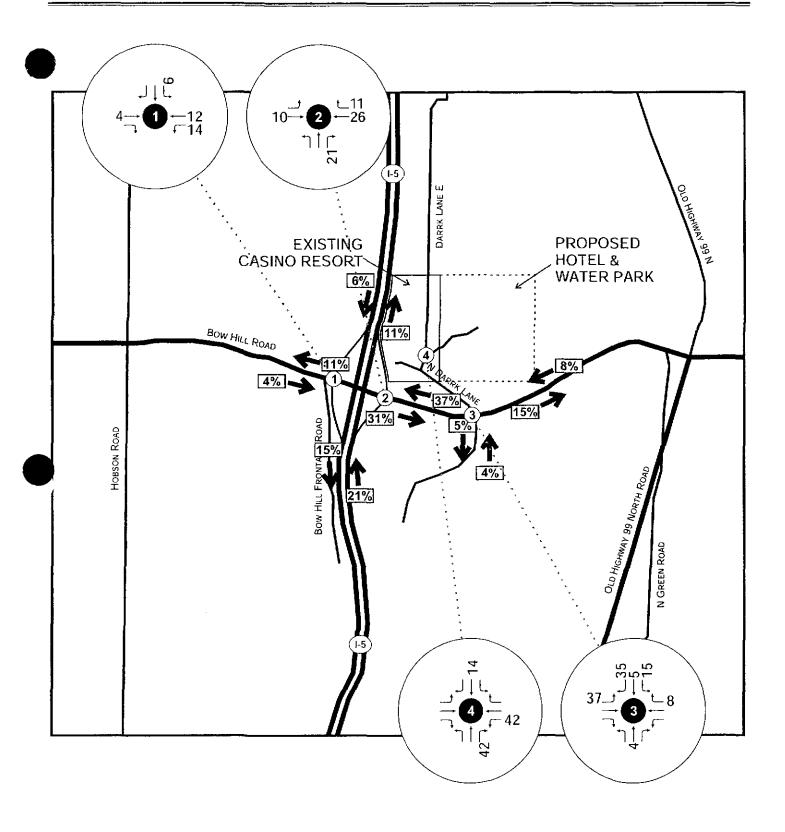
FIGURE 5: HOTEL/ WATER PARK GENERATED PM PEAK HOUR TRIP DISTRIBUTION AND TRAVEL ASSIGNMENT Upper Skagit Hotel & Water Park Transportation Impact Analysis

The peak hour trip distribution is based on 2010 traffic volumes and turning movement distribution patterns and is illustrated in Figure 5. Peak hour hotel generated trips are multiplied by the distribution percentages to illustrate the travel assignment for the development, also shown in Figure 5. The new PM peak hour trips generated by the proposed development were superimposed onto the background traffic volumes (Figure 4) to forecast the future 2012 traffic conditions with the hotel complete and occupied. Future 2012 traffic conditions with the hotel in place are shown in Figure 6.
