**SKAGIT COUNTY**

**RIGHT-OF-WAY  
ADA TRANSITION PLAN**

**2024**

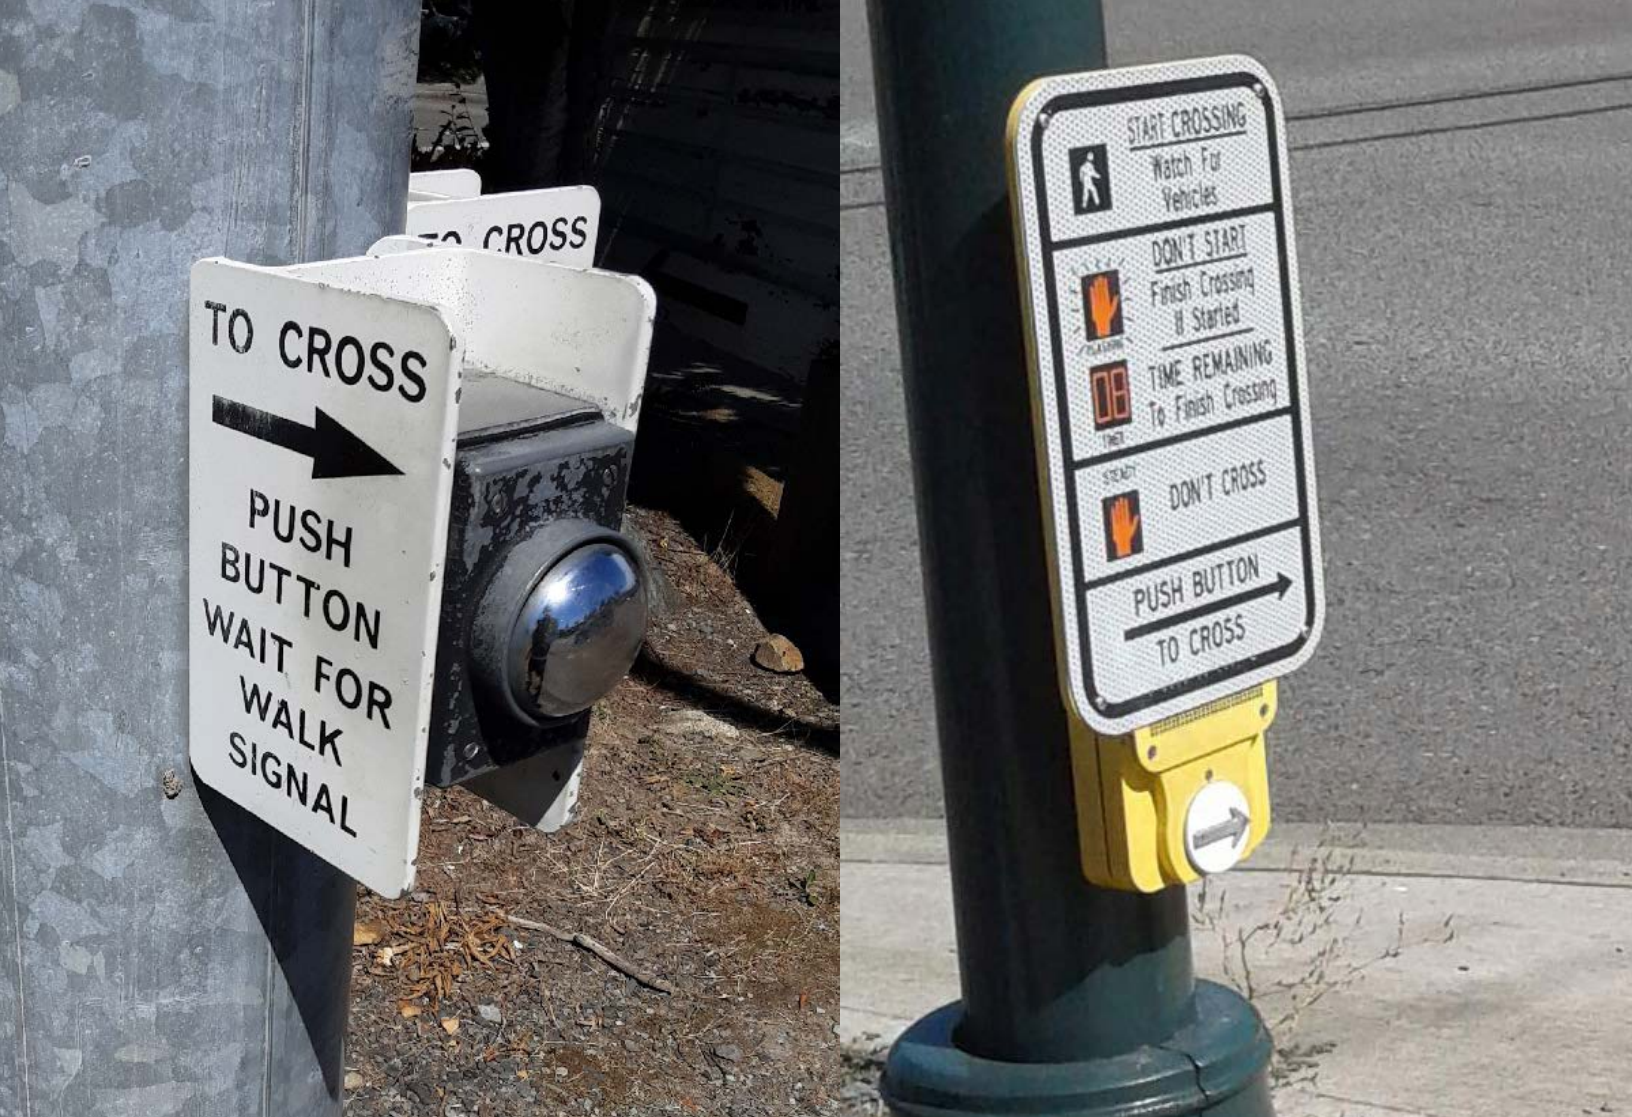
**Figure 2-17** “H-style” (left) and APS-style pedestrian pushbutton (right)

Of the 28 pedestrian signal pushbuttons inventoried during this self-evaluation, 27 were found to be non-compliant. The non-compliant pedestrian pushbuttons include non-APS style buttons to be replaced and APS-style buttons to be reprogrammed or relocated.

accessibility but must be fully replaced with an accessible pedestrian signal (APS)-style pushbutton to achieve full ADA compliance (see Figure 2-17 bottom).

The requirement to use APS-style pushbuttons is relatively new and lack of compliance is typically due to a crossing not being upgraded over time to reflect evolving requirements. Pushbuttons are typically upgraded to APS-style in groups rather than individually. As a result, APS-style additions and upgrades usually occur on an intersection-by-intersection basis.
