# Draft Martin Road Feasibility Study

Addressing Skagit River Erosion and Fish Passage

**SKAGIT COUNTY**

### Channel Migration Evaluation for the Skagit River at Martin Road (RM 68.5 -69)

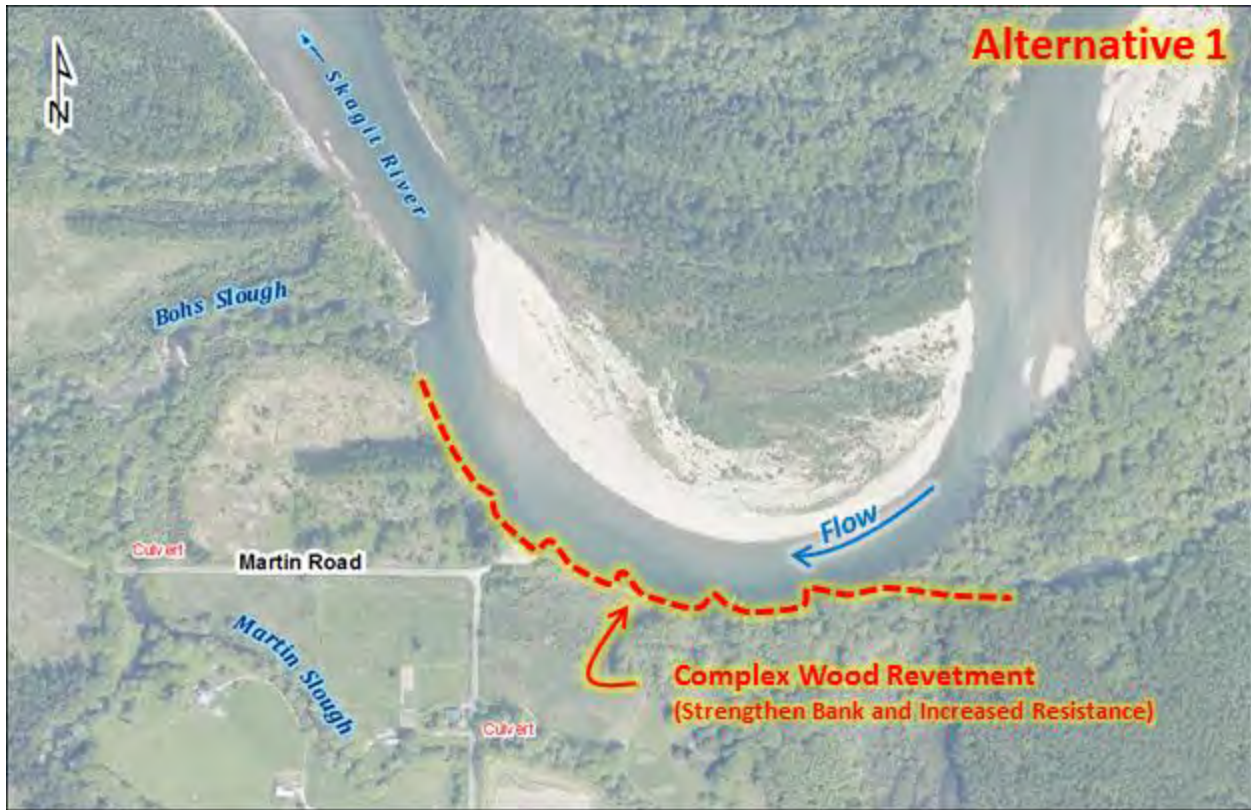
Figure 5 Bank Protection alternatives from NSD

Alternative 1 - A revetment designed to strengthen the bank and dissipate energy along the channel margin. The conceptual design for Alternative 1 includes a 2,200 foot long complex wood revetment to strengthen the bank resistance and yield an overall benefit to habitat-forming processes. The bank protection constructed upstream at the WSDOT Cascadian Farm site in 2014 is likely the best reference to consider regarding the construction of a complex wood revetment at the Martin Road project site. Using WSDOT cost for the Cascadian Farm project it is estimated construction cost for a similar project at Martin Road would be \$11,000,000. (See Figure 5)

Alternative 2 - Flow in the project reach will be redirected by an array of Engineered Logjams (ELJs) to reduce the hydraulic forces on the eroding streambank. As opposed to strengthening the streambank as described by Alternative 1, this alternative goal is to reduce the flow velocity and shear stress acting on the bank material near Martin Road. The ELJ deflector array would

consist of multiple structures that are staggered in the active channel corridor to interrupt the flow patterns and create additional physical and hydraulic complexity. Estimated construction cost is \$2,250,000. (See Figure 5)

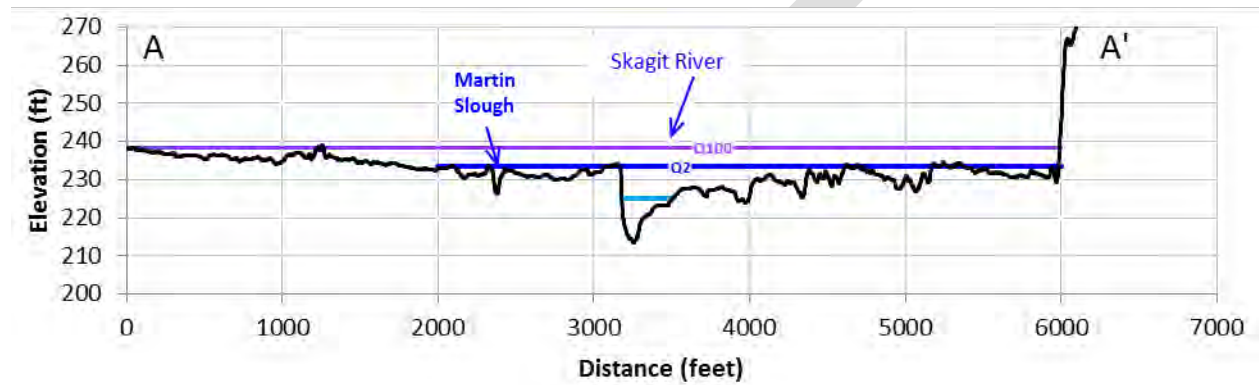
Figure 11. 2015 cross-sectional profile with the observed water surface elevation during base flow (7,600 cfs; light blue) and simulated water surface elevations for the 2-year (Q2) and 100-year (Q100) recurrence interval flows. The location of section A-A' is indicated on reach maps in Figure 1.

The entire project area at Martin Road is within the Special Flood Hazard Area (100-year floodplain) mapped by FEMA as part of the Flood Insurance Study for Skagit County. Flood flows are most common in the period between October and March. Large flood events in recent decades include November 1995, October 2003, and November 2006. The Base Flood Elevation (water surface elevation of the 100-year flood) defined by FEMA is 239 feet NAVD 88 at the 90 degree bend in Martin Road. This flood stage corresponds to an inundation depth of 5 to 9 feet over the floodplain area where ground surface elevations range between 230 and 234 feet (Figure 3).

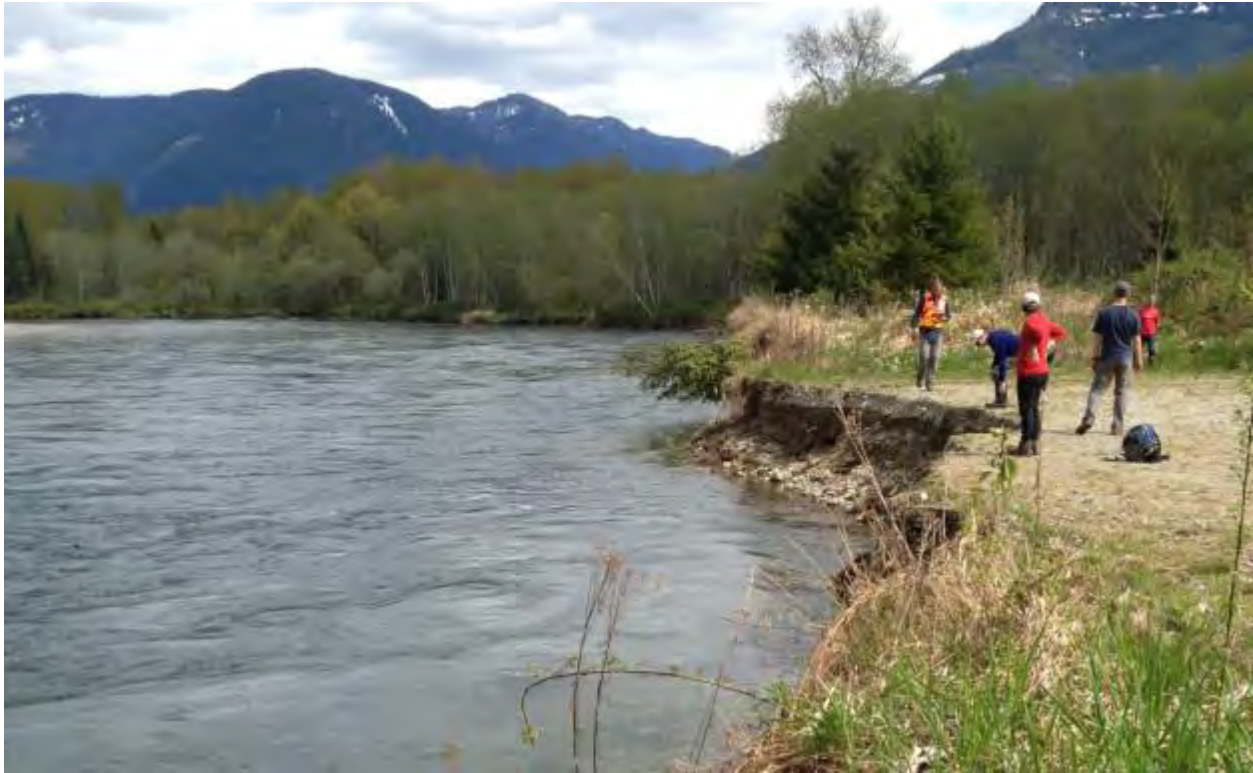
Figure 12. Photo looking upstream along eroding (left) bank at the WDFW access site near the 90 degree bend in Martin Road.

The outer bend of the meander near Martin Road has a bank height ranging between 12 and 15 feet and bank material is composed of erodible alluvium. The bank stratigraphy reveals a coarse deposit of gravel- to cobble-sized sediment that is overlain by approximately 5 feet of flood deposited sand and sandy loam. Soils covering the adjacent floodplain area are mapped as Larush silt loam (Klungland and McArthur, 1989). The Larush series consists of very deep, well drained soils formed in mixed alluvium. The surface layer is fine sandy loam or silt loam about 15 inches thick. The subsoil is very fine sandy loam and silt loam about 19 inches thick. The substratum to a depth of 60 inches or more is fine sand and silt loam. The bank near the WDFW access site is capped by a 12- to 18-inch layer

of compacted fill that is a remnant from the parking area eroded by recent channel migration.

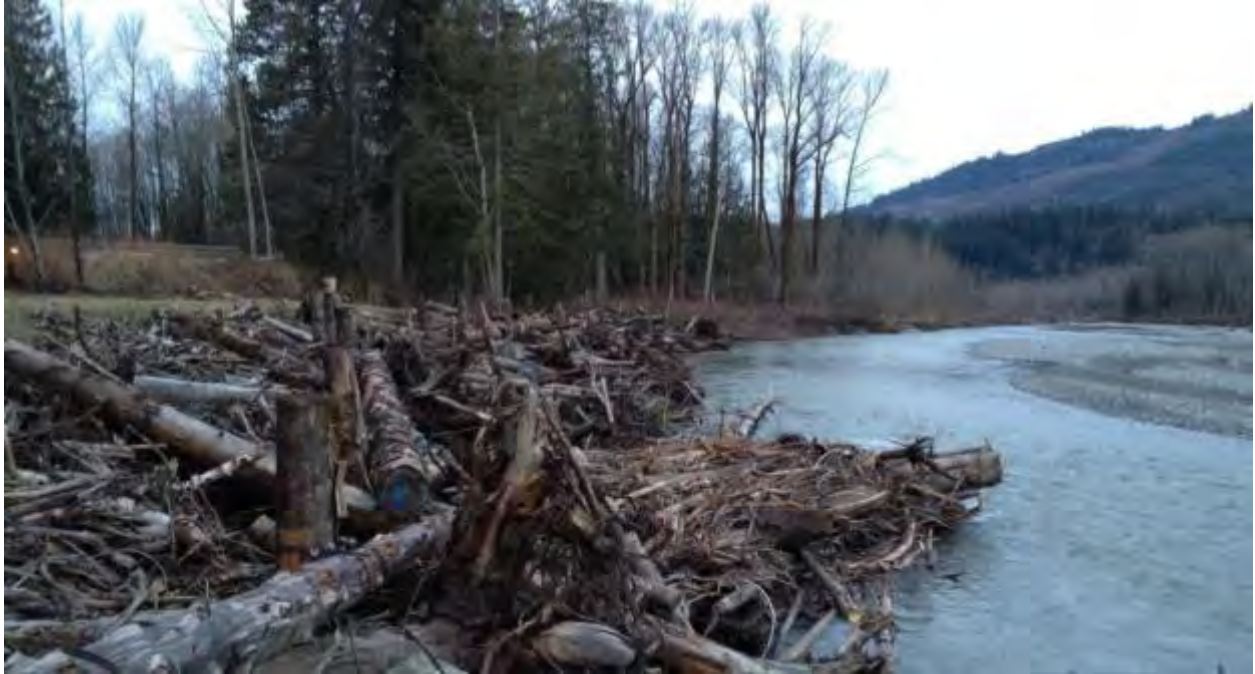
Figure 17. An engineered, complex wood revetment built by the Lummi Nation along the South Fork Nooksack River. The structure is stabilized with timber piles and rock collars creating a rough streambank very different than traditional rock revetments such as riprap.

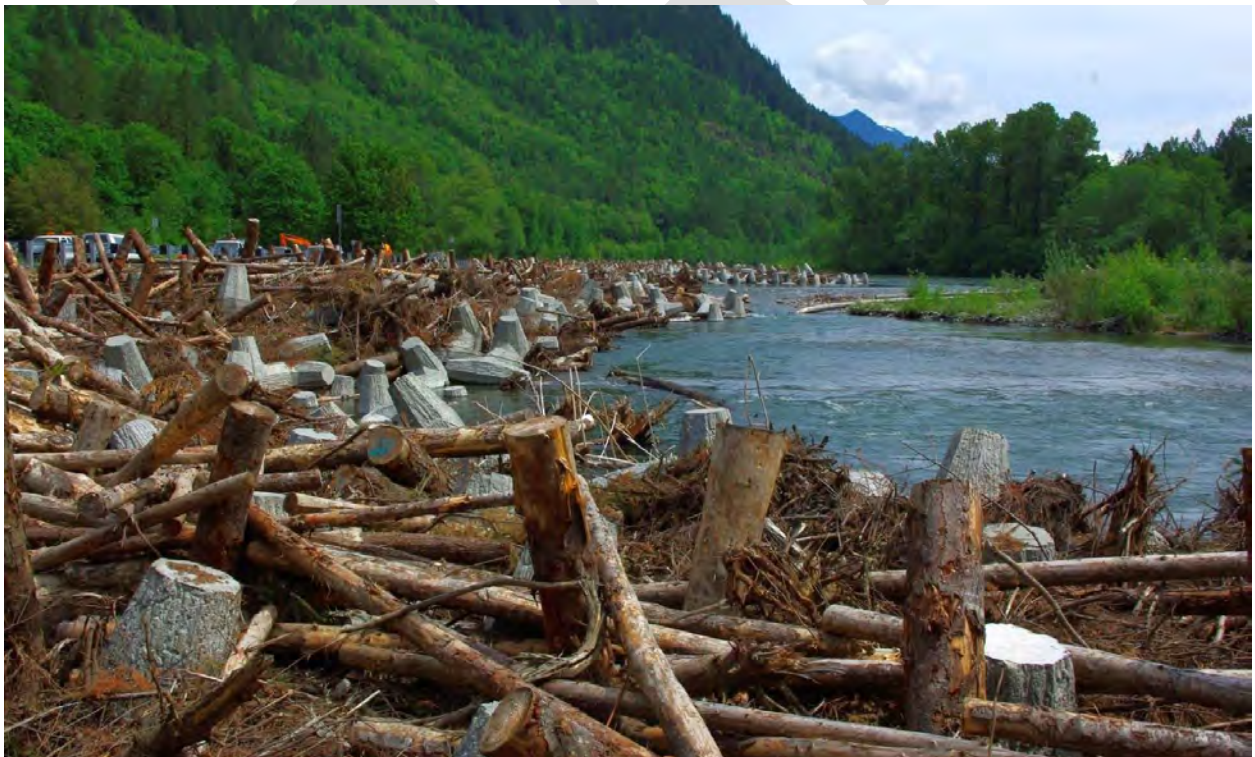
Figure 18. An engineered, complex wood revetment constructed by WSDOT on the Skagit River to protect SR 20 at milepost 100.7. This structure is stabilized with concrete dolo anchors and ballast due to site constraints. Photo from WSDOT (2014).

The Skagit River example constructed at the WSDOT CED site in 2014 is likely the best reference to consider in regards to construction of a complex wood revetment at the Martin Road project site. Similar to the WSDOT site upstream, the thalweg is against the eroding bank near Martin Road and dewatering is not likely feasible given the flow regime of the Skagit River and other constraints. As such, construction will need to be completed with equipment located on the top of bank, as opposed to working in the channel, and material will be placed directly in the wetted channel. Such conditions limit many common construction approaches and the dolo-ballasted structure constructed by WSDOT is the most feasible approach to constructing a long-term stable revetment at the Martin Road site.

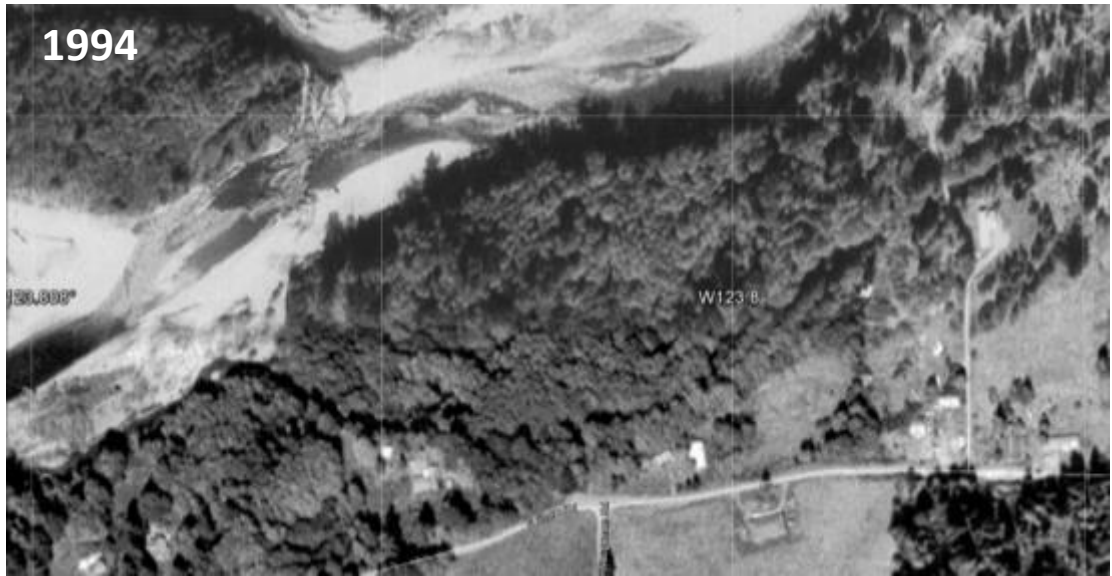
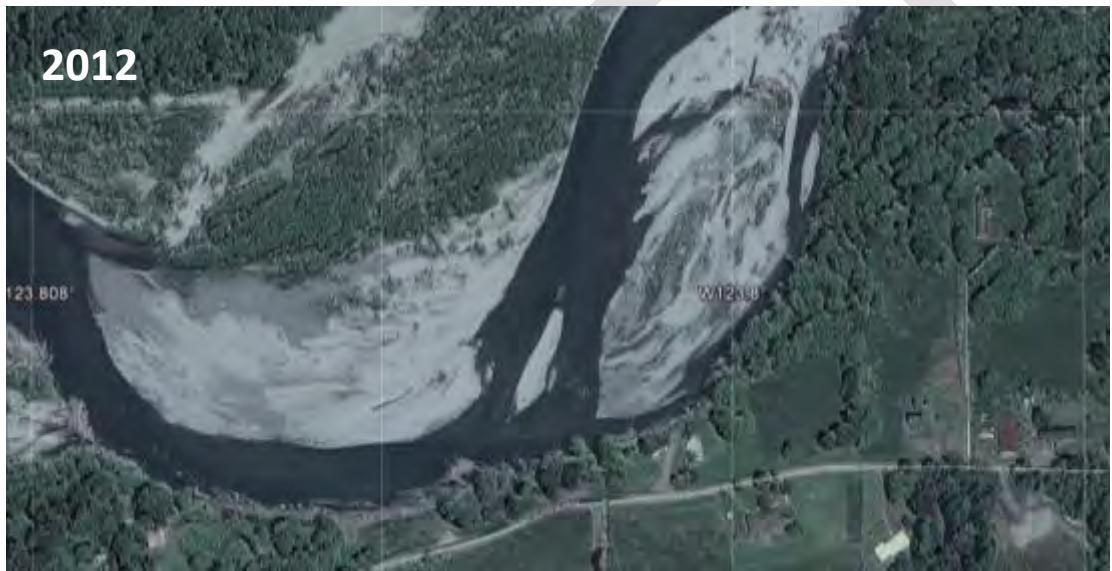
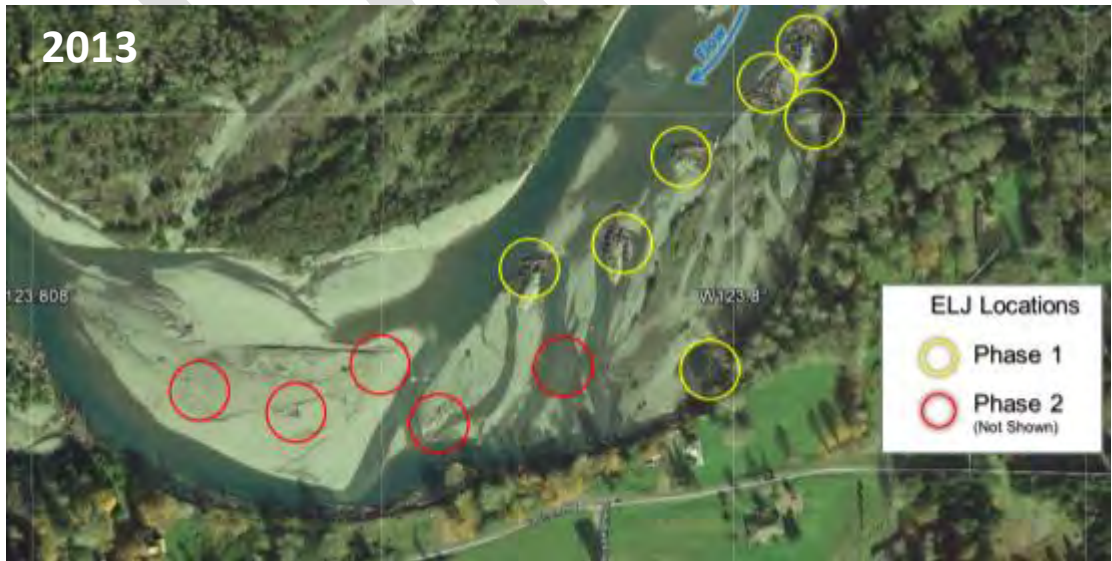
**Figure 19 (next page). Channel migration hazard and bank protection treatments in the Upper Quinault River near South Shore Road. An array of ELJs was constructed in 2013 (phase 1) to deflect flow and enhance habitat-forming processes in the reach. The array of ELJs was expanded in 2015 (Phase 2) to include additional structures.**
