## Skiyou Rock Removal Impact Analysis

Skagit River  
October 28, 2020

**Prepared by:**

Aaron Lee, MS, EIT  
Tim Abbe, PhD, PEG, PHG  
Natural Systems Design, Inc.  
127 E 1<sup>st</sup> Street, Mezzanine  
Port Angeles, WA 98362

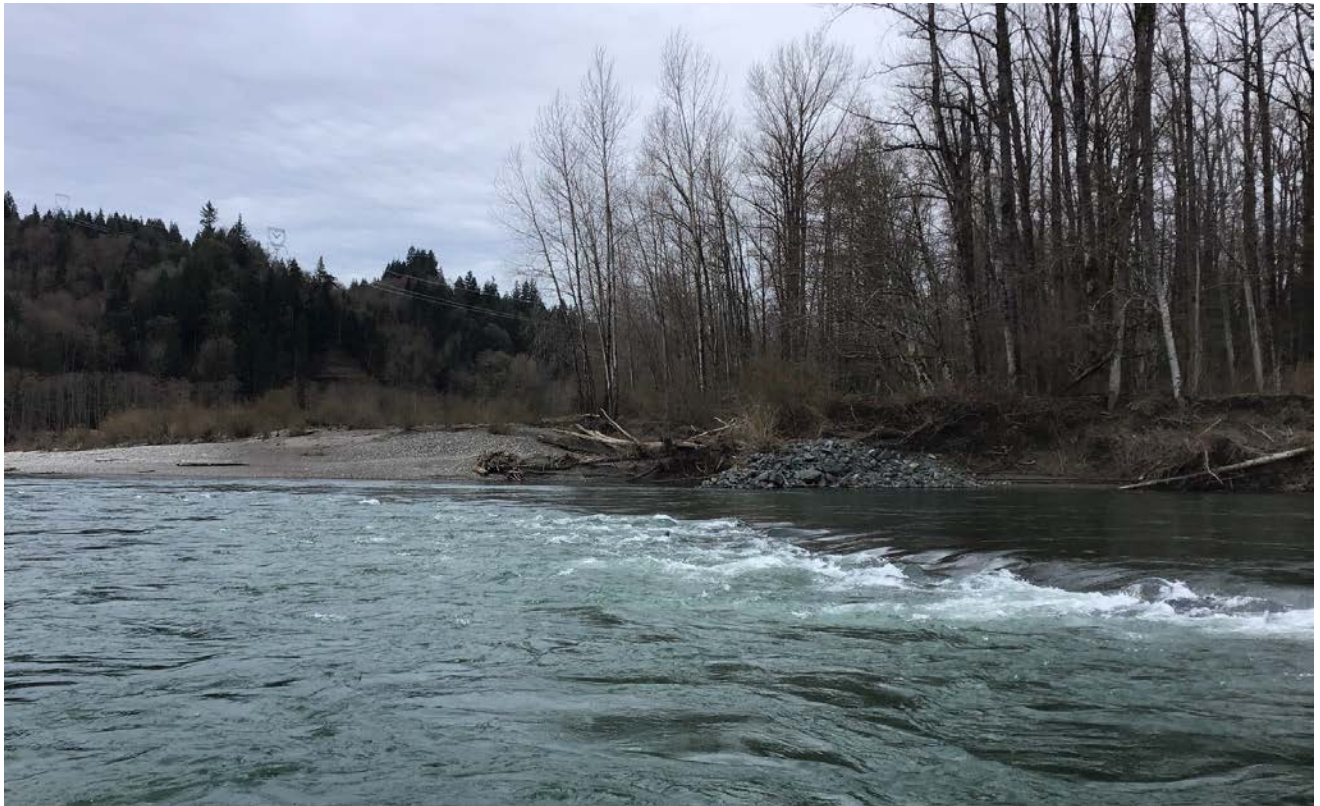
Figure 3. Skiyou rock, view from center of the channel towards the right bank. Flow direction is from right to left of photo. Note that the rock is overtopped at the time of survey during a flow of approximately 13,900 cfs. Bank rock is visible in the background (March 10, 2020).

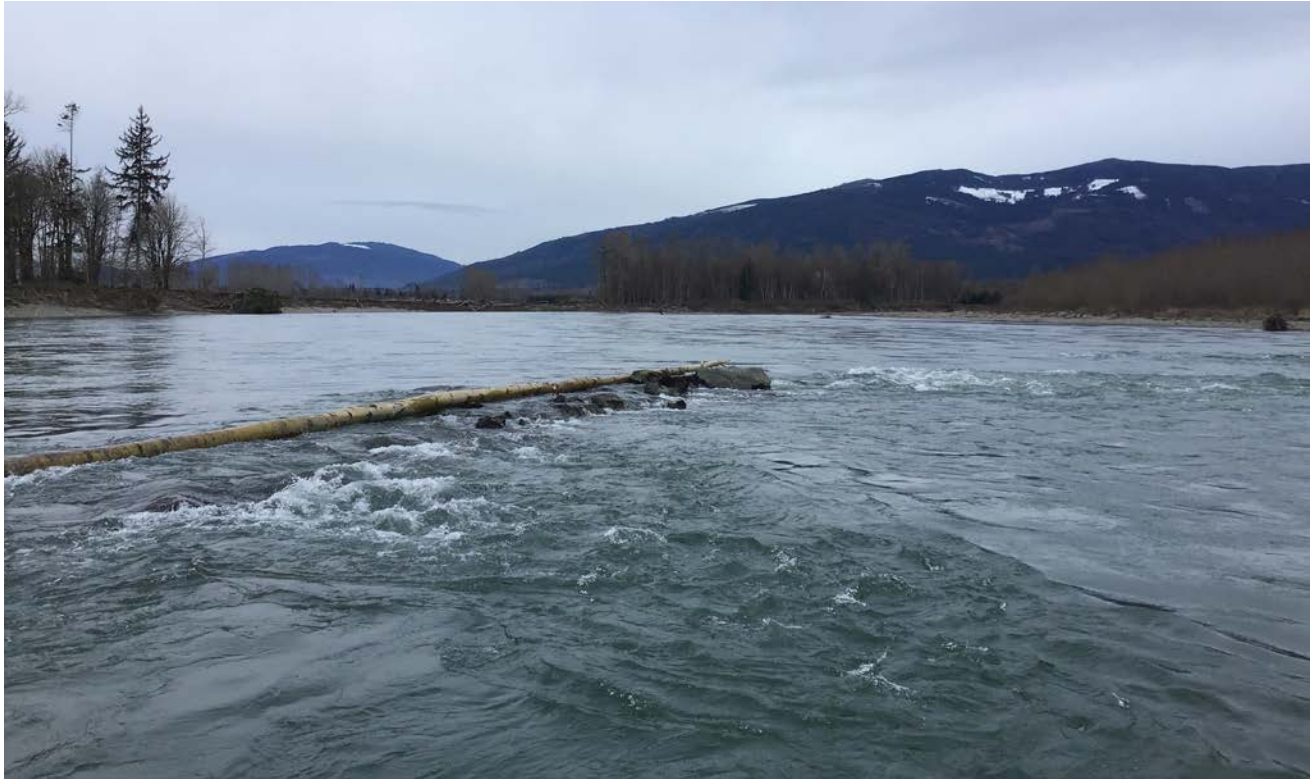
Figure 4. Skiyou rock, view looking upstream near the center of the channel. Log raked against the rock illustrates the 40 degree angle alignment (0 being upstream) that forms a bend-way weir that sets up a grade line perpendicular to its alignment – directing flow away from right bank. This is the eastern edge of the intact rock segments (March 10, 2020).

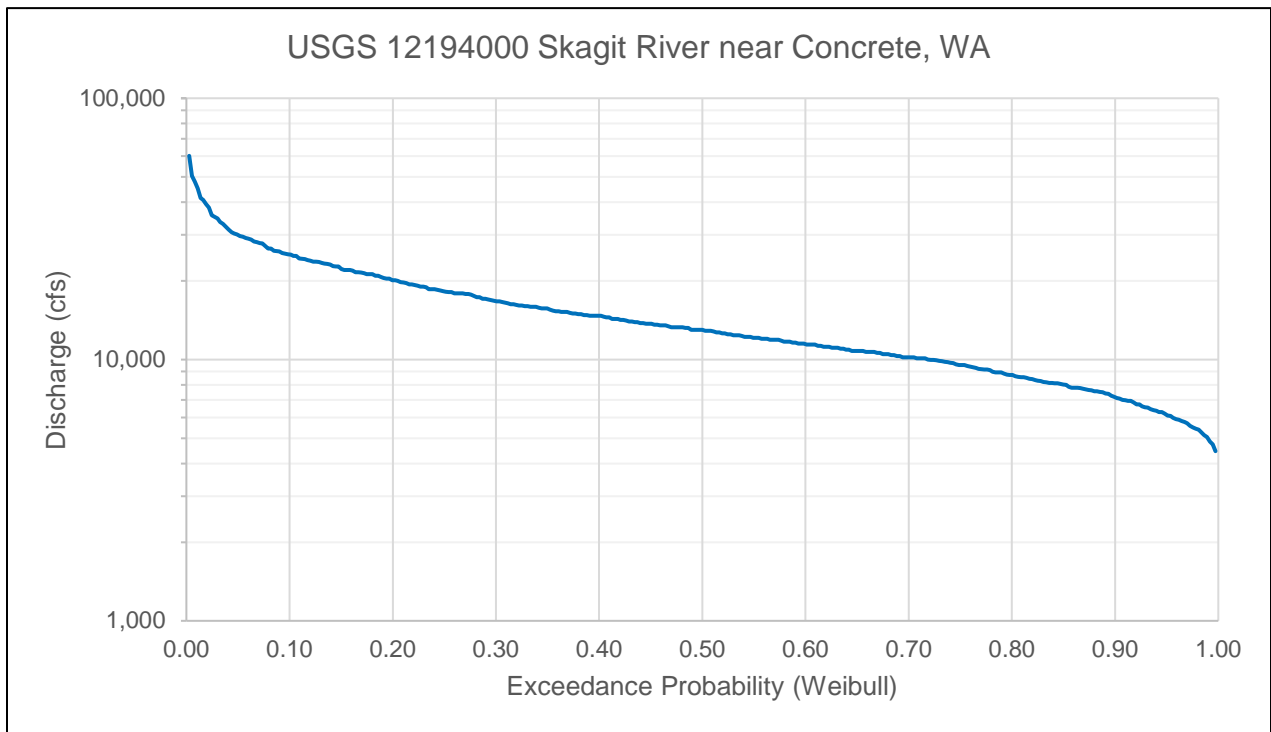
Figure 5. Flow duration curve for USGS 1219400 Skagit River near Concrete, WA. Computed using daily mean flow over the period of record (1924 to present). Note that the y-axis is based on a logarithmic scale.

The hydraulic analysis is primarily focused on low to moderate flows, where the interaction with the rock and streamflow is most pronounced. A flow duration curve is a useful method of providing context to any given discharge in terms of expected probability of exceedance, particularly at lower magnitudes. Figure 5 is the flow duration curve for USGS 12194000, using daily mean flow over the period of record (1924 to present). Flows used in the hydraulic model are listed in Table 2. Note that the flow duration curve is based on daily mean discharge and does not include measurements of peak instantaneous discharge.

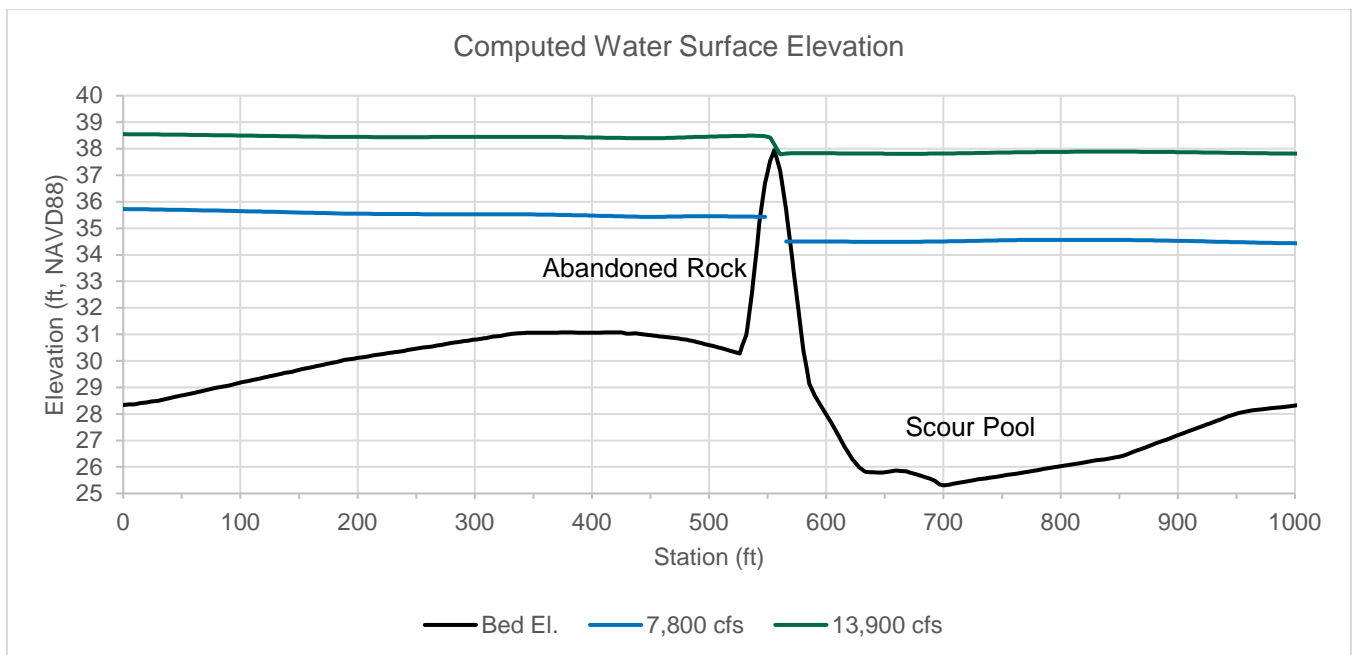
**Figure 8. Longitudinal profile of computed water surface elevation and surveyed channel bed topography (NSD March 10, 2020 survey). Water surface elevation drops approximately 1 ft over the crest of the rock at 7,800 cfs. The rock is located at approximately station 500 ft. Stationing increases in the downstream direction.**

As flow loses energy at the face of the rock, water surface elevation increases in the upstream direction to create a backwater effect (shown in Figure 8). The result is an increase in energy gradient through the rock openings. The pools formed by local scour around the toe of the rock leads to undermining of the intact segments, which are shown in the left window of Figure 9. The 90% exceedance flow at the study site is 7,800 cfs, which indicates that throughout most of the year low to moderate flows will continually undermine the intact portions of the rock.

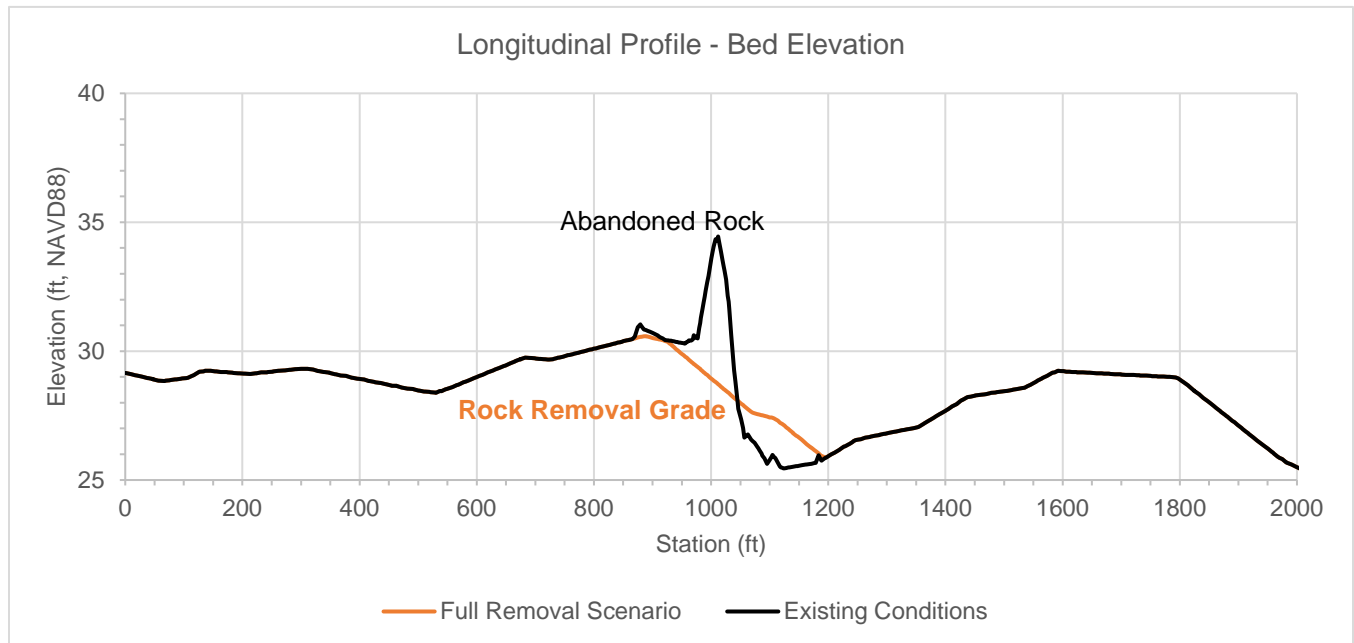
Figure 18. Longitudinal profile of Existing Conditions vs. Full Removal Scenario bed elevation. The orange line represents the complete removal of rock.

There is a 1,300 ft section upstream of the rock where velocity would increase if the rock were removed. This is attributed to the change in bed gradient at the rock site (Figure 18, orange line). Note that this effect would be temporary and that over the long term, the channel bed gradient would flatten to the reach average, assuming the prevailing geomorphic and flow regimes are constant.

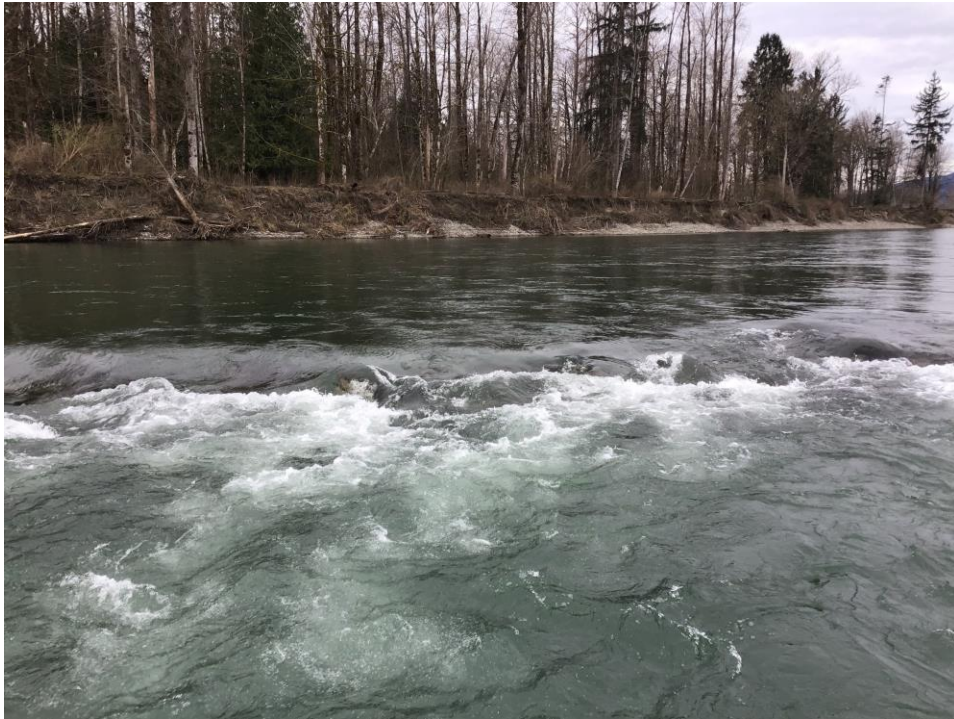
Figure 1. Close view of Skiyou rock looking upstream towards right bank.

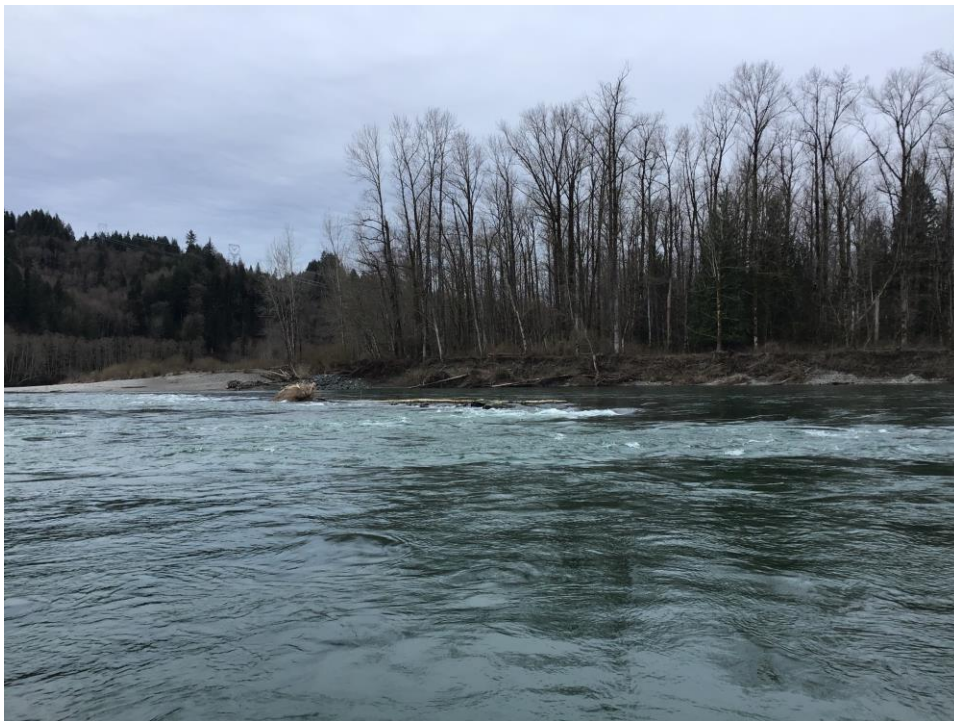
Figure 2. Skiyou rock, view from right channel margin. Log is racked on upstream edge of the left rock segment. Flow direction from right to left of photo.

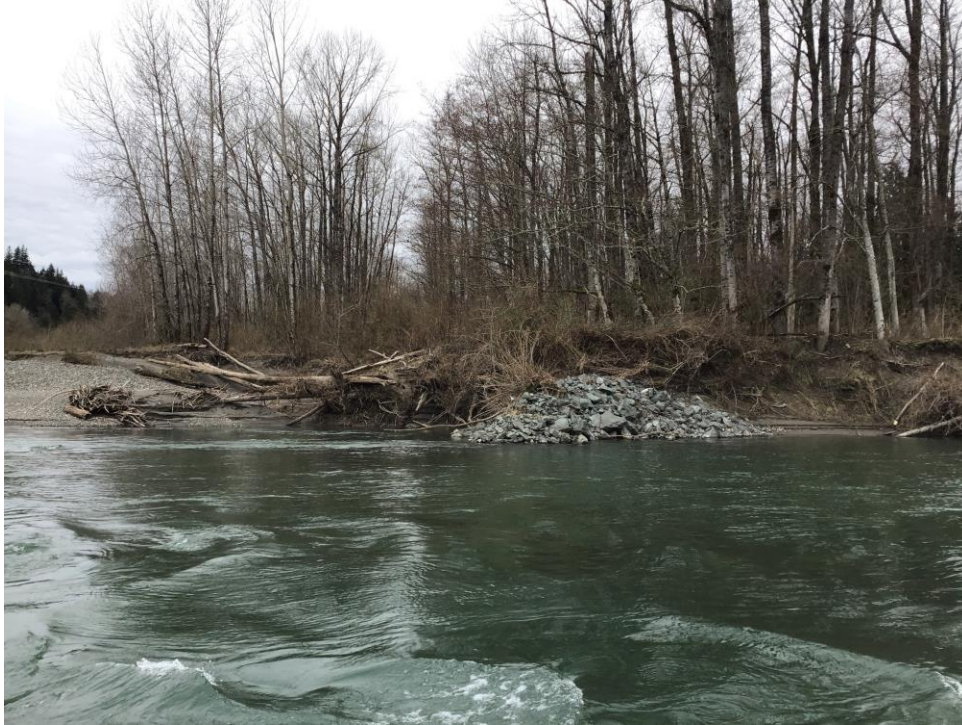
**Figure 3. Skiyou bank rock on right bank. Flow direction from right to left of photo. Scour and undermining of the streambank is visible around the rock.**

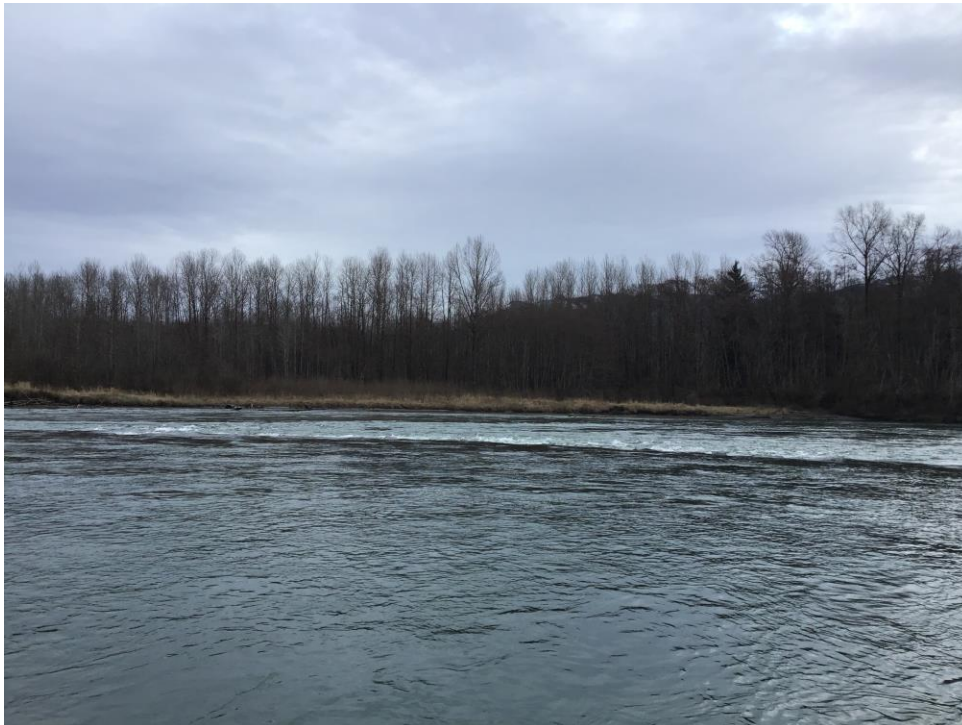
**Figure 4. View of Skiyou rock from upstream looking downstream. The weir effect is visible, as flow is overtopping the intact rock segments. Discharge at the site is approximately 13,900 cfs on March 10, 2020.**

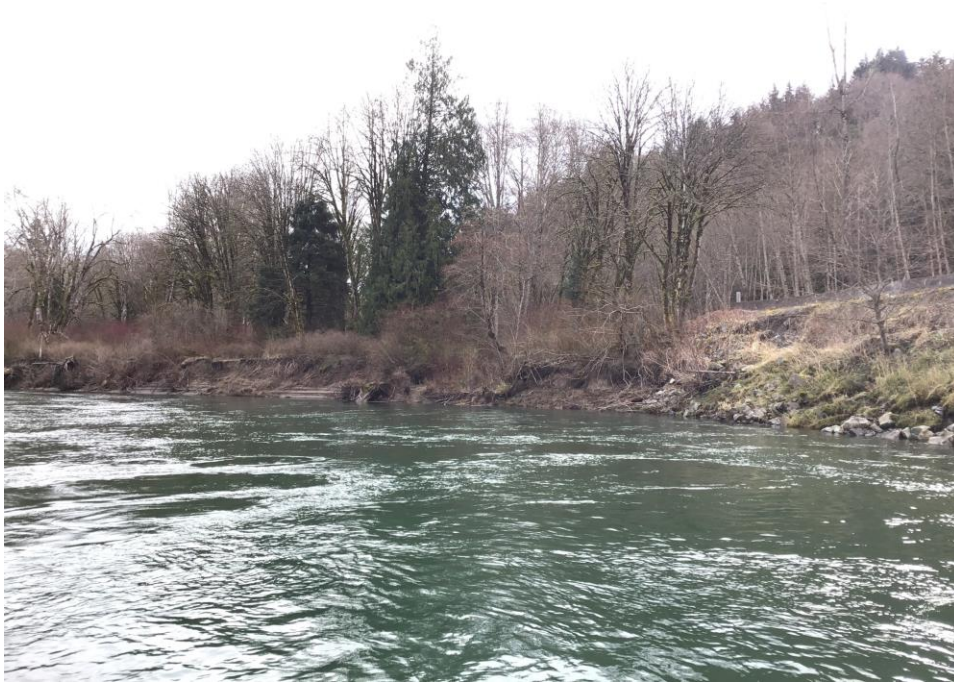
**Figure 5. Left bank along the South Skagit Highway, view looking in the upstream direction. Riprap is visible in the foreground of the photo. Note eroding bank upstream where riprap is not present.**

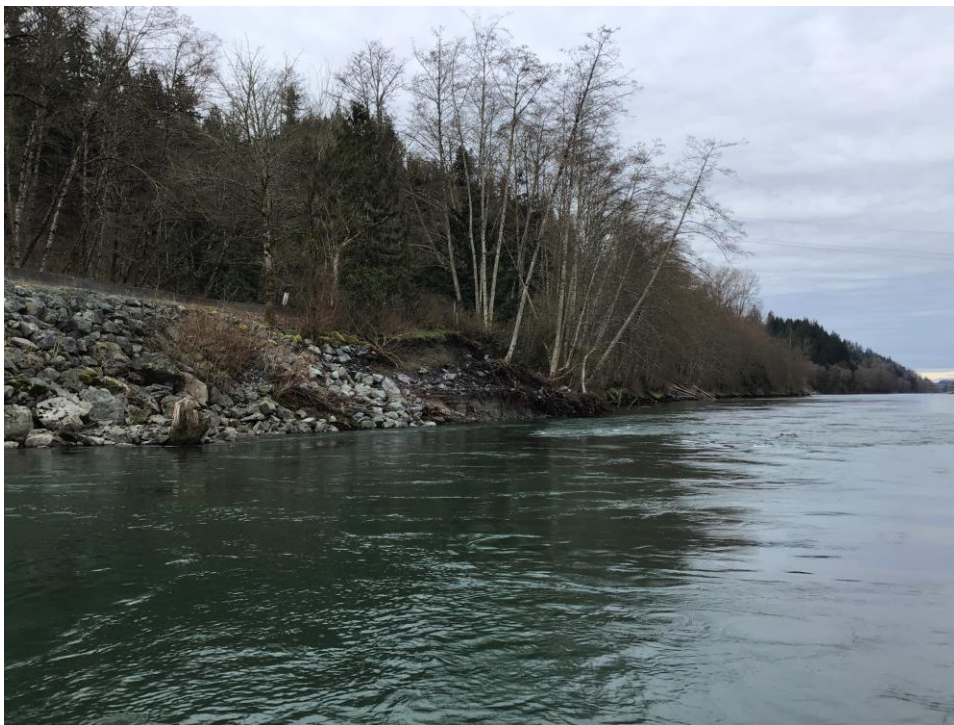
**Figure 6. Left bank along South Skagit Highway, view looking in the downstream direction. Riprap is visible in the foreground. Active erosion of the streambank was observed downstream of the revetted bank. Shown in the center of the photo is old wood embedded in the streambank, which has been exhumed by the eroding bank.**

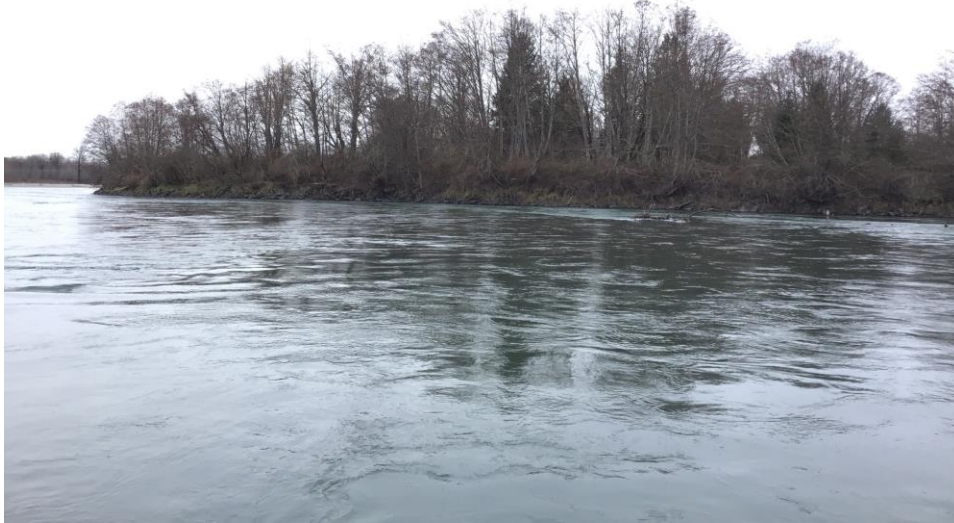
**Figure 7. Upstream bank of the Skiyou Slough inlet. Flow direction is from right to left of photo. This entire section of bank has riprap present.**

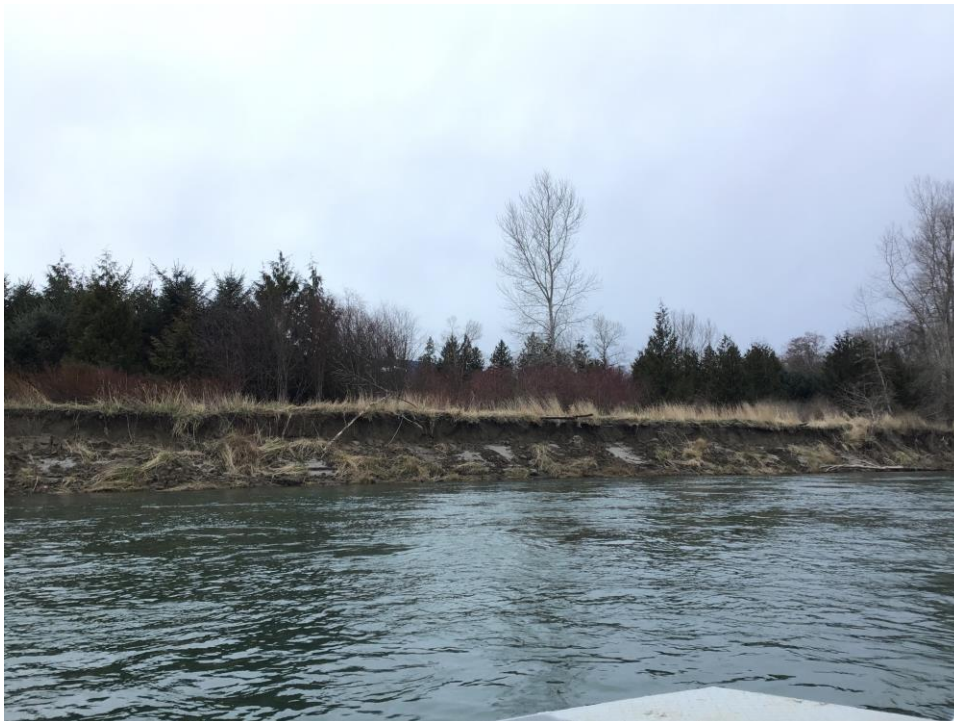
**Figure 8. Right bank of the Skagit River immediately downstream of the Skiyou Slough inlet. Flow direction is from right to left of photo. Active sloughing of the streambank indicates undermining of the bank toe.**

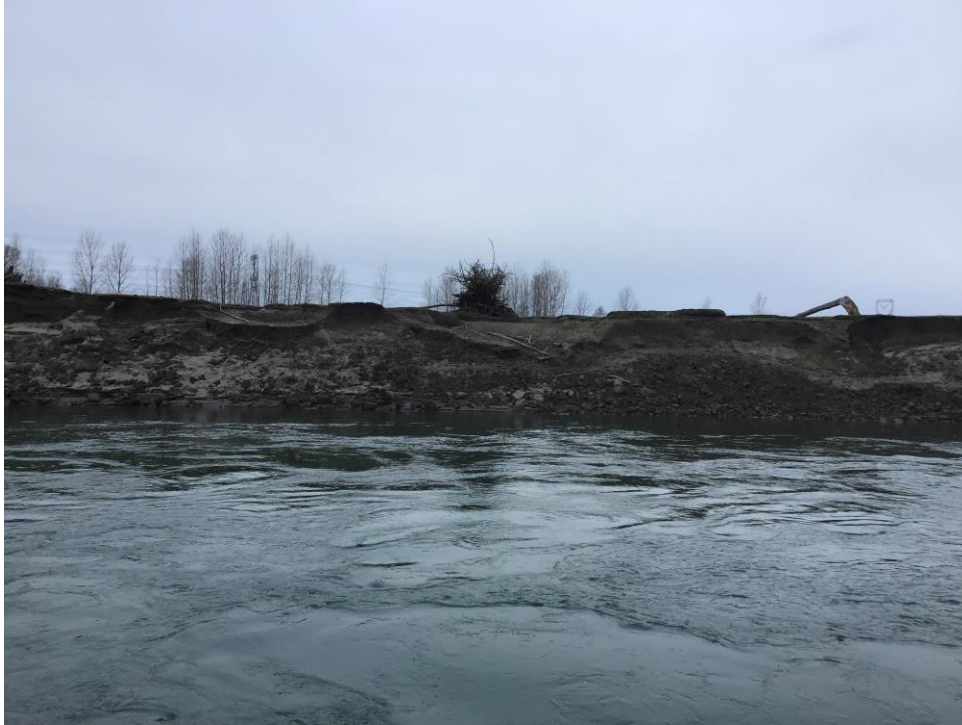
**Figure 9. Right bank of the Skagit River immediately along the Benson parcel and evidence of active erosion, located upstream of Skiyou rock. Flow direction is from right to left of photo. Note that trees on the bank are deposited from recent flood flows (personal communication with Emily Derenne, 2020). Power transmission lines are visible in the background of photo.**

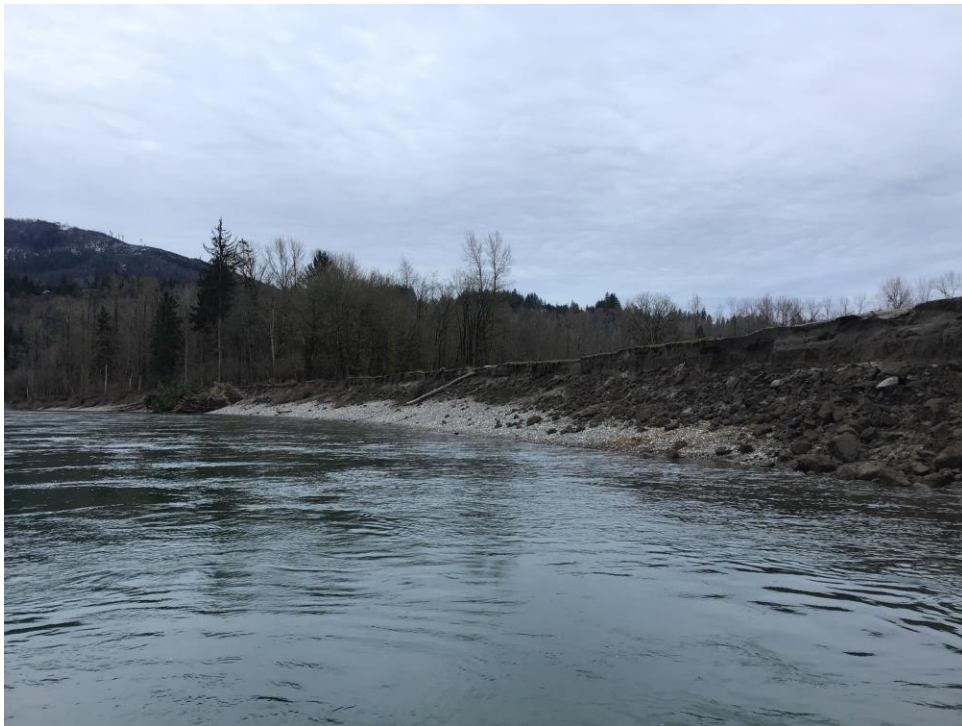
**Figure 10. Right bank of the Skagit River immediately along the Benson parcel and evidence of active erosion, located upstream of Skiyou rock. Flow direction is from right to left of photo.**
