THE CONCRETE HERALD

February 4, 1965

SLIDES CONTINUE TO PLAGUE PSPL

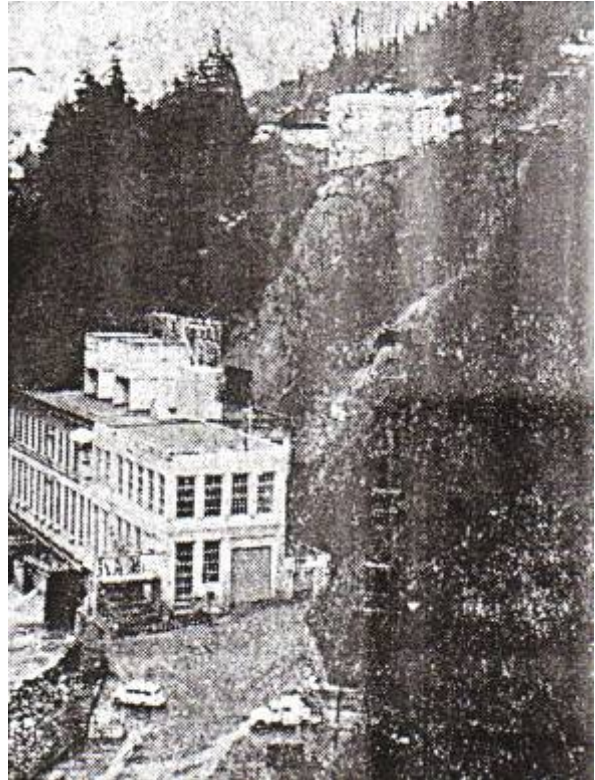
The top photo, taken Friday, shows oozing mud blocking the two doors on the south end of the power house.

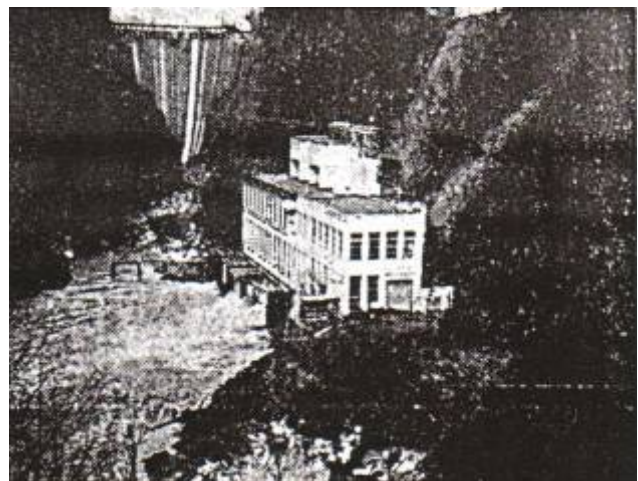
Mud from the slipping hillside above the powerhouse of the Lower Baker River Dam here, continued to harass the officials and employees last week as they fought to keep the doors of the powerhouse clear and the material moving from the rear of the building where a thick retaining wall shunted it around both sides of the building.

The slides on the hill above had been caused by the heavy rains. In the adjoining photo the paths of two separate channels of the mud and dirt can be seen coming down at the rear of the building. Work is continuous on the upper slopes to pump water pockets from the slide area and take weight off the loose masses of top soil.
