Skagit County Monitoring Program

Annual Report

2005 Water Year (October 2004 – September 2005)

Skagit County Monitoring Program Annual Report

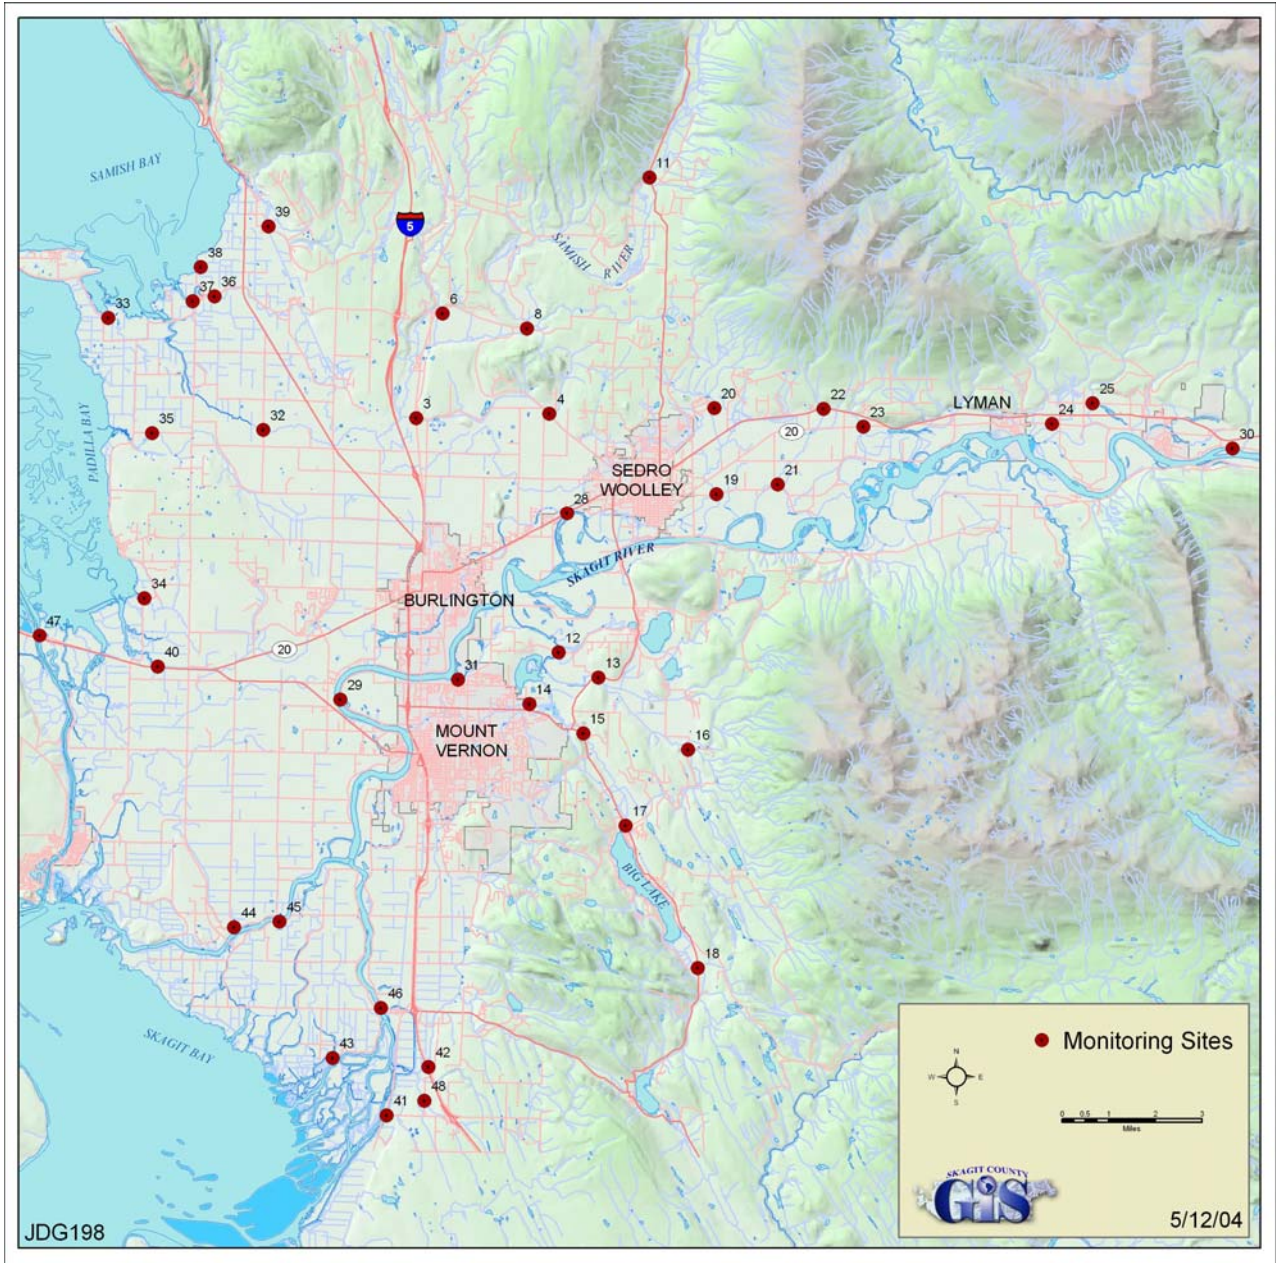
Figure 1. Sample sites in the Skagit County Monitoring Program. Refer to Tables 1 and 2 for site locations and descriptions.

Figure 1 is a map with the sampling sites in the Skagit County Monitoring Program marked. Tables 1 and 2 list the sampling sites and site descriptions for the Skagit County Monitoring Program. Forty sites are currently included in the Program. These sites are located primarily in the agricultural zones (Agriculture-Natural Resource and Rural Resource). Other sites are located to provide context to, and comparisons with, the sites in the agricultural zones. These include sites located just upstream or downstream of agricultural areas or in streams draining suburban watersheds.

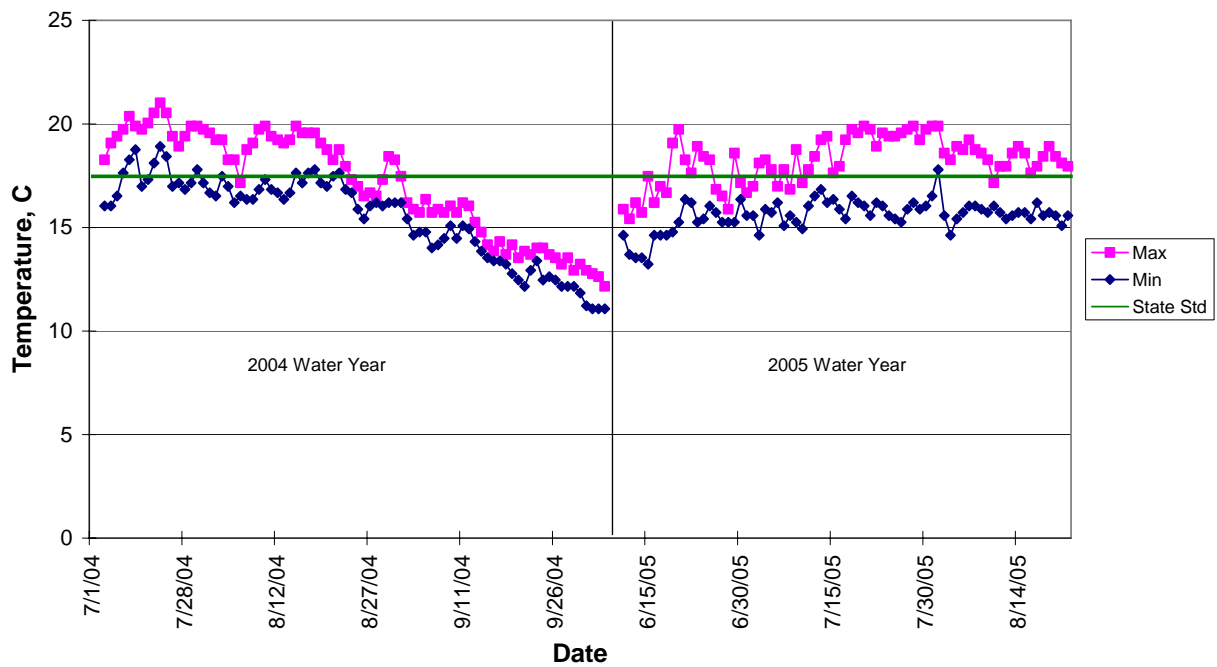
Thomas Creek at Hwy 99 - Site 3 Temperature

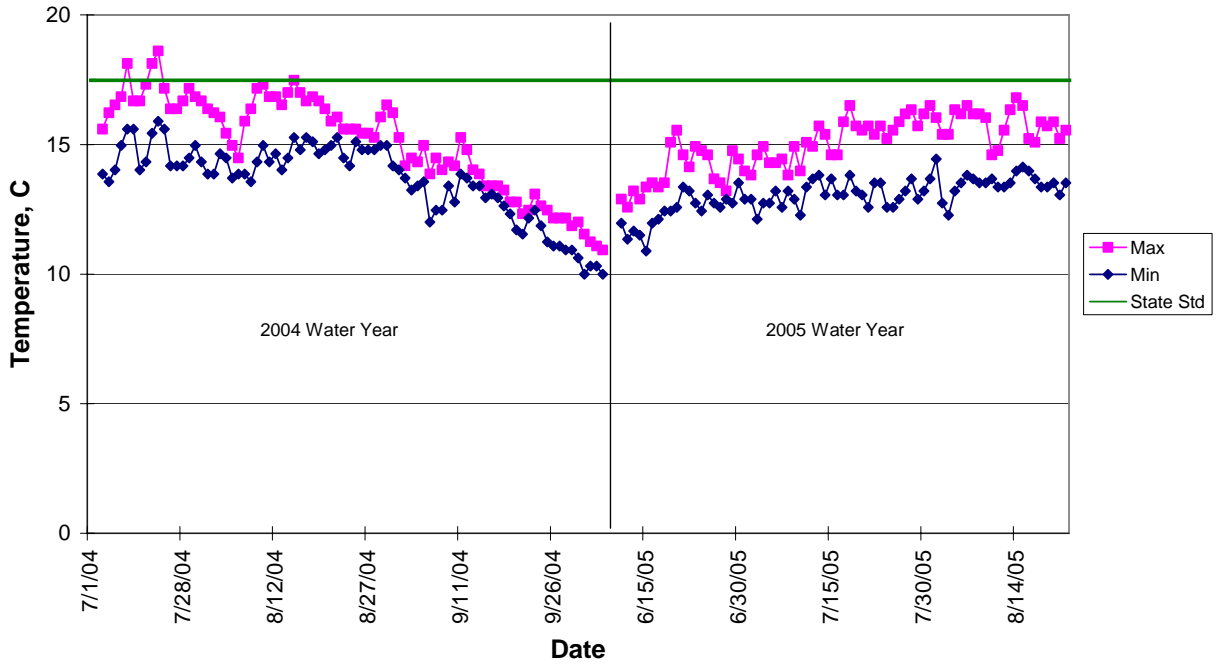
Thomas Creek at F&S Grade Rd - Site 4 Temperature

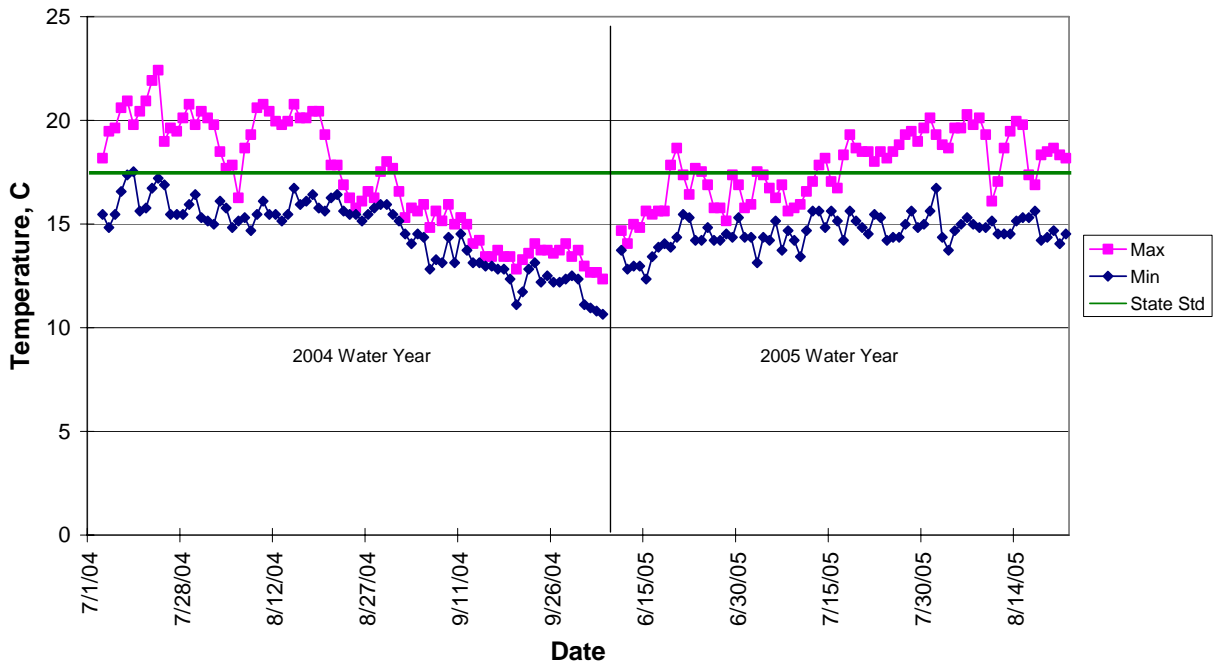
Friday Creek at Prairie Rd - Site 6 Temperature

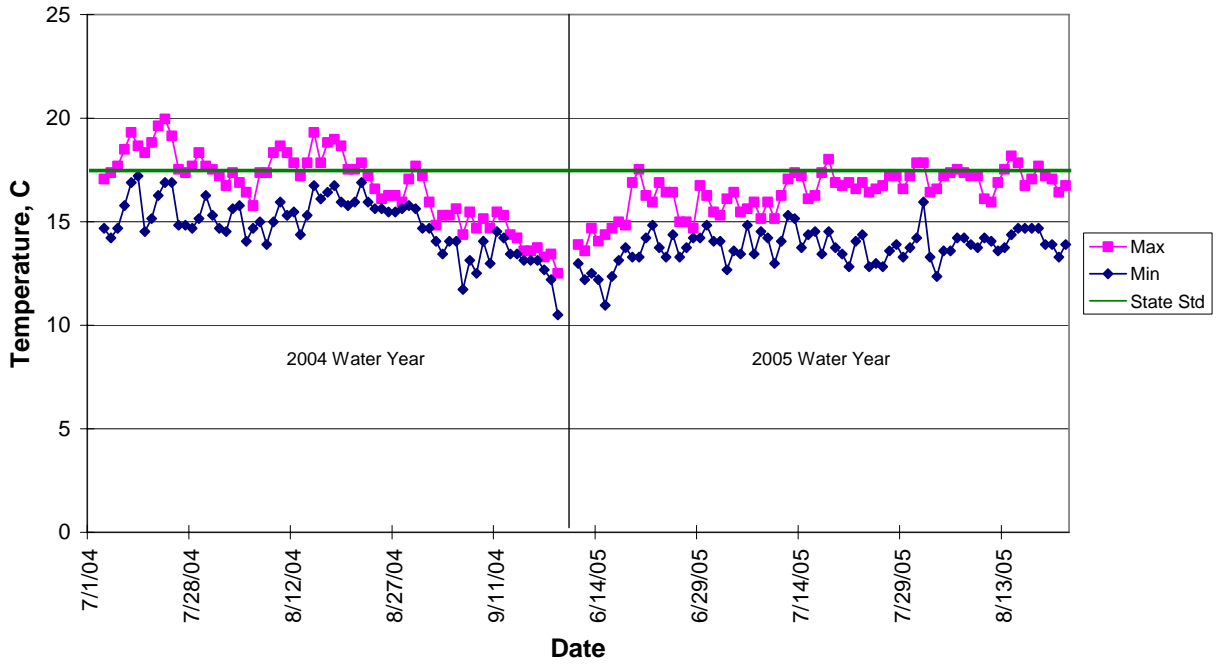
Swede Creek at Grip Rd - Site 8 Temperature

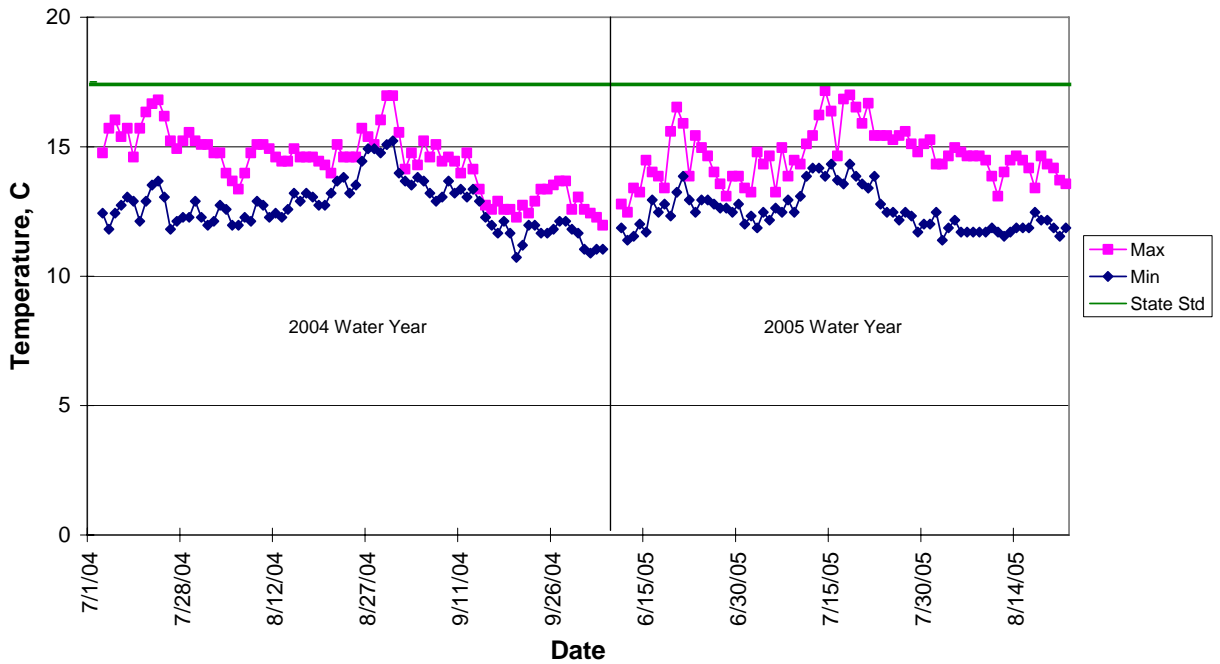
Samish River at Hwy 9 - Site 11 Temperature

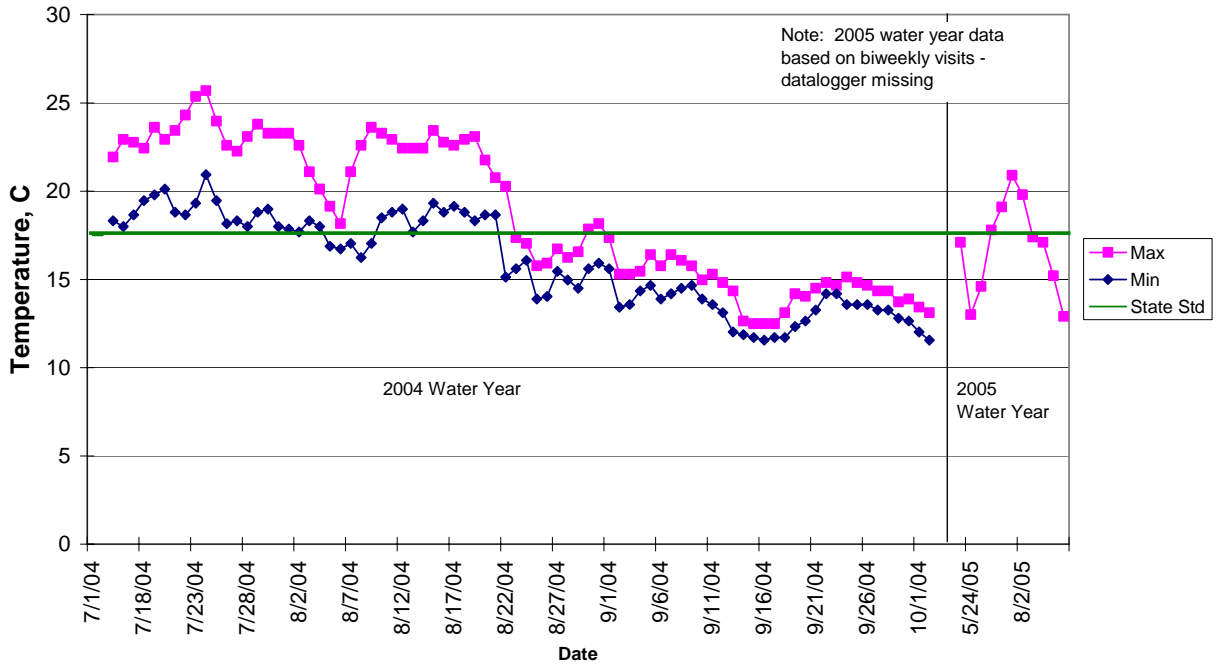
Nookachamps Creek at Swan Rd - Site 12 Temperature

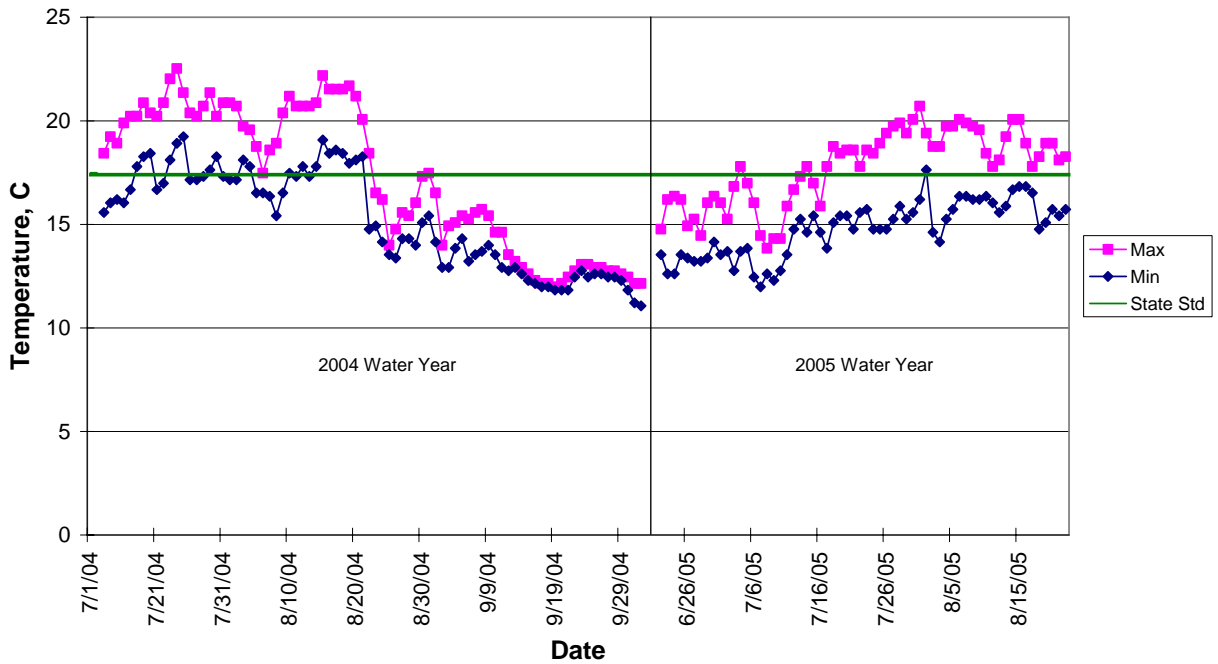
EF Nookachamps Creek at Hwy 9 - Site 13 Temperature

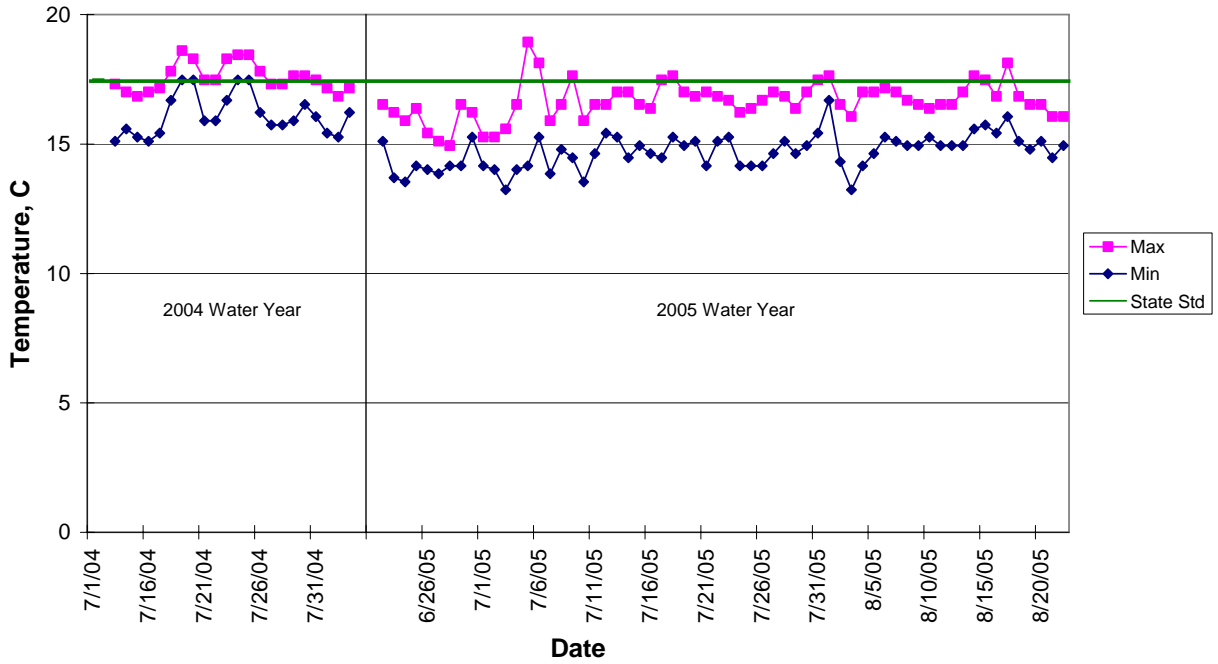
College Way Creek at College Way - Site 14 Temperature

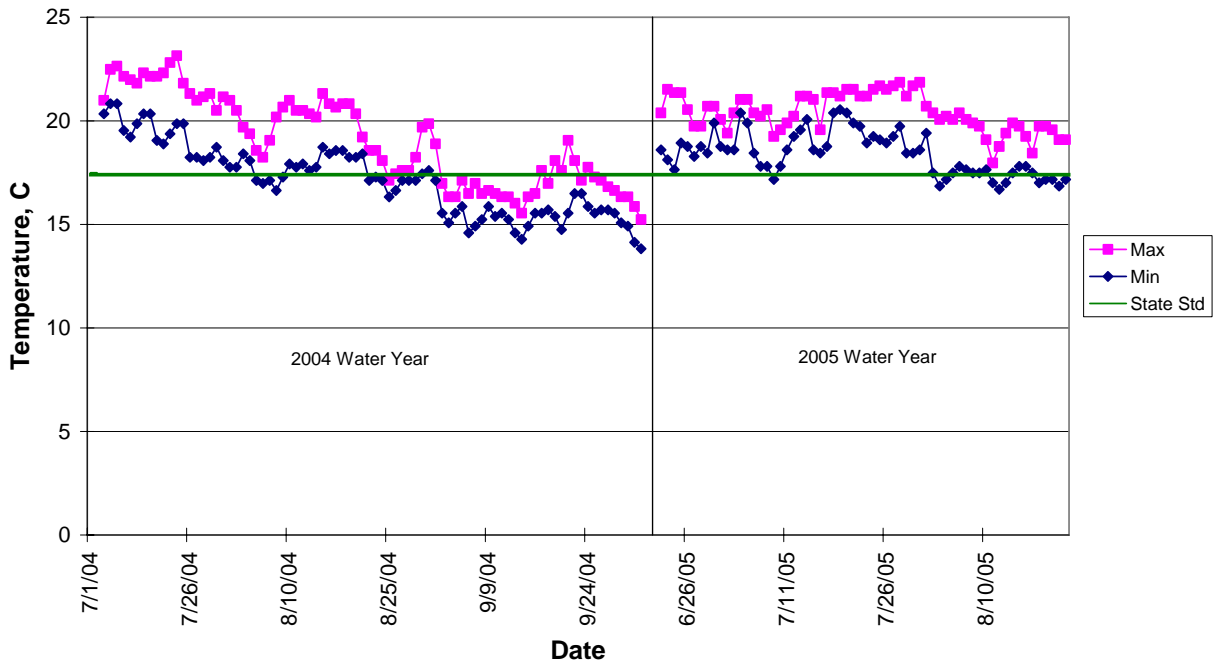
Nookachamps Creek at Knapp Rd - Site 15 Temperature

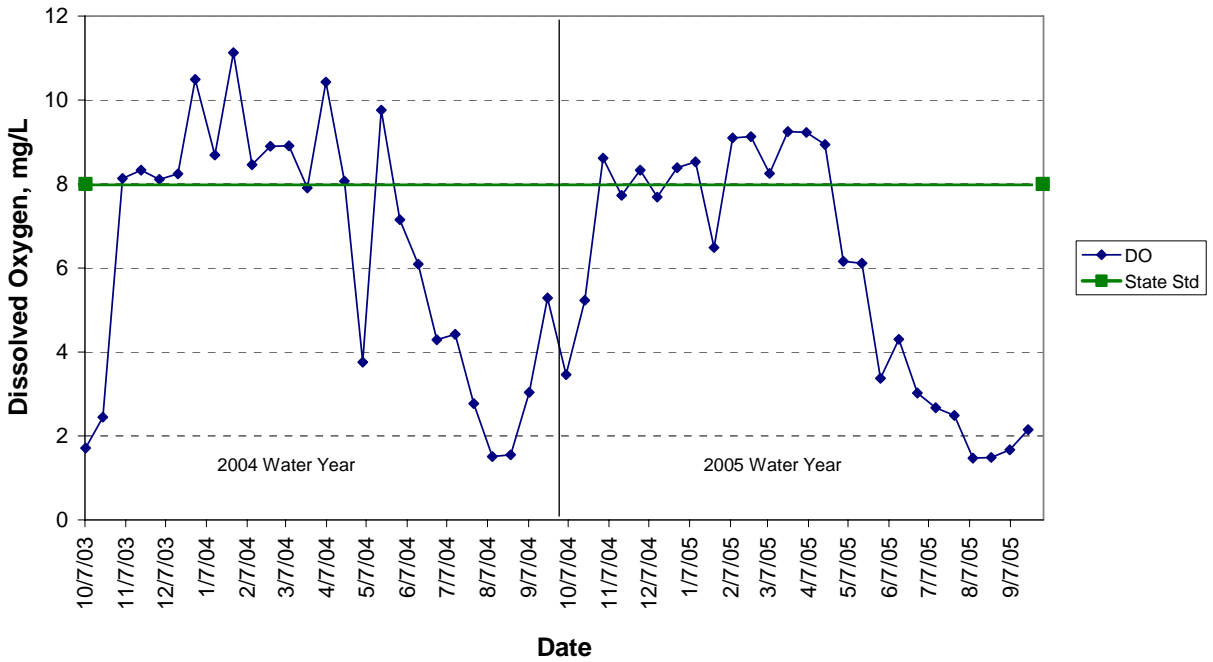
Thomas Creek at Hwy 99 - Site 3 Dissolved Oxygen

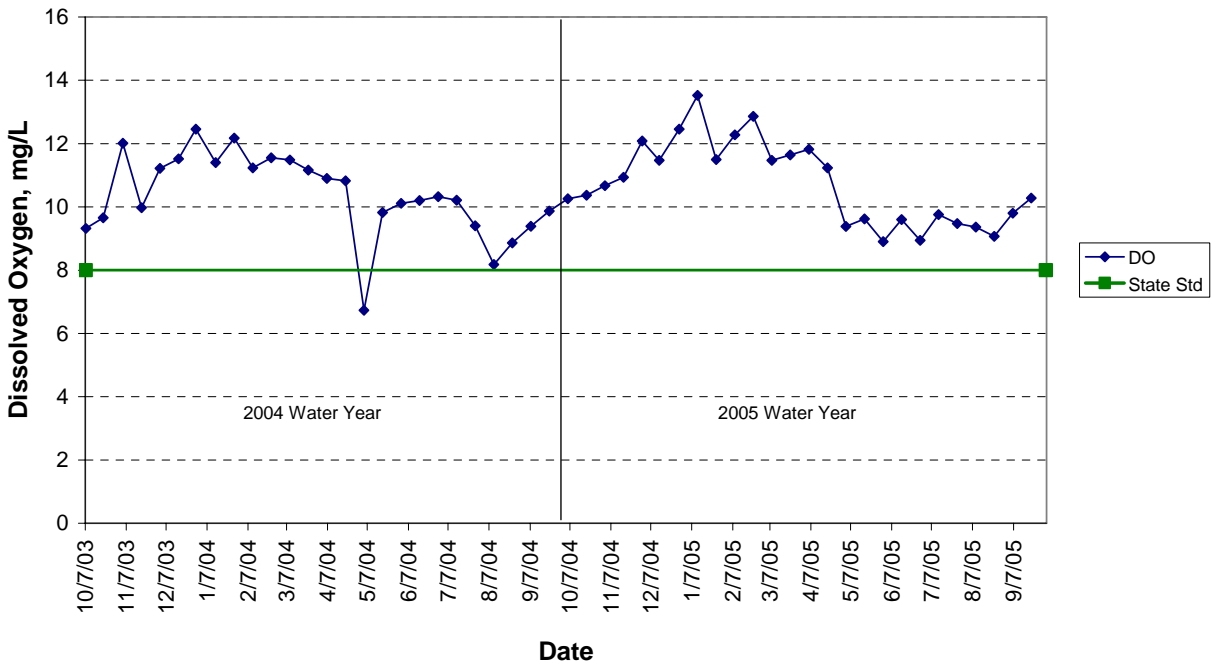
Thomas Creek at F&S Grade Rd - Site 4 Dissolved Oxygen

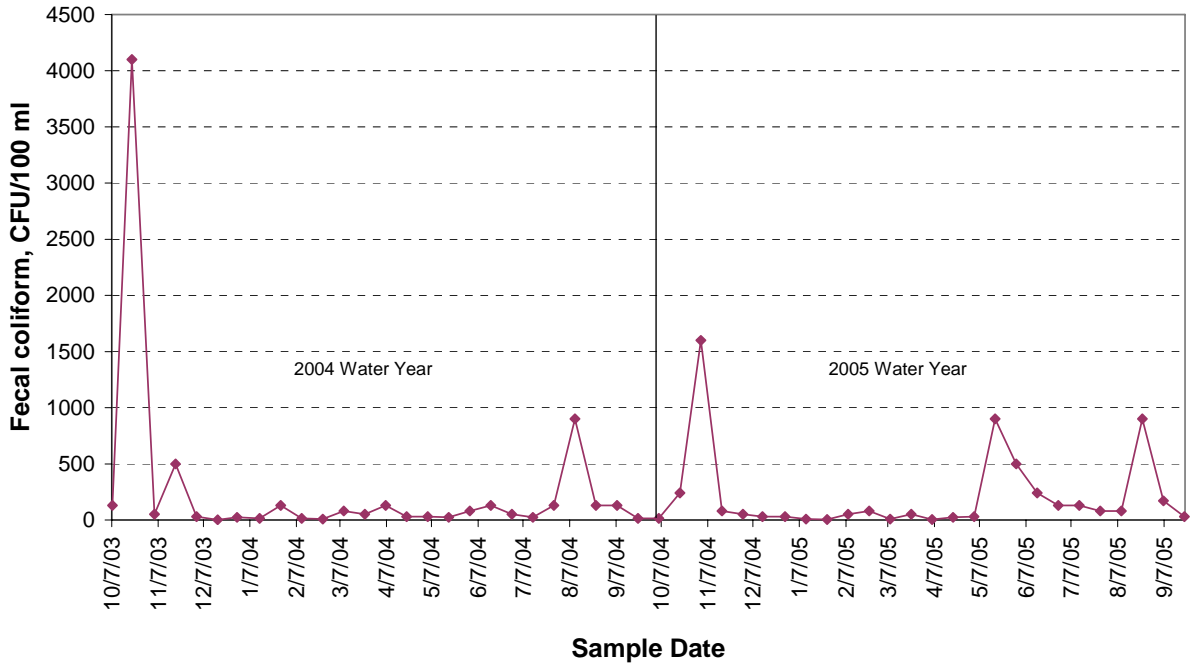
Thomas Creek at Hwy 99 - Site 3 Fecal coliform

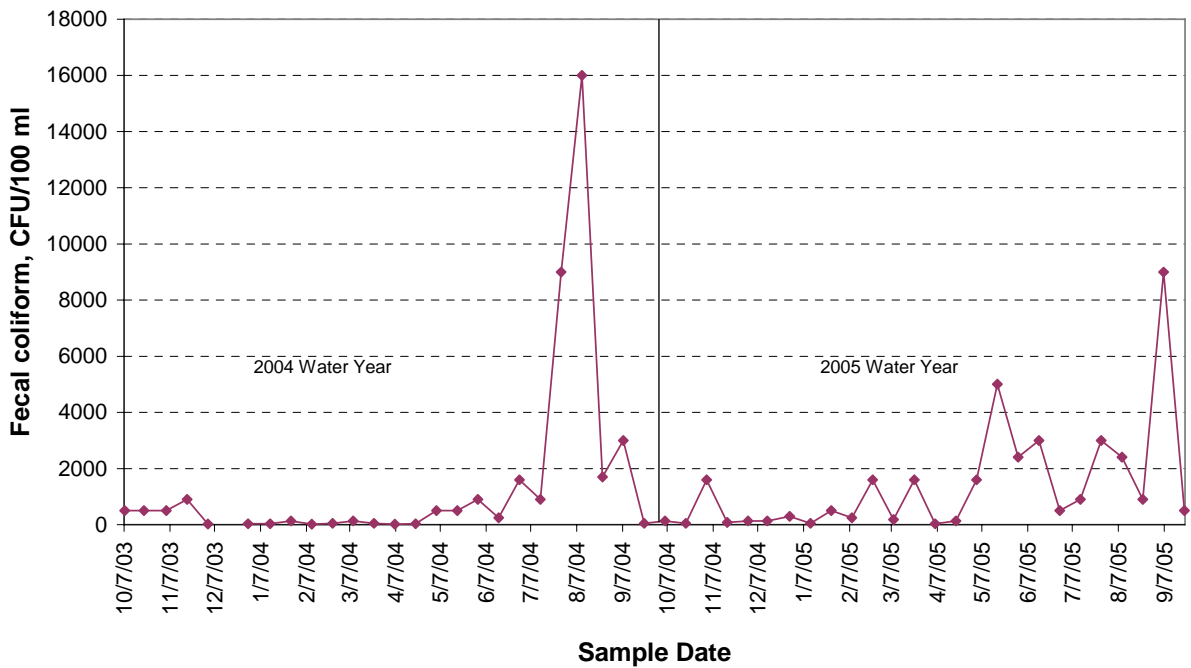
Thomas Creek at F&S Grade Rd - Site 4 Fecal coliform
