DEBAY SLOUGH SITE ASSESSMENT

Appendix A-2 Existing Conditions Hydraulic Model Output Maps

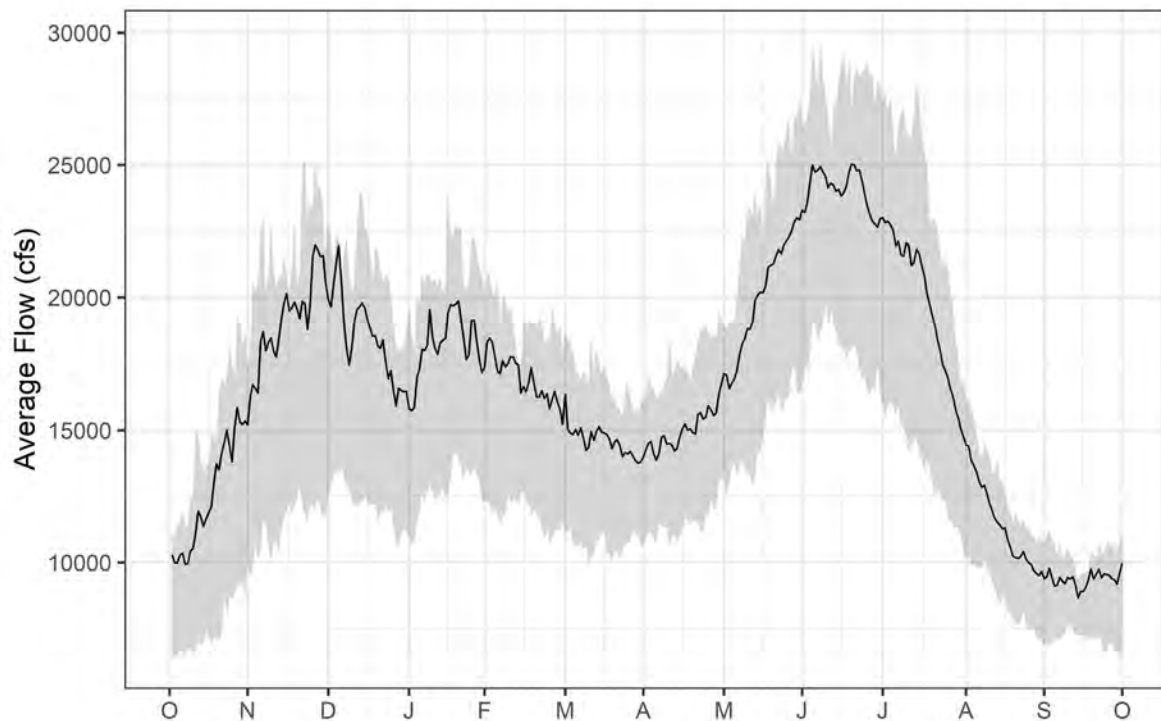
Figure 4. Average daily streamflow for the Skagit River at USGS #12200500 near Mount Vernon. Black line is the mean and gray banded area represents the 25 - 75th percentile range.

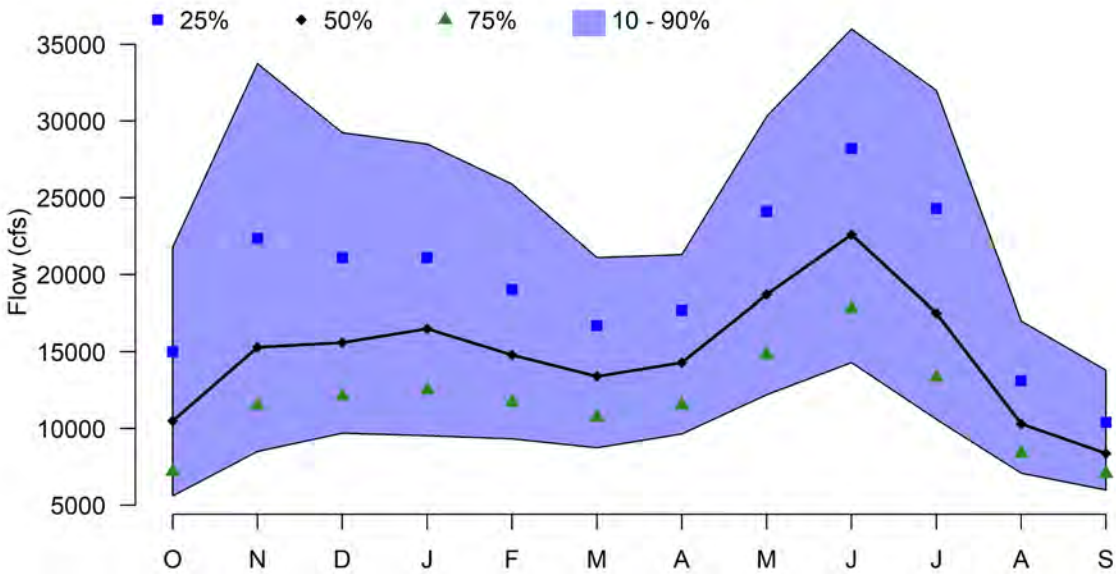
Figure 5. Exceedance probabilities for daily flow aggregated by month at the Skagit River at USGS #12200500 near Mount Vernon. Black line is the median, blue squares are the 25th %, green triangles are the 75th %, and the blue banded area represents the 10 - 90th percentile range. For example, daily streamflow in June exceeded ~35,000 cfs in only 10% of the records, but exceeds ~22,000 cfs in more than 50% of records.

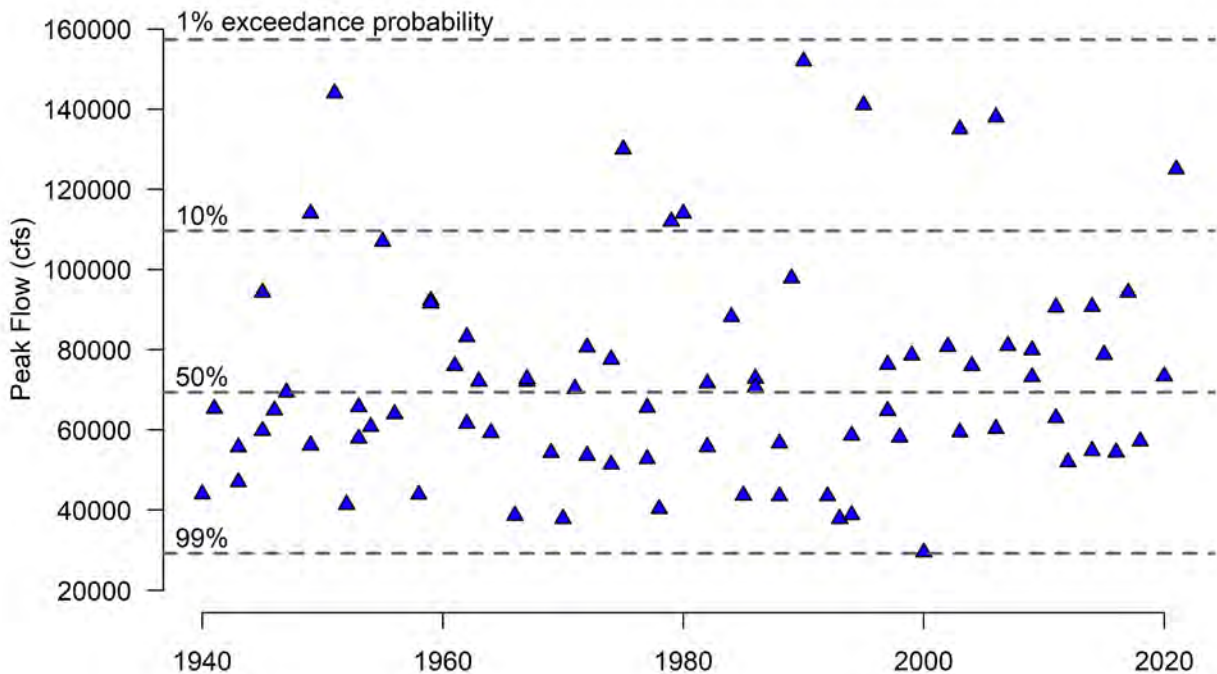
Figure 7. Historical flood peaks for the Skagit River at USGS Gage #12200500 near Mount Vernon. Dashed lines show estimated recurrence floods based on Bulletin 17B Log-Pearson III analysis.

Annual flood peak records indicate the flood of record occurred in November of 1990, with an observed peak of 152,000 cfs at the Mount Vernon USGS gage site (#12200500, Figure 7). The 1990 flood peak is estimated as roughly a 100-year recurrence flood event (e.g., 1% chance of exceedance; Figure 8). Flood frequency estimates are shown with and without the November 2021 flood event in Table 1, since the USGS has not completed data collection and approval for water year 2022 data (October 1, 2021, through September 30, 2022). Review of peak flow estimates with and without the November 2021 flood event indicate that this most recent flood peak skewed lower probability (larger flood) estimates upward by several thousand cubic feet per second (cfs). Note that flood flows at Mount Vernon are affected by regulation in the upper watershed at the Ross, Diablo, and Baker River dams. The US Army Corps of Engineers (USACE) conducted a peak flow analysis in 2013 to estimate regulated and unregulated peak flows, which differ from Bulletin 17B estimates for the Mount Vernon USGS gage.

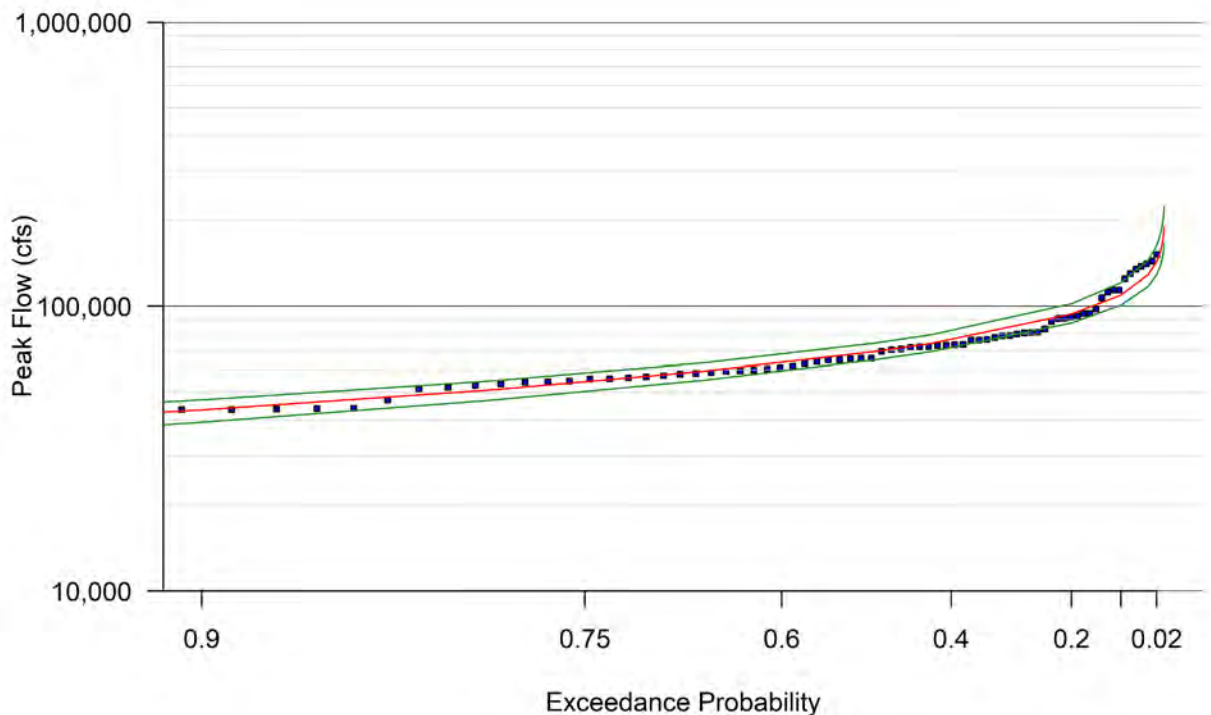
Figure 8. Log-Pearson III fit for estimating flood recurrence intervals (red line) from historical peaks (blue squares). Green lines show 95% confidence range for peak flow estimates. Data from USGS Gage #12200500 for the Skagit River near Mount Vernon.

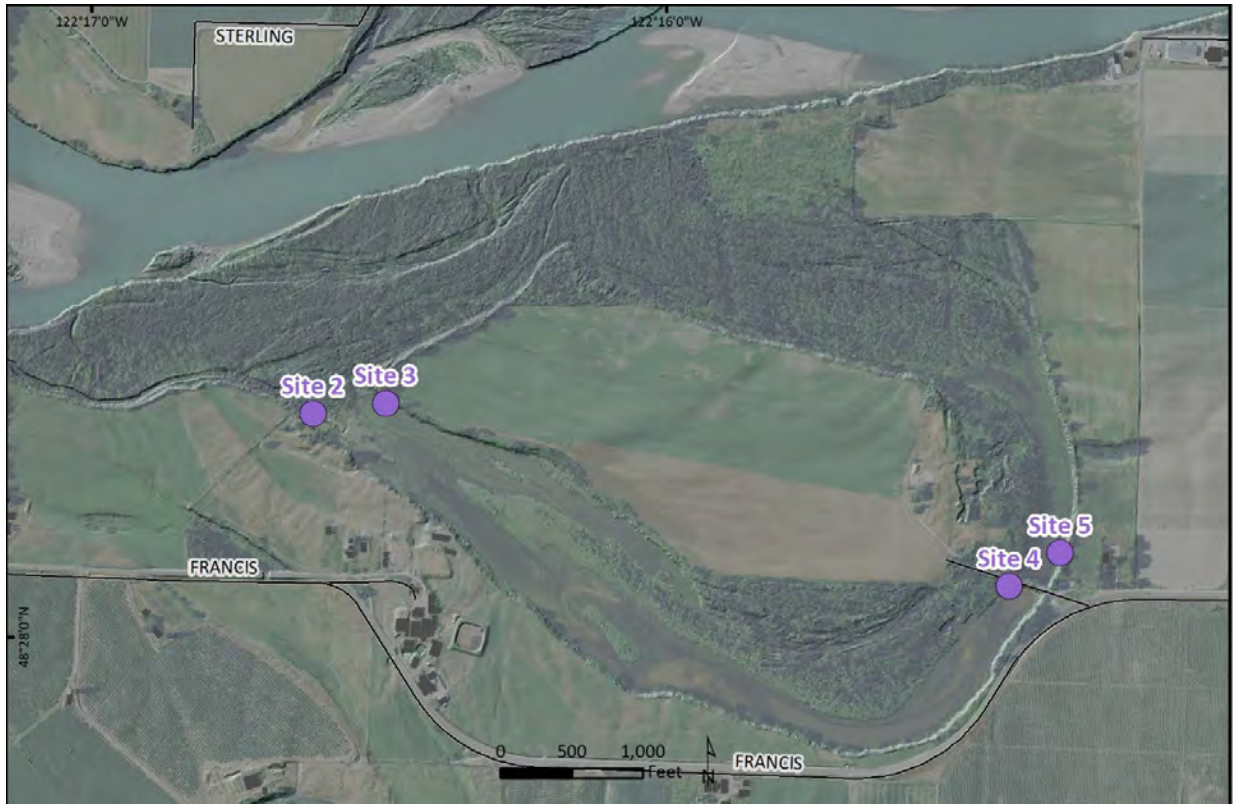
Figure 9. SCPW water level logger sites for 2020-2022.

Water level logger locations for data collected by SCPW are shown in Figure 9, and WSE extracted from the level loggers are shown in Figure 10. Level logger data show a strong linkage between DeBay Slough and the Skagit River (as measured at SR9 USGS gage), with flow peaks in the Skagit generally resulting in increased stage within the slough (Sites 3-5) and the outlet connector channel (Site 2). For periods of data overlap, the water surface at Site 5 on the northern side of the DeBay's Isle Road culvert is perched higher than Site 4 on the southern side of the culvert, which is roughly 0.1 ft higher than the west/downstream end of the slough at Site 3. This pattern of a perched water surface along the northern side of the Slough is consistent with surveyed WSE points (Figure 11). Note that surveyed WSE points occurred during two different flow conditions and were adjusted for the observed difference in stage (see methods above). Comparison of surveyed WSE with the 2016 lidar WSE (Figure 12) shows a similar pattern in surface water gradients within the reach and confirm findings from the adjusted survey WSE. Limited data are available for the connector channel at Site 2, however WSE at Site 2 appears to draw down more rapidly than the slough areas (Sites 3-5) following the spring freshet in June – July 2020 and following fall and winter flood peaks in 2020 – 2021 (Figure 10).

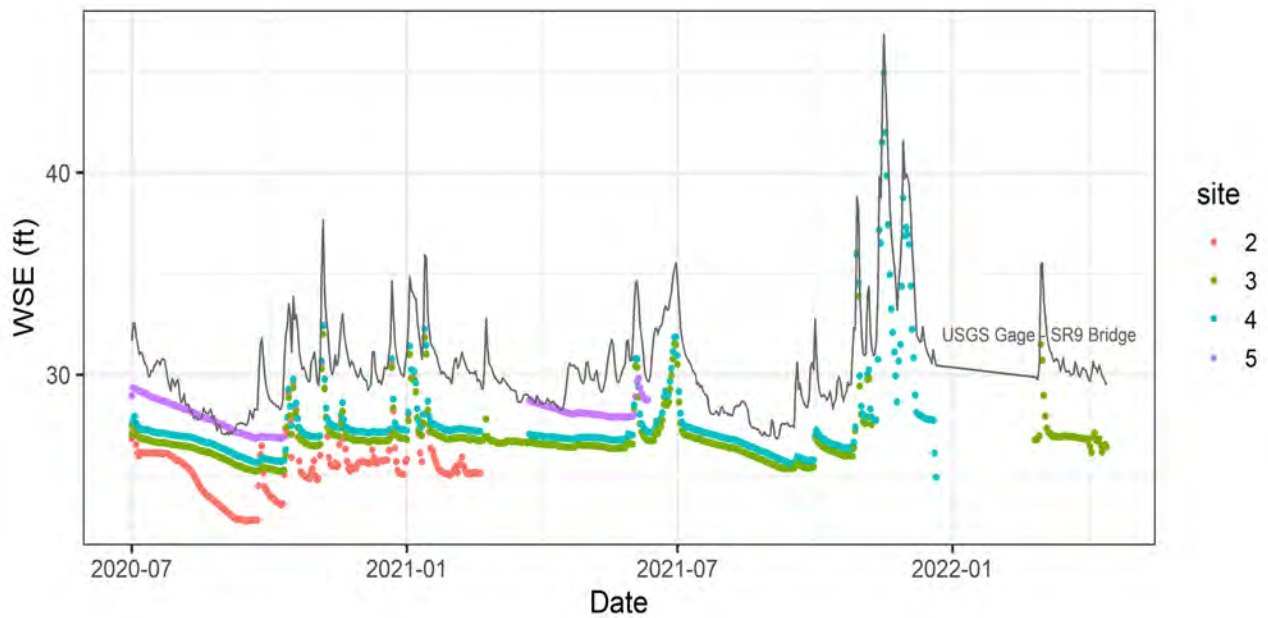
Figure 10. Level logger water surface elevations for SCPW sites 2-5 (colored points) and the USGS stage gage at the SR9 bridge (black line).

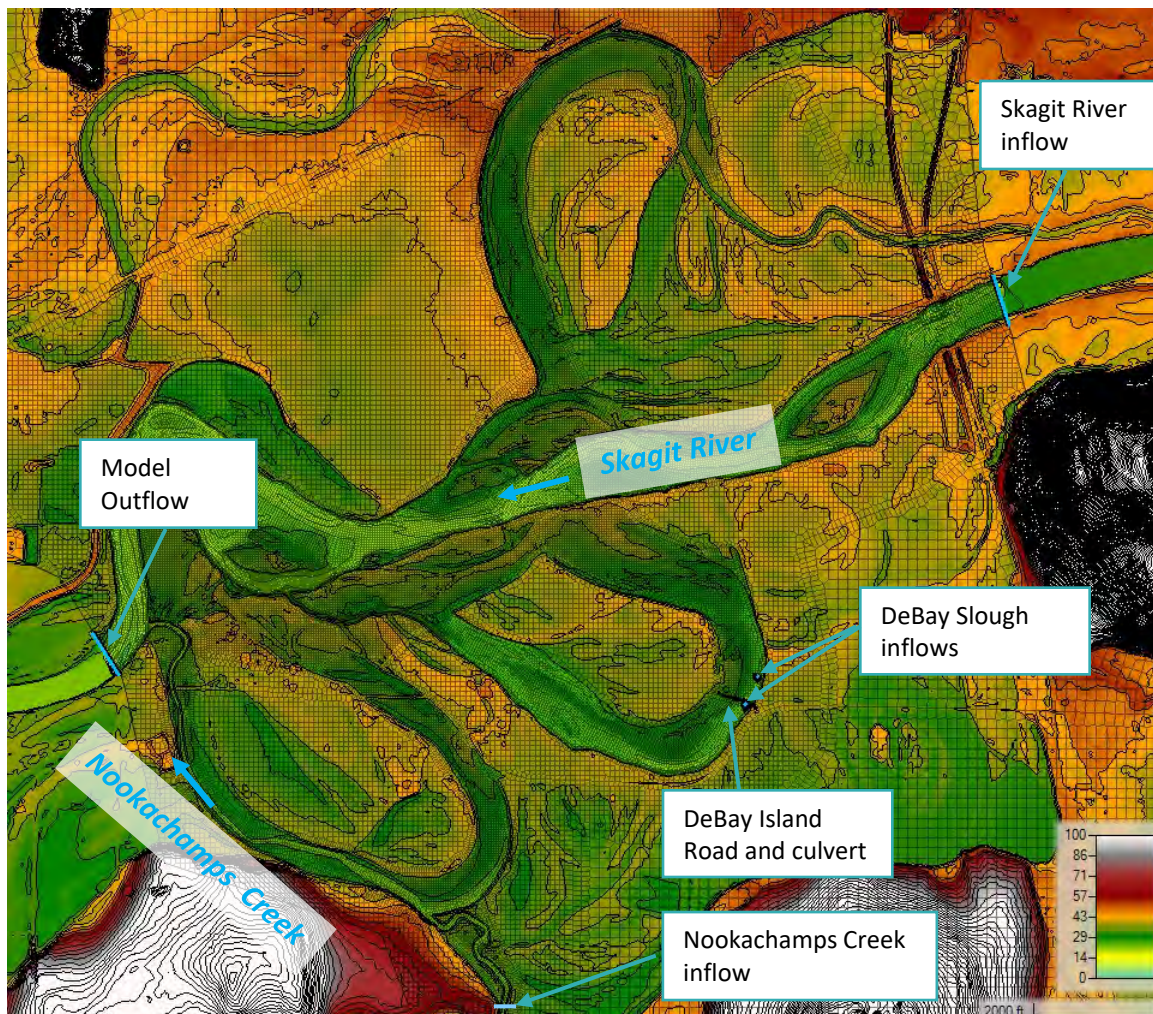
Figure 13. HEC-RAS 2D Model Domain

The model mesh utilized varying cell sizes to fully capture terrain details and flow pathways. Cell sizes ranged from 10 feet in the connector channel to 40 feet within the Skagit mainstem and 200 feet in the surrounding Skagit Valley (Figure 13). Model inflow was set at the SR 9 bridge and model outflow was set at the limits of the bathymetric survey data collection just downstream from the confluence with Nookachamps Creek. Model outflow was set to a normal depth condition with a slope of 0.0016 ft/ft as derived from the approximate water surface slope at this location in the 2016 lidar data. Additional model inflows were included in the upper (north of DeBay's Isle Rd) and lower (south of DeBay's Isle Road) portions of DeBay Slough to account for groundwater inflows into the slough. For the peak flow modeling runs, an additional inflow was added for the combined East Fork and West Fork Nookachamps Creek near the Swan Road Bridge crossing, located approximately 4,600 feet southwest of DeBay Slough.

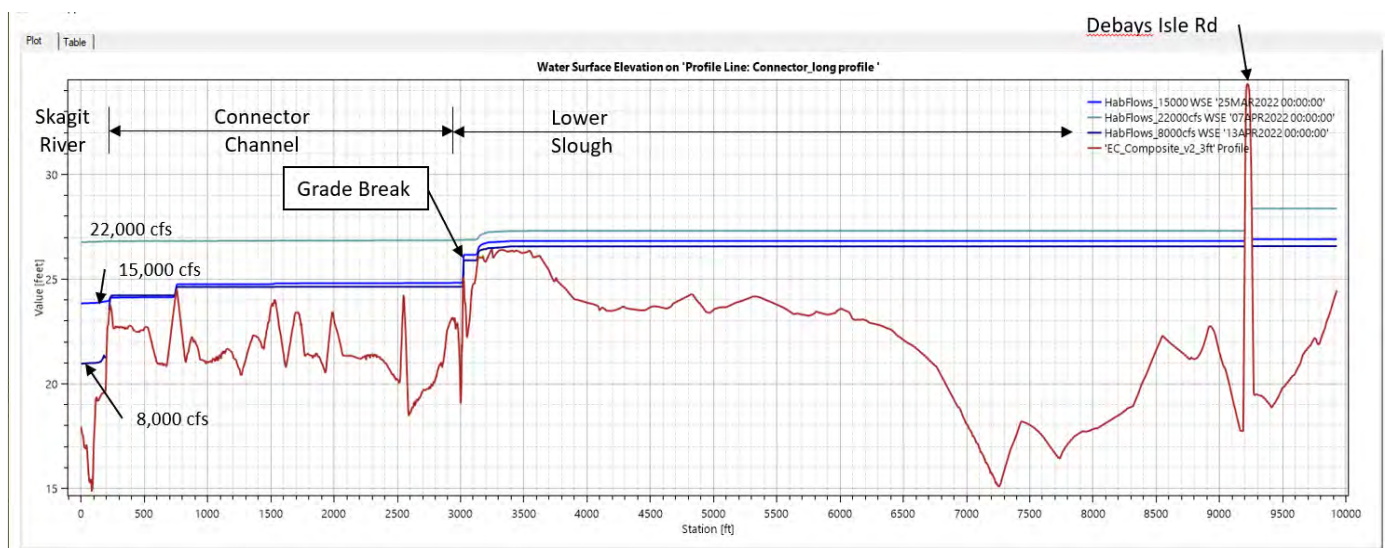
Figure 15. Longitudinal Profile of Water Surface Elevations in DeBay Slough from the Skagit River up to DeBay's Isle Road for flows in the Skagit River ranging from 8,000 to 22,000 cfs.

To evaluate the effect of backwatering and geomorphic features on water surface elevations within the slough, a longitudinal profile was developed from the Skagit River, through the connector channel and the lower and upper portion of DeBay Slough, including DeBay's Isle Road as shown in Figure 15. At the lowest flow condition (8,000 cfs), which represents an average flow for August through October, the WSE of the Skagit River at the outlet of the connector channel is below the bottom on the connector channel indicating there is no backwatering of the connector channel and DeBay Slough from the Skagit River. Any water present within the slough during this low flow condition is a result of groundwater.

At the typical winter flow condition (15,000 cfs), the water surface at the outlet of the connector channel is approximately even with the water surface in the lower portion of the connector channel. However, as you approach the outlet of DeBay Slough, a grade break consisting of a clay sill functions to hold water surface elevations in the lower slough at an approximately 2-foot higher elevation than within the connector channel. During the typical winter flow, groundwater inflow into the slough is also a main contributor to the stage elevation of the slough and water surface in the slough and connector channel are dependent on antecedent hydraulic conditions as well as stage within the Skagit River.

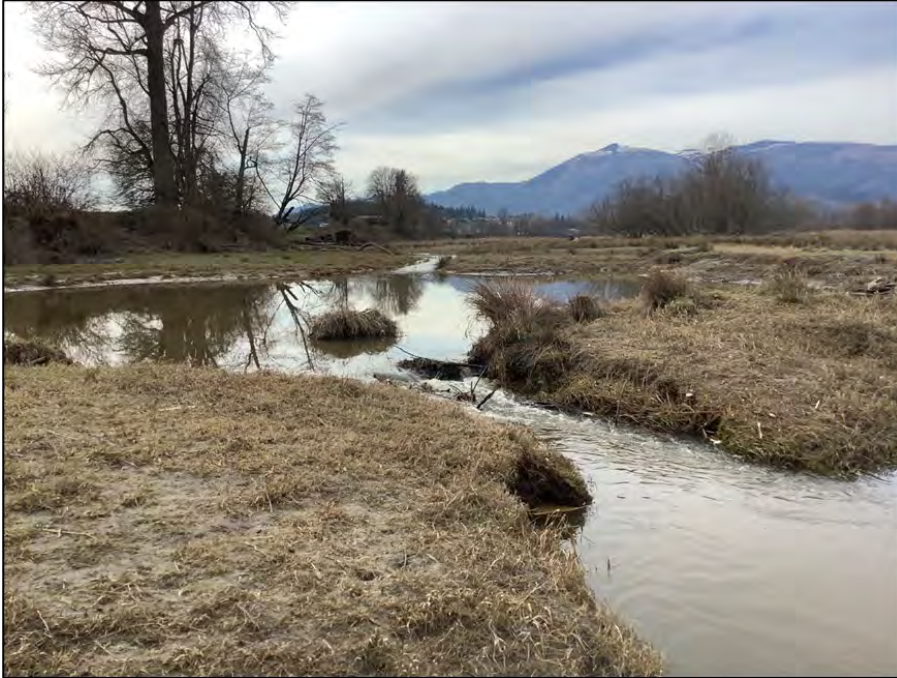
Figure 20. Clay sill holding grade at the downstream end of the slough. The sill appears to be resistant to erosion and is likely contributing to the maintenance of water levels within the slough. The sill forms the upstream end of the connector channel. Photo taken on March 10, 2022, looking upstream.

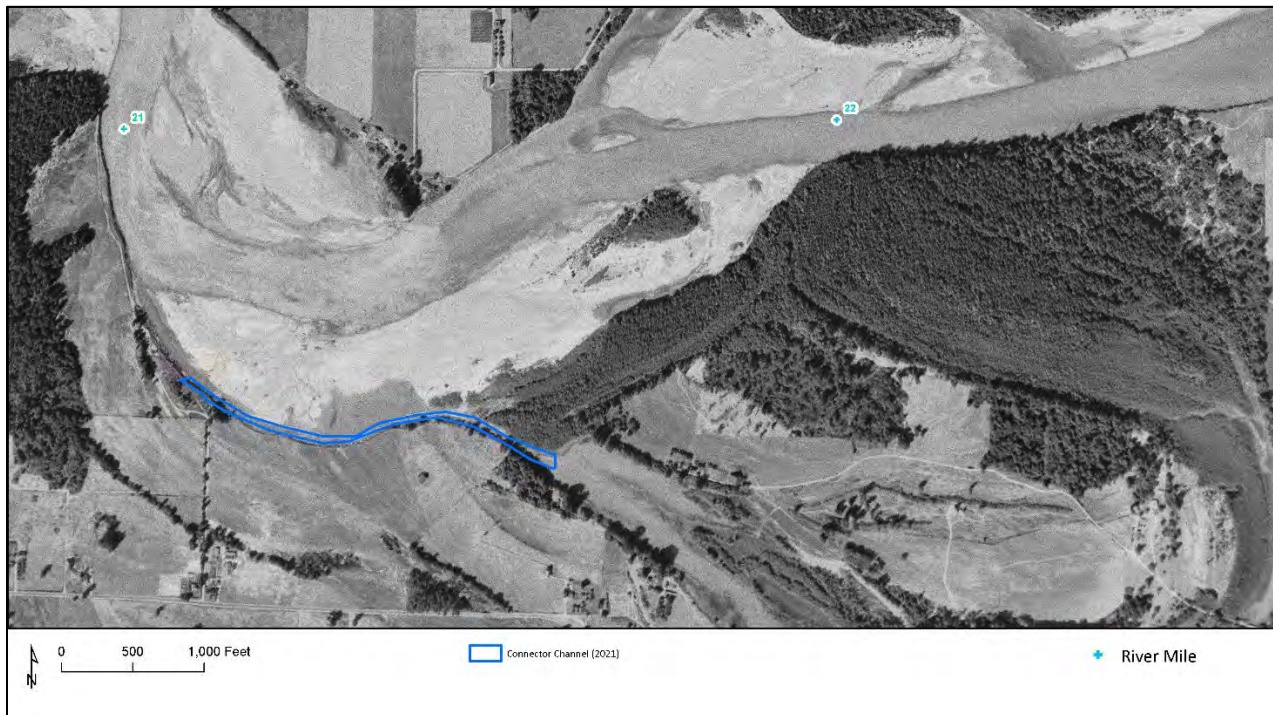
Figure 23. 1951 aerial imagery of the project area compared to the 2021 location of the connector channel. The connector channel appears to have formed along the left bank of a former Skagit River main-stem channel and has remained relatively stable since its formation after 1951.

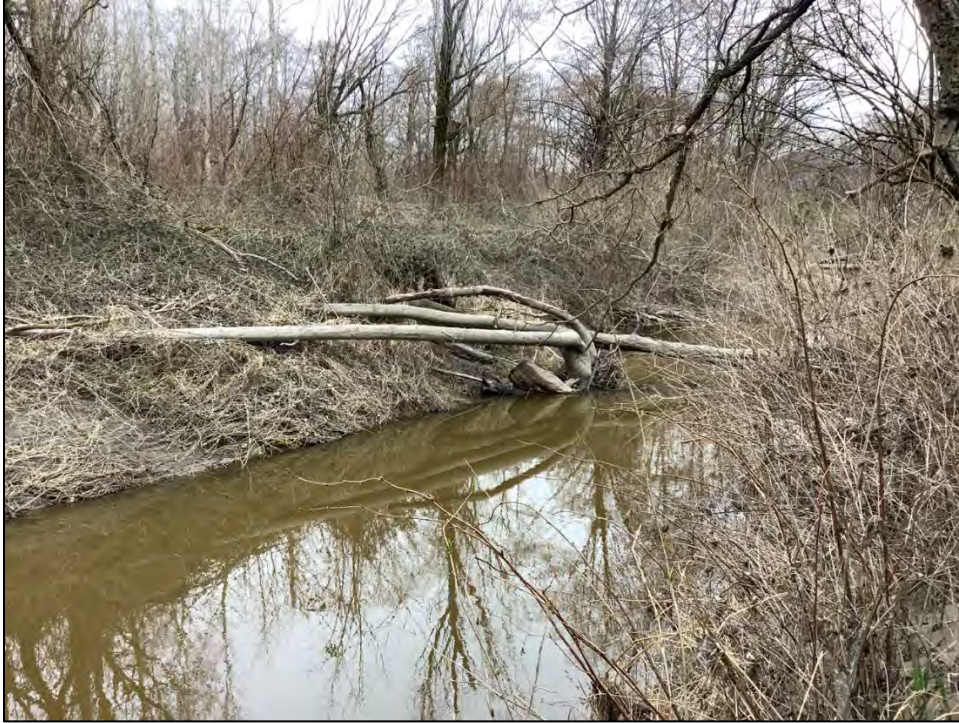
Figure 24. Typical example of large wood within the connector channel. The majority of the minimal amounts of wood within the channel consist of small, bank attached pieces of red alder or small accumulations. Photo taken on March 10, 2022, looking upstream.

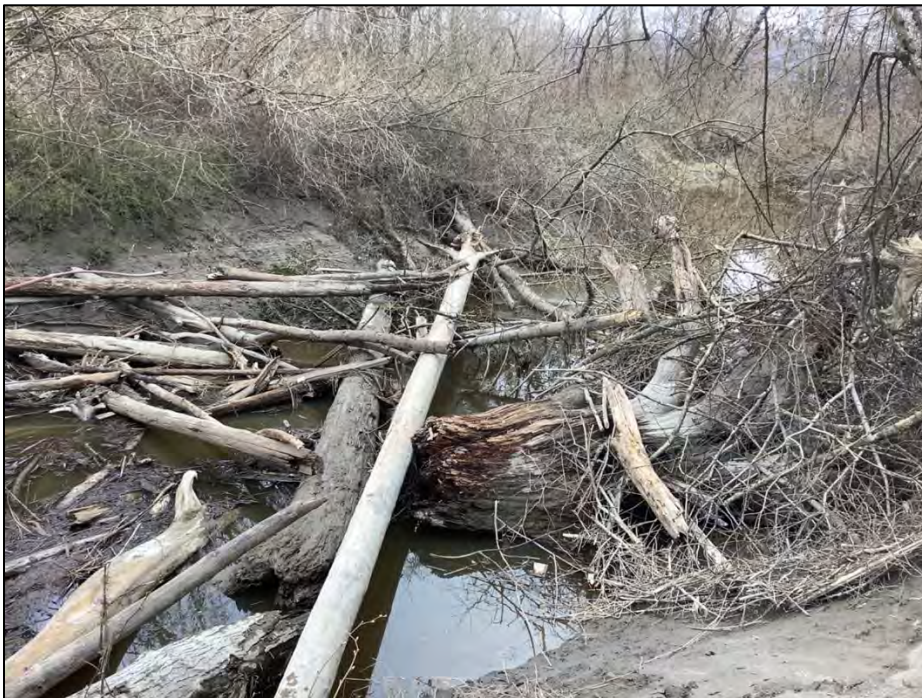
Figure 25. Log jam at the outlet of the connector channel. The log jam appears to have formed from wood rafted down the Skagit River during the November 2021 flood. Photo taken March 10, 2022, looking upstream.

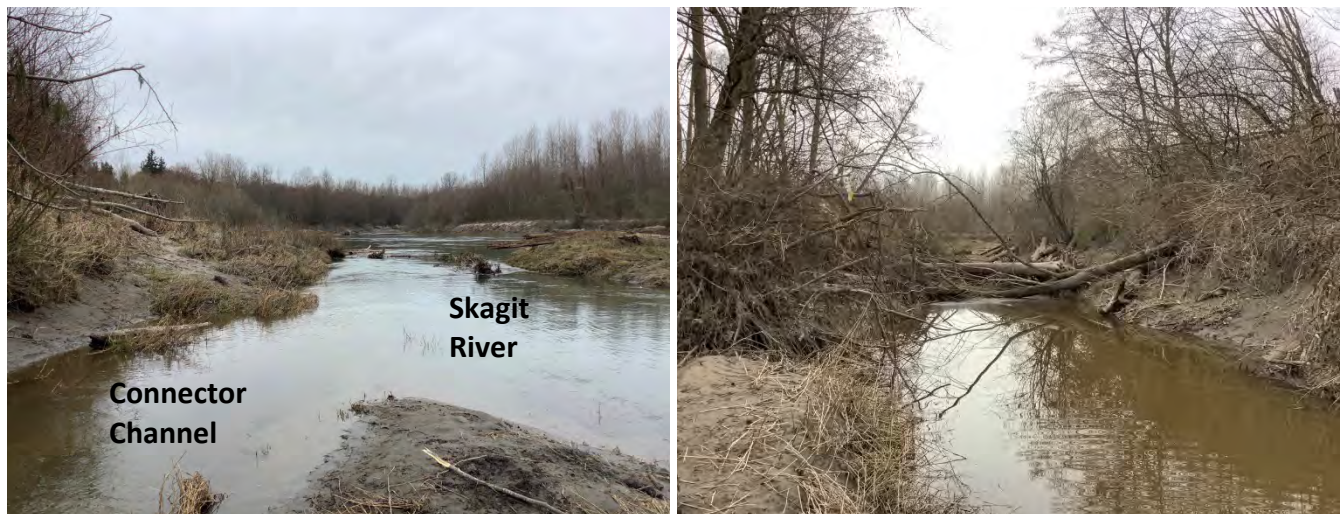
Figure 26. Connector channel junction where the channel meets the Skagit River (left) and connector channel with the log jam near the mainstem junction in the background. Photos taken March 9, 2022.

The connector channel is a steep sided uniform channel with a flat bed and low gradient. Due to the low gradient, the channel has slow water velocities throughout it (see Appendix A.2 for velocities during modeled flows). The channel connects to the mainstem Skagit River, providing flow refugia compared to the higher velocities in the adjacent Skagit mainstem (Figure 26). The proximity to mainstem means the channel is likely intermittently used by juvenile Chinook, Steelhead/rainbow, and coho salmon. At the junction of the channel with the mainstem river a log jam has formed and provides cover habitat for juveniles. In contrast, throughout most of the channel fish cover is low with open areas comprising a majority of the channel area. Fish cover where present includes undercut banks, aquatic vegetation, and small, bank attached pieces of red alder with a few small that appear to be locally recruited. The bed and banks throughout the connector channel are comprised sand and silt which is likely deposited during floods from the Skagit River.

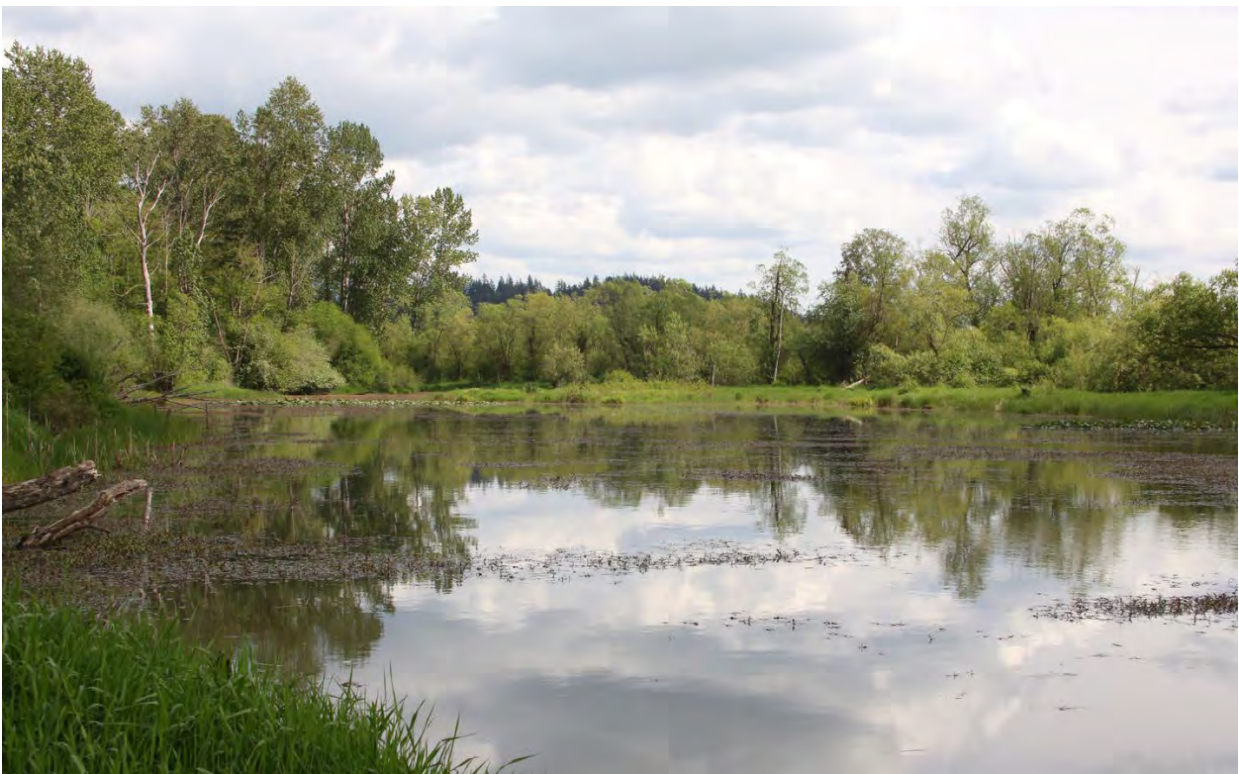
Figure 27. DeBay Slough example of open water habitat looking upstream toward road crossing. Photo taken June 8, 2022.

The slough is a much wider open water habitat with essentially no water velocity except during flood events. The off channel nature of the slough, coupled with its submerged aquatic vegetation and fringe of emergent wetland plants and fringe of overhanging trees and shrubs (Figure 27), make it likely more suitable for coho

Due to summer temperature limitations, discussed in the water quality section below, juvenile Chinook use of the slough is most likely to occur from fall through late spring (i.e., June) as the young salmon seek off channel rearing habitat before outmigrating in ~June down river through the estuary. The majority of the slough's water surface is not shaded, contributing to high summer water temperatures. Aquatic vegetation, primarily yellow pond lily (*Nuphar polysepalum*) grows in patches throughout the slough and provides considerable cover for juvenile fish. Emergent wetland species, described in more detail below, as well as overhanging brush, and small, and large pieces of wood are also present (Figure 27) and provide some cover but are generally low in abundance.

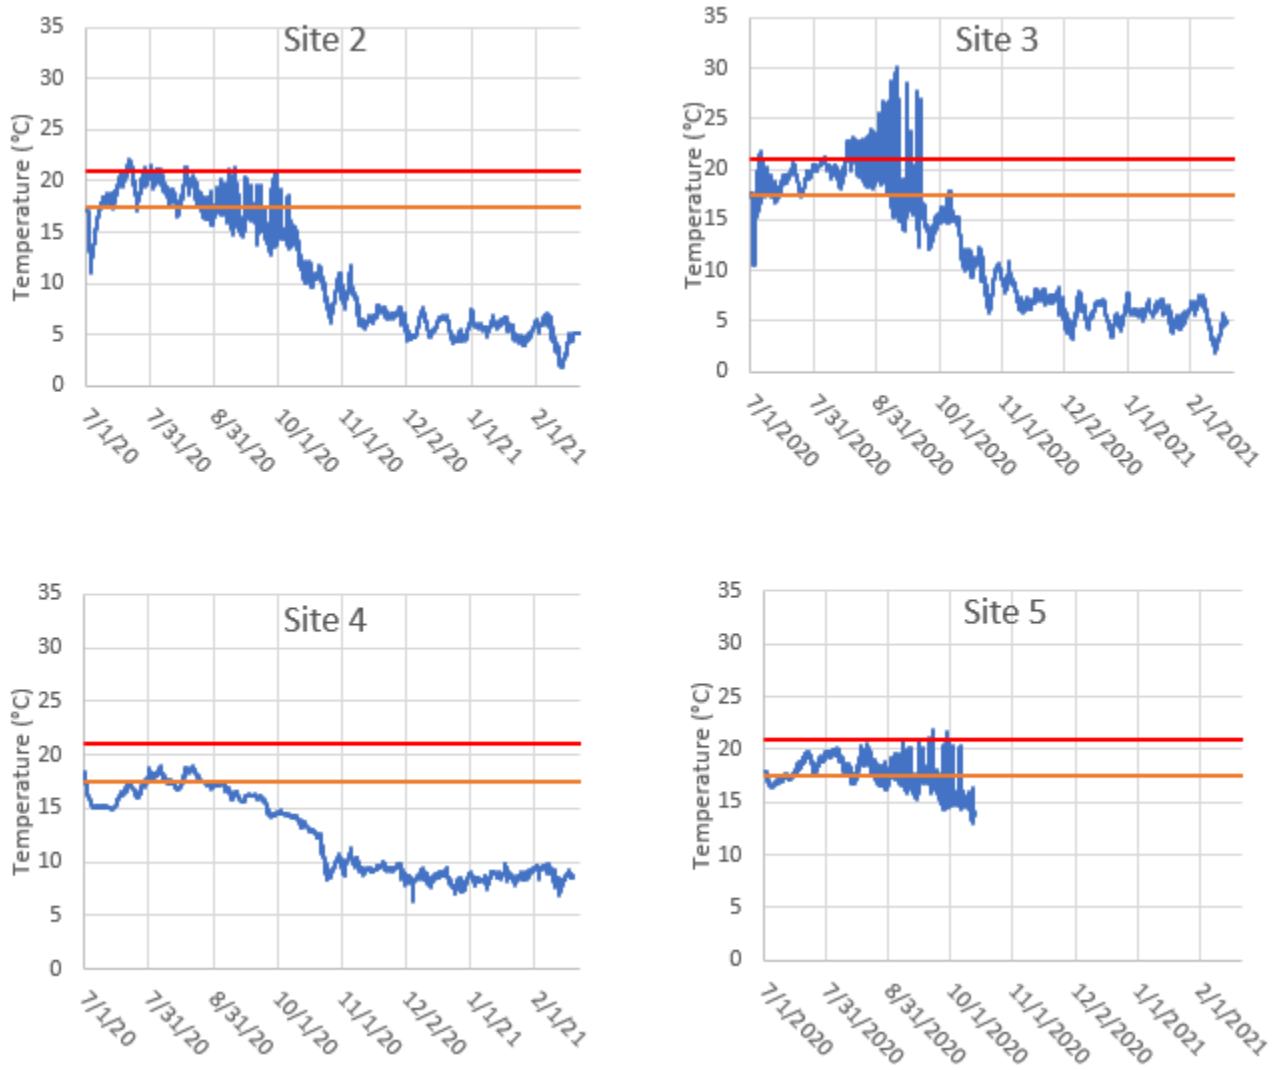
Figure 28. Skagit County Public Works HOB0 gage water temperature data recorded at four locations within the DeBay Slough site. Sites 2 and 3 are at the downstream end of the lower slough. Sites 4 and 5 are downstream and upstream of the DeBay’s Isle Road culvert, respectively. Orange line indicates temperature threshold for salmonid rearing and migration habitat. Red line indicates lethal temperature threshold for juvenile salmonids.

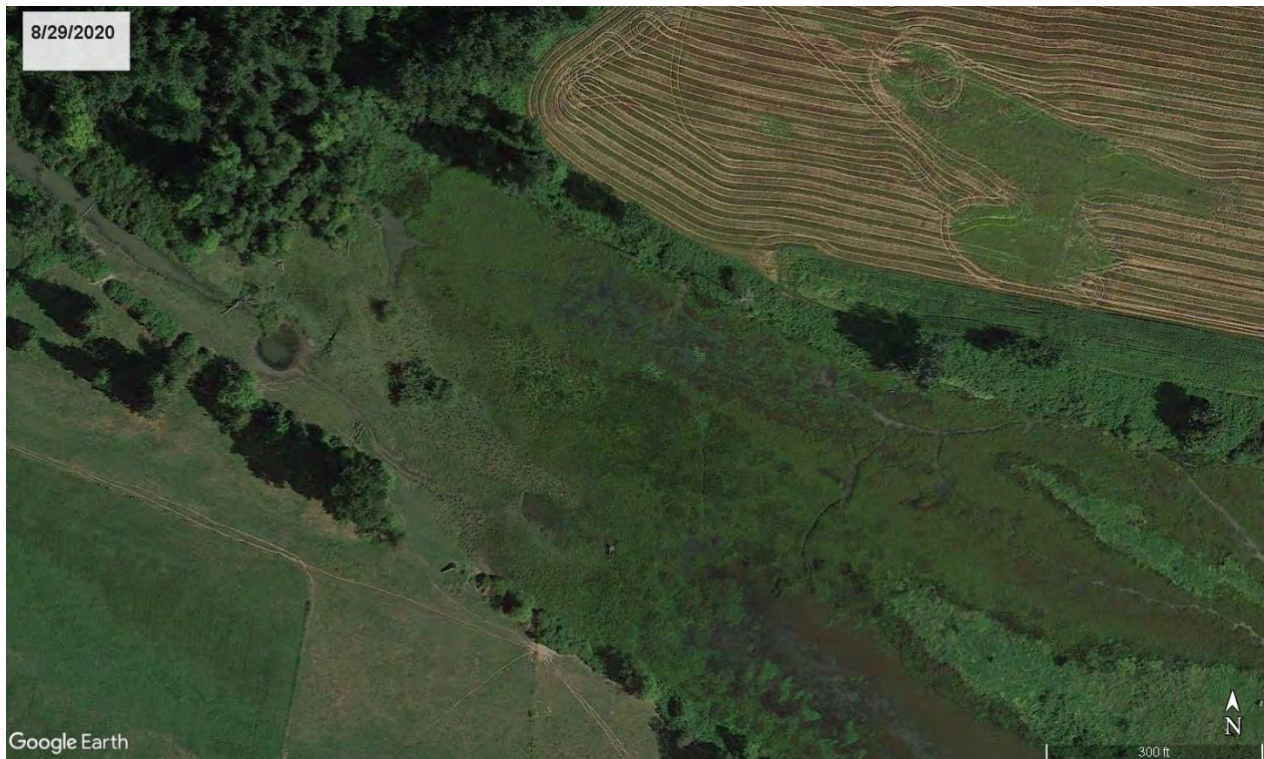
Figure 29. Western end of DeBay Slough and the connector channel on 8/29/2020 showing no surface water connection between the slough and channel.

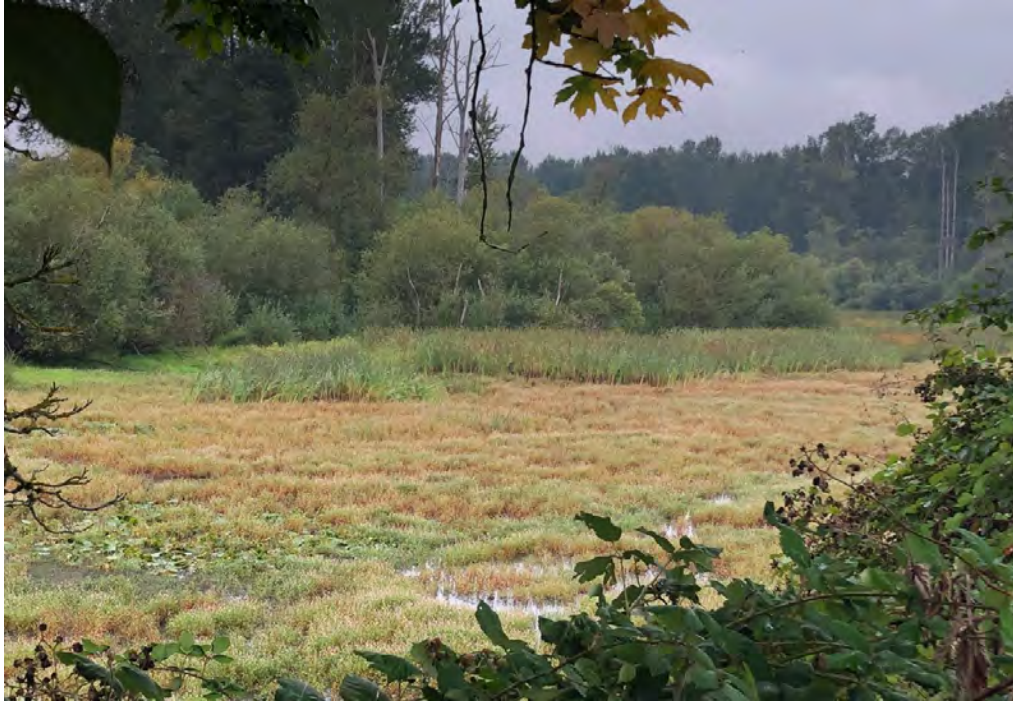
Figure 30. Slough upstream of culvert, view north. Photo taken September 5, 2021.

Aquatic habitat conditions upstream of the DeBay's Isle Road culvert are similar to those downstream, but with a greater portion of the slough supporting submerged aquatic and emergent wetland vegetation through the growing season and into late summer (Figure 30). The area of open water north of the culvert is confined by late summer to the deepest area immediately upstream of the culvert (Figure 31).

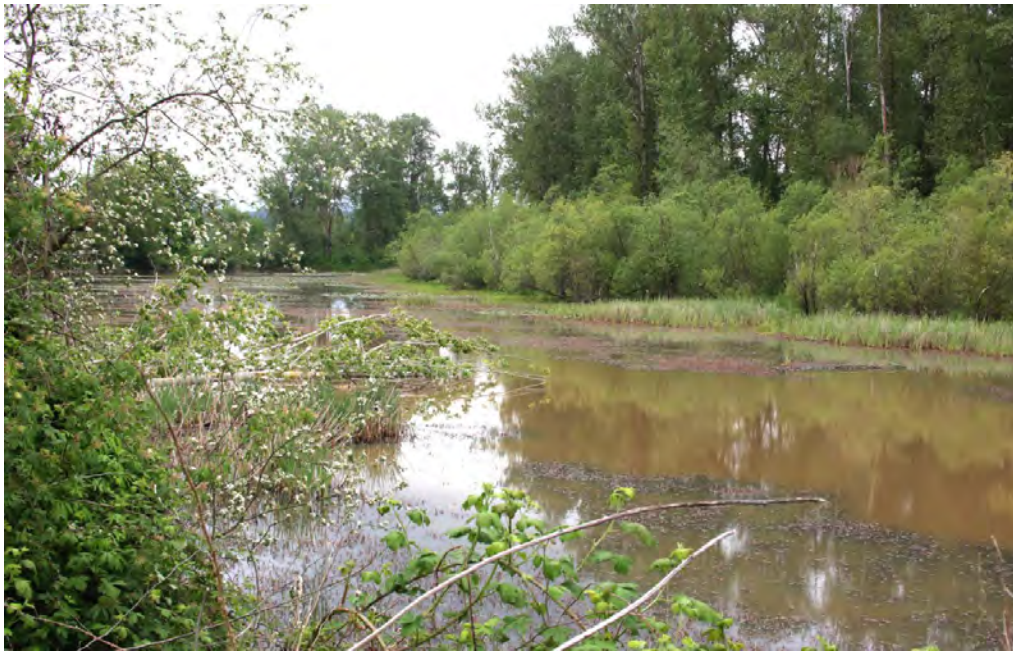
Figure 31. Slough upstream of DeBay's Isle road culvert, view south toward culvert (background left of center). Photo taken June 8, 2022.

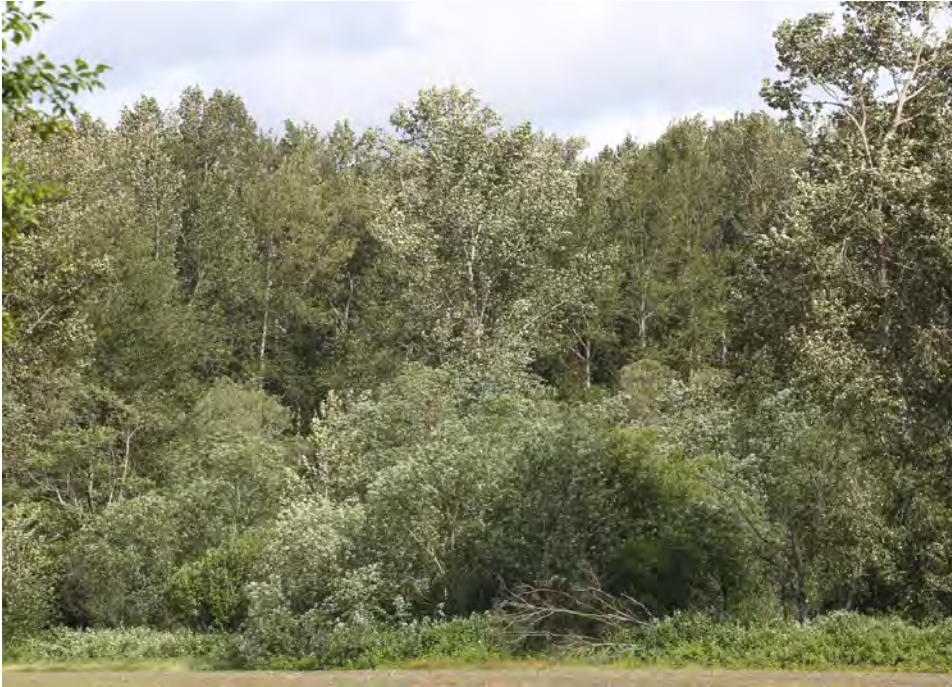
Figure 34. Deciduous forest vegetation community and density of largely native understory; Game Reserve Agricultural field is in the foreground. Photo taken June 8, 2022.

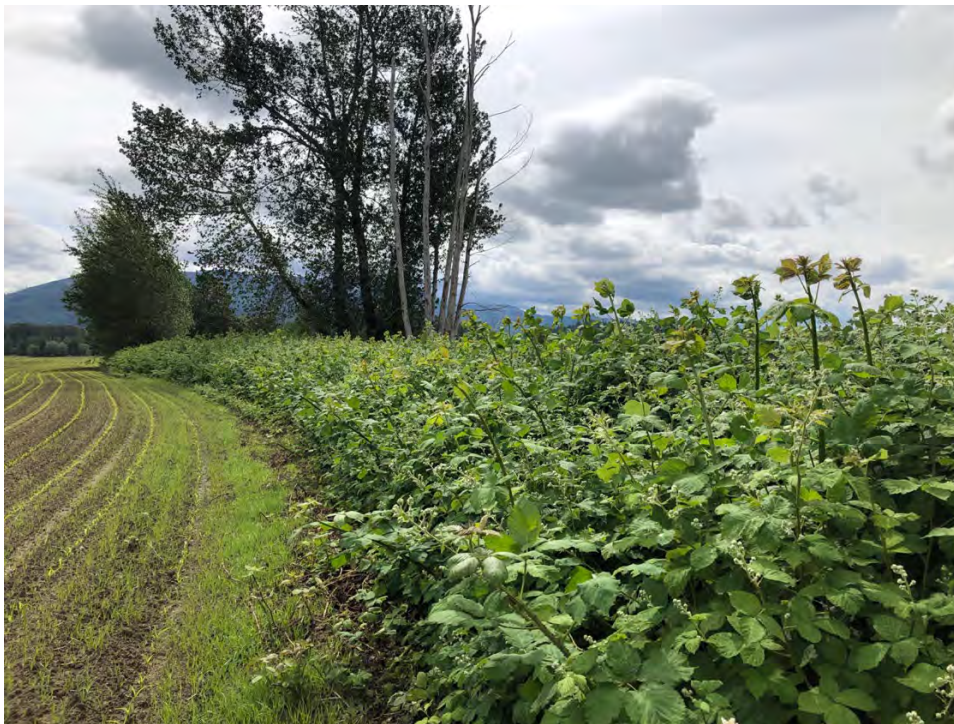
Figure 36. Himalayan blackberry-dominated deciduous scrub shrub habitat adjacent to agricultural field and the lower slough. Photo take May 17, 2022.

Prominently occupying the many of the edges within the project area are relatively narrow bands of dense scrub-shrub dominated by Himalayan blackberry. This habitat type almost surrounds the Game Reserve agricultural field forming a dense thicket between the farmed field and the mature cottonwood-alder forest (Figure 36). It also occurs in several locations along the slough edge, extending from the top of high banks down to water's edge or to the emergent plant community if the slope gradient allows for an emergent community along the water's edge. This community is extensive along the south and east edges of the slough where riparian forest is absent, very narrow, or sparse. Where it occurs as a riparian edge, the landward uplands are mowed or farmed, thus maintaining the blackberry in a narrow band.

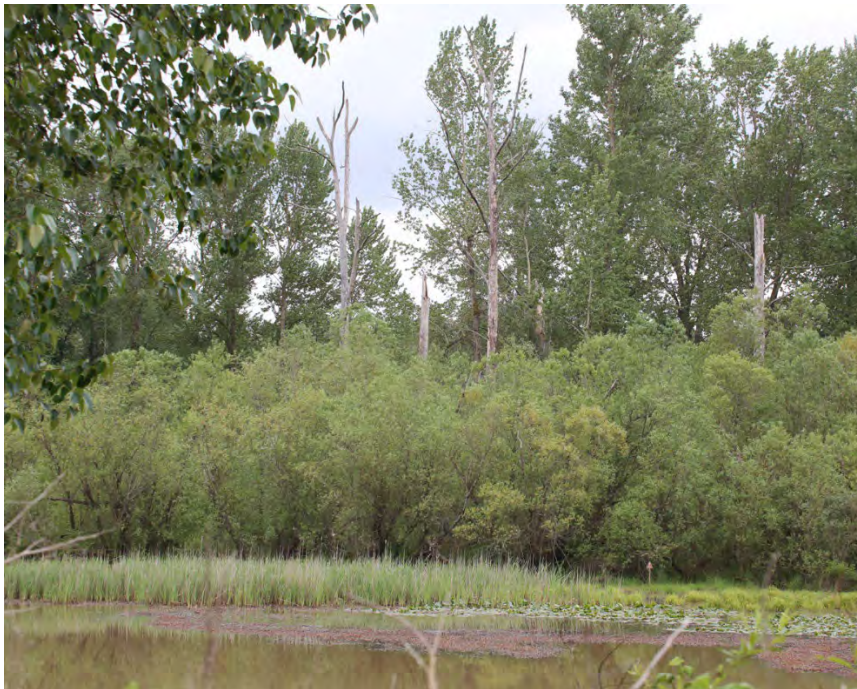
Figure 37. Scrub-shrub community of willows fringing upper slough, with emergent and aquatic bed wetland adjacent, as well as deciduous riparian forest adjacent in background. Photo taken May 17, 2022.

The willow-dominated wetland habitat consists primarily of Pacific willow (*Salix lasiandra*) with an understory variously dominated in some areas by reed canarygrass. This habitat type is extensive – approximately 107 acres and occupies much of the lower slough edge including a prominent peninsula and an island in the lower slough, as well as the edges of upper slough occupying the elevation between open water/emergent wetland and the mature deciduous forest (Figure 37).

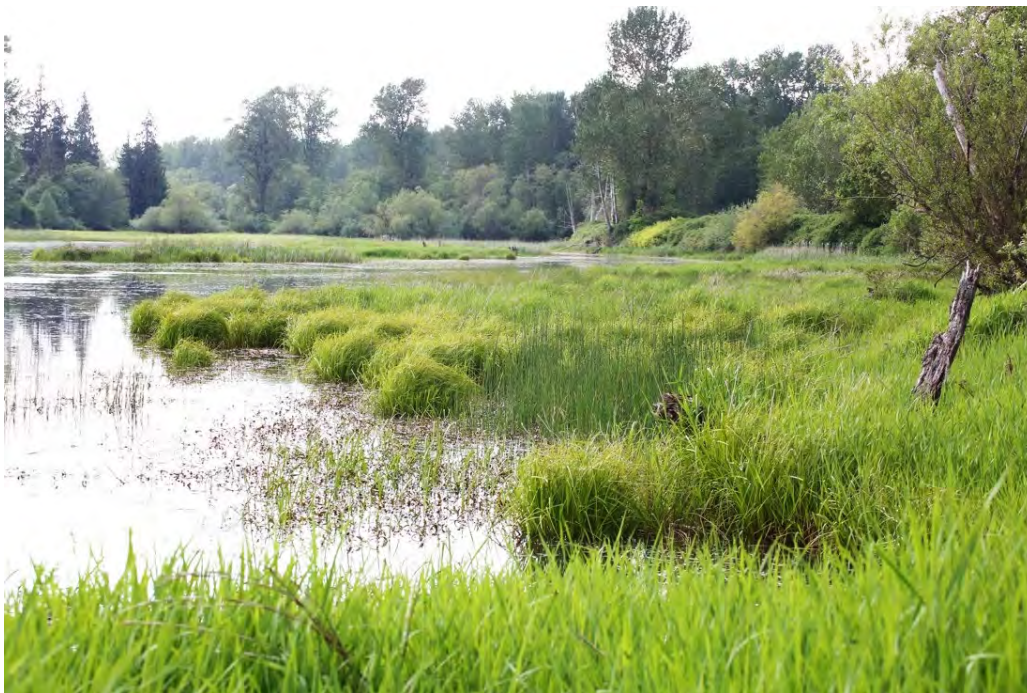
Figure 38. Emergent and aquatic bed vegetation communities in the lower slough. Photo taken May 17, 2022.

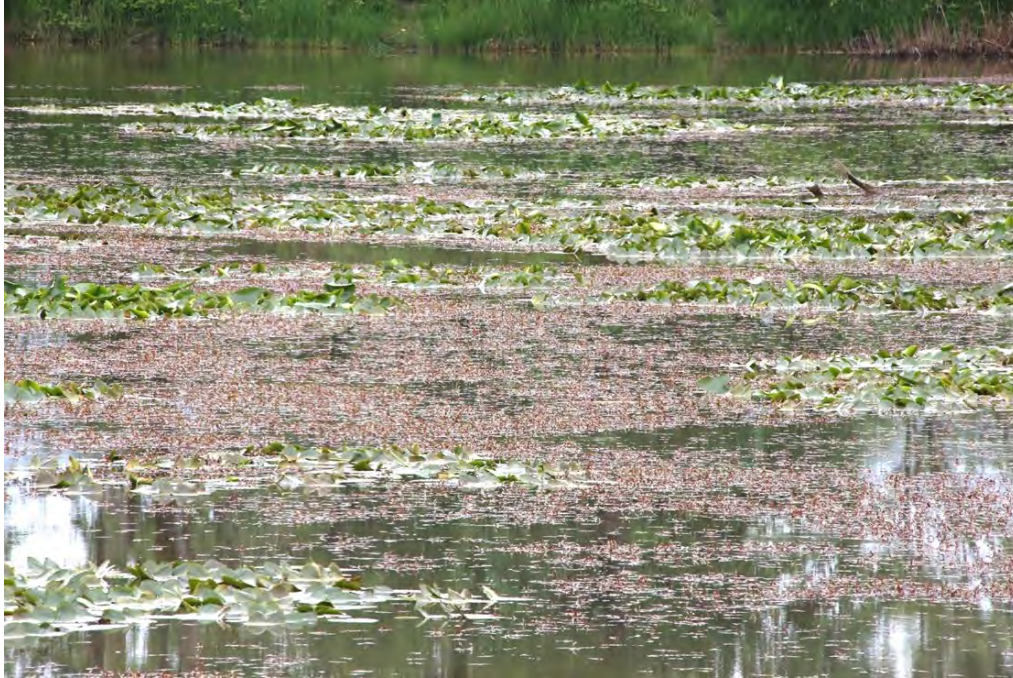
Figure 39. Aquatic Bed habitat with water lily and *Potamogeton* spp. in the upper slough. Photo taken May 17, 2022.

Because the slough's hydroperiod is so heavily influenced by Skagit River flows, the slough maintains vast areas that are shallowly inundated into late July and early August. Shallow water and warmer temperatures support large areas of predominately native aquatic plants, primarily Rocky Mountain/yellow pond lily (*Nuphar lutea*, spp. *polysepala*), cattail (*Typha* spp.) and an undifferentiated *Potamogeton* (pondweed) species (Figure 39).

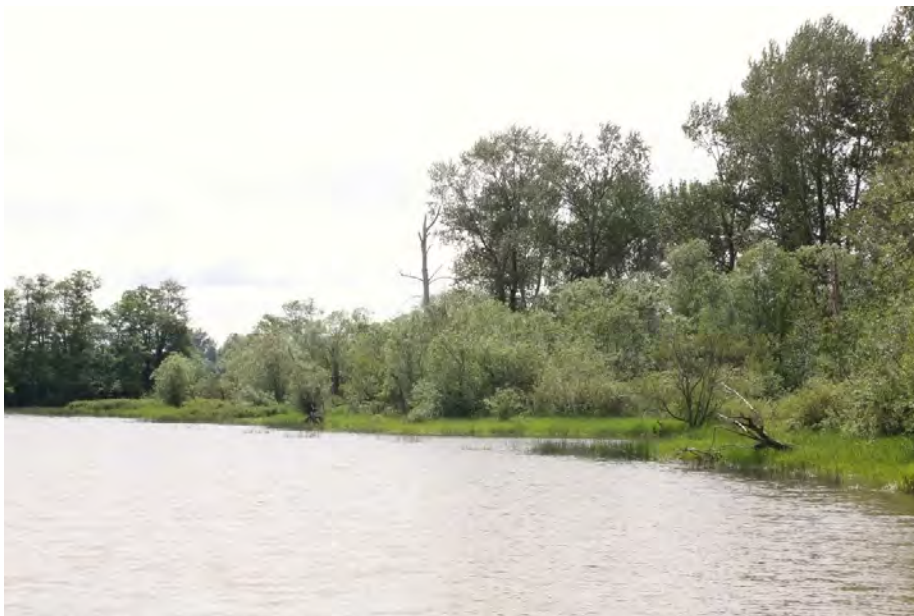
Figure 41. Open water habitat south of DeBay's Isle Road culvert, with fringe of aquatic bed/emergent wetland, deciduous scrub shrub wetland, and deciduous forest. Photo taken May 17, 2022.
