DEBAY SLOUGH SITE ASSESSMENT

Appendix A-2 Existing Conditions Hydraulic Model Output Maps

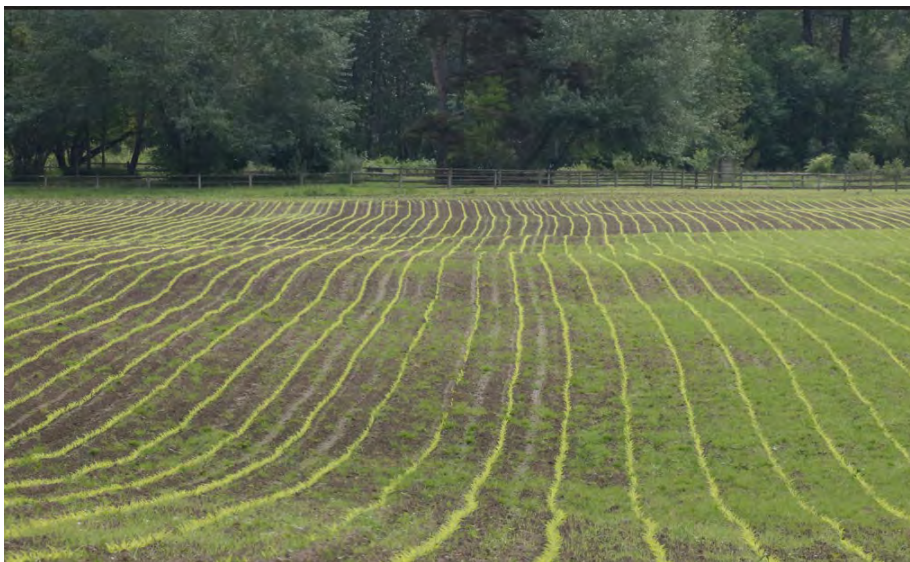
Figure 43. Game Reserve agricultural field, June 8, 2022, planted in rows of corn.

Although annual variations may occur, the typical management cycle includes spring seeding, summer grow-out, early-fall harvest, and late-winter/early-spring tillage and prep for spring planting. Standing crops or crop stubble are present for the majority of the year, typically from late-May or June when seeds are sown (Figure 43), through the following April when tillage of the stubble occurs prior to replanting.

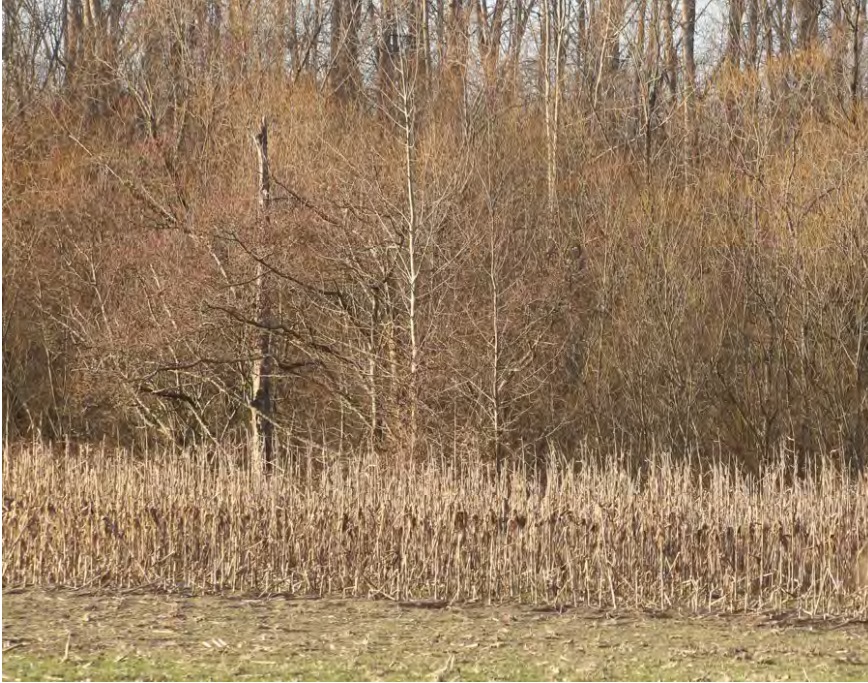
Figure 44. Game Reserve agricultural field, eastern edge of unharvested corn adjacent to deciduous riparian forest. Photo taken February 16, 2022.

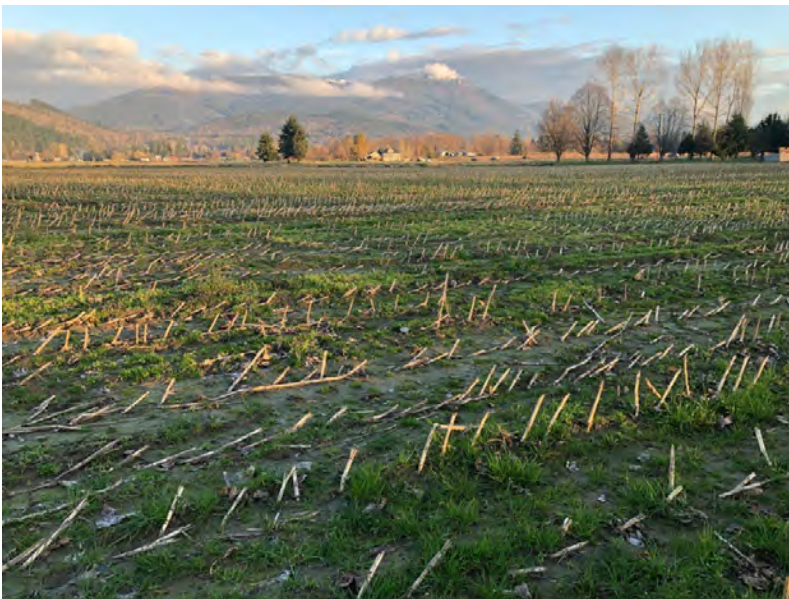
Figure 45. Example of crop stubble left to overwinter in the Hunt Safety Zone. Photo taken February 16, 2022.

Planting zone boundaries and habitat conditions within a field can vary by year. Similarly, different management practices may exist between the Game Reserve and the Hunt Unit resulting in differences in winter swan and waterfowl habitat qualities at any given time. For example, it appeared that the Game Reserve agricultural field was tilled and seeded with a cover crop during the fall of 2021, but success of that crop may have been reduced by the November flood event. While no cover crop was present, unharvested corn was left standing in the eastern portion of the Game Reserve agricultural field (Figure 44) through at least late February 2022 while the hunt unit field retained crop residue and stubble (Figure 45).
