Big Lake 2013 Aquatic Plant Control Program

**Prepared By
Northwest Aquatic Eco-Systems
855 Trosper Road SW #108-313
Tumwater, WA 98512
360-357-3285
Pondweeds@comcast.net
www.nwaquaticecosystems.com**

Project Overview

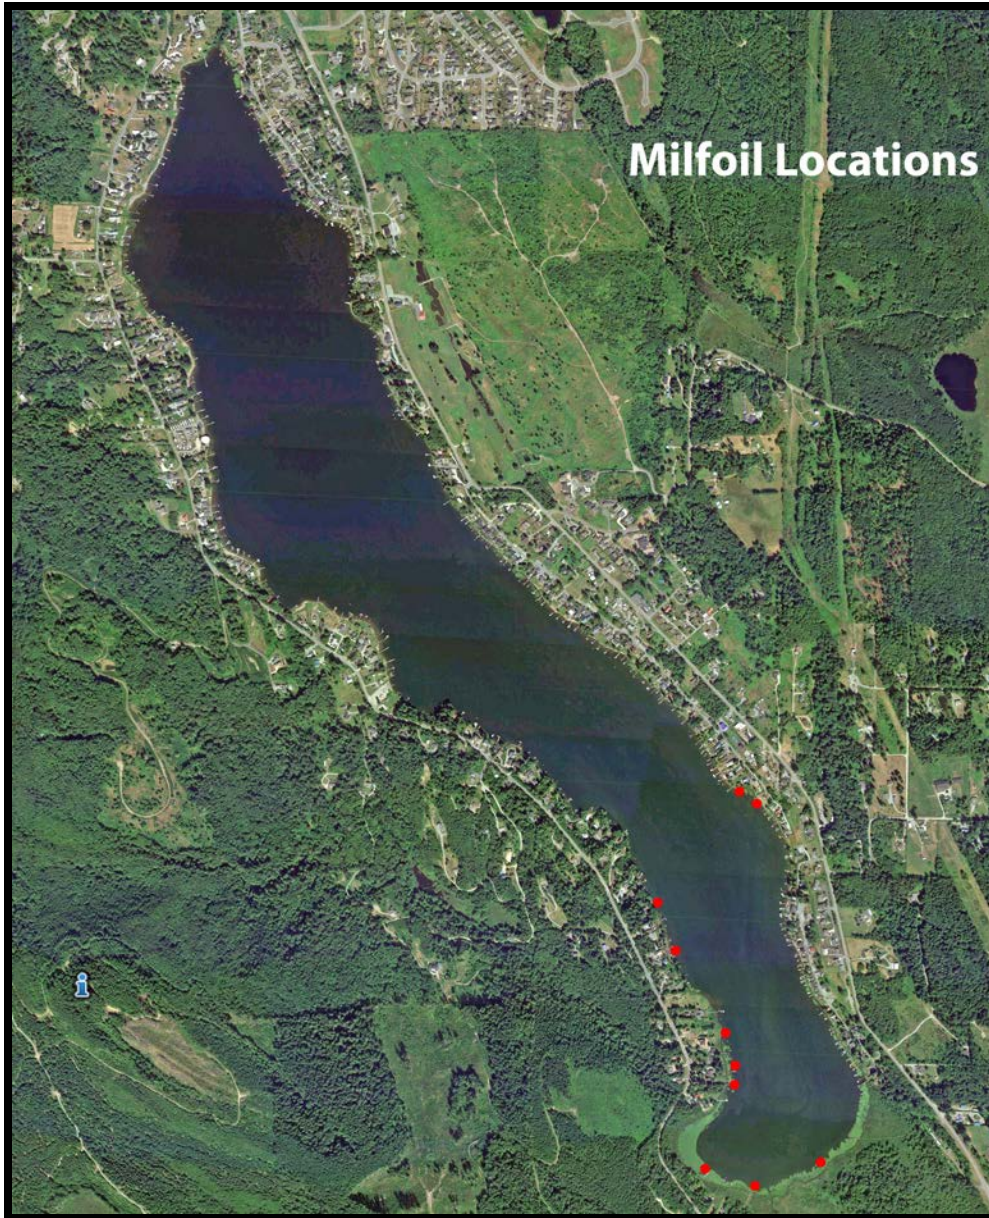
Big Lake was surveyed on June 28. At the time of the survey water clarity exceeded ten feet. The relative shallow slope of the immediate shoreline lakebed was already experiencing visible weed growth with some species breaking the water's surface. As the survey progressed it became obvious that there were no "extended" shoreline "weed free" zones. There were only a few parcels that were not experiencing some degree of plant growth. Milfoil locations were similar to those reported over the last five years. The 2013 NWAE survey identified only minor occurrences of *P. amplifolius* while most of the entire shoreline was occupied by a number of pondweeds including *P. richardsonii*, *P. robbinsii*, *P. praelongus*, *P. foliosus* and *P. epihydrus*. Problematic non pondweed species included *Elodea canadensis*, *Vallisneria americana*. Different shoreline sections of the lake were dominated by the dissimilar pondweed species.

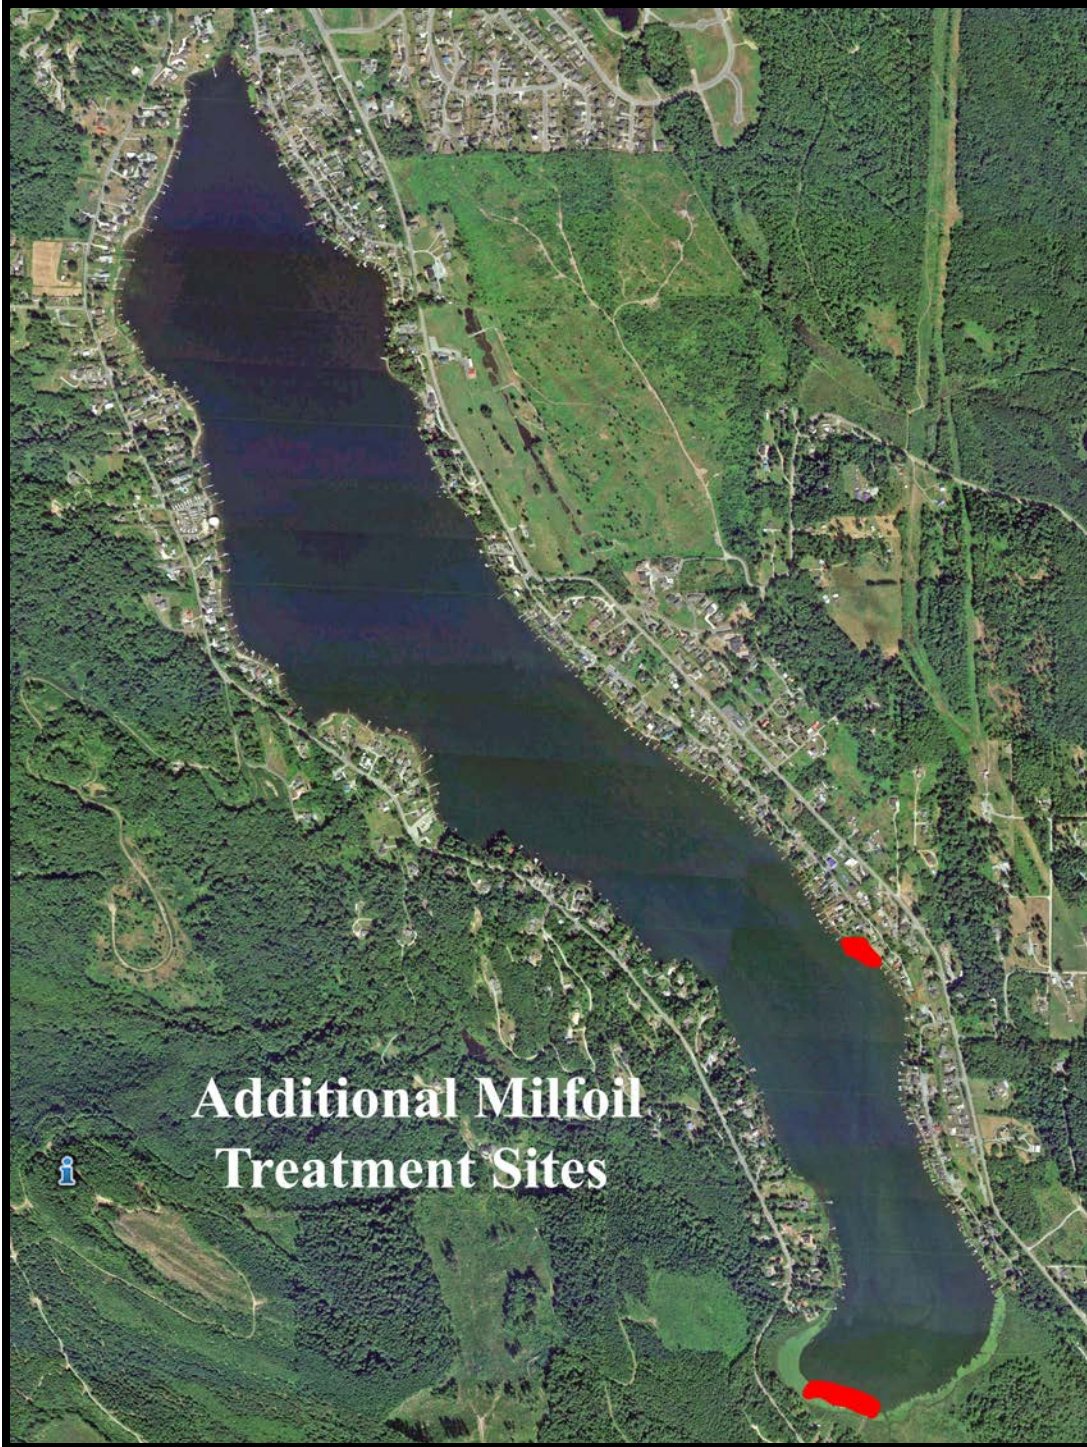
July 22 Treatment

Big Lake is 520 acres with a shoreline length of 6.2 miles. Under current NPDES guidelines, native macrophytes control is limited to no more than 30% of the shoreline or approximately 9,820 feet. “In water bodies over 500 acres in size the Permittee may intentionally apply herbicides to no more than 30 percent of the littoral zone”).

the lake under 500 acres enabling a larger permitted area to treat. Lakes less than 500 acres are allowed treatment up to 50% of the shoreline. The 2013 treatment model was designed to adhere to the 30% rule and also expand treatment outward into the main water-body. This approach is commonly referred to as the “block treatment” scenario. During 2013 Aquathol K was incorporated into the spray mixture at one of the treatment sites in an effort to enhance control. As noted in the NPDES permit requirements the same areas treated during 2012 were again treated during 2013.

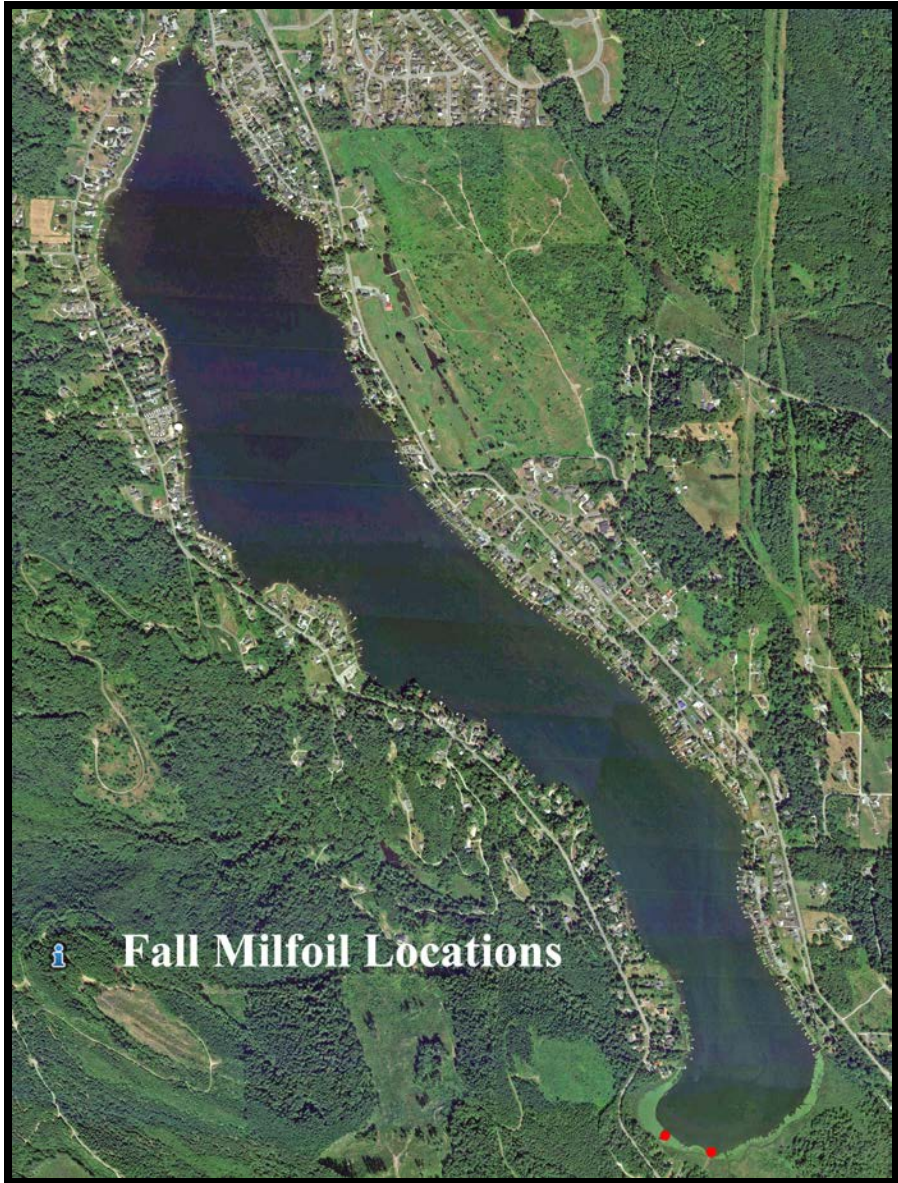
The poor water quality during the fall survey restricted our efforts at possibly identifying all of the remaining milfoil plants. Although we were able to inspect those areas that had documented milfoil prior to treatment the effort to locate new plants may have resulted in inaccurate results. Limited milfoil regrowth had occurred. This is not an unusual occurrence when contact herbicides are used, expansion of the plant was not noted. Plants were individual in nature and very sporadic.

4. Noxious species appear to no longer represent the problematic species lake-wide. The range and location of milfoil plants have stabilized and not much expansion has been detected. All of the milfoil is localized within two small areas of the lake and is now classified as subdominant. Plants currently coexist in mixed stands of native species. Milfoil can now seasonally be controlled with either contact herbicides or specifically targeted with systemic materials. How these plants are controlled and what materials should be applied requires evaluation preceding the spring survey.

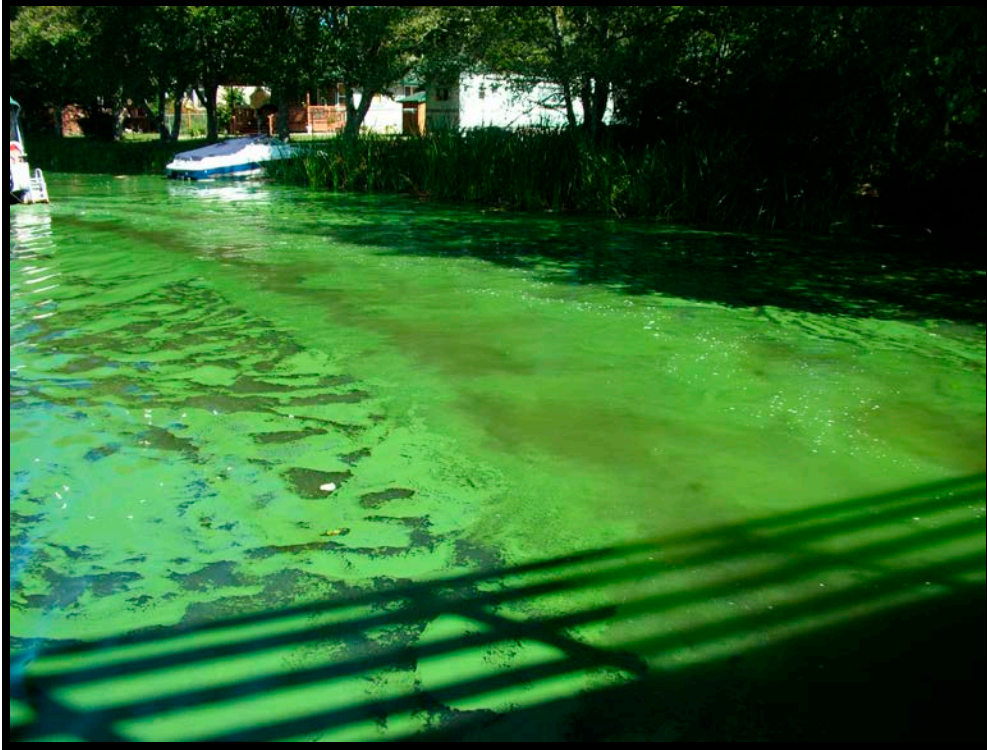
Typical severe algae bloom, Ocean Shores WA.
