# **2017 Big Lake Aquatic Weed Control Program**

Prepared for

Big Lake LMD #1  
Skagit County Public Works  
Mount Vernon, Washington

Prepared by

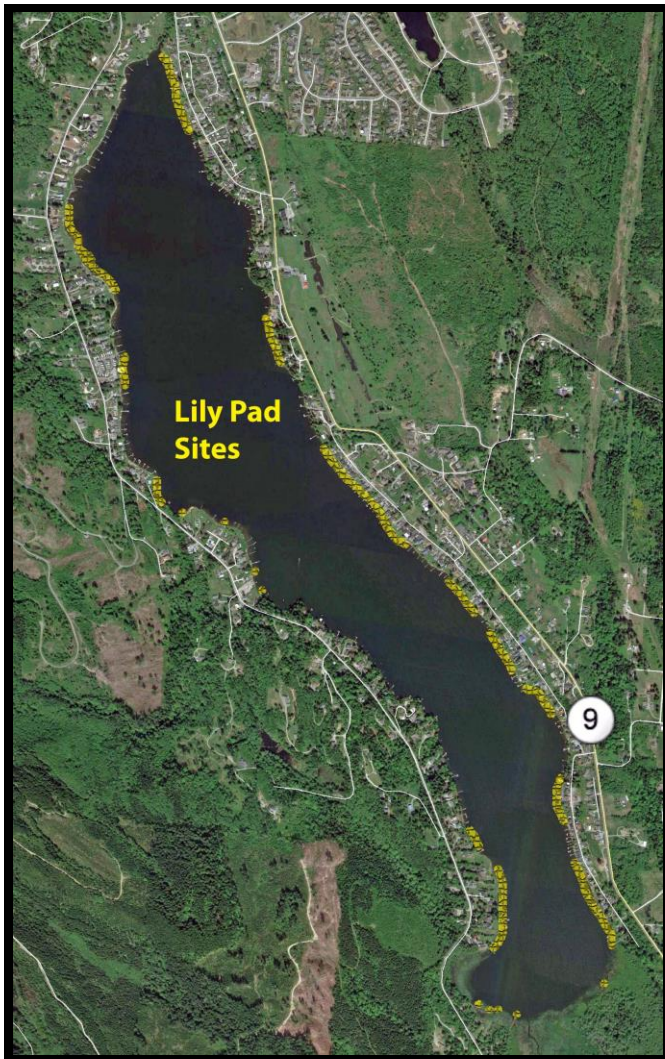
As the boat targeting the submersed weeds treated the designated sites, a second boat was then utilized to apply herbicide to the lily pad infestations. Weather conditions posed no problems throughout the day and permitted the entire basin to receive treatment for both lily pads and submersed weeds. For lily pad control an 18 foot aluminum boat equipped with one 25 gallon spray tank was utilized during this spray event. Use of this smaller maneuverable boat permitted access to the entire lake shoreline. The 25 gallon tank was filled with lake water, herbicide and surfactant. Once mixed, the application boat drove along the shoreline identifying targeted floating plants. The spray mixture was then discharged using a spray gun. When emptied, the tank was refilled and the process was repeated until the entire lake shoreline was covered. Lily pads received a 1.0% solution of glyphosate sprayed directly onto the floating leaves. Similar areas treated during 2014, 2015 & 2016 received treatment again during 2017. Plant densities were reduced considerably with many of the original patches now supporting only a few floating leaves.
