2018 Big Lake Aquatic Weed Control Program

Big Lake LMD #1
Skagit County Public Works
Mount Vernon, Washington

Northwest Aquatic Eco-Systems, Inc.
855 Trospen Road SW #108-313
Tumwater, Washington 98512
Pondweeds@comcast.net
Telephone: (360) 357-3285

December 2018

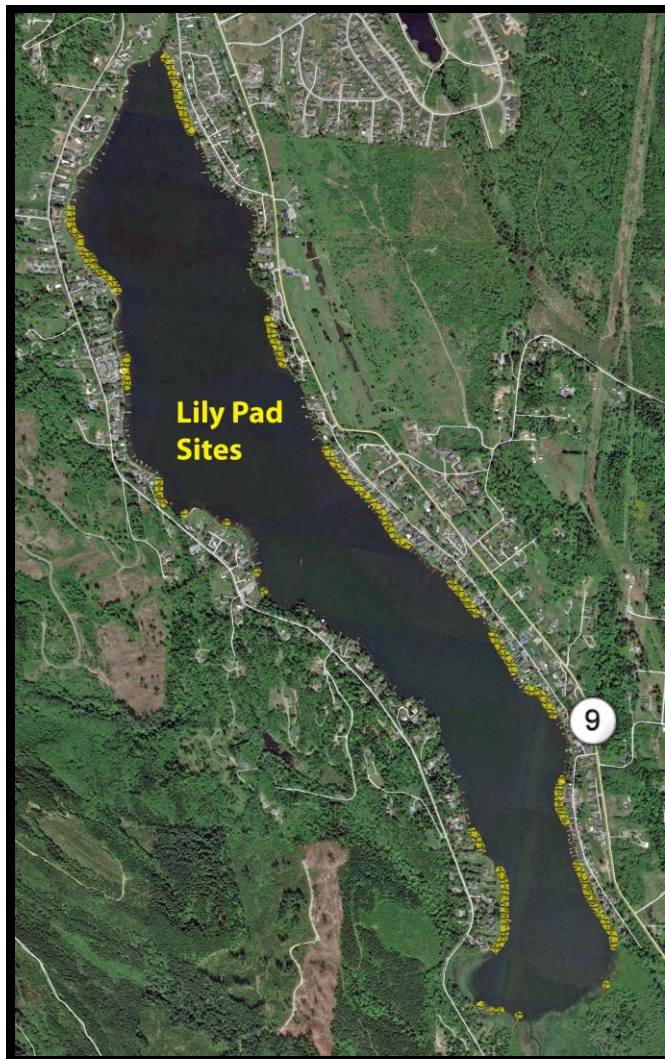
As the boat targeting the submersed weeds treated the designated sites, a second boat was then utilized to apply herbicide to the lily pad infestations. Weather conditions posed no problems throughout the day and permitted the entire basin to receive treatment for both lily pads and submersed weeds. For lily pad control, an 18 foot aluminum boat equipped with one 25 gallon spray tank was utilized during this spray event. Use of this smaller maneuverable boat permitted access to the entire lake shoreline. The 25 gallon tank was filled with lake water, herbicide and surfactant. Once mixed, the application boat drove along the shoreline identifying targeted floating plants. The spray mixture was then discharged using a spray gun. When emptied, the tank was refilled and the process was repeated until the entire lake shoreline was covered. Lily pads received a 1.0% solution of glyphosate sprayed directly onto the floating leaves. Similar areas treated during 2016 & 2017 received treatment again during 2018. Plant densities in most of the prior treatment sites have now been eliminated or reduced to considerably smaller patches consisting of only a few floating leaves. Three residents historically have requested no treatment. These same sites continued to receive no treatment.

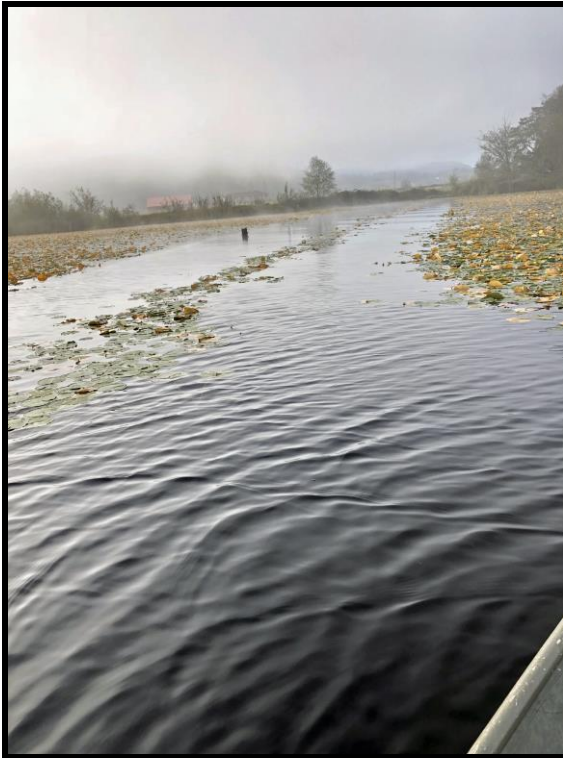
During the 2018 season a new property owner located in the southeast portion of the lake contacted NWAEC to have their parcel included in the lily pad control program. This parcel was sprayed twice during the 2018 season. Our approach was to provide to lanes of open water and expand outward in future years.

Completed Two
Spray Events

New Site Location
