# **2019 Big Lake Aquatic Weed Control Program**

Big Lake LMD #1  
Skagit County Public Works  
Mount Vernon, Washington

Northwest Aquatic Eco-Systems, Inc.  
855 Trospen Road SW #108-313  
Tumwater, Washington 98512  
Pondweeds@comcast.net  
Telephone: (360) 357-3285

January 2020

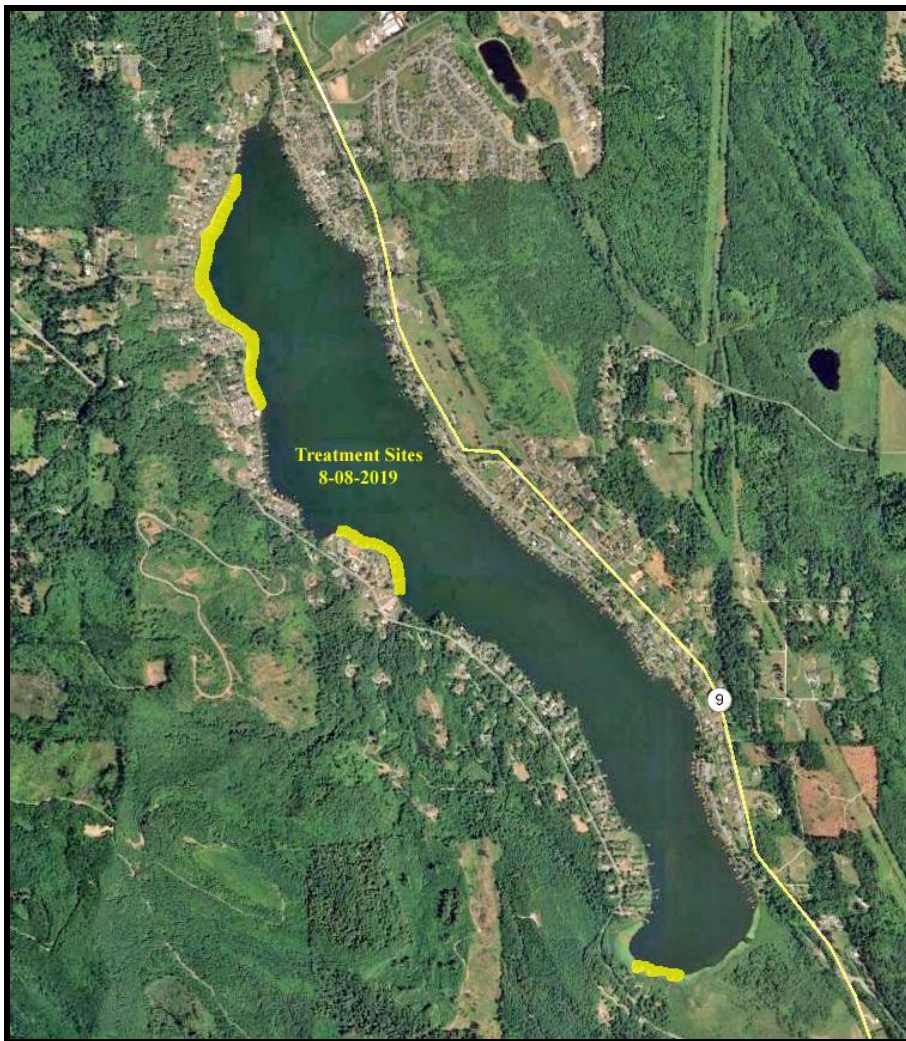
## August 09, 2019 Treatment

Approximately 30 acres of the northwestern shoreline of the lake was treated to control pondweed growth that had surfaced as a result of regrowth and lower than expected water level. Low water levels were common throughout Washington State during 2019 creating problematic shoreline recreational access issues, boat launching problems and exposure of stumps that historically posed no problems. At the close of the summer some Washington State lakes were at their historically lowest levels. Some had dried up while others lost up to 5 feet in depth. Posting of the shoreline was completed prior to treatment on the day of application.

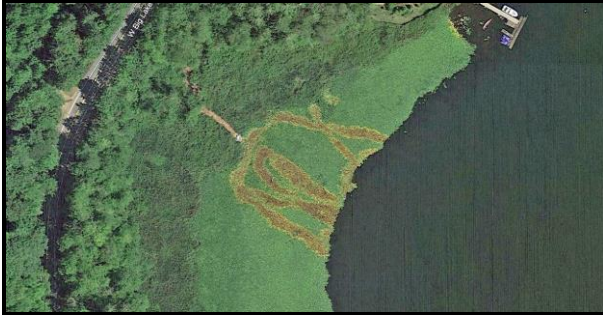
Note: Yellow brown areas are sites responding to an application

Glyphosate was not utilized on Big Lake during 2019. Because of the controversy surrounding glyphosate, imazapyr was substituted for lily pad control. Herbicide was mixed into a 25 gallon tank and then sprayed directly onto the pads utilizing a 1% solution of herbicide and water. Windy conditions during site visits resulted in our inability to treat all the lake-wide pads during any one visit. What resulted was that spraying occurred until conditions prohibited further application.

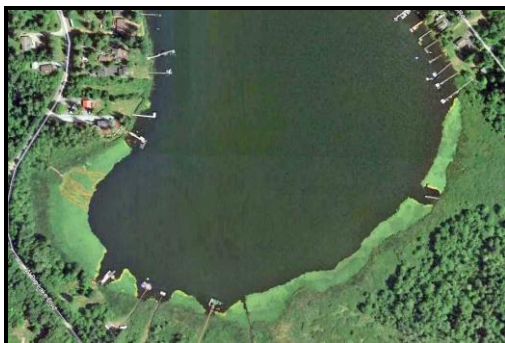
Wetland Conservancy zone

One *Egeria densa* and three purple loosestrife locations were identified by the Washington State Department of Ecology to be present within Big Lake. The *Egeria densa* location was identified to be in the extreme southern portion of the lake a wetland conservation zone.

The area is designated as a lake area that typically receives no native plant control except for three or four private docks. Noxious floating plants and submersed nonnative species are targeted when identified. Since our presence on the lake in 2011, no *Egeria densa* had been recognized to be present. This particular area of the lake is heavily infested with
