# AQUATIC VEGETATION SURVEY AT CLEAR AND BEAVER LAKES, SEPTEMBER 2005

PREPARED FOR  
Skagit County, Washington

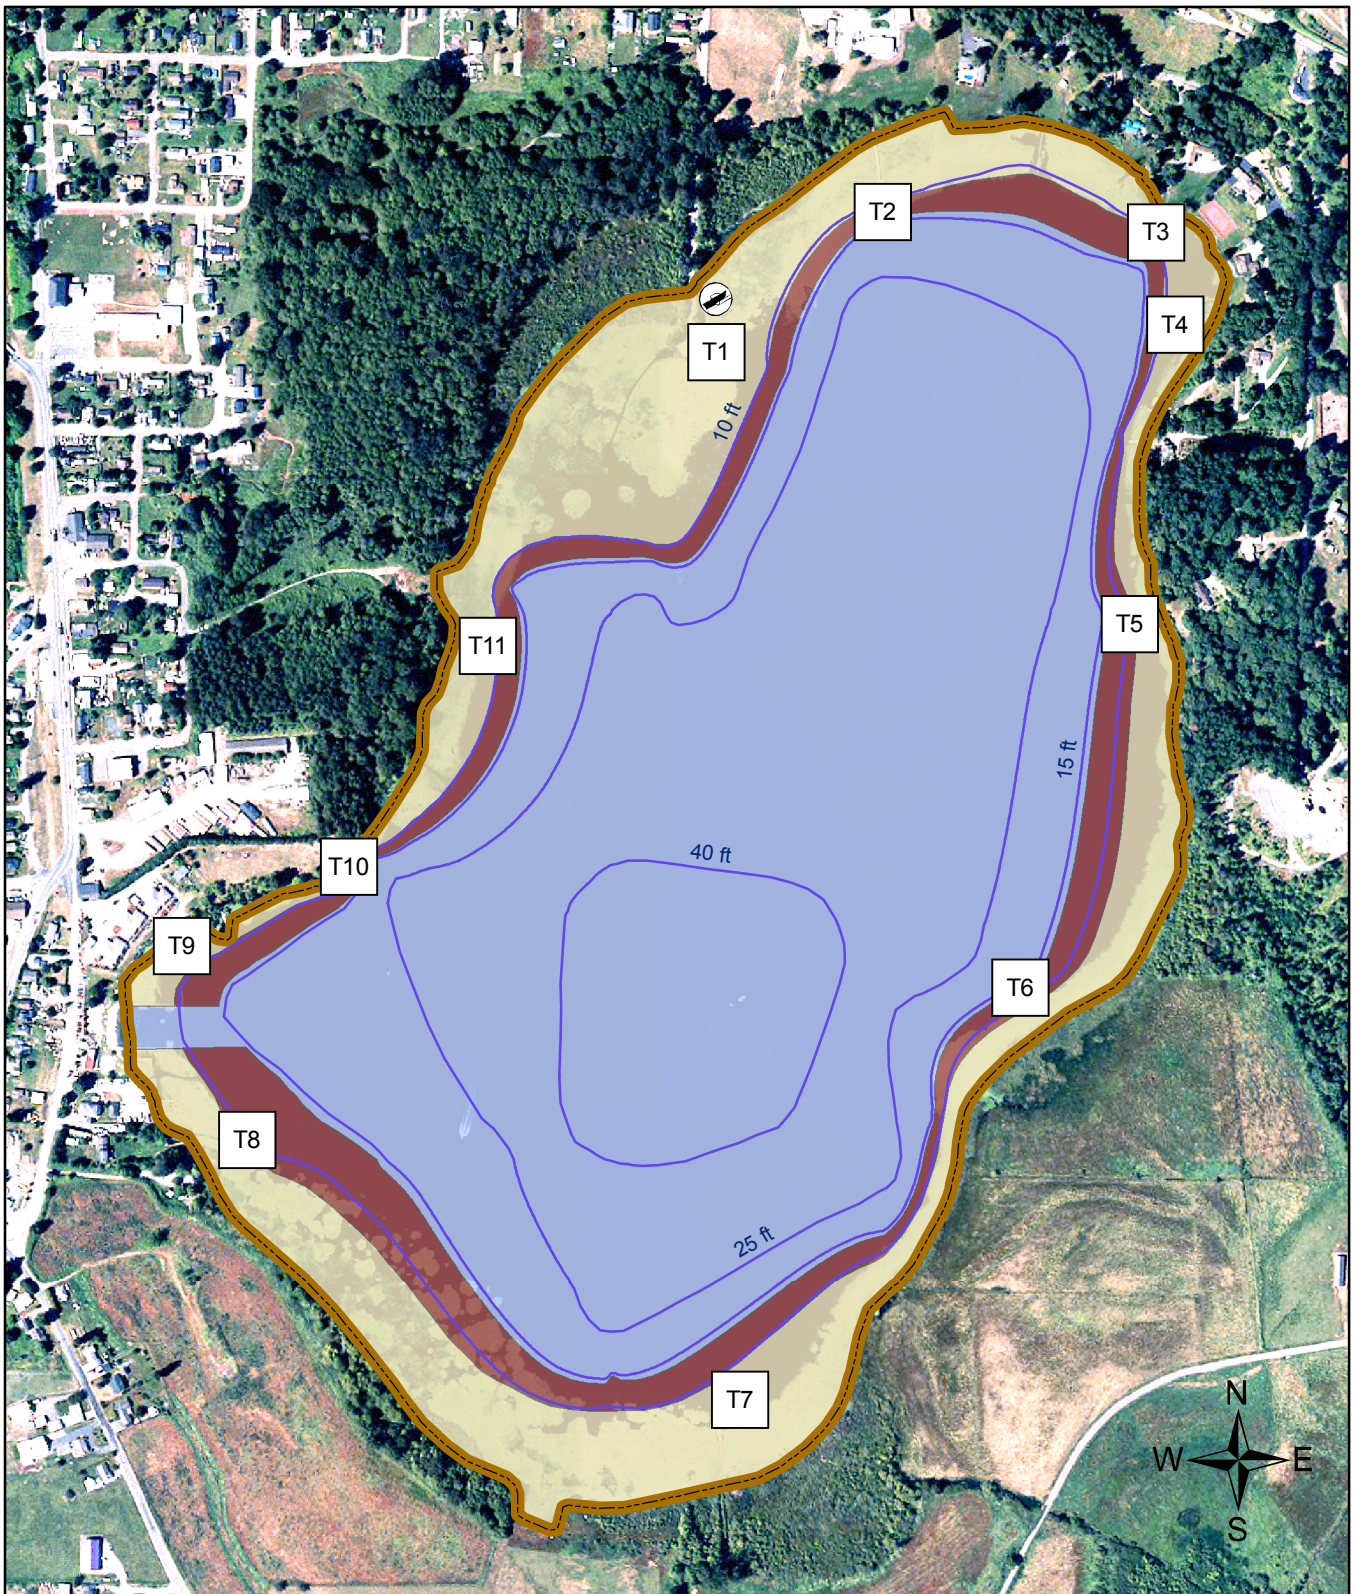
**Figure 1**

Two basic plant communities were observed at Clear Lake (Figure 1) and are defined to be the fragrant waterlily (*Nymphaea odorata*) dominated community and the Eurasian watermilfoil (*Myriophyllum spicatum*) dominated community. The fragrant waterlily dominated community extended from the shoreline to a water depth of 8-10 feet, while the Eurasian watermilfoil dominated community extended from the edge of the lilies to a depth of approximately 14 feet.

The fragrant waterlily dominated community was estimated to be approximately 53 acres in size which represents 27% of the open water area in Clear Lake. The lilies exist as a solid band along the shoreline, extending as much as three hundred feet from shore to a depth of 8-10 feet. The only openings in the lily band were near the County maintained swimming area, in front of the sawdust burner (Transect 10), and in areas maintained by residents for access to the lake. The southern end of Clear Lake had the widest and densest band of lilies, which corresponds to the wide shallow shelf at this end of the lake. The mat of lilies on the western shoreline was patchier.

The Eurasian watermilfoil dominated community began at a water depth of 8-10 feet (the edge of the fragrant waterlilies) and ended at approximately 14 feet (the edge of the submersed aquatic plant zone). An estimate of the size of this zone based on GIS calculations indicates that approximately 23 acres (or 11% of Clear Lake) is Eurasian watermilfoil dominated.

Eurasian watermilfoil was clearly visible throughout the lake in this zone. At the south end, a very large surface mat of milfoil stretched out from the lilies. Areas with lower milfoil densities included just outside the vicinity of the County maintained swimming area, and in front of the sawdust burner (Transect 10).

At Clear Lake, approximately 53 acres of fragrant waterlily should be considered for treatment along with approximately 76 acres of Eurasian watermilfoil. At Beaver Lake, since the entire lake contains Eurasian watermilfoil, the entire lake (75 acres) would need to be considered for treatment. The pioneering infestation of Brazilian elodea at Beaver Lake may also be of immediate concern, depending on the goals of the County and area residents. The existing population is small enough to be hand-pulled. However, if the Brazilian elodea is allowed to invade further, it may make future treatment options more complex.

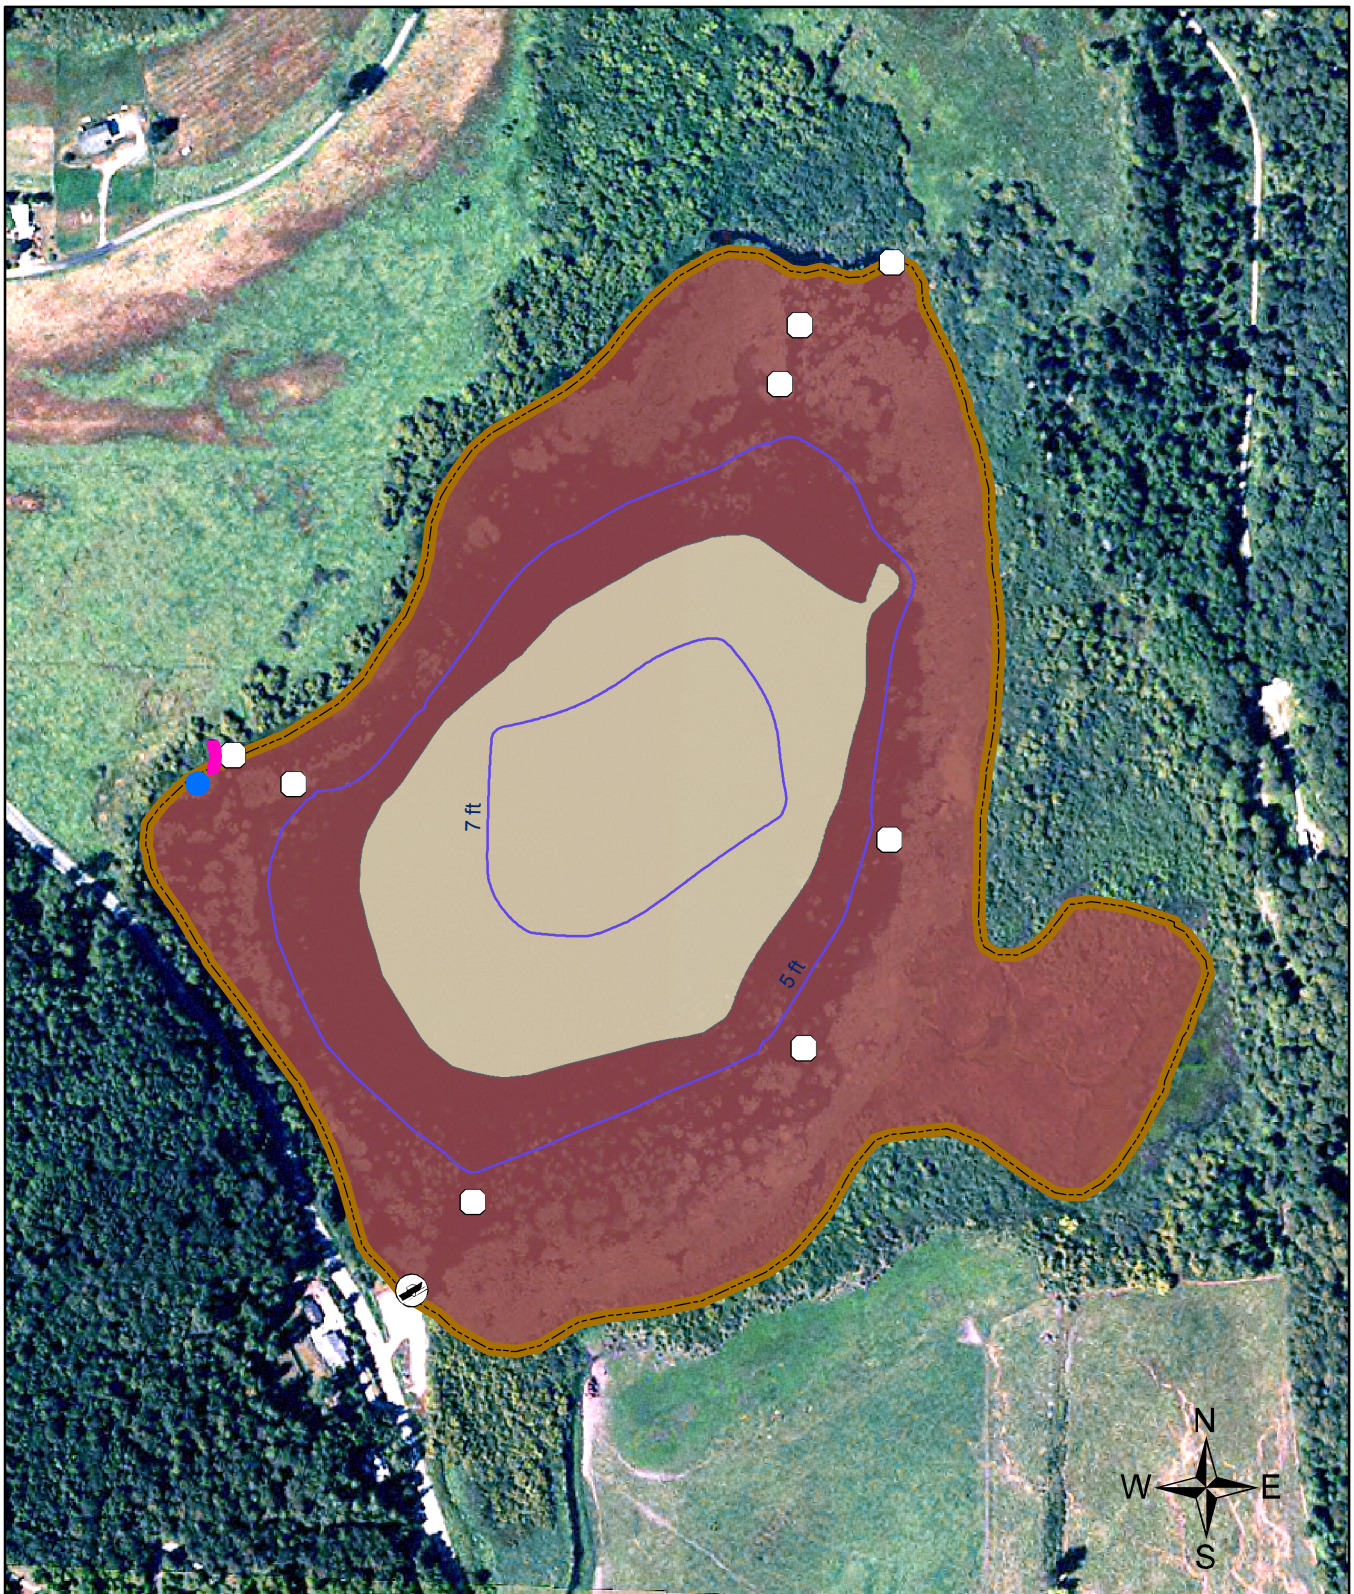
**Figure 2**  
**Beaver Lake, Skagit County**  
**Aquatic Plant Survey**  
 Survey Date: September 8, 2005  
 ENVIROVISION CORP.  
 0 150 300 600 900  
 Feet  
 DAIS 2001 Imagery from Skagit County  
 Cartography by Sound GIS

Two basic plant communities were observed at Beaver Lake; both were dominated by submersed plants. They were (Figure 2) defined as the Eurasian watermilfoil (*Myriophyllum spicatum*) dominated community and the coontail (*Ceratophyllum demersum*) dominated community. The Eurasian watermilfoil dominated community extended from the shoreline to a depth of approximately 6 feet. From a depth of 6 feet to the center of the lake, coontail became the dominant species.

The Eurasian watermilfoil dominated community (Figure 2) was estimated, to be 52 acres in size and represented 70% of the open water area of Beaver Lake. Eurasian watermilfoil grew throughout this zone in thick mats. Floating-leaved plants (primarily native yellow pond-lily (*Nuphar polysepala*)) were patchier in this lake, which apparently allowed more room for milfoil. Although fragrant waterlily was also observed, it was in scattered patches. The largest patch of fragrant waterlilies was on the eastern side of the lake and was approximately 0.023 acres in size.

The coontail (*Ceratophyllum demersum*) dominated community extended from a depth of 6 feet throughout the rest of Beaver Lake. The size of this zone was estimated to be 21 acres and represents 28% of the open water area of Beaver Lake. This community also contained scattered groupings of Eurasian watermilfoil (*Myriophyllum spicatum*). There were few other native plants observed and those present were primarily found at shallower depths within this zone.

Of particular note at Beaver Lake was the discovery of a pioneering infestation of blooming Brazilian elodea (*Egeria densa*), a state listed noxious weed. A patch, estimated to be 0.03 acres in size was discovered in a cove on the west-side of the lake (Figure 2). Brazilian elodea had not been previously observed at the lake.

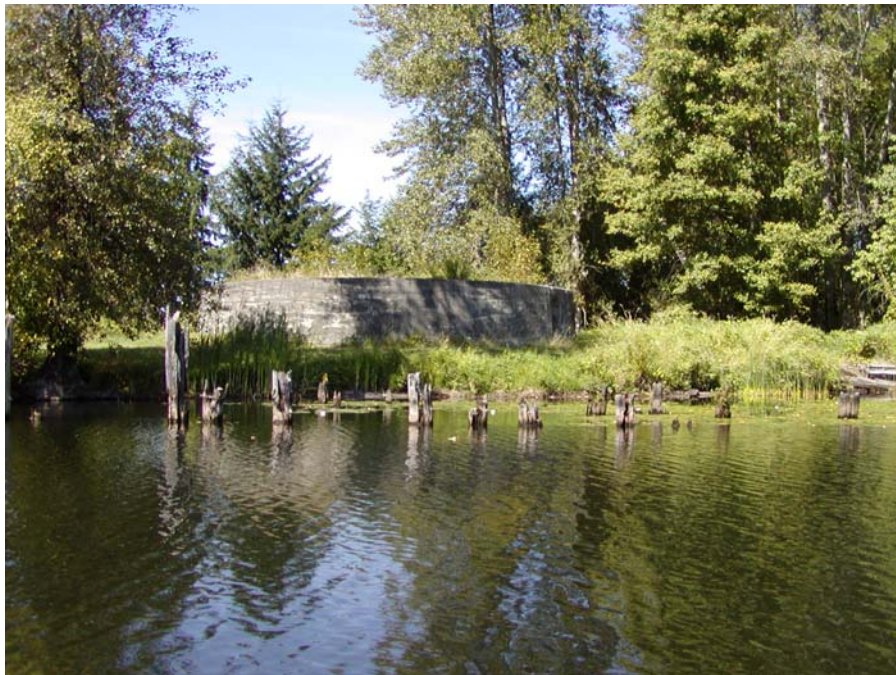
**Transect 10**

The plant community at Transect 10 differed from other areas. At this location, from a water depth of 0-14 feet, fragrant waterlilies were dominant with a few elodea and Eurasian watermilfoil plants scattered throughout. At 14 feet depth, elodea was the dominant species. The diver noted that the lake bottom at this location appeared to be man-made fill that was of a heavy, gravel cobble which could have restricted the growth of other submersed aquatic plants.

Although, the fish and wildlife community were not part of this survey, freshwater mussels were observed on a piling along the western shoreline. This piling was in the vicinity of Transect 10.
