2017 Beaver Lake Aquatic Weed Control Program

**Beaver Lake LMD #4
Skagit County Public Works
Mount Vernon, Washington**

Northwest Aquatic Eco-Systems, Inc.
855 Trospen Road SW #108-313
Tumwater, Washington 98512
Pondweeds@comcast.net
Telephone: (360) 357-3285

January 2, 2018

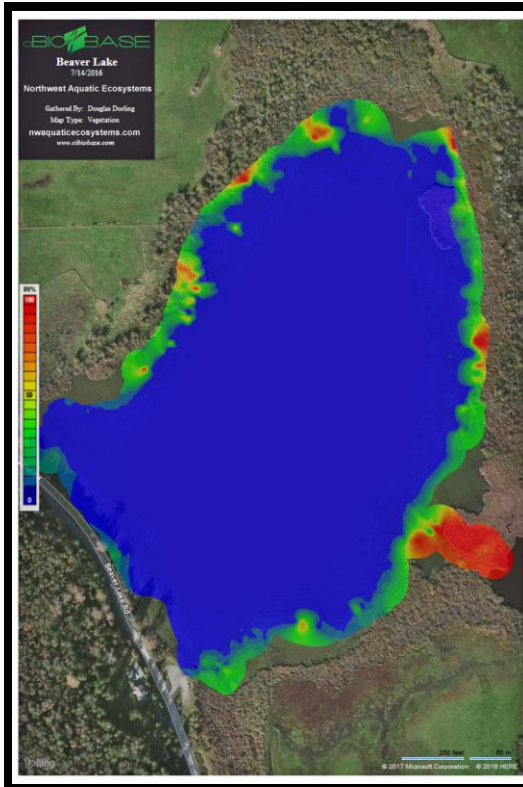
Spring 2016

Beaver Lake was surveyed on June 11, 2017. Macrophyte growth had increased from the 2016 survey. This was an encouraging sign since the survey was performed approximately one month earlier than 2016. The increased weed growth resulted in the inability of the survey boat to transverse the entire lake area as boat access was denied at several locations. Milfoil growth was sparse probably as a result of last season’s treatment. Fragrant water lily infestations were similar to those noted in the past with infestations identified within areas that had been historically treated. Native pondweeds dominated the survey throughout the littoral zone with both elodea, najas and ceratophyllum species exhibiting dominance in isolated locations within the northeastern section of the lake.

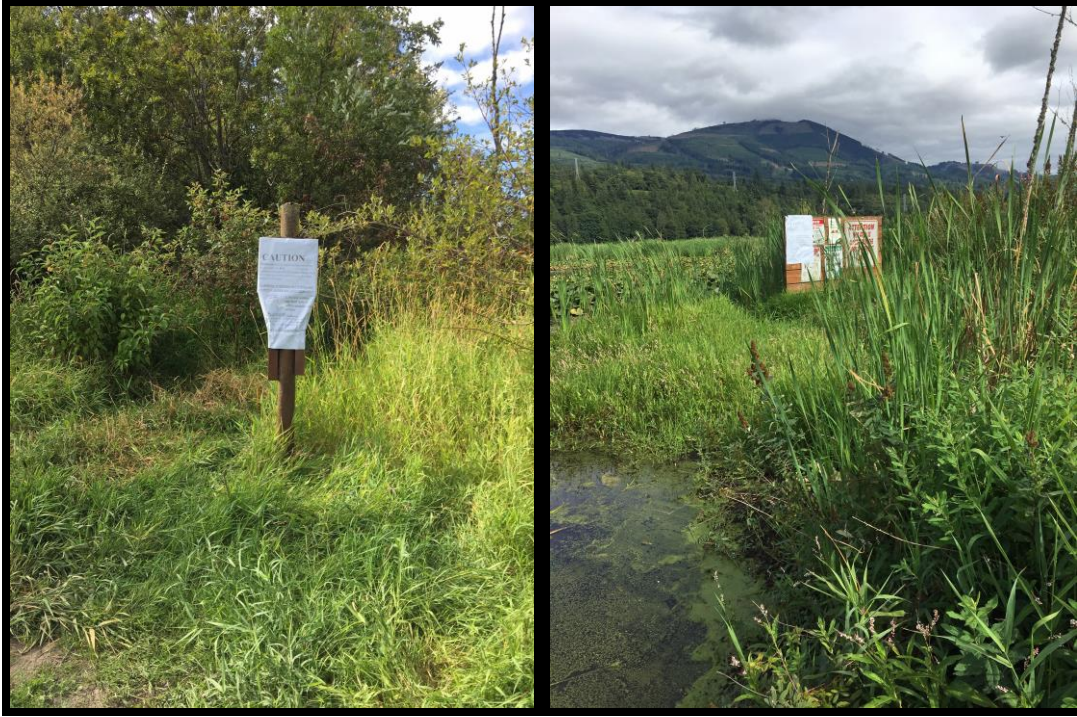
Shoreline posting was conducted on the day of treatment. Posting consisted of two large signs secured at the boat launch. These signs were removed and NWAE returned to the site later in the day and replaced the signs that were torn down. There are no residential homes on the immediate shoreline. Material was offloaded and transferred into a single 25 gallon spray tank mounted on the application boat. Containers were triple rinsed on site and returned empty back into the truck.

Signage posted at Public Access

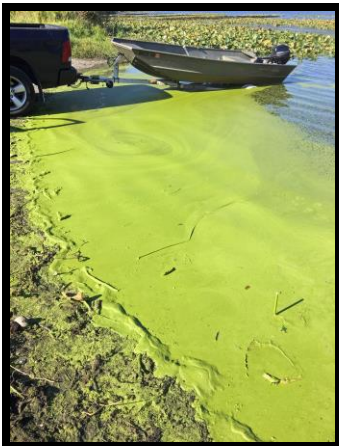
The fall survey was performed on September 26, 2017. Weed growth as noted in prior years once again experienced a considerable reduction in plant densities throughout the lake. At the time of the survey a severe algae bloom was in progress. NWAE is unsure as to when the bloom initiated or how long the bloom had been in progress prior to the survey. The reduced water clarity may have resulted in plant decline lake wide. No milfoil plants were noted. However, this task was difficult to complete because of the poor water clarity and access associated problems.

This reduction in native plant growth is unusual since the materials used to control milfoil is specific to the milfoil species only and has no impact to native plants. One can only conclude that this reduction is associated with some type of environmental condition that occurs regularly at Beaver Lake. Likely causes could be associated with poor water quality or a fungus/virus that is attacking the plant community.

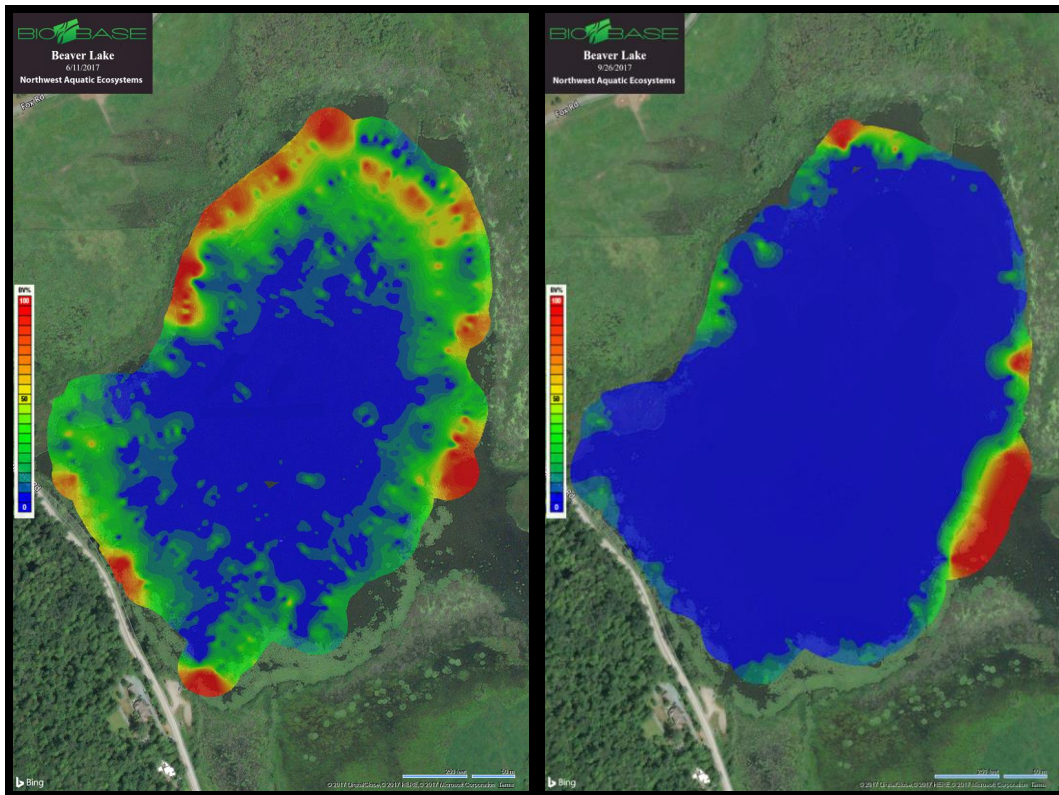
Spring 2017

Fall 2017
