2017 Clear Lake Aquatic Weed Control Program

Clear Lake LMD #4
Skagit County Public Works
Mount Vernon, Washington

Northwest Aquatic Eco-Systems, Inc.
855 Trospen Road SW #108-313
Tumwater, Washington 98512
Pondweeds@comcast.net
Telephone: (360) 357-3285

December, 2017

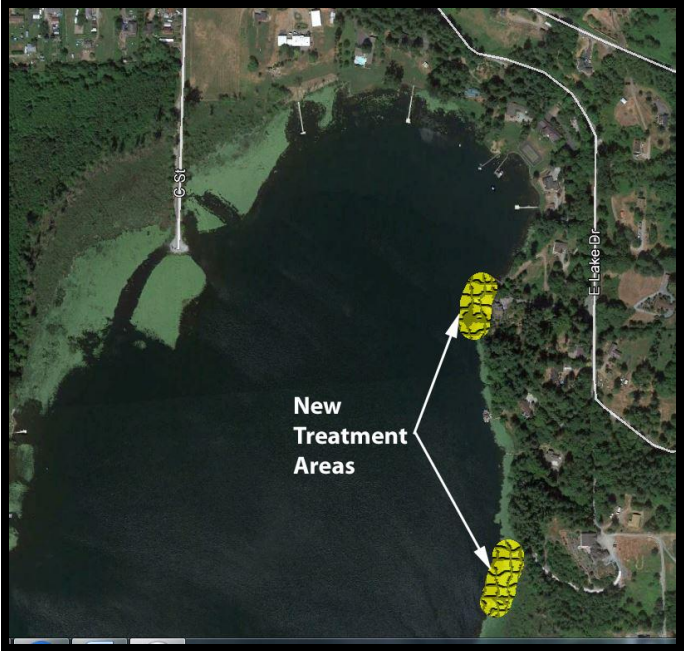
Our approach during 2017 was similar to past treatments. Provide lake property owners with an acceptable degree of native plant control while continuing the project goals of attacking milfoil infestations when identified. *In the past, much of the eastern residential portion of the lake shoreline was left untreated at the request of a family member. This family member represented himself as having jurisdiction over all of the parcels within this specific shoreline area and that no treatment was to occur. During 2017 we were notified by one of the family members that the person we had been talking with was not authorized to speak on behalf of the other family members and in fact didn't own any of the parcels in question. These parcels were treated during 2017.*

Under current NPDES guidelines, native macrophyte control is limited to no more than 50% of the shoreline or approximately 6,300 feet. The permit also mandates that “the geographic area where the Permittee intentionally applies chemicals must remain the same for the entire length of the permit coverage up to the maximum percentage of the littoral zone allowed by the water body”. In essence, once native plant treatment sites within Clear Lake reach the 50% threshold level, no further expansion of the treatment areas are permitted. The new cycle period for the next permit began during 2016. With the establishment of the new permit cycle, changes in the treatment areas can be evaluated and altered, if necessary, to conform to the fluctuating environmental conditions lake wide.

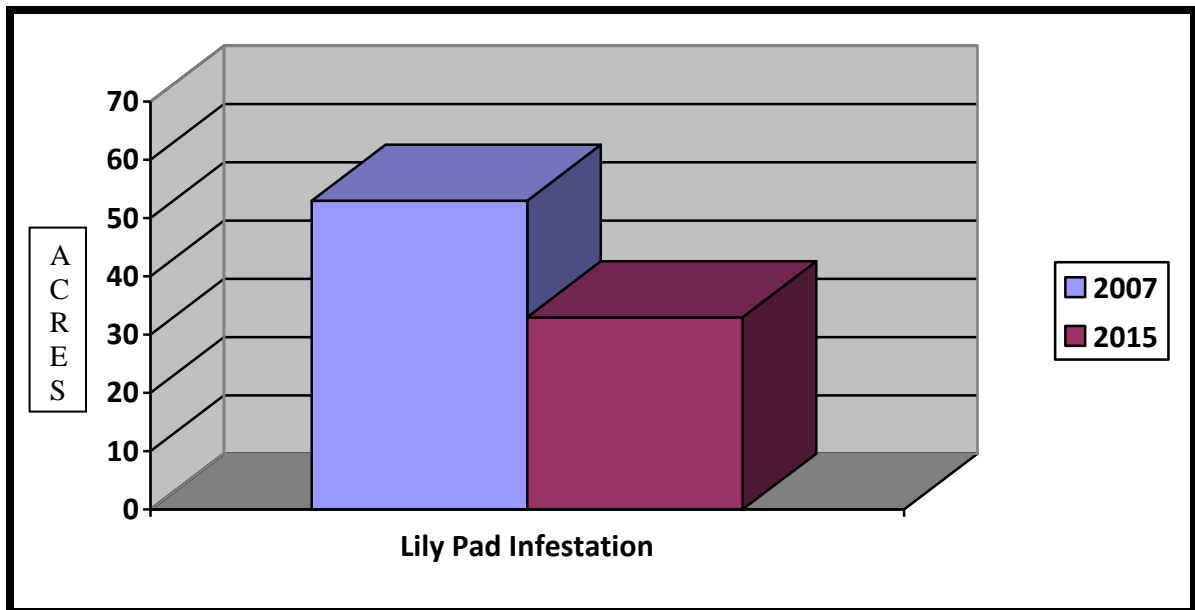
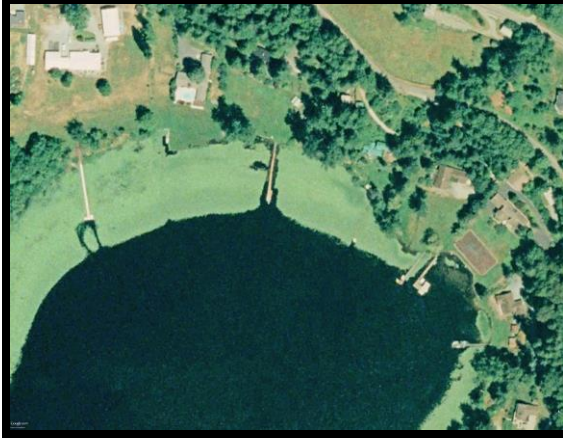
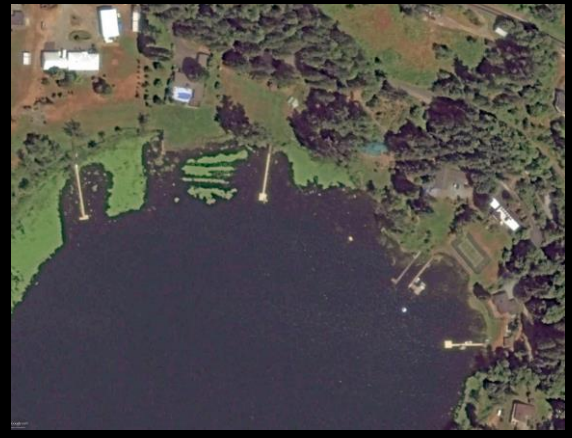
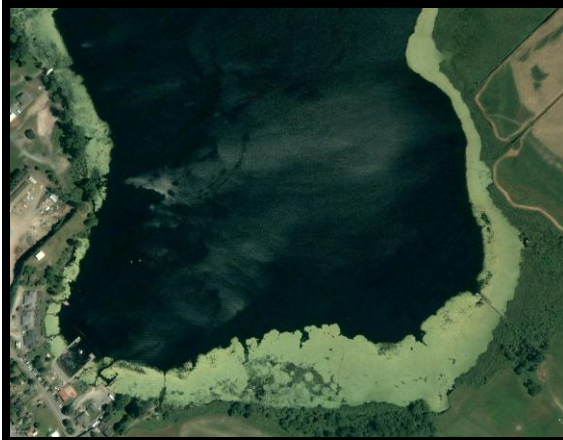
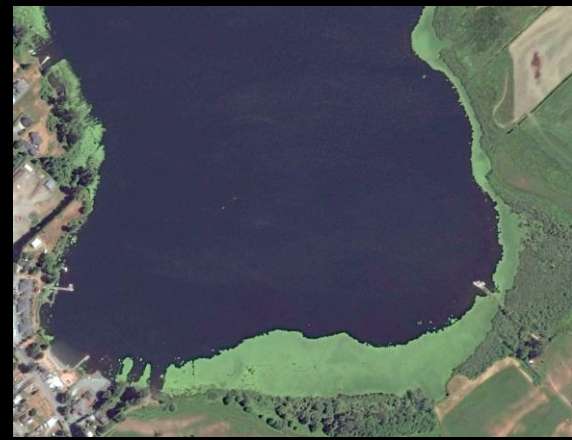
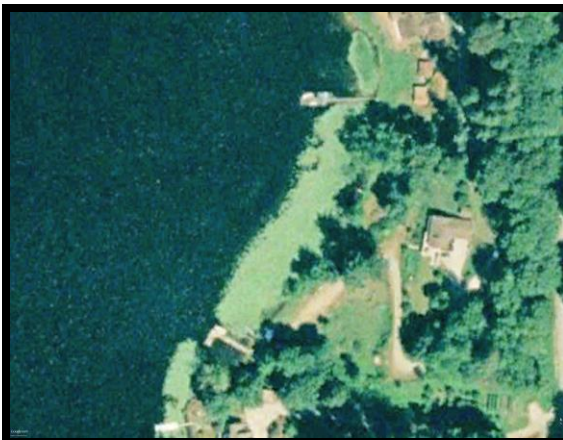
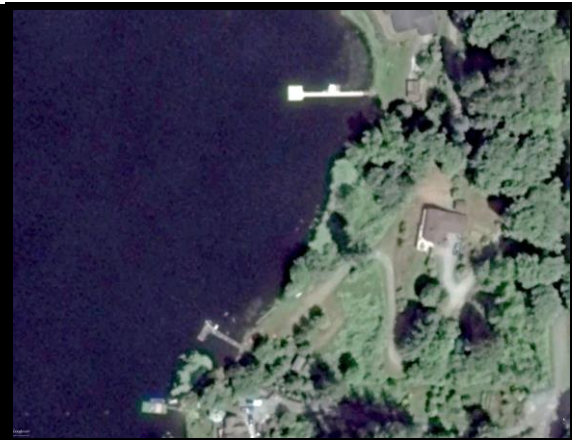
In an effort to document the progress of the control activities, a June 2015 satellite image of the lake was digitized and evaluated to obtain the current acreage of the fragrant lily pad population lake wide. The resulting effort resulted in a determination that the current infestation consists of approximately 33 acres.

The Clear Lake LMD started treatments during 2007. At the time of the LMD formation approximately 53 acres (personal communication LMD) of the lake was infested with the fragrant water lily, a Washington State noxious species. Since inception, the LMD has been actively targeting this species on a yearly basis by applying state registered herbicides according to the manufacturers recommendation and label specifications.
