2018 Clear Lake Aquatic Weed Control Program

Clear Lake LMD #4
Skagit County Public Works
Mount Vernon, Washington

Northwest Aquatic Eco-Systems, Inc.
855 Troster Road SW #108-313
Tumwater, Washington 98512
Pondweeds@comcast.net
Telephone: (360) 357-3285

December, 2018

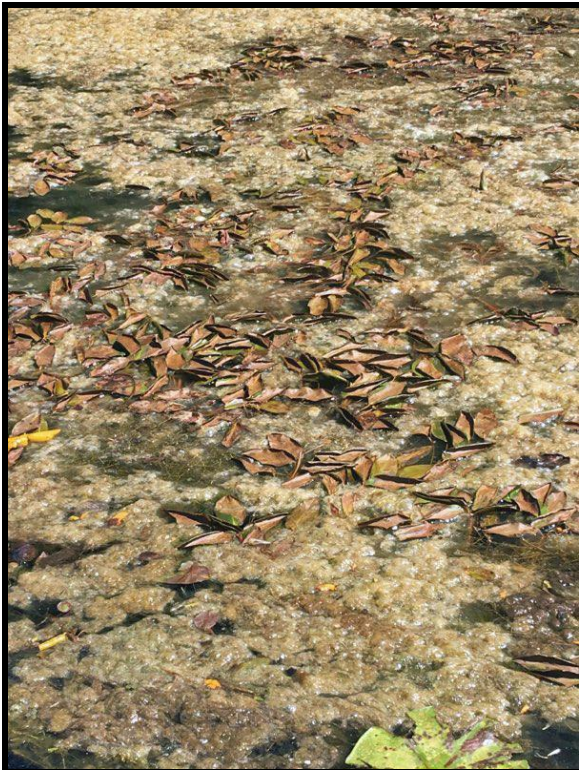
At the time of the initial treatment, large sections of the lake were experiencing thick dense floating filamentous algae growth in lake areas where floating pondweeds and lily pads appeared to have been sprayed. It is nearly impossible to determine what material was used that resulted in the “burning” of the floating pads and plant leaves. One can confidently conclude that the material was sprayed at too high of a concentration on a hot sunny day resulting in only the burning of the plants’ surface leaves. Pondweed subsurface leaves were still healthy and actively growing while floating pads, although damaged, still contained healthy green pad areas. None of the pads appeared to be severely sick but exhibited the typical response associated with spraying from the outer edges - not being able to extend into the middle of the infestation and spraying with the nozzle adjusted at a straight stream pattern instead of a more dispersed fan configuration.

It is unlikely that these attempts to control the plants would have been successful; simply because the wrong material was used at an elevated concentration resulting in only the burning of the surface leaves while leaving limited, if any, impact on the submersed leaves. What the spraying did accomplish was to provide surface decaying vegetation that offered a nutrient source for algae growth that remained attached to the healthy stems and leaf components below the water’s surface. These problematic algae mats likely would

1. Brown curled floating leaves.
2. Attached filamentous algae growth.

Clear Lake was inspected on August 19, 2018. All of the sites treated earlier in the year were responding to the treatment. All of the floating filamentous algae issues had been resolved.

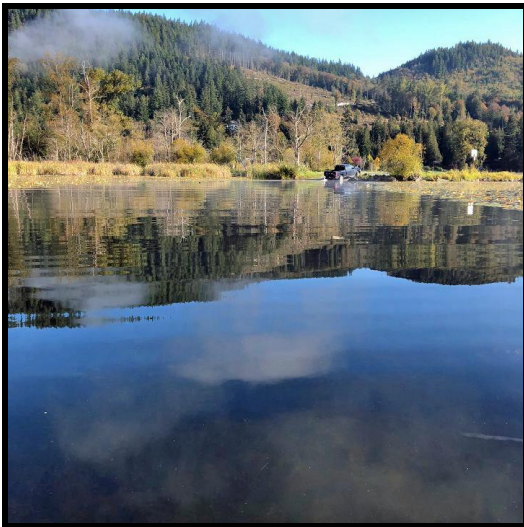
**South Side Boat
Access Lane**

Lily pad control continues on a yearly basis. Since the onset of initiating lily pad control in 2007, large areas of the lake have been opened up for boat traffic. In particular, the boat launch area once provided for only a single lane of access. Now the site supports easy access from both sides of the launch site.

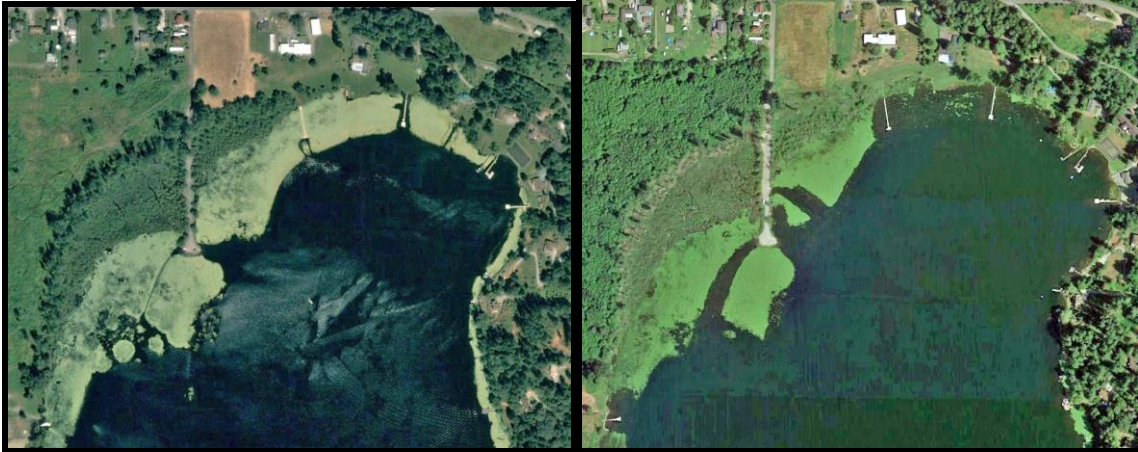
2007

2017
