# Lake McMurray

## 2014 Aquatic Plant Control Program

Prepared By  
Northwest Aquatic Eco-Systems  
855 Trosper Road SW #108-313  
Tumwater, WA 98512  
360-357-3285  
[Pondweeds@comcast.net](mailto:Pondweeds@comcast.net)  
[www.nwaquaticecosystems.com](http://www.nwaquaticecosystems.com)

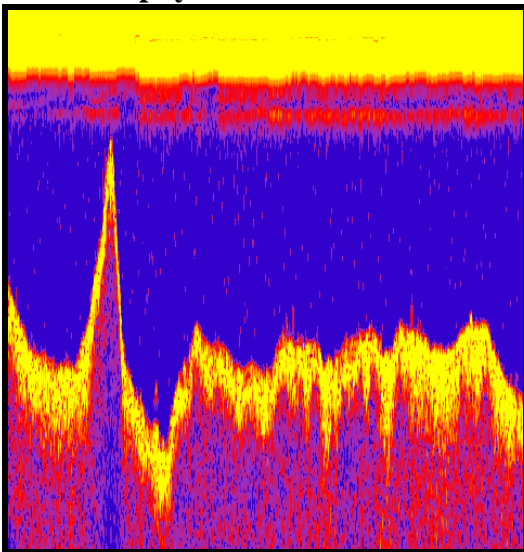
**No Macrophyte Growth**

2014 sonar data was collected similar to those noted during 2013. Electronic data was collected onto a chart recorder utilizing sonar and structure scan transducers. Milfoil, when identified, was recorded as a waypoint during the survey. Surveying was terminated once plants were no longer detected on the chart graph recorder's monitor.

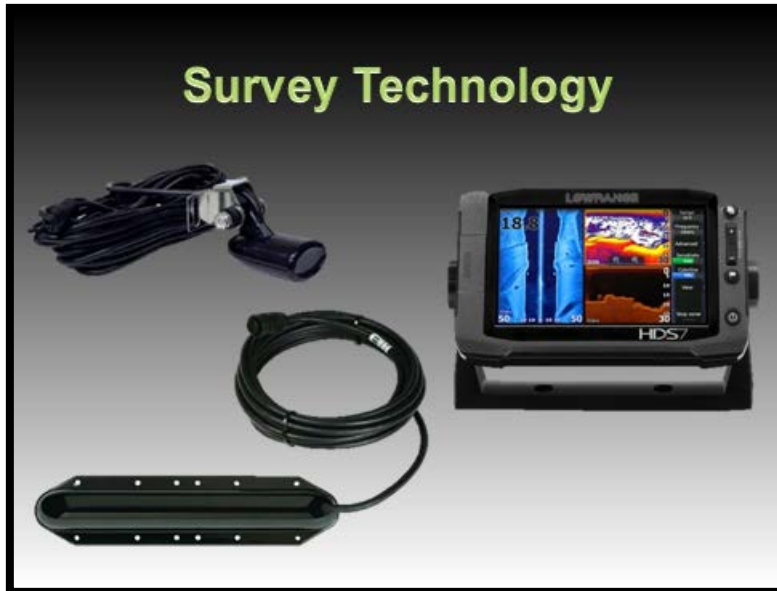
## Lake McMurray Spring Survey Results

Lake McMurray was surveyed on June 22, 2014. Water clarity was excellent with secchi disc readings exceeding 20 feet. Bottom sediments were visible throughout most of the lake's littoral zone. No milfoil plants were identified. Results of the spring 2014 survey resulted in no unexpected growth patterns and conformed with similar survey findings. Yellow flag iris plants were identified sporadically along the shoreline at approximately 50 locations. Most infestations were less than 15 square feet in area. Fragrant water lily plants were noted lake wide with the largest infestations occurring in the outlet portion of the lake and in the southeast corner just north of the public boat launch. Native plant communities posing potential interference to lake users were noted along various residential shoreline areas of the lake. Pondweeds and elodea species dominated the lake's macrophyte composition.

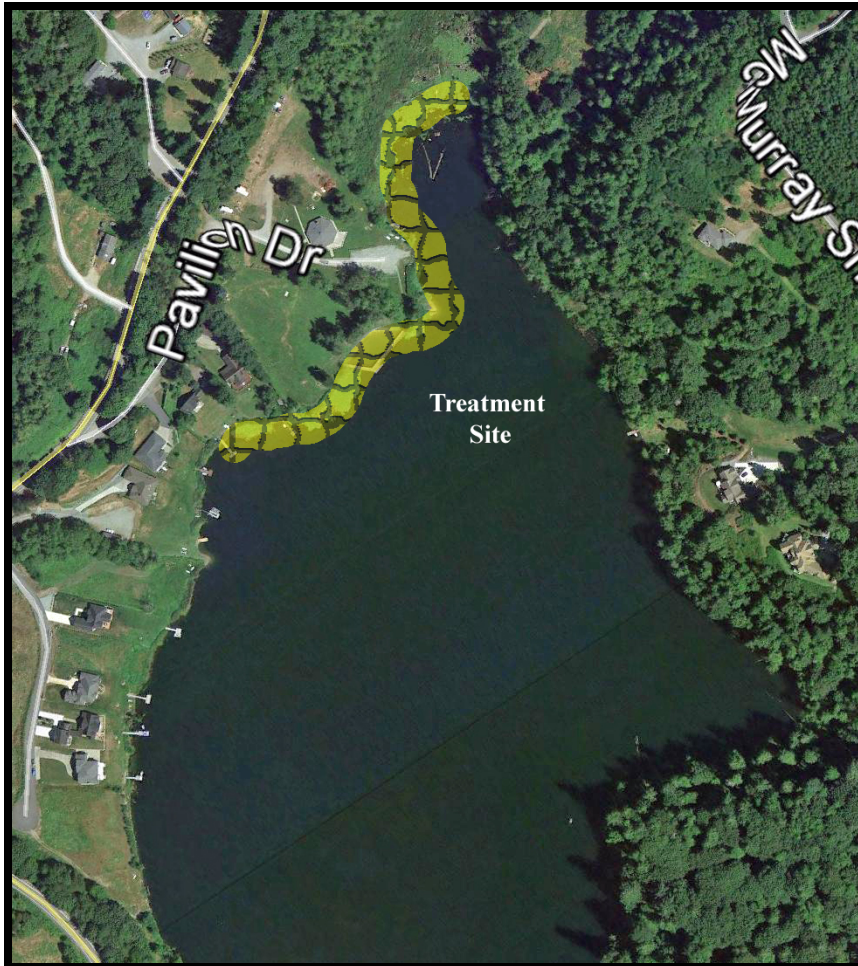
Yellow Flag Iris and Lily Pad Control Zone

Lake McMurray received treatment for lily pads, submersed weeds and yellow flag iris on August 11, 2014. Only infestations in excess of ½ mile of the McHaven potable water intake were targeted. The treatment was divided into two phases. The first phase consisted of a glyphosate application to both the iris and lily pads. At the completion of the initial phase the boat was refitted to accomplish the submersed weed control component of the project. An 18 foot aluminum boat equipped with one 25 gallon spray tank was utilized during this spray event. The 25 gallon tank was filled with lake water;

herbicide and surfactant were then added directly to the tank. Once mixed, the application boat drove along the shoreline identifying targeted emergent plants. The spray mixture was then discharged directly onto the targeted species' leaf structures using a spray gun. When emptied the tank was refilled and discharged as needed. Spray mixture consisted of a 1.5% solution of glyphosate.

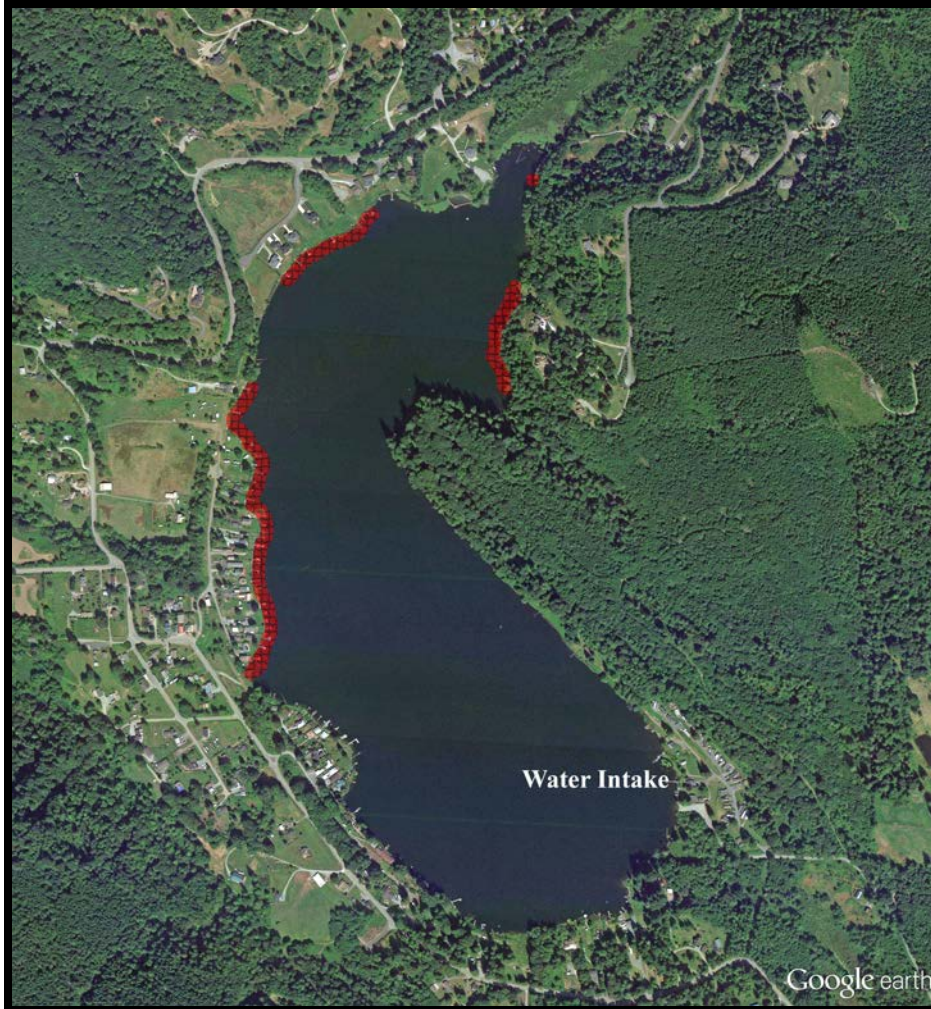
**Submersed Weed Control**

Once the glyphosate spraying was completed, the boat was refitted with a boom mounted injection system that was positioned to disperse herbicide just above the canopy of the weed beds. The 25 gallon tank was filled with a herbicide lake water mixture. Water was drawn from the lake and infused with the water herbicide tank mixture. The resulting mixture was then dispersed directly over the weed bed canopy. Herbicide mixture was applied at a rate of two gallons per surface acre.

At the time of the application no spraying occurred in or around the Friends of Norway facility located along the far northwest shoreline of the lake. This area was excluded from the treatment due to the presence of a large number of swimmers and boaters utilizing the site.

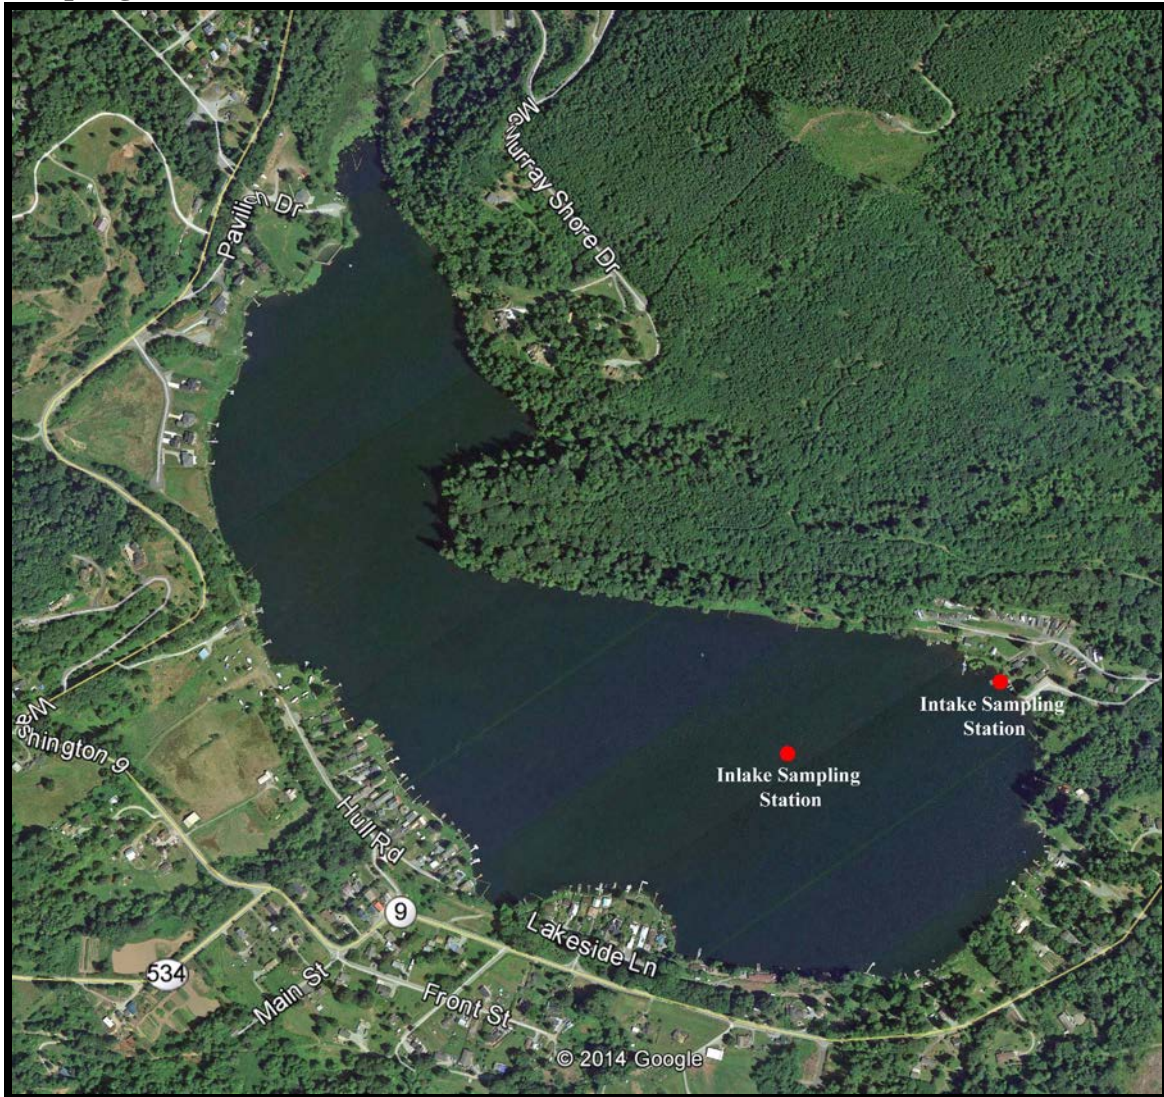
## Sampling Stations

Samples were collected on August 12, 2014 and August 16, 2014, stored in ice and delivered to Matrix Labs in Portland. Samples were analyzed for diquat dibromide and glyphosate. One sample was taken mid-basin adjacent to the McHaven development and the remaining sample was taken directly above the McHaven Inc. water intake. All samples were collected approximately three feet below the water surface.

Sample Station	Glyphosate Concentration	Diquat Concentration
Inlake Sampling Site 8-12	N/D	.00717 mg/L
Intake Sampling Site 8-12	N/D	.0146 mg/L
Inlake Sampling Site 8-16	N/D	.00305 mg/L
Intake sampling Site 8-16	N/D	.00579 mg/L

There was no glyphosate detected at any of the sampling stations. Low levels of diquat were noted at both the intake and potable intake sampling stations. The EPA guideline for diquat concentrations within active potable systems is .02 mg/L. Although the half mile buffer zone failed to keep any diquat from entering the potable intake, the concentrations were below the EPA drinking water guidelines.

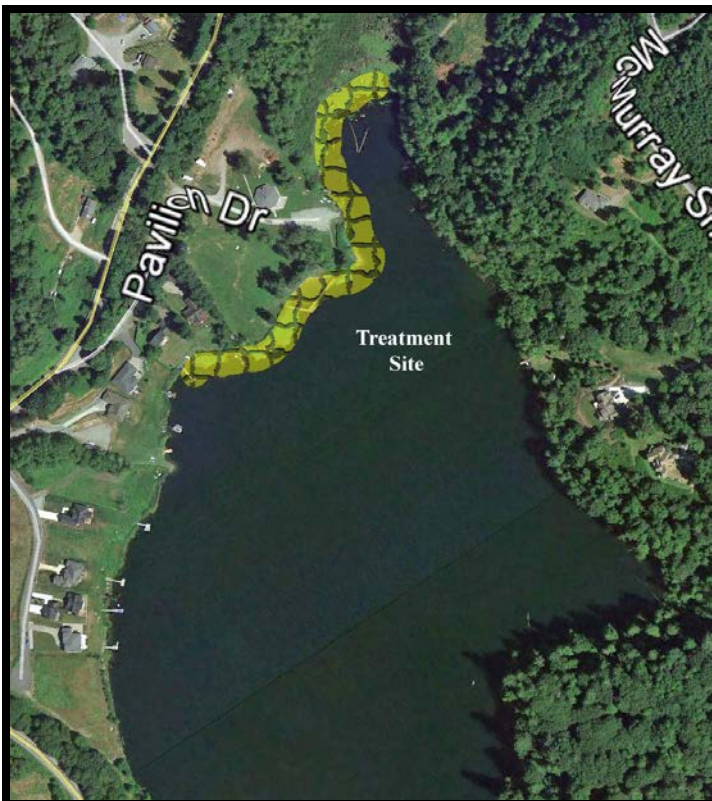
Lake McMurray was revisited on September 16, 2014 to conduct the fall survey. At the time of the survey the Friends of Norway site received a glyphosate application targeting lily pads and yellow flag iris. The procedures and application rates utilized earlier in the year were once again adopted. The entire lake was not posted during this event; only those areas of the lake that received treatment were posted in addition to properties within 400 feet of the treatment site.
