Lake McMurray

2016 Aquatic Plant Control Program

Prepared By
Northwest Aquatic Eco-Systems
855 Troser Road SW #108-313
Tumwater, WA 98512
360-357-3285
Pondweeds@comcast.net
www.nwaquaticecosystems.com

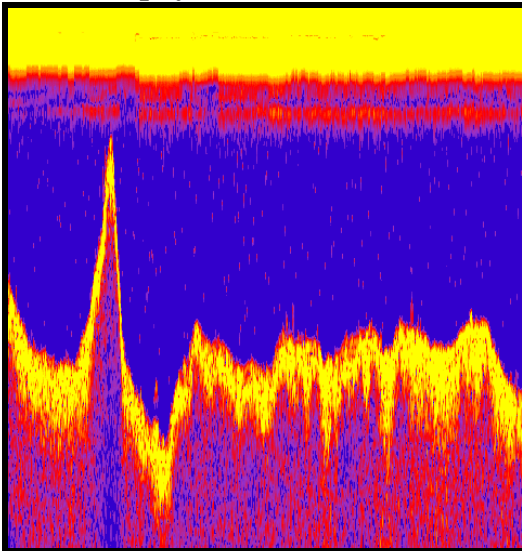
No Macrophyte Growth

2016 sonar data was collected similar to those noted during 2014 & 2015. Electronic data was collected on chart recorder utilizing sonar and structure scan transducers. Milfoil, when identified, was recorded as a waypoint during the survey. Surveying was terminated once plants were no longer detected on the chart graph recorder's monitor.

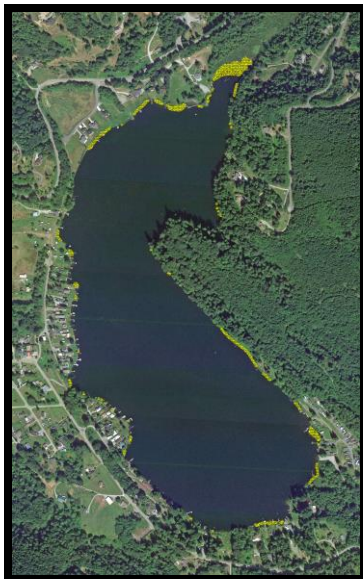
**Major
 Lily
 Pad
 Locations**

Lake McMurray received treatment for lily pads and yellow flag iris on July 21, 2016. Only infestations in excess of 1/4 mile of the McHaven potable water intake were targeted. An 18 foot aluminum boat equipped with one 25 gallon spray tank was utilized during this spray event. The 25 gallon tank was filled with lake water; Glyphosate and surfactant were then added directly to the tank. Once mixed, the application boat drove along the shoreline identifying targeted species. The spray mixture was then discharged directly onto the plants' leaf structures using a spray gun. When emptied, the tank was refilled and discharged as needed. Spray mixture consisted of a 1% solution of glyphosate.

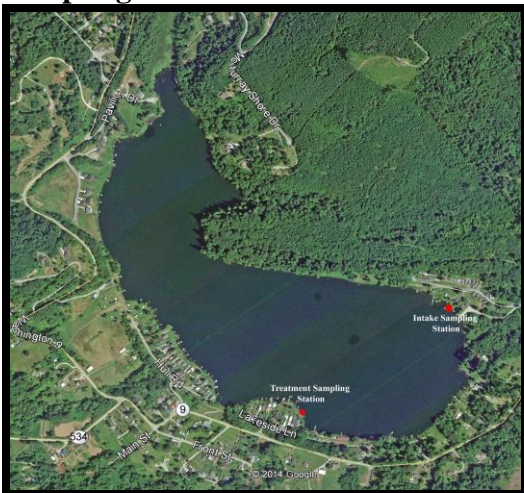
Sampling Stations

During 2015, the sampling event incorporated past protocol by collecting one sample directly above the potable water intake, one sample mid-basin adjacent to the McHaven development and one sample at the water's surface within the lily pad treatment zone. Except for the treatment site sample, all other samples were collected approximately three feet below the water surface.

There was no glyphosate detected at the McHaven water intake during any of the sampling events.

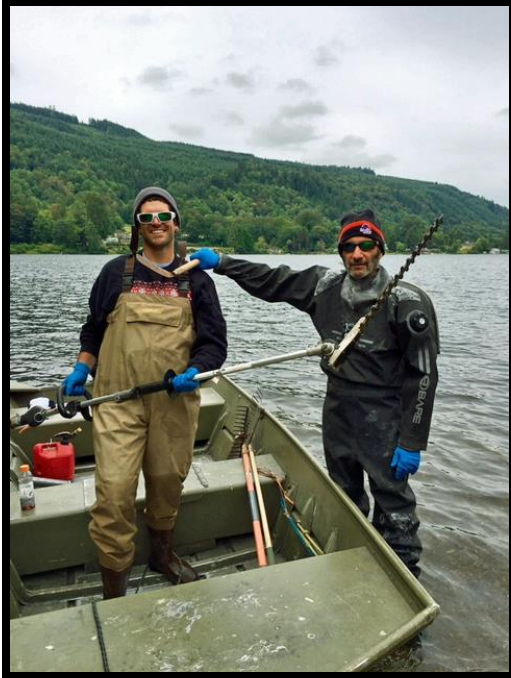
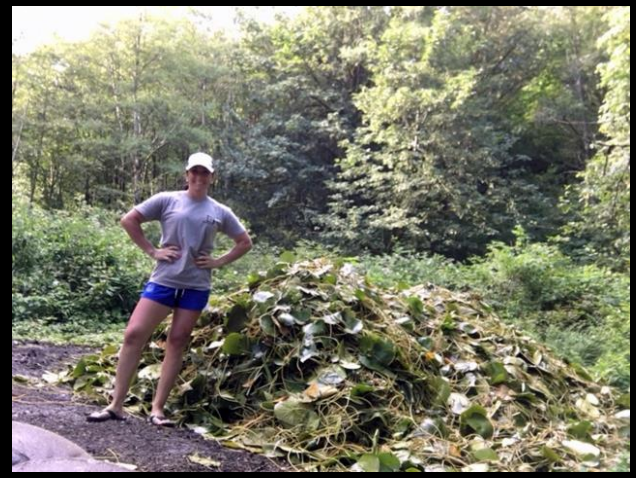
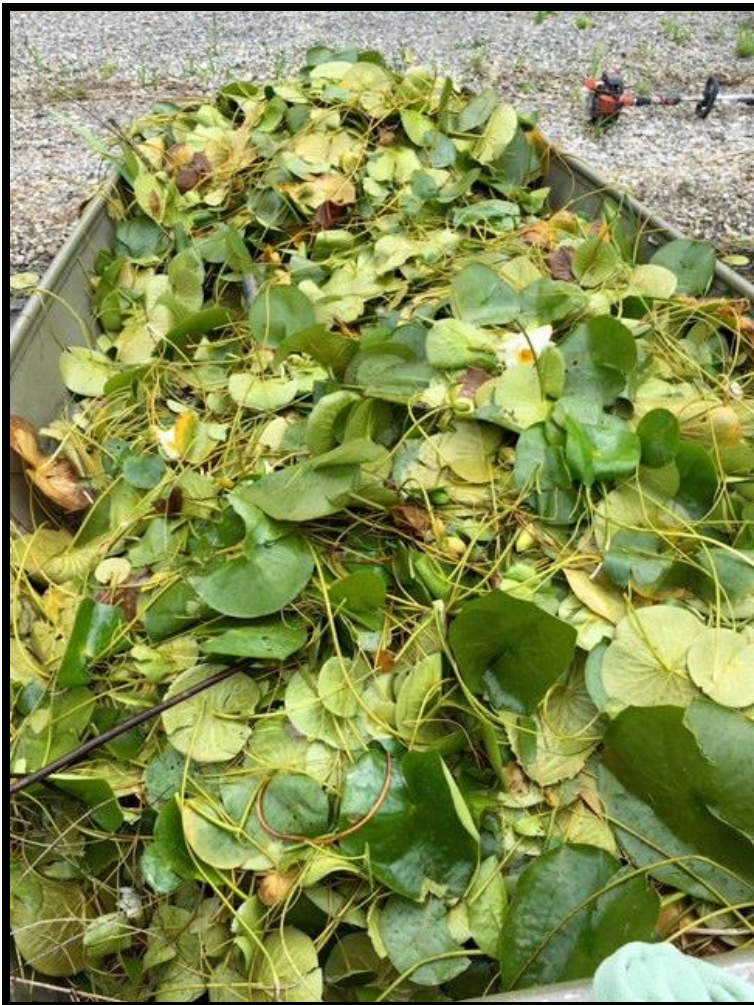
Lily pad manual removal occurred on July 1 & 2, 2016. Our July 1st date addressed approximately 14 shoreline residences while July 2nd was dedicated solely to the McHaven site. Removal at the McHaven site was accomplished with a three person crew cutting, loading pads into a small boat and offloading to a dump site provided by the McHaven development. The process was slow and labor intense. One person with a gas cutter cut the pads approximately four feet below the water's surface while the others collected for disposal. The McHaven site took approximately thirteen hours to complete. Unfortunately approximately 20-25 % of the pads had resurfaced seven days after the cutting.

The shoreline residential removal consisted of a four person crew that cut and collected the pads. Pads were then placed into a boat and transported back to the launch site where they were then loaded into the bed of a pickup truck.

4. Continued use of glyphosate in the control of lily pads, yellow flag iris and loosestrife.
5. Re-evaluate the use of manual control for lily pads within the no spray zone. During 2016 regrowth was faster than anticipated. However, the pads that resurfaced were smaller in diameter. In order for the manual removal to benefit the system, a secondary cutting following the initial cutting would need to be undertaken approximately 7-14 days post with a third cutting occurring 14-21 days following the second cutting. This method is a labor intense approach. Without a long term commitment to continue cuttings throughout the season a single cutting event would not be worthwhile.
