Lake McMurray 2017 Aquatic Plant Control Program

Prepared By
Northwest Aquatic Eco-Systems
855 Troser Road SW #108-313
Tumwater, WA 98512
360-357-3285
December 2017

Project Overview

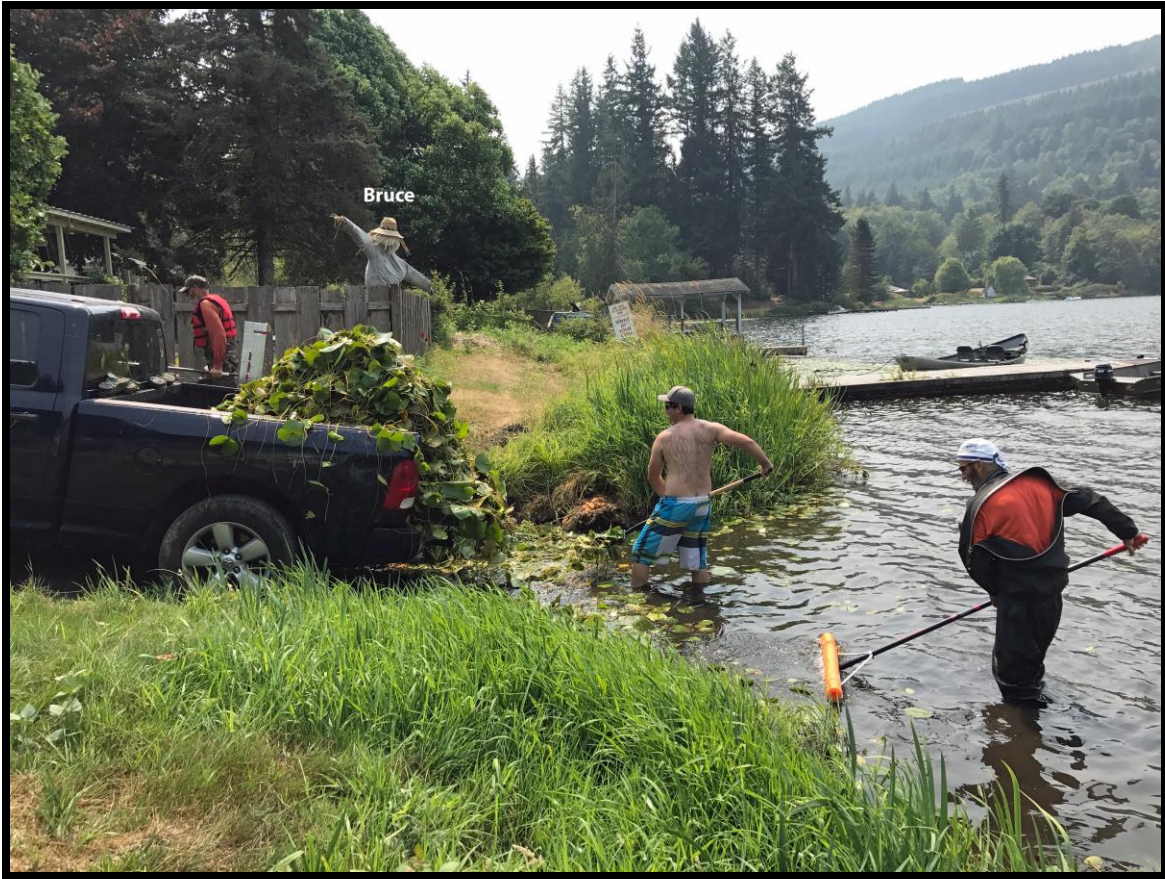
Collecting pads for disposal

Lily pad manual removal occurred twice during 2017 on July 2 & 3 and August 6 & 7. During each lily pad event one day was utilized to service the individual properties within the no treatment zone and the other day was spent at the McHaven site. Removal efforts at all sites consisted of a three person crew cutting and loading pads into a small boat and offloading or cutting and raking the plants to a shoreline staging area where the plants were then loaded into a pickup truck and delivered to a dump site provided by the McHaven development. Utilizing the McHaven dump site reduced the cost of the removal project considerably. Bruce, from the McHaven community assisted. The cutting and removal process was slow and labor intense.

Northwest utilized two types of hand held throwing cutters, a gas powered cutter and a set of bush trimming loppers. Each piece of equipment generated both positive and negative reviews dependent on the environment each tool was working within. One hand held throwing cutter was utilized in conjunction with a boat tethered along a pull line stretched from dock to dock in the deeper waters. All the other equipment was operated in areas under six feet in depth.

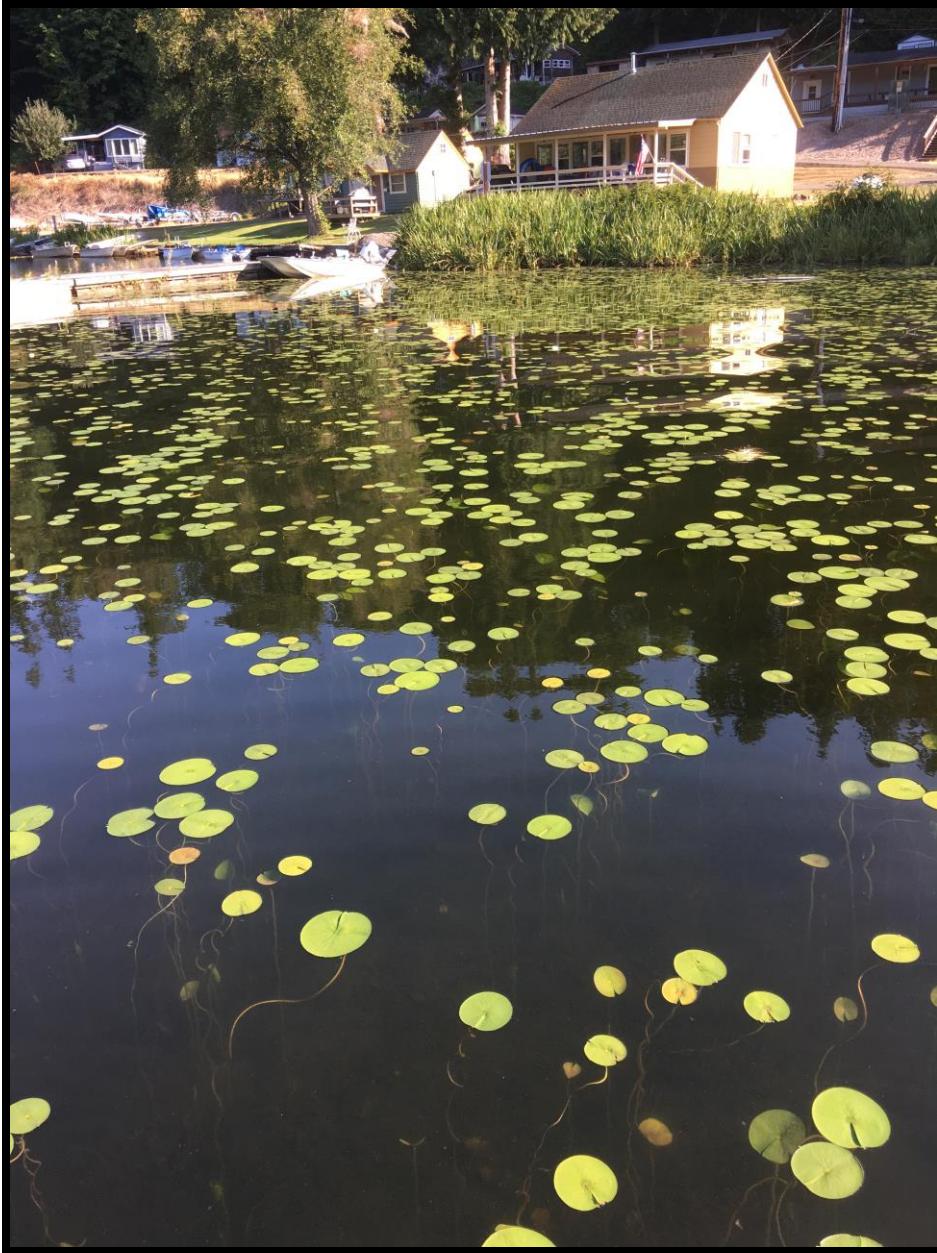
Lily pads 21 days post initial harvesting

4. Continue use of glyphosate in the control of lily pads, yellow flag iris and loosestrife.
5. Re-evaluate the use of manual control for lily pads within the no spray zone. Pads that resurfaced were smaller in diameter after each cut. The length of time between cuts should not exceed three weeks. A single seasonal cutting would not be worthwhile although it would provide short term relief.
