# Lake McMurray

## 2018 Aquatic Plant Control Program

**Prepared By**  
**Northwest Aquatic Eco-Systems**  
**855 Troser Road SW #108-313**  
**Tumwater, WA 98512**  
**360-357-3285**  
**December 2018**

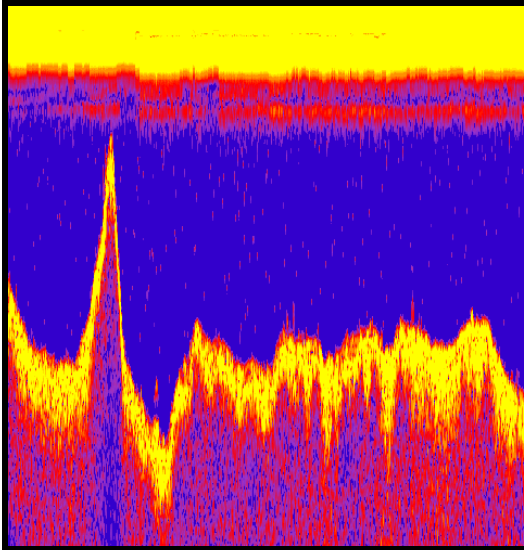
**No Macrophyte Growth**

2018 sonar data was collected similar to those noted during 2016 & 2017. Electronic data was collected on a chart recorder utilizing sonar and structure scan transducers. Milfoil, when identified, was recorded as a waypoint during the survey. Surveying was terminated once plants were no longer detected on the chart graph recorder's monitor.

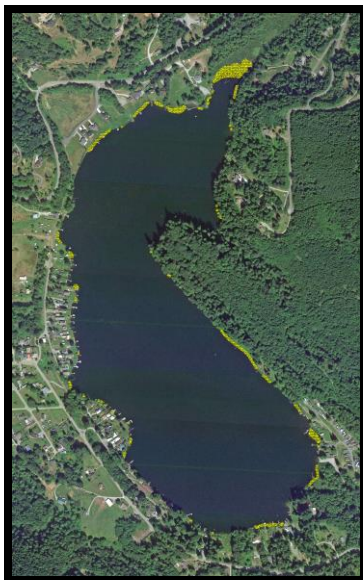
**Major  
 Lily  
 Pad  
 Locations**

Lake McMurray received treatment for lily pads and yellow flag iris on August 6, 2018. Notice was provided to the LMD prior to treatment and the shoreline was posted just prior to treatment. The same areas targeted for control during 2017 were again considered for the 2018 project. Only infestations more than 1/4 mile from the McHaven potable water intake were targeted. An 18 foot aluminum boat equipped with one 25 gallon spray tank was utilized during this spray event. The 25 gallon tank was filled with lake water. Glyphosate and surfactant were then added directly to the tank. Once mixed, the application boat drove along the shoreline identifying targeted species. The spray mixture was then discharged directly onto the plants' leaf structures using a spray gun. When emptied, the tank was refilled and discharged as needed. Spray mixture consisted of a 1% solution of glyphosate.

Pad infestations continue to decline with some prior targeted sites not requiring treatment during 2018.

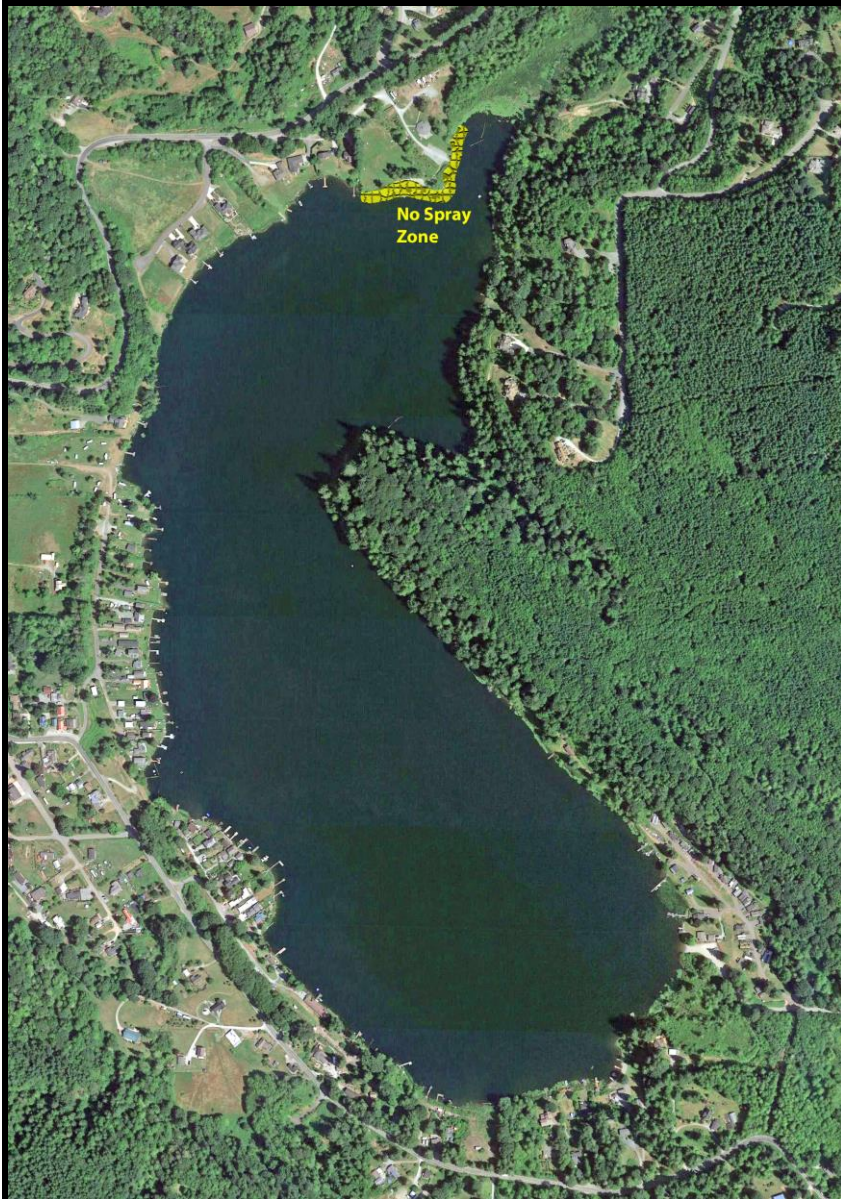
No spraying occurred at the “Friends of Norway” park located along the northwest shoreline of the lake. At the time of posting, a husband and wife present at the park protested the use of herbicides at the lake. NWAEC made contact with one of the park representatives via cell phone in order to determine what action should be taken. After a lengthy conversation with a club representative and the concerned parties, a determination to not spray was made by the representative.

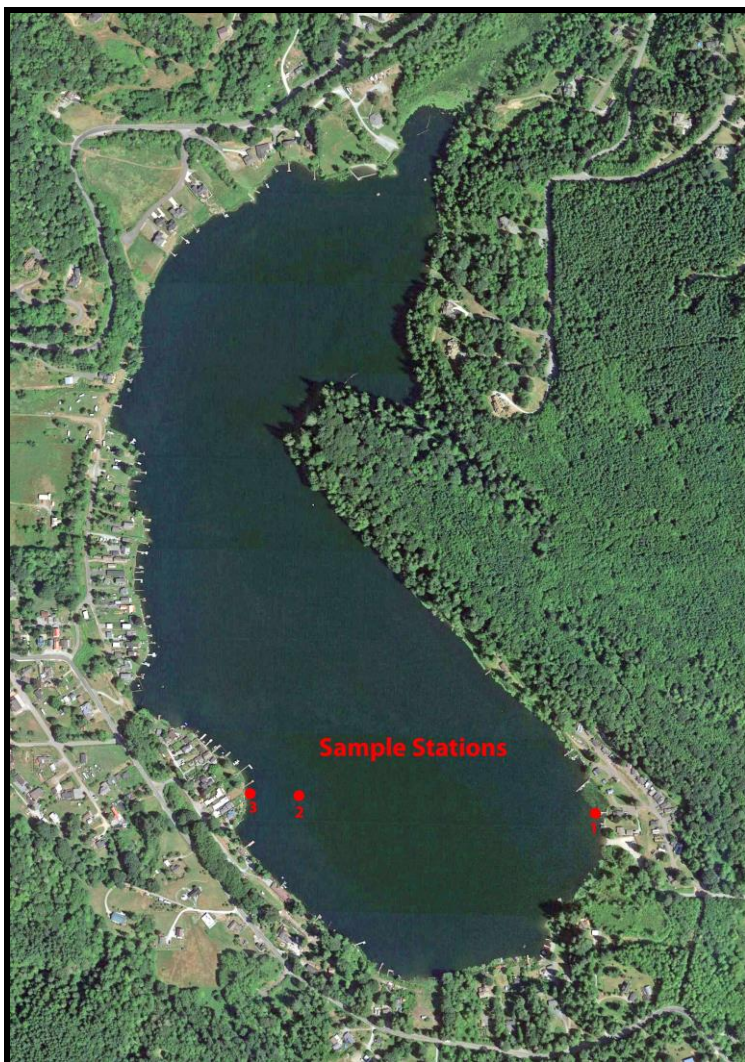
**Sample Stations**

evaluated photoelectrically. During each sampling event one sample was collected at the treatment (#3) site just below the surface, one sample was collected approximately 300 feet from the treatment (#2) site and one sample was taken directly above the McHaven water intake (#1). All of the samples collected except for the August 6 sample taken at the treatment site returned glyphosate levels below the detectable limits of the equipment. The sample taken at the treatment site on the day of treatment registered a concentration of 3.2 ppb glyphosate.
