# Skagit County Monitoring Program

## Annual Report

2004 Water Year (October 2003 – September 2004)

## Skagit County Monitoring Program Annual Report

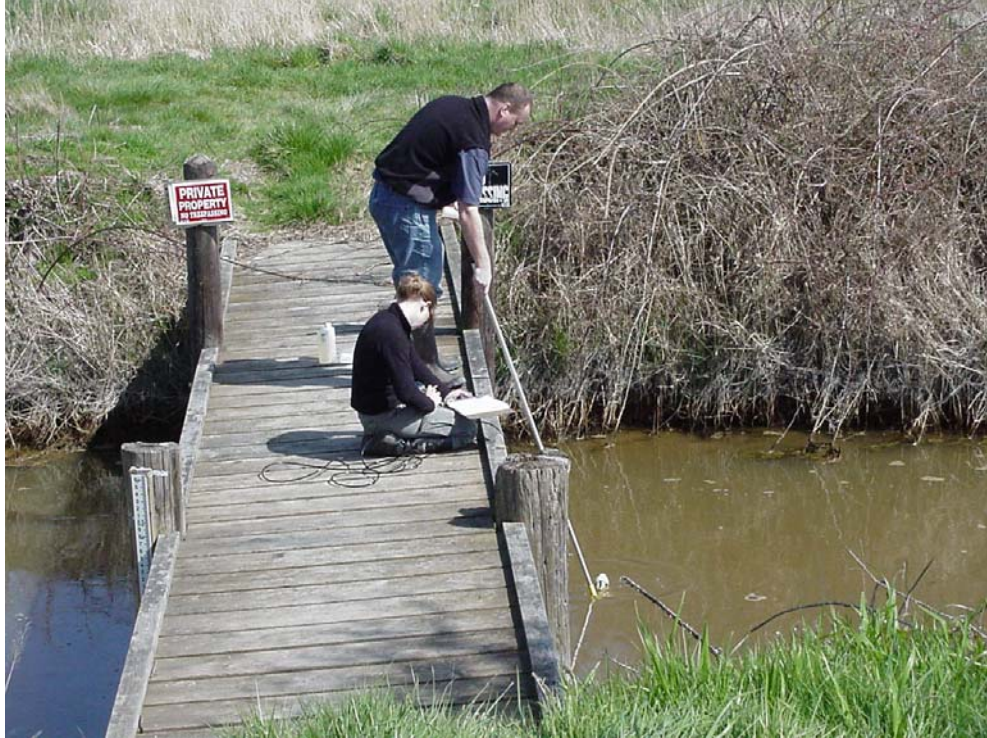
Figure 2. Collecting water samples and water quality data at Alice Bay Pump Station.

**Weekly Sampling** - All weekly sampling trips were conducted on schedule, beginning on October 7, 2003. Sampling normally took place on Tuesdays except during holiday weeks (Thanksgiving and Christmas), when sampling took place on Mondays to accommodate laboratory schedules. Sampling activities are illustrated in Figures 2 and 3.

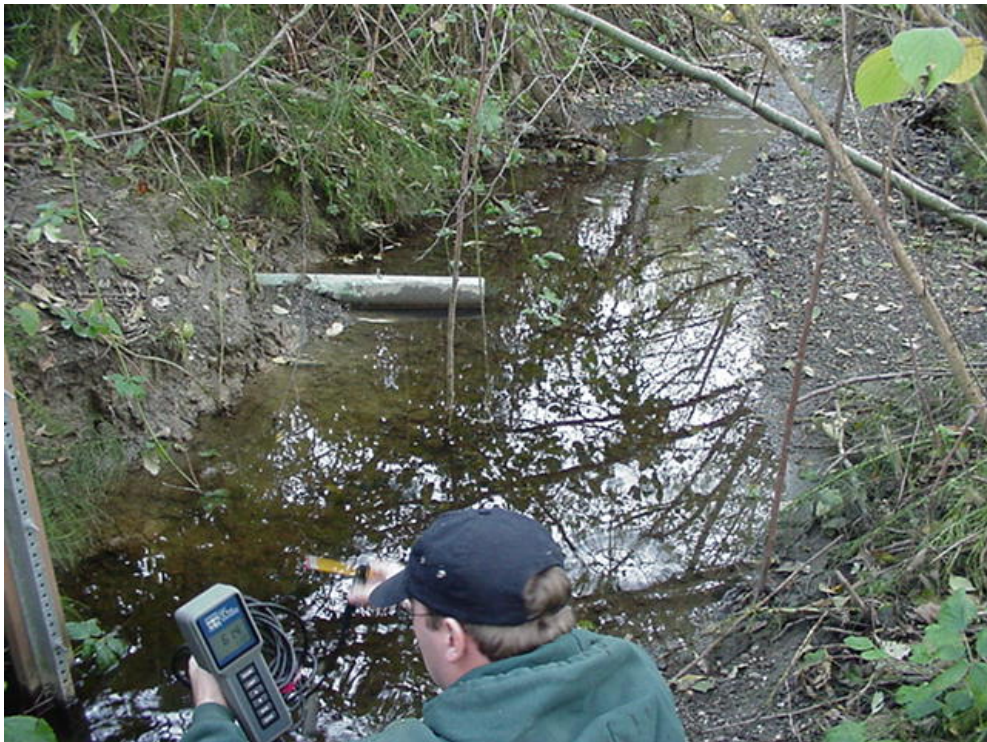
Figure 3. Obtaining dissolved oxygen reading from College Way Creek.
