**Skagit County Water Quality  
Monitoring Program  
Three-Year Review**

**December, 2007**

# Skagit County Monitoring Program

# Skagit County Salmon Habitat Monitoring Program

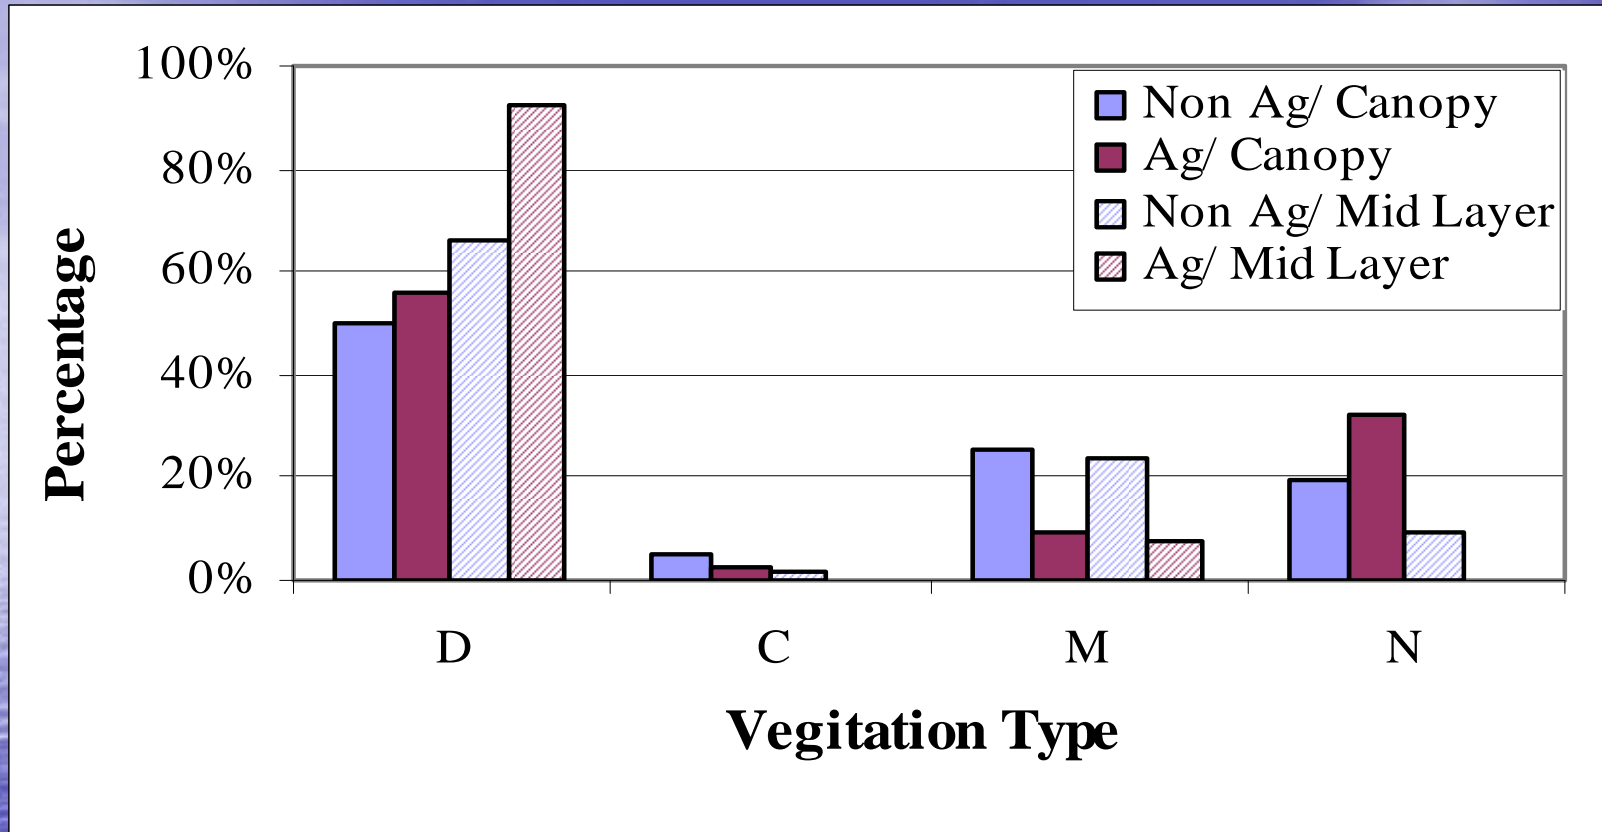
**Canopy Composition percentage for both Ag/RR and Non-Ag/RR sites. (D= Deciduous; C=Coniferous; M= Mixed Canopy; N= No Canopy Present).**

Riparian Vegetation Woody Vegetation Layers	
Canopy	> 5 m height
Mid level	.5m – 5m
Ground cover	< .5m

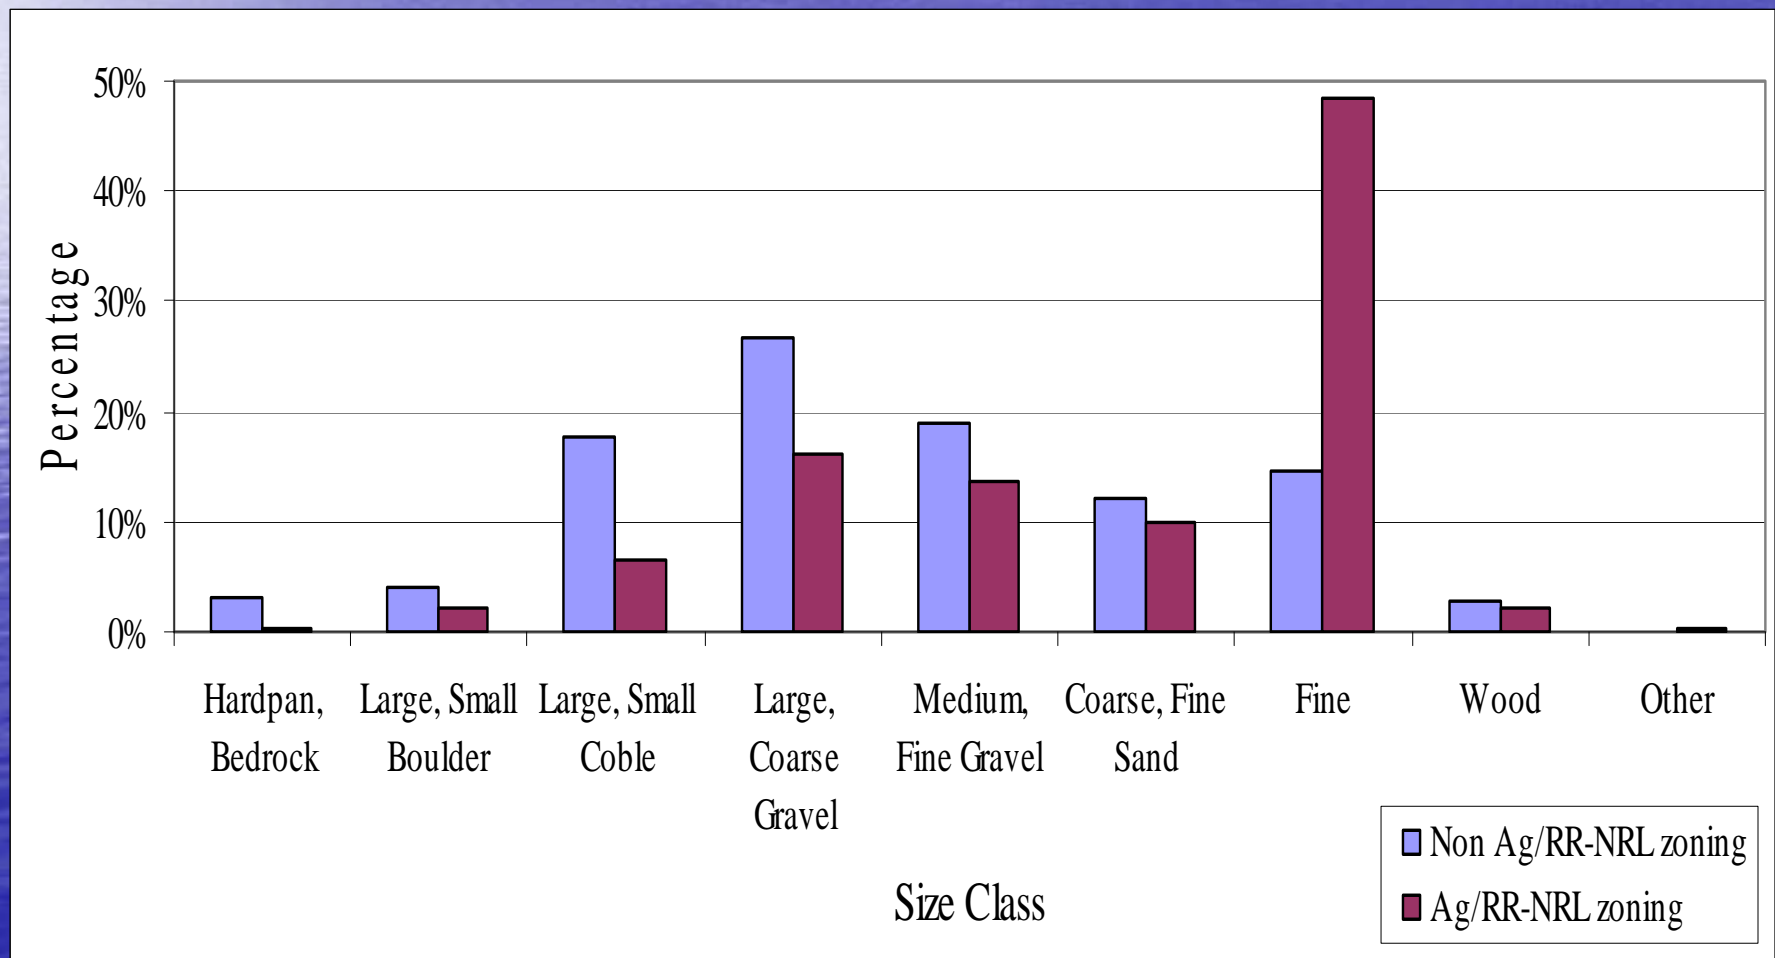
## Channel and Riparian Characterization –Substrate

We found that gravel was the prominent substrate type for Non-Ag sites. Sites on Ag had a significantly larger amount of fines than those on Non-Ag sites. Fine sediment accounted for nearly 50% of the sediment samples from the Ag sites

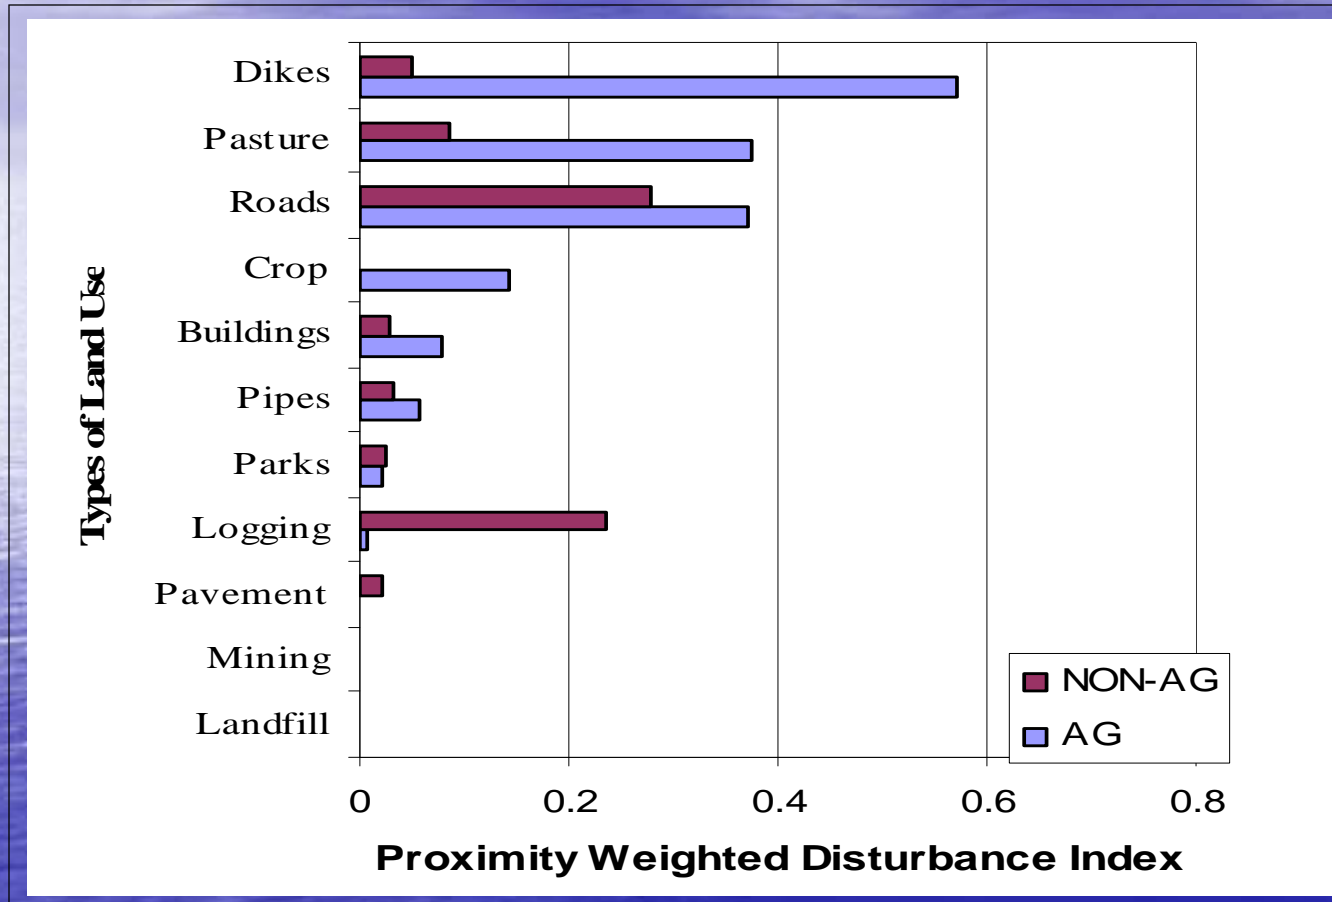
Figure 10. PWDI values for land use types

This index combines the extent of the disturbance as well as the proximity of the disturbance to the stream

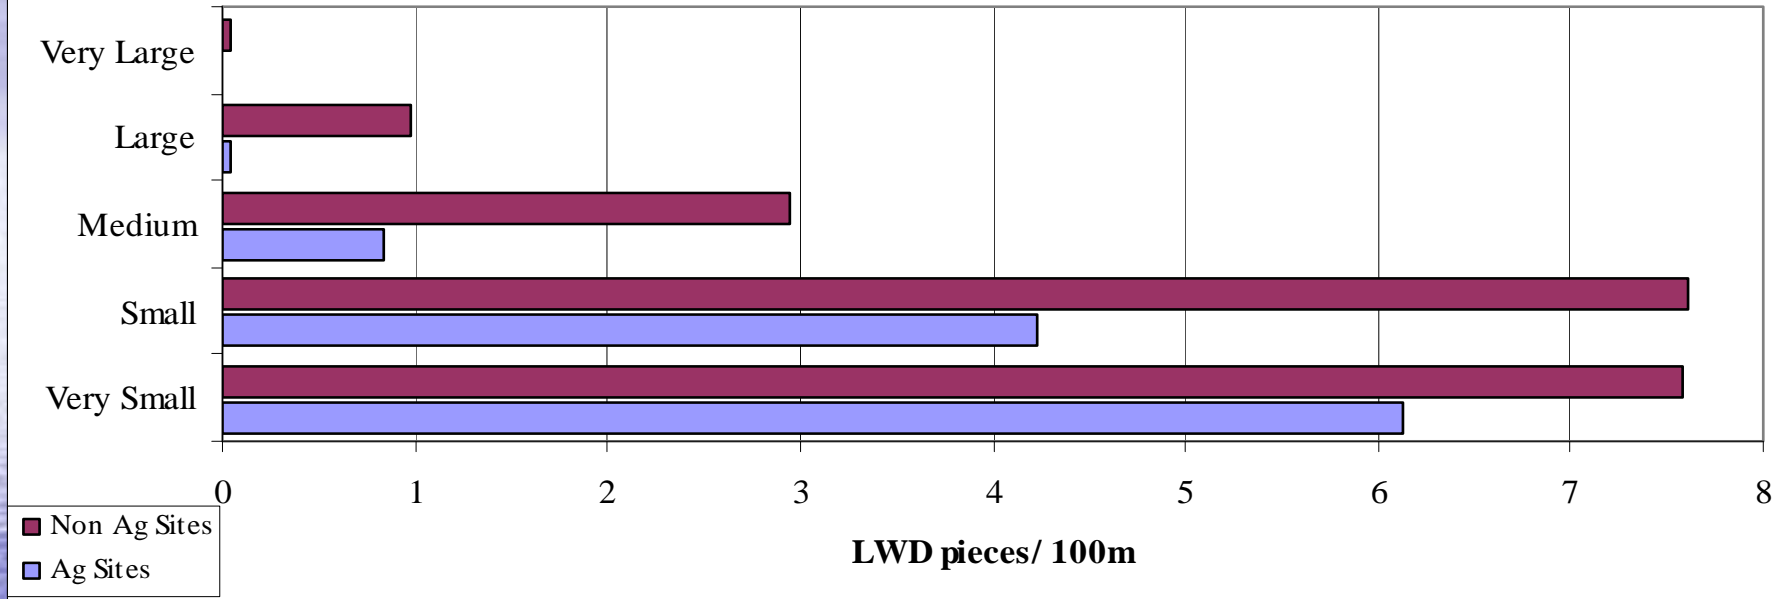
Mean LWD Quantity by Size Class

Diameter Class (m)	Length Class (m)		
	1.5- 5	>5- 15	>15
0.1- 0.3	Very Small	Small	Medium
>0.3- 0.6	Small	Medium	Large
>0.6- 0.8	Small	Large	Large
>0.8	Medium	Large	Very Large
