June 12, 2026
Report No.: 26-040 – Revision 1

RE: Preliminary Geologic Hazard Site Assessment, 12790 Marine Drive, Anacortes, Washington
Parcel P68272

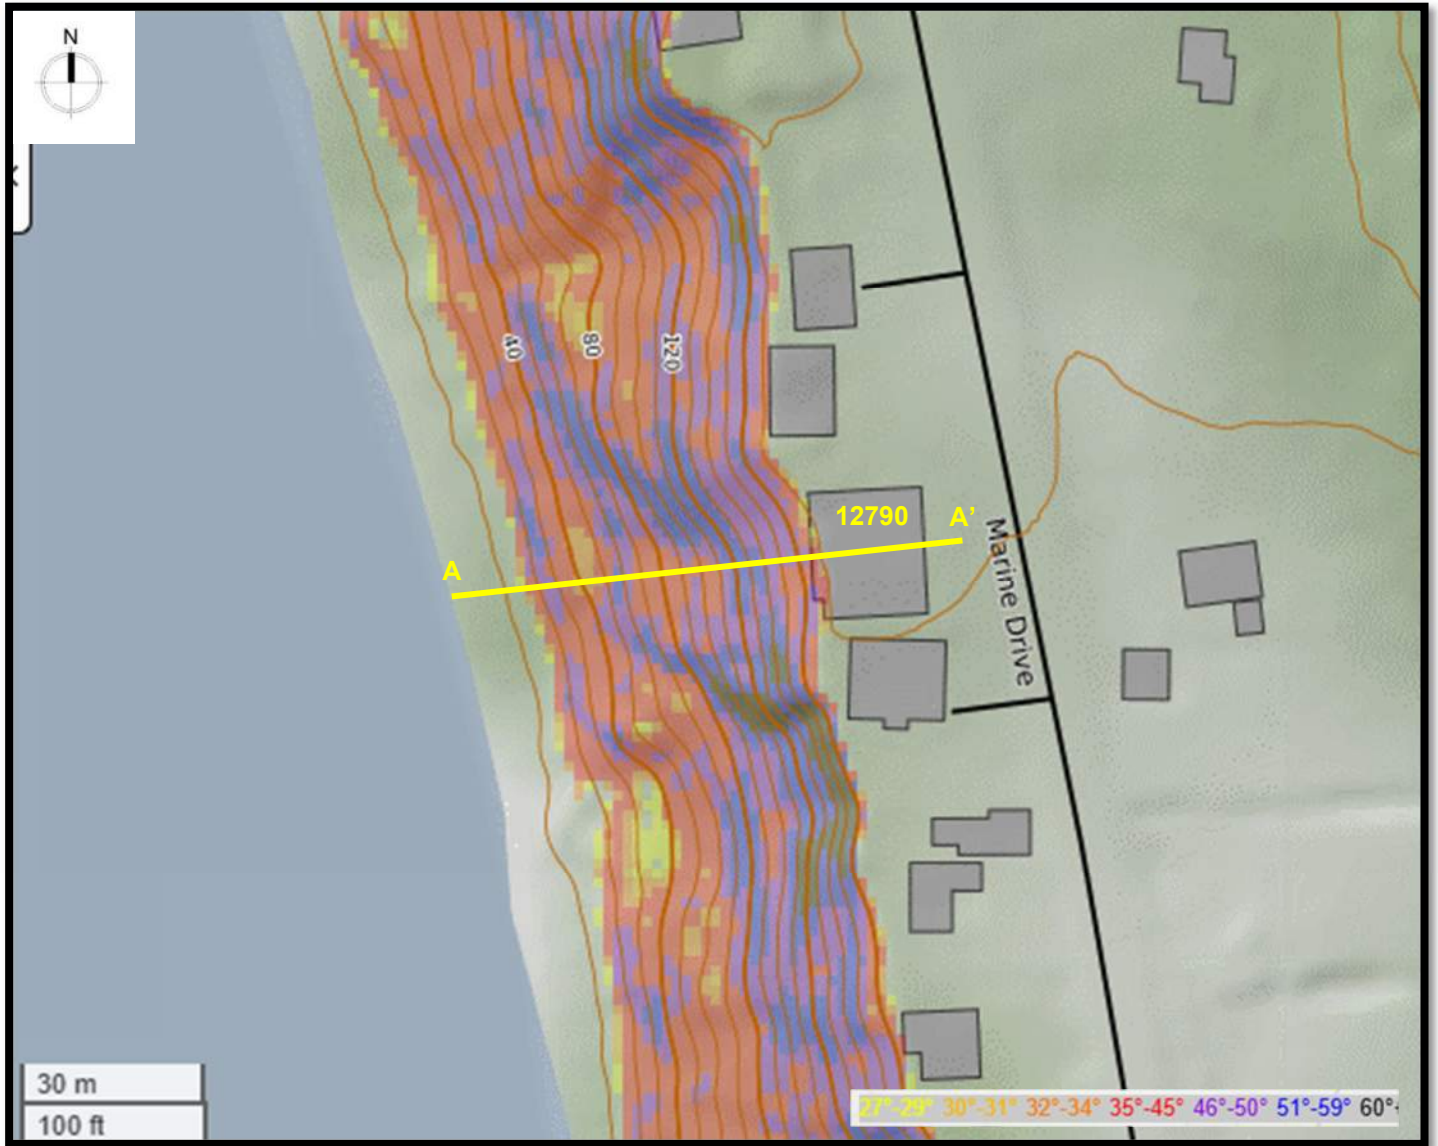
Figure 3: *Site Plan* showing coastal bluff topography and relative gradients in the vicinity of 12790 Marine Drive. Cross-section A-A' shown in yellow. Image courtesy CalTopo™, 2026. Scale as shown.
