SKAGIT COUNTY DEPARTMENT OF PUBLIC WORKS

2022 ANNUAL BRIDGE REPORT

SUBMITTED MARCH, 2023

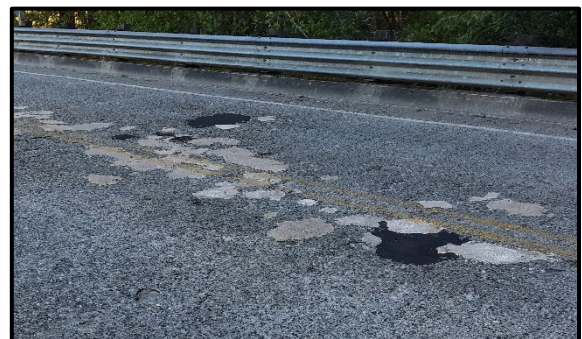
- **The Deck Repair Bundle Project** was awarded \$1.6 Million to repair and resurface the decks of three bridges: **F&S Grade Road at Samish River** (right), **Cascade River Bridge**, and **S. Skagit Highway at Pressentin Creek**. Design is scheduled to begin later this year, construction in 2025.

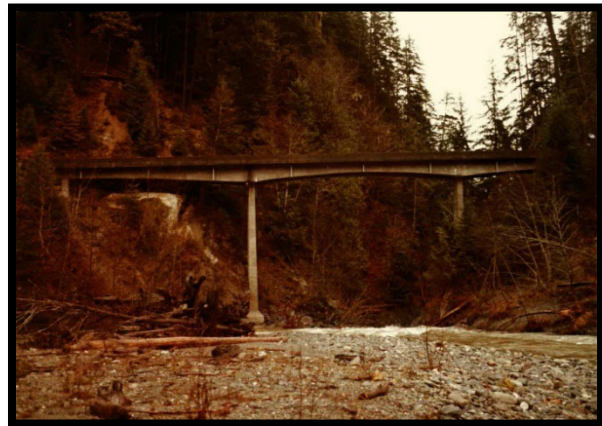
Upper Finney Creek Bridge

In 2012, we repaired a damaged girder, but the bridge still does not have the load carrying capability to handle today's logging industry vehicles. Skagit County has been awarded **\$3 Million** in grant funds from the Federal Local Bridge Program to perform a seismic retrofit, making the bridge more resistant to earthquake damage, while also increasing its overall strength and load capacity. Construction has begun and will be **completed in Fall of 2023**.

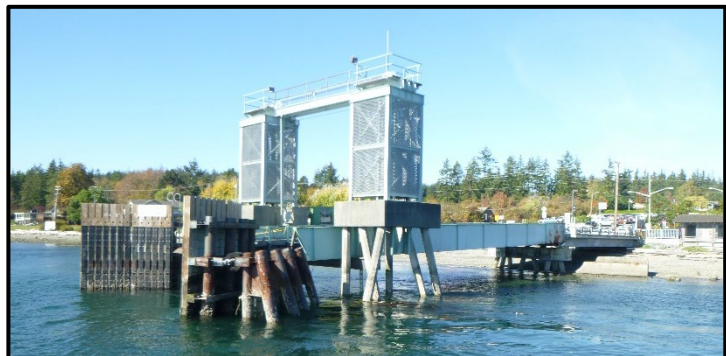
Steel bridge paint is not only for aesthetic purposes but it also provides a protective coating that prevents rust and corrosion of the steel. Skagit County owns several steel bridges that could use a good cleaning, Rainbow Bridge and Dalles Bridge in particular, but the **Guemes Island Ferry Dock #40153** (right) is currently the only structure in our inventory that has enough documented paint deterioration to be eligible for grant funding.

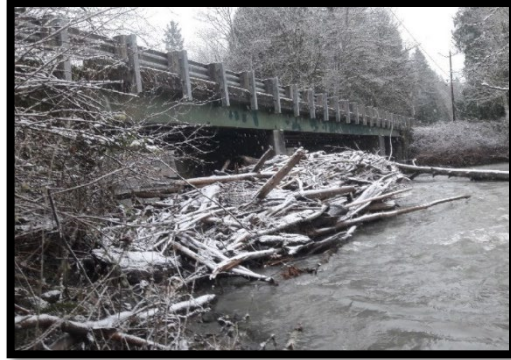
South Skagit Highway at Finney Creek

Debris is an ongoing issue for many of our bridges. To improve crew efficiency and response time, Environmental Services secured programmatic HPA's for clearing debris from problem bridges. Our crews were able to remove the debris from South Skagit Hwy at Finney Creek #40089 during the November '21 flood event (*right*).
