SKAGIT COUNTY DEPARTMENT OF PUBLIC WORKS

2023 ANNUAL BRIDGE REPORT

2023 BRIDGE REPORT

Submitted: March 2024

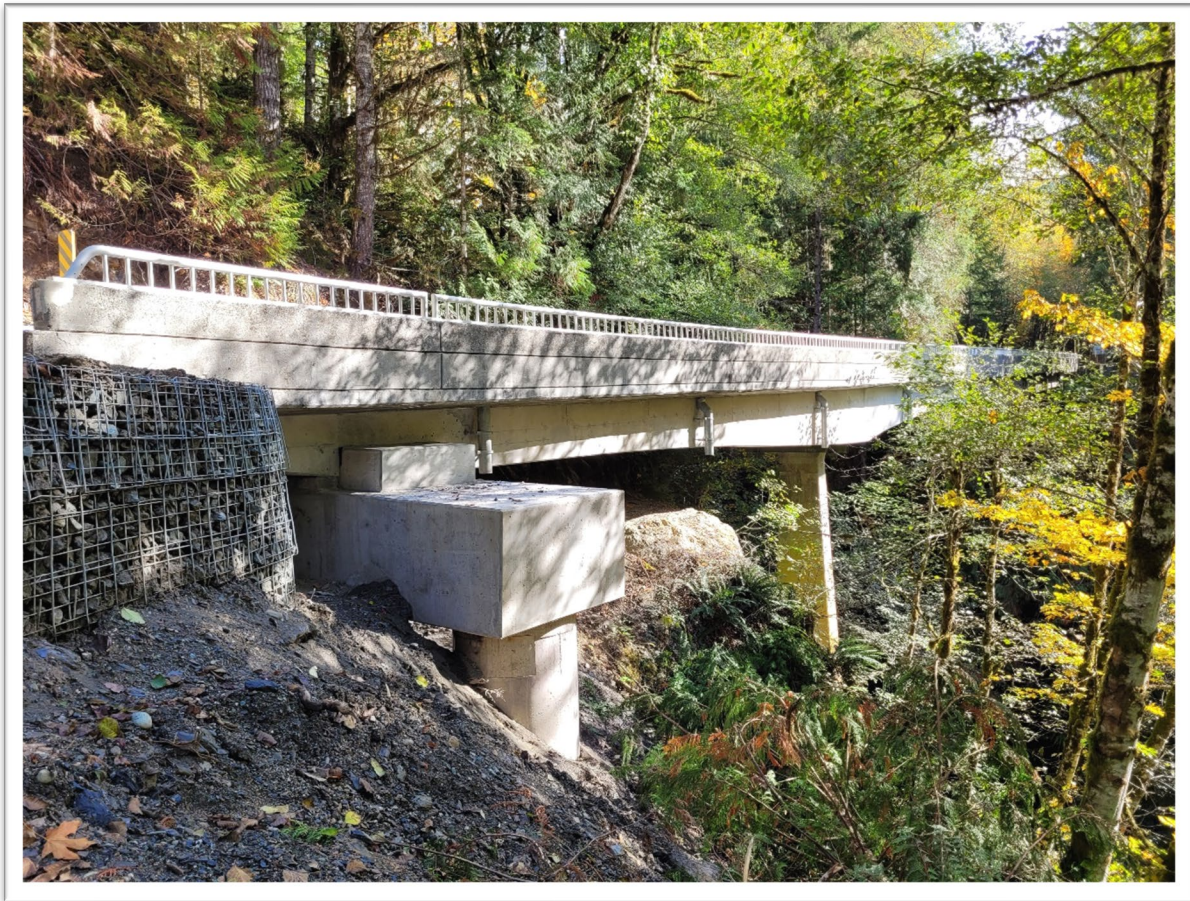
“Upper Finney Creek Bridge”

Completed strengthening and seismic retrofit project, August of 2023.

- ❖ Construction was completed on the **Upper Finney Creek Bridge** Seismic Retrofit and Strengthening Project (cover page). The work included installation of 4 additional concrete columns into the subgrade, enlarged abutments, and bolstered girders, as well as a new deck surface and rails. Total cost of the project was just under \$3.6 million that was entirely funded by the Federal Local Bridge Program.

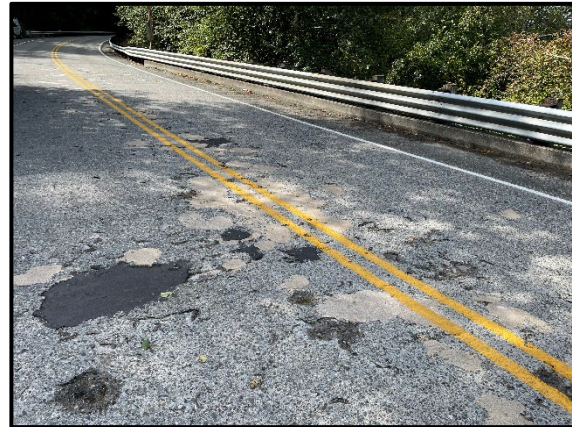
➤ **The Deck Repair Bundle Project** was awarded \$1.6 Million to repair and resurface the decks of three bridges: **F&S Grade Road at Samish River** (right), **Cascade River Bridge**, and **S. Skagit Highway at Pressentin Creek**. Sargent Engineers, Inc. was selected as the design consultant, construction is scheduled for spring of 2025.

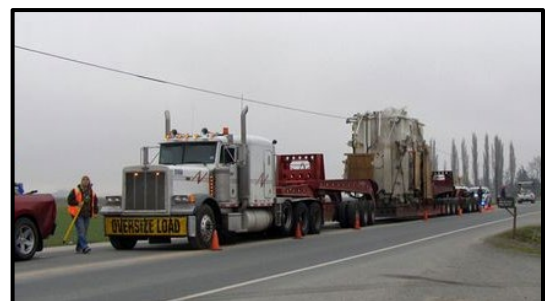
Super-load requiring bridge loading analysis.

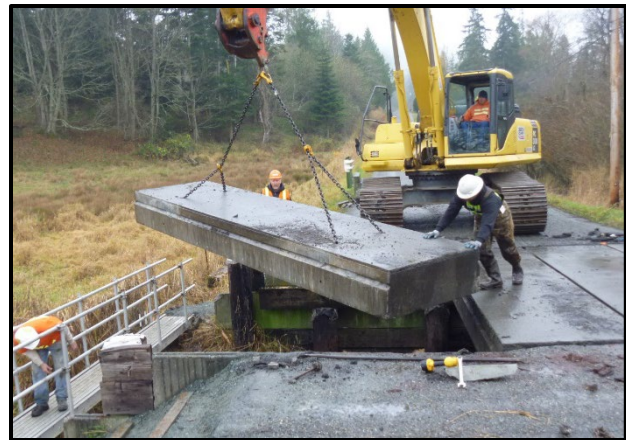
Campbell Lake Outlet receiving new timber cap, 2013

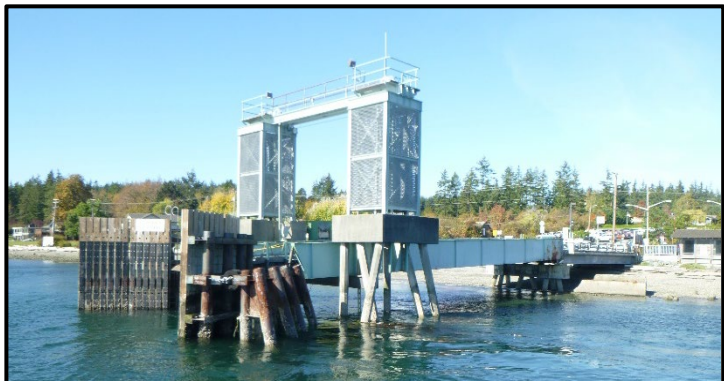
Steel bridge paint is not only for aesthetic purposes but it also provides a protective coating that prevents rust and corrosion of the steel. Skagit County owns several steel bridges that could use a good cleaning, Rainbow Bridge and Dalles Bridge in particular, but the **Guemes Island Ferry Dock #40153** (right) is currently the only structure in our inventory that has enough documented paint deterioration to be eligible for grant funding.
