## SKAGIT COUNTY DEPARTMENT OF PUBLIC WORKS

# 2024 ANNUAL BRIDGE REPORT

**SUBMITTED MARCH, 2025**

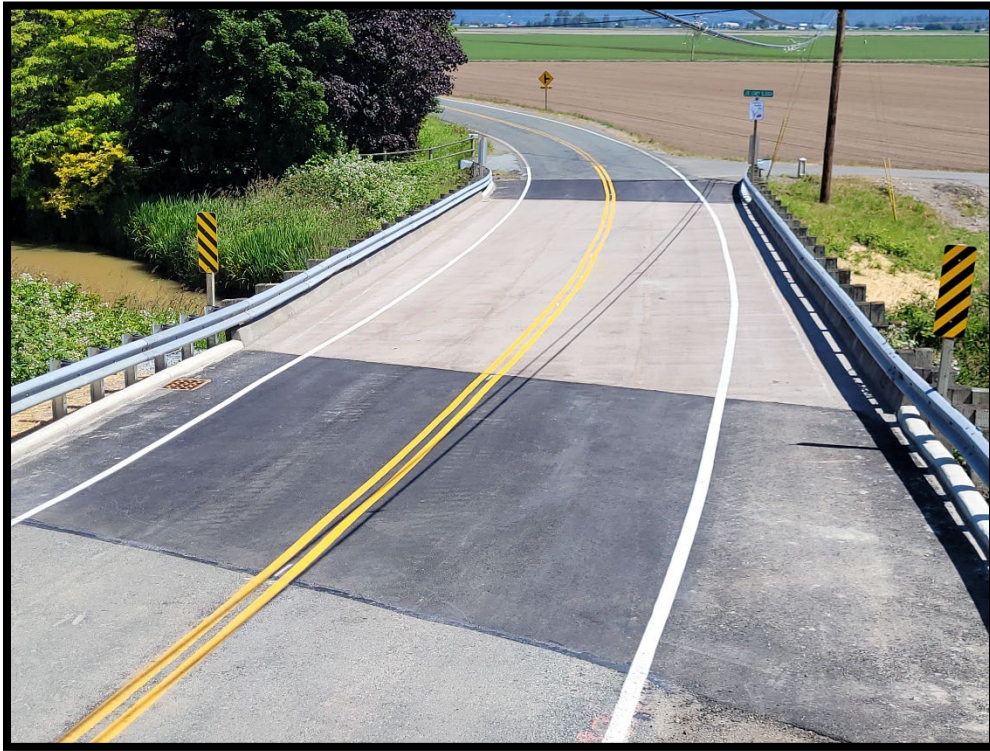
- ❖ Construction was completed on the Bayview-Edison at Joe Leary Slough Bridge Deck Rehabilitation Project (below). The work included shot blasting off the top inch of the deck, repairing any damaged rebar, and filling any delamination voids. Then a new 1.5” polyester polymer concrete overlay was applied to seal the concrete deck and apply a smooth driving surface. Existing drainage and bank armoring were also repaired.

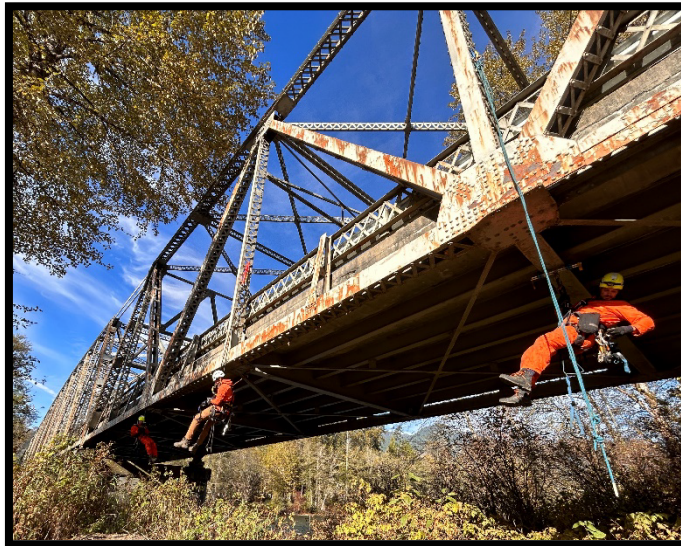
- ❖ **Skagit River Marblemount Bridge** (see page 14) was awarded \$18.6 Million for Rehabilitation that will include replacement of some damaged/deteriorating members as well as upsizing gusset plates and members with the goal of increasing its load

carrying capacity to handle legal loads. The funding will also go towards cleaning and applying a new protective paint coating. David Evans and Associates, Inc. performed an in-depth climbing inspection (left) and completed the design. The County will be advertising for competitive contractor bids beginning March 13, 2025.

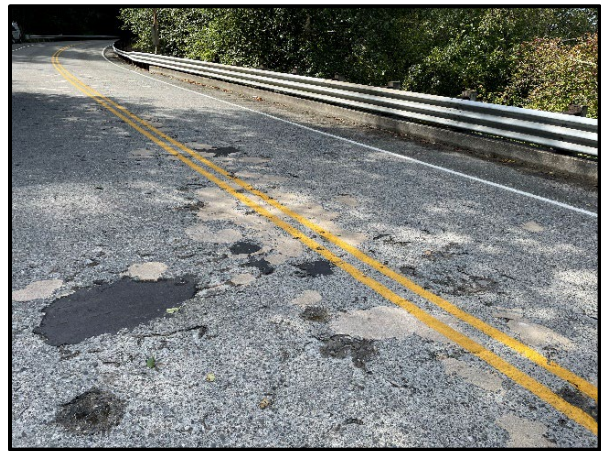
❖ **The Deck Repair Bundle Project** was awarded \$1.6 Million to repair and resurface the decks of three bridges: **F&S Grade Road at Samish River** (right), **Cascade River Bridge**, and **S. Skagit Highway at Pressentin Creek**. Sargent Engineers, Inc. was selected as the design consultant, construction is currently scheduled for spring of 2026.

BRIDGE NUMBER	BRIDGE NAME	DEFICIENCY	FUNDING STATUS
40013	F&S GRADE SAMISH RIVER	Deck	Repair Funding Awarded – Const. 2026
40113	OLD HWY 99 at THOMAS CK	Deck/Substructure	Replacement Funding Awarded – Const. 2026

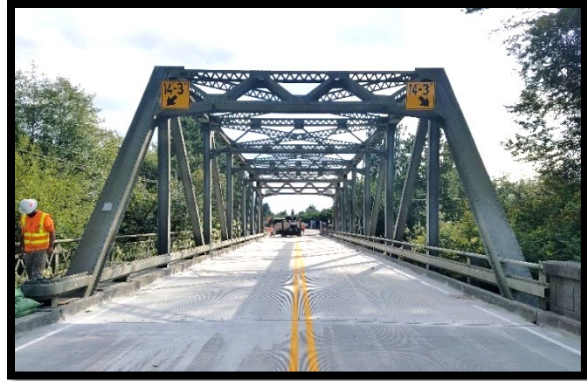
Samish River Bridge - Vertical Clearance Signage

**Vertical Clearance Limited Bridges:**  
 Steel Truss Bridges all have sway bracing across the top which creates a vertical limitation to vehicles traveling over the bridge. Below is a list of bridges that have vertical limitations and their vertical measurement which helps when reviewing the route of an oversized load application. Skagit County crews have also posted the height restriction on two of the bridges that are near or below legal height (See Table 3).

Bridge Number	Bridge Name	Vertical Measurement	Posted Clearance
40114	SAMISH RIVER BRIDGE	14' 06"	14' 3"
40152	ANACORTES FERRY DOCK	16' 00"	
40153	GUEMES ISLAND FERRY DOCK	16' 00"	
40090	DALLES BRIDGE	16' 01"	15' 10"
40039	RAINBOW BRIDGE	16' 07"	
40070	SKAGIT RIVER MARBLEMOUNT	17' 09"	
40099	GOVERNMENT BRIDGE	18' 00"

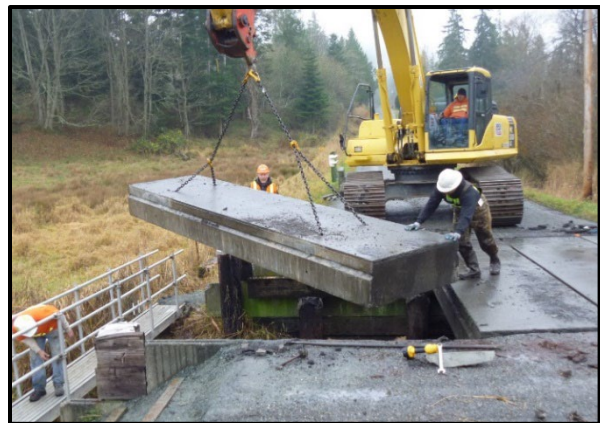
Campbell Lake Outlet receiving new timber cap in 2013
