TECHNICAL MEMORANDUM

Date: May 24, 2010

From: Simon Page, Anchor QEA, LLC

Re: Lake McMurray Lake Level and Beaver Control Improvement Needs Evaluation Services

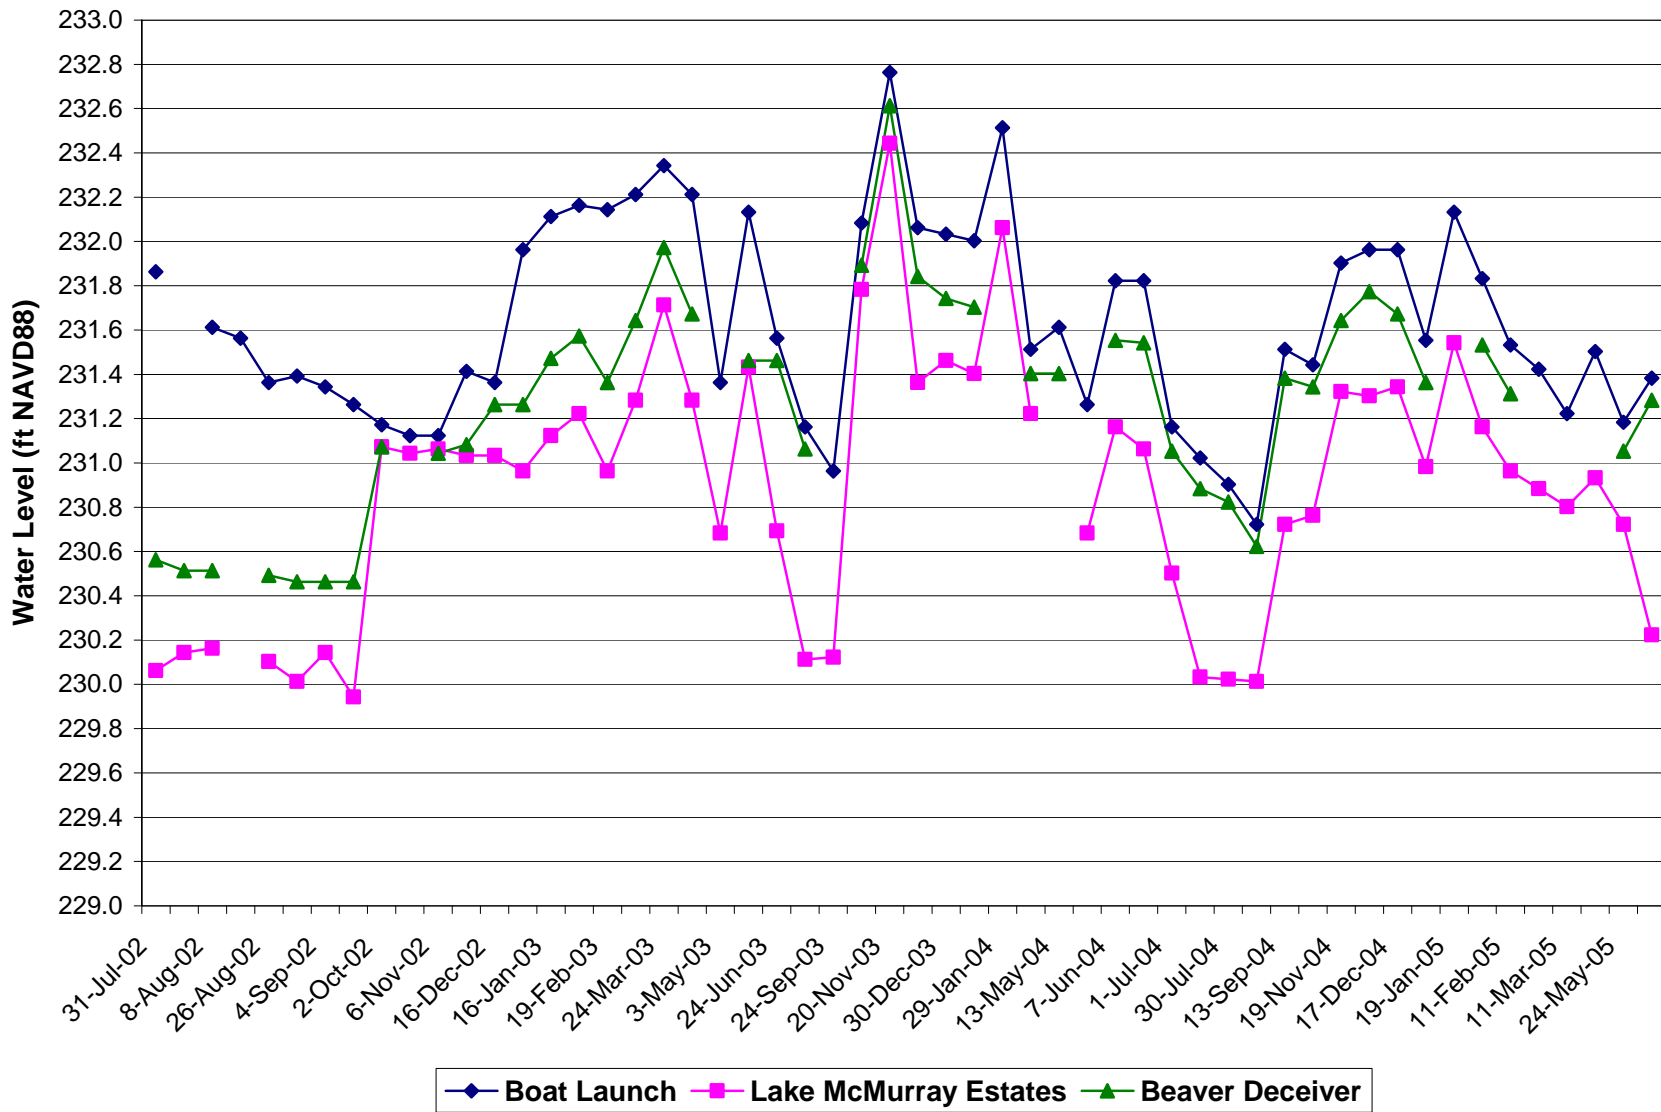
The County water level data show that the installation of the beaver deceivers provided increased discharge from the lake, which can be seen by the close tracking of water levels in the lake and at the Lake McMurray Estates culverts since 2003 when the beaver deceivers were last modified (Table 1).

The low water level (which is the water level at the time of survey) was 230.6 feet, which is presumed to be controlled by the hydraulics of the lake outlet. Table 3 reports the surveyed water levels at each of the beaver deceivers. The water levels upstream and downstream of all the beaver deceivers are essentially equal at approximately 230 feet. The invert of the lower of the Lake McMurray Estates culverts, surveyed during the Big Lake project is at an elevation of 228.67. During the site visits during the summer of 2009, water was observed to be ponded in the culverts to an elevation of approximately 229.8 feet, which is consistent with the low levels recorded in the late summer of 2002, 2003, and 2004 by the County (Figure 2).

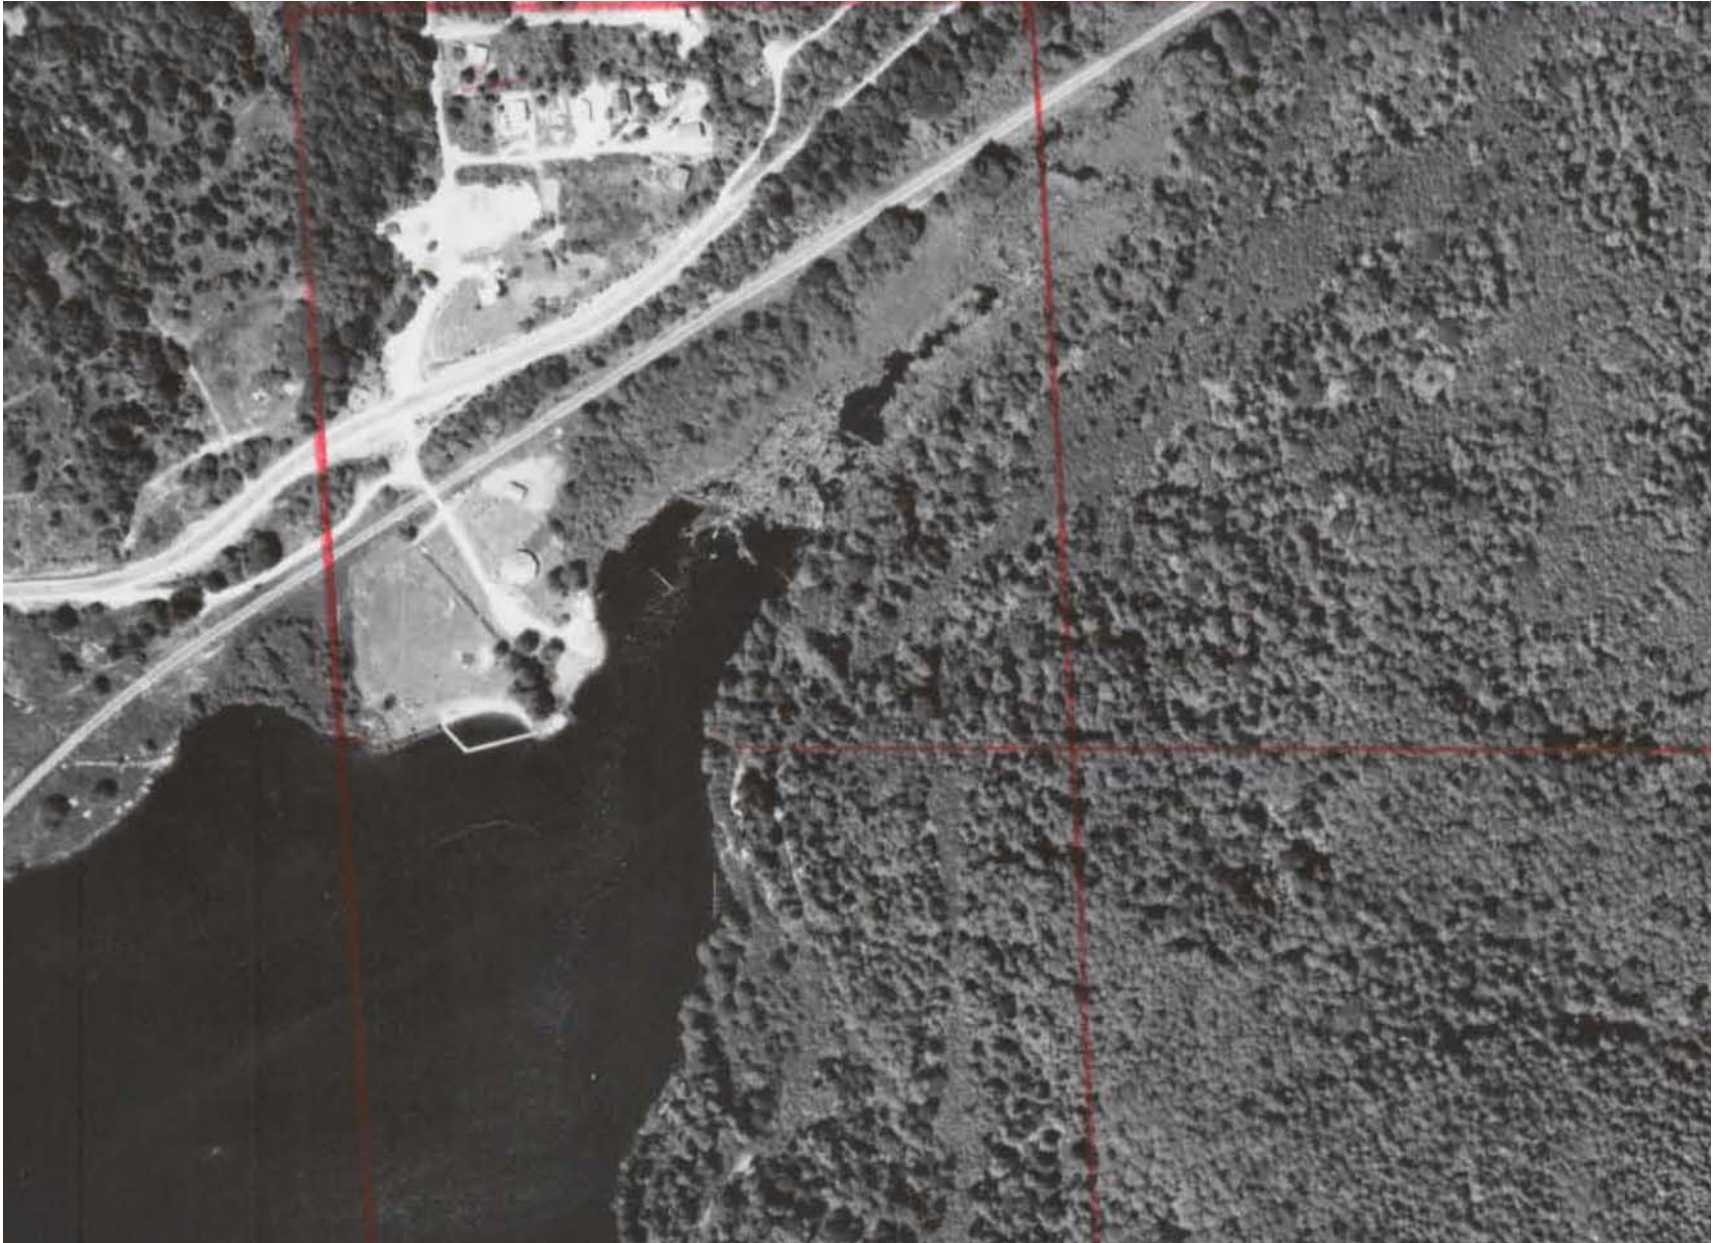
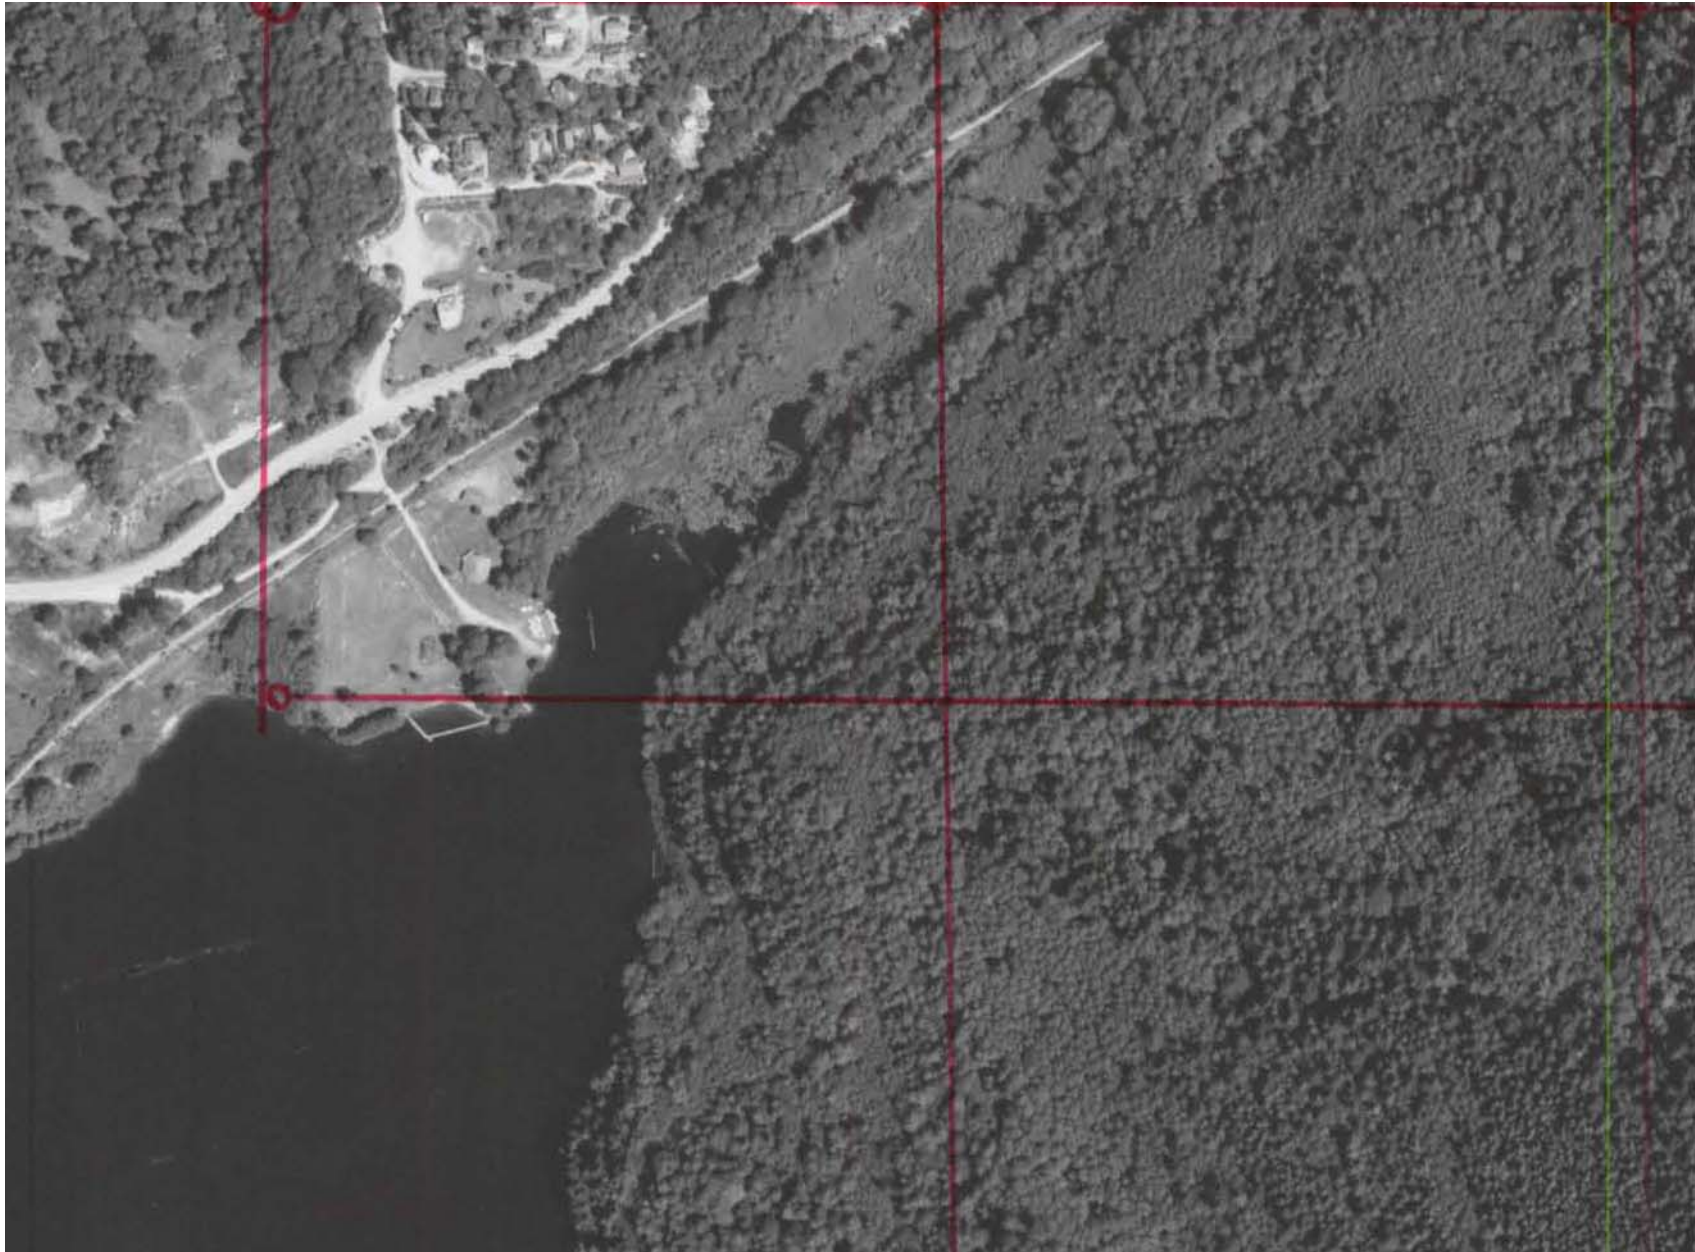
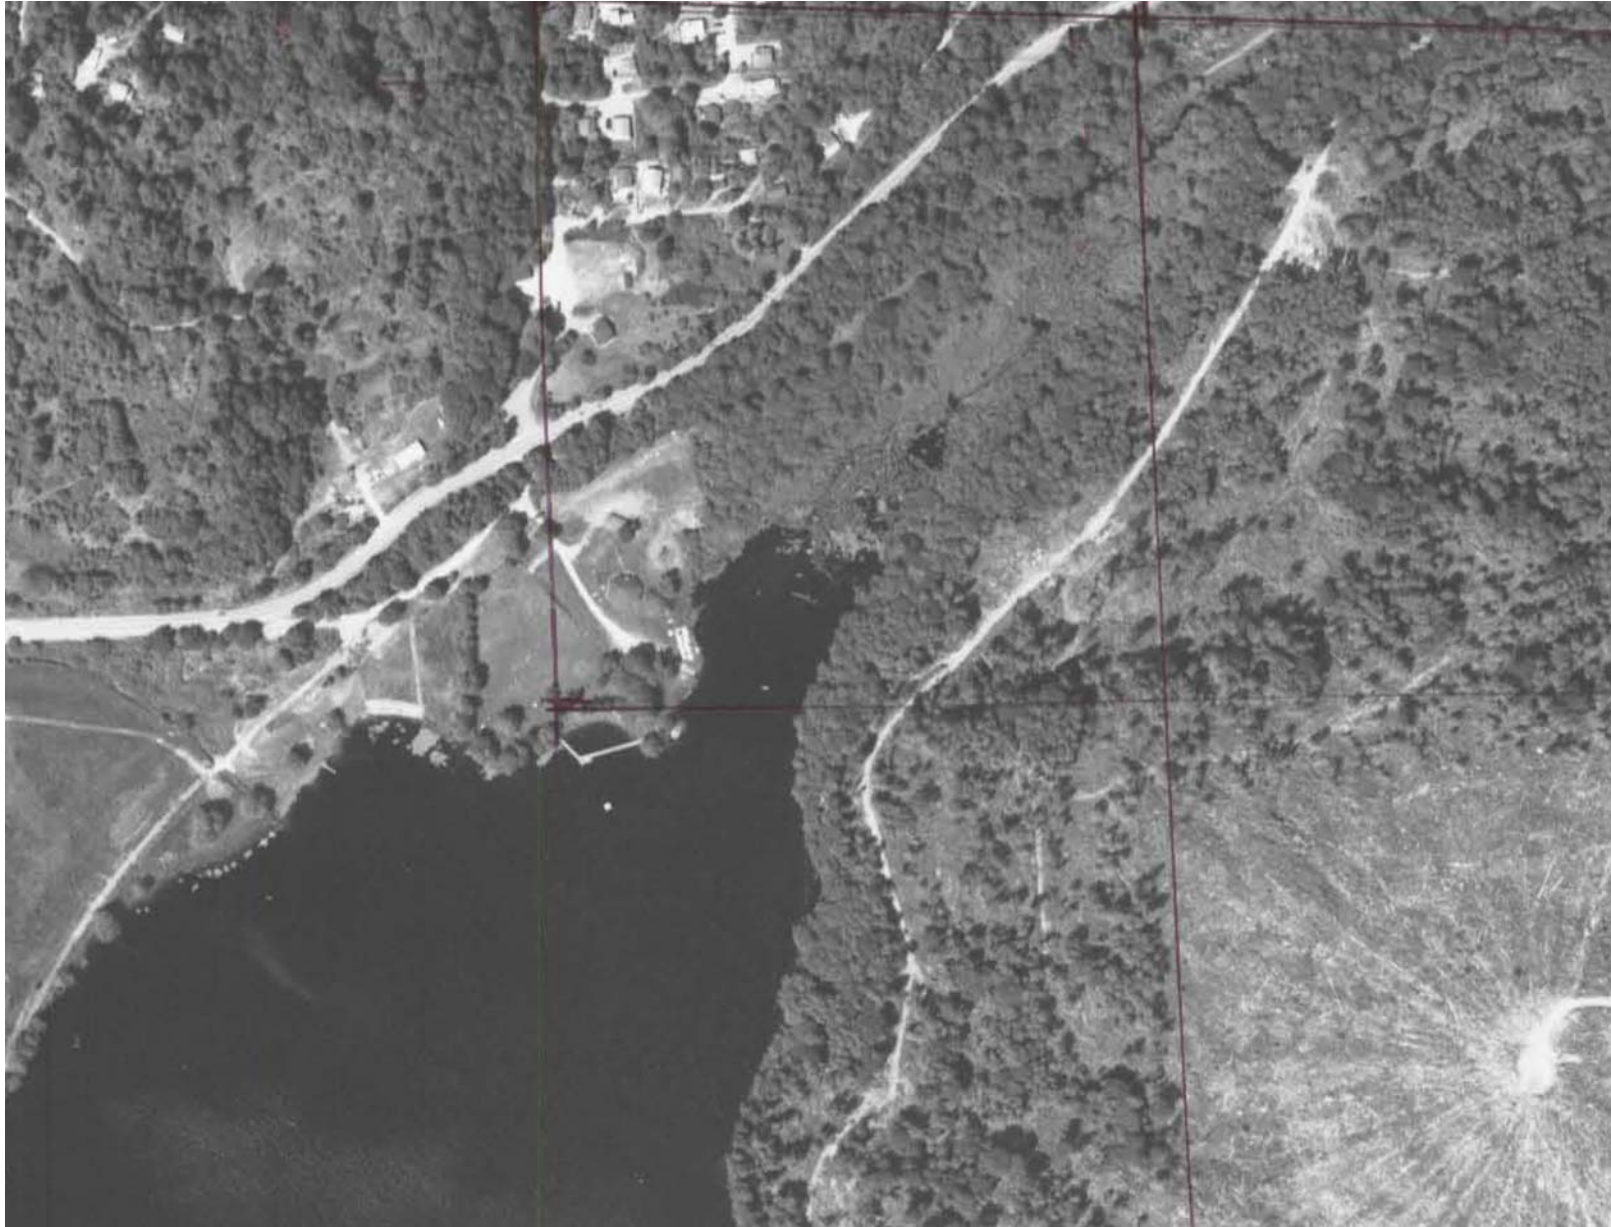
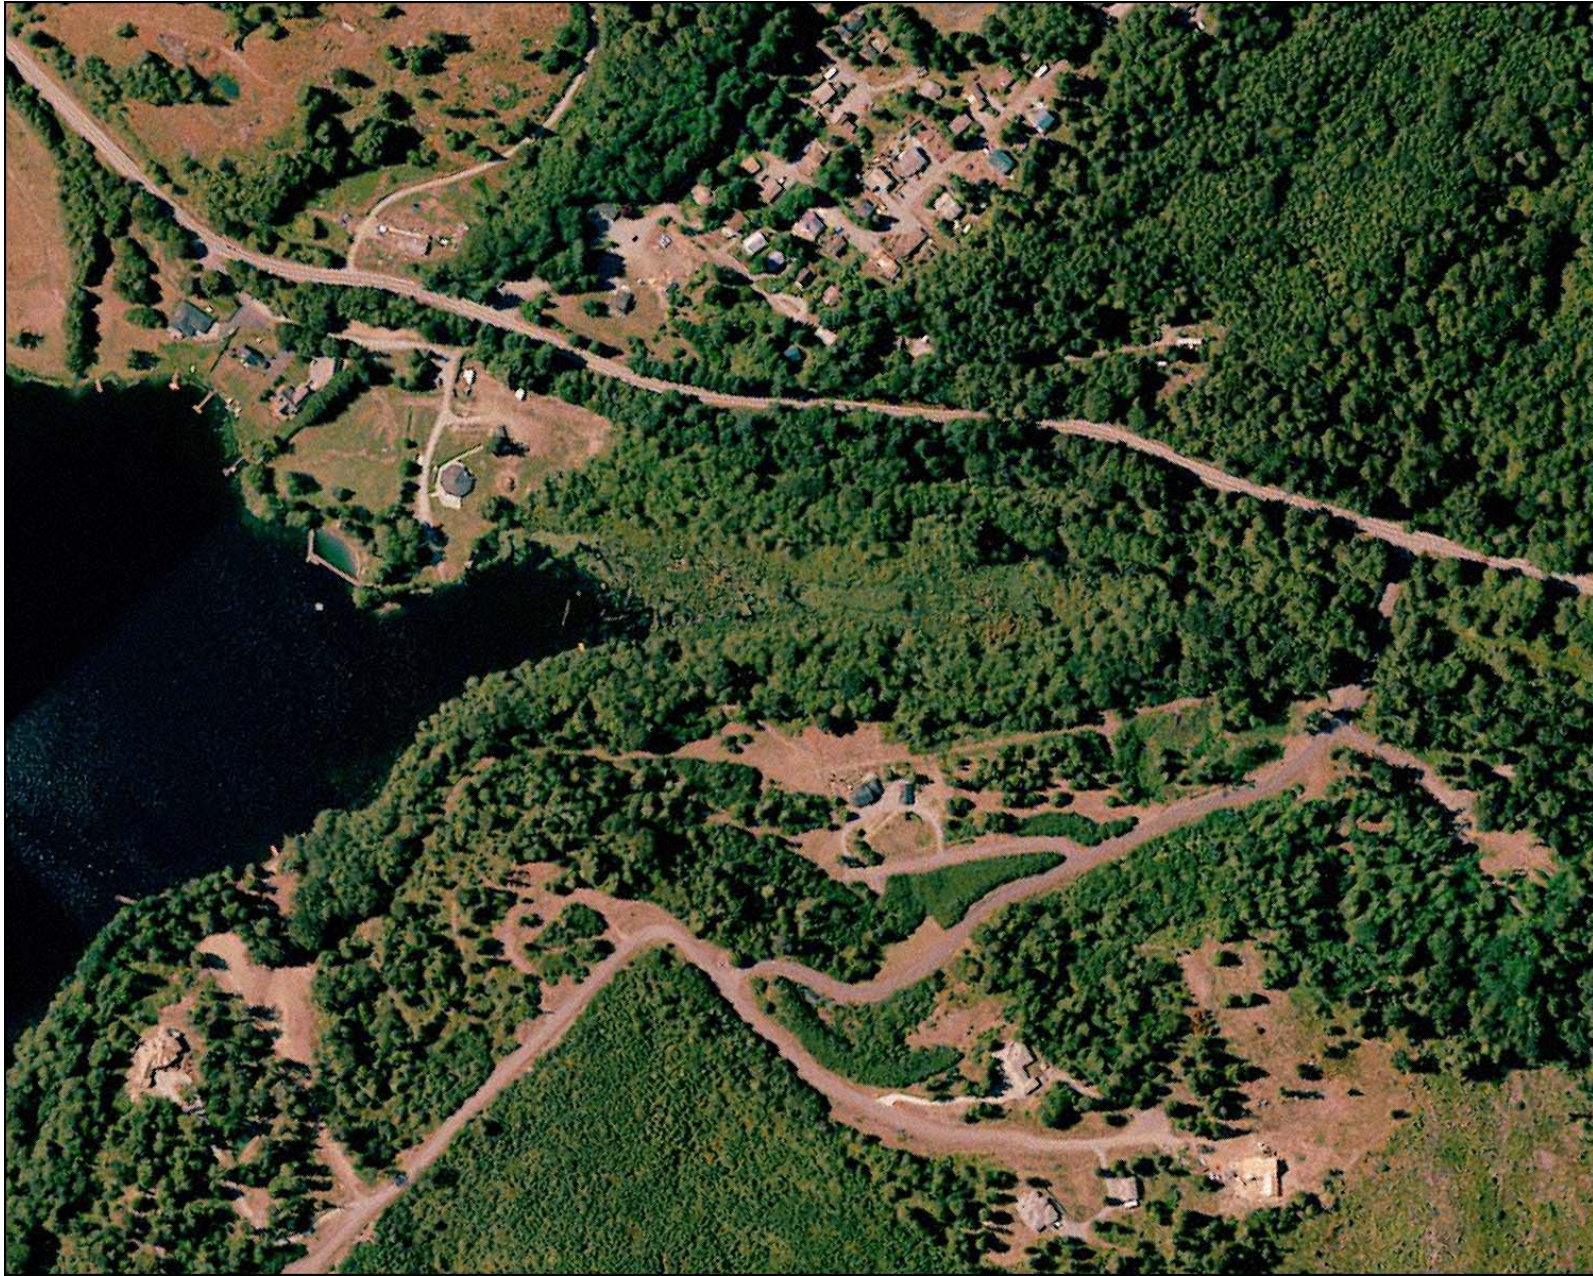
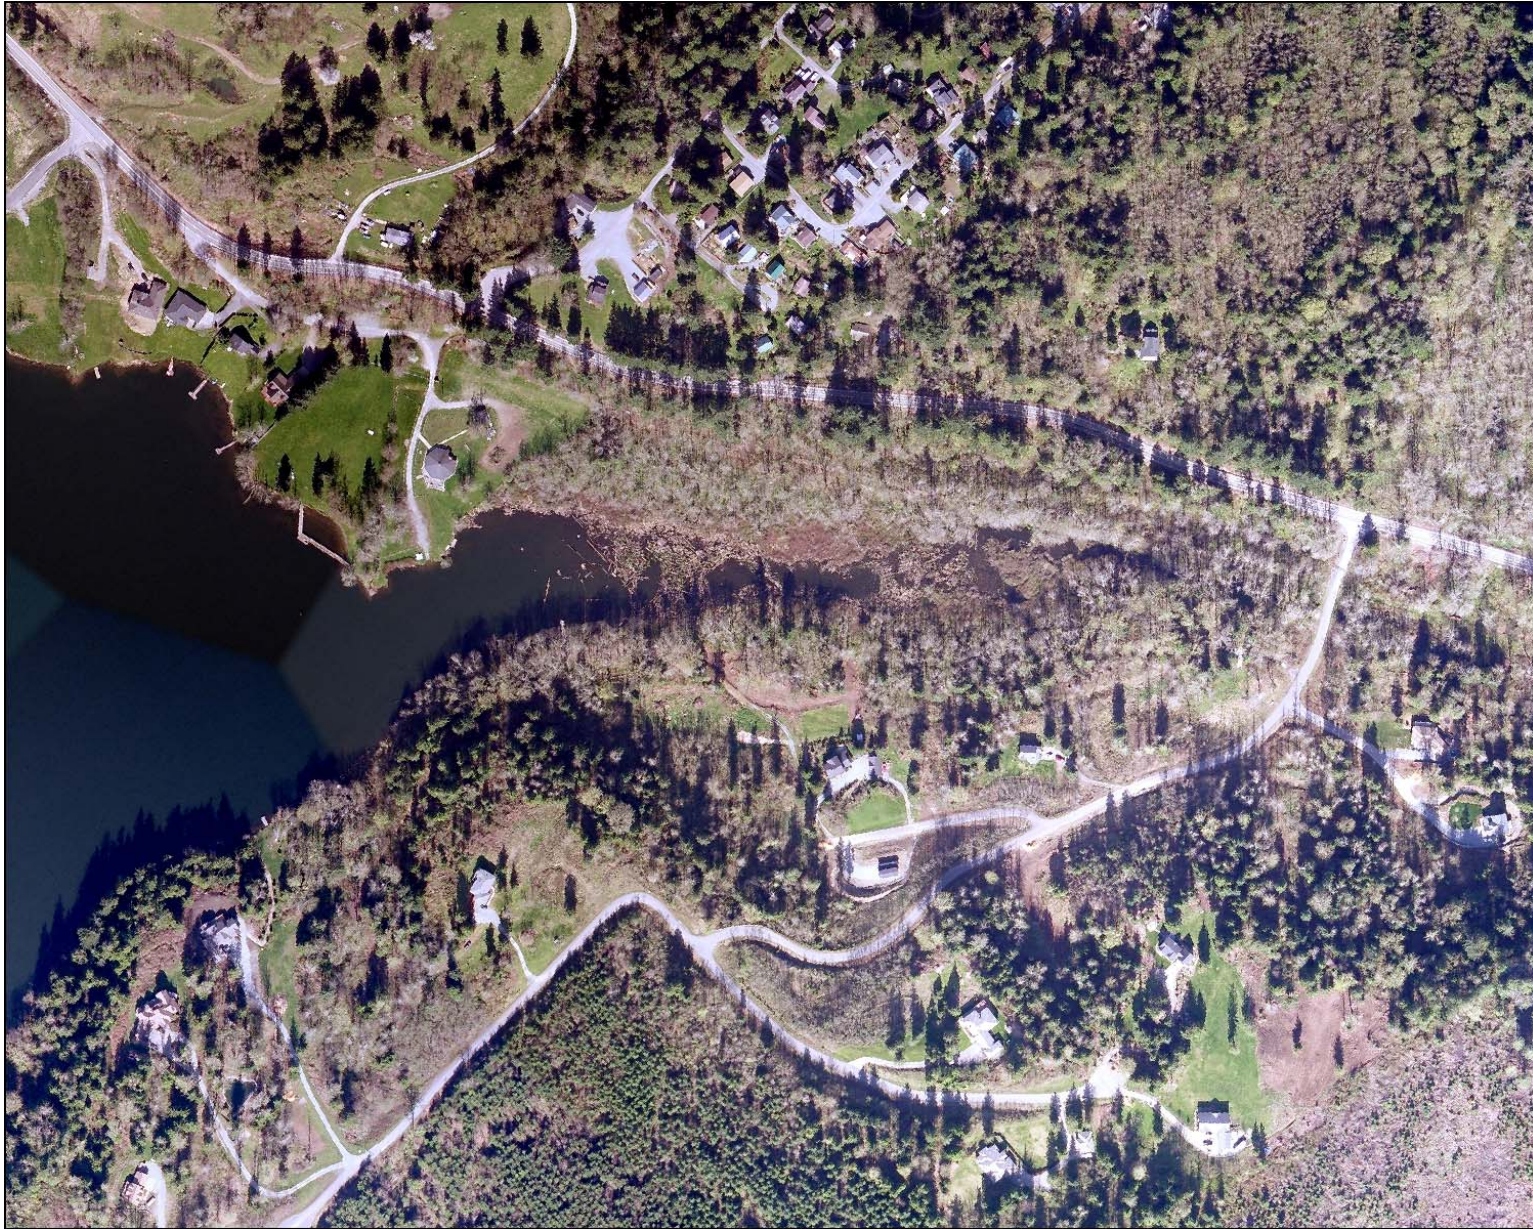
- Fallen trees and debris from the old mill
- Beaver dams
- Dense vegetation

It is believed that all of the items identified by the County contribute to the control of the lake levels. In the past, Atlas Shingle and Lumber Company used a portion of Lake McMurray as a log pond in their milling operations. There are remnants of pilings in the wetlands upstream of upstream most beaver deceiver and a large number of logs visible in the current aerial photography. A series of aerial photos from 1969 to present were collected and reviewed. It appears generally that the accumulation of logs and aquatic vegetation in the outlet are similar in all of the aerial photos (Figures 3 through 7). Although logging has occurred in the watershed, it is not believed that a significant number of new logs have accumulated among the debris at the lake outlet.

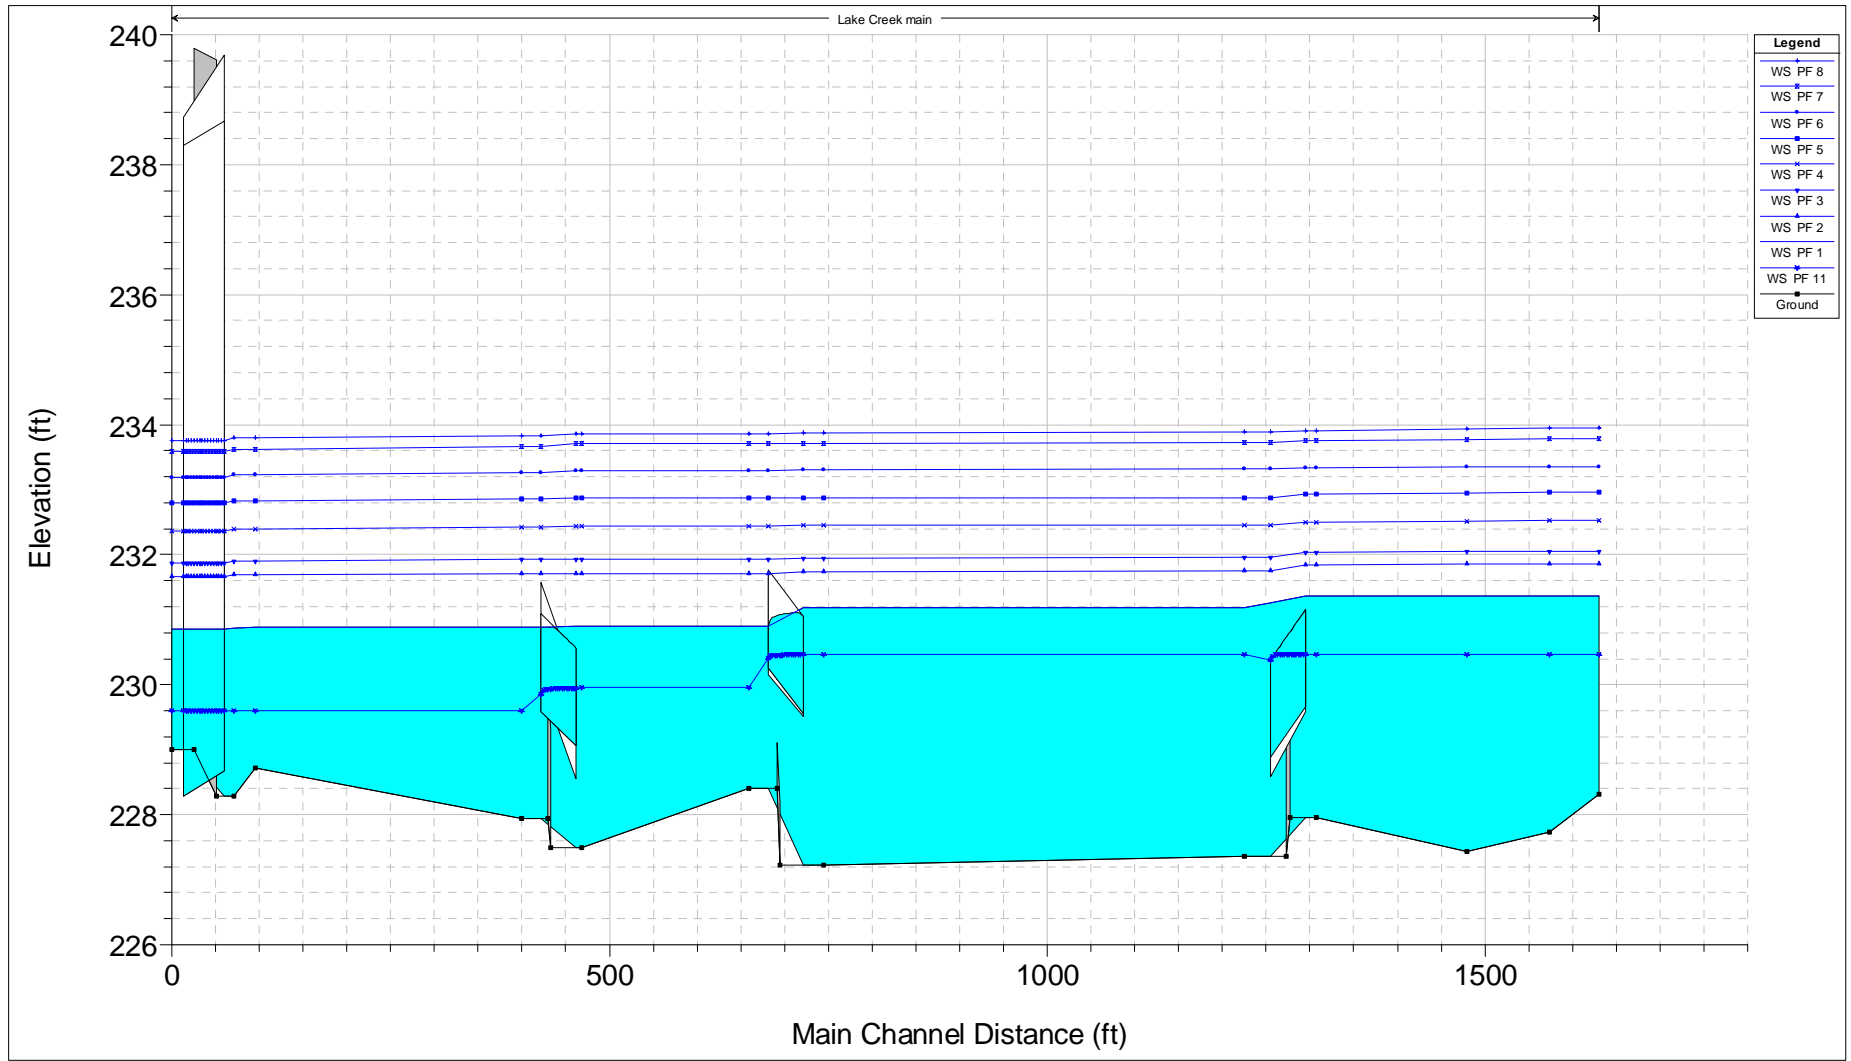
A HEC-RAS model was developed using surveyed sections along the beaver dam crests and the inverts of the beaver deceiver culvert inverts. Manning's roughness values and ineffective flow areas were used to retard flows so that the water surface elevations matched the surveyed water levels reasonably well under very low flows. The model results show that the beaver dams and beaver deceivers would be completely inundated during flood events. Figure 8 provides the HEC-RAS flood profiles for the existing conditions. Because of the very low gradient of the outlet and Lake Creek, the velocities remain very low at significant distance downstream of the McMurray Shore Drive culverts, and stage does not increase appreciably between the culverts and the lake. This is consistent with what was shown by the County water level monitoring data (Figure 2).

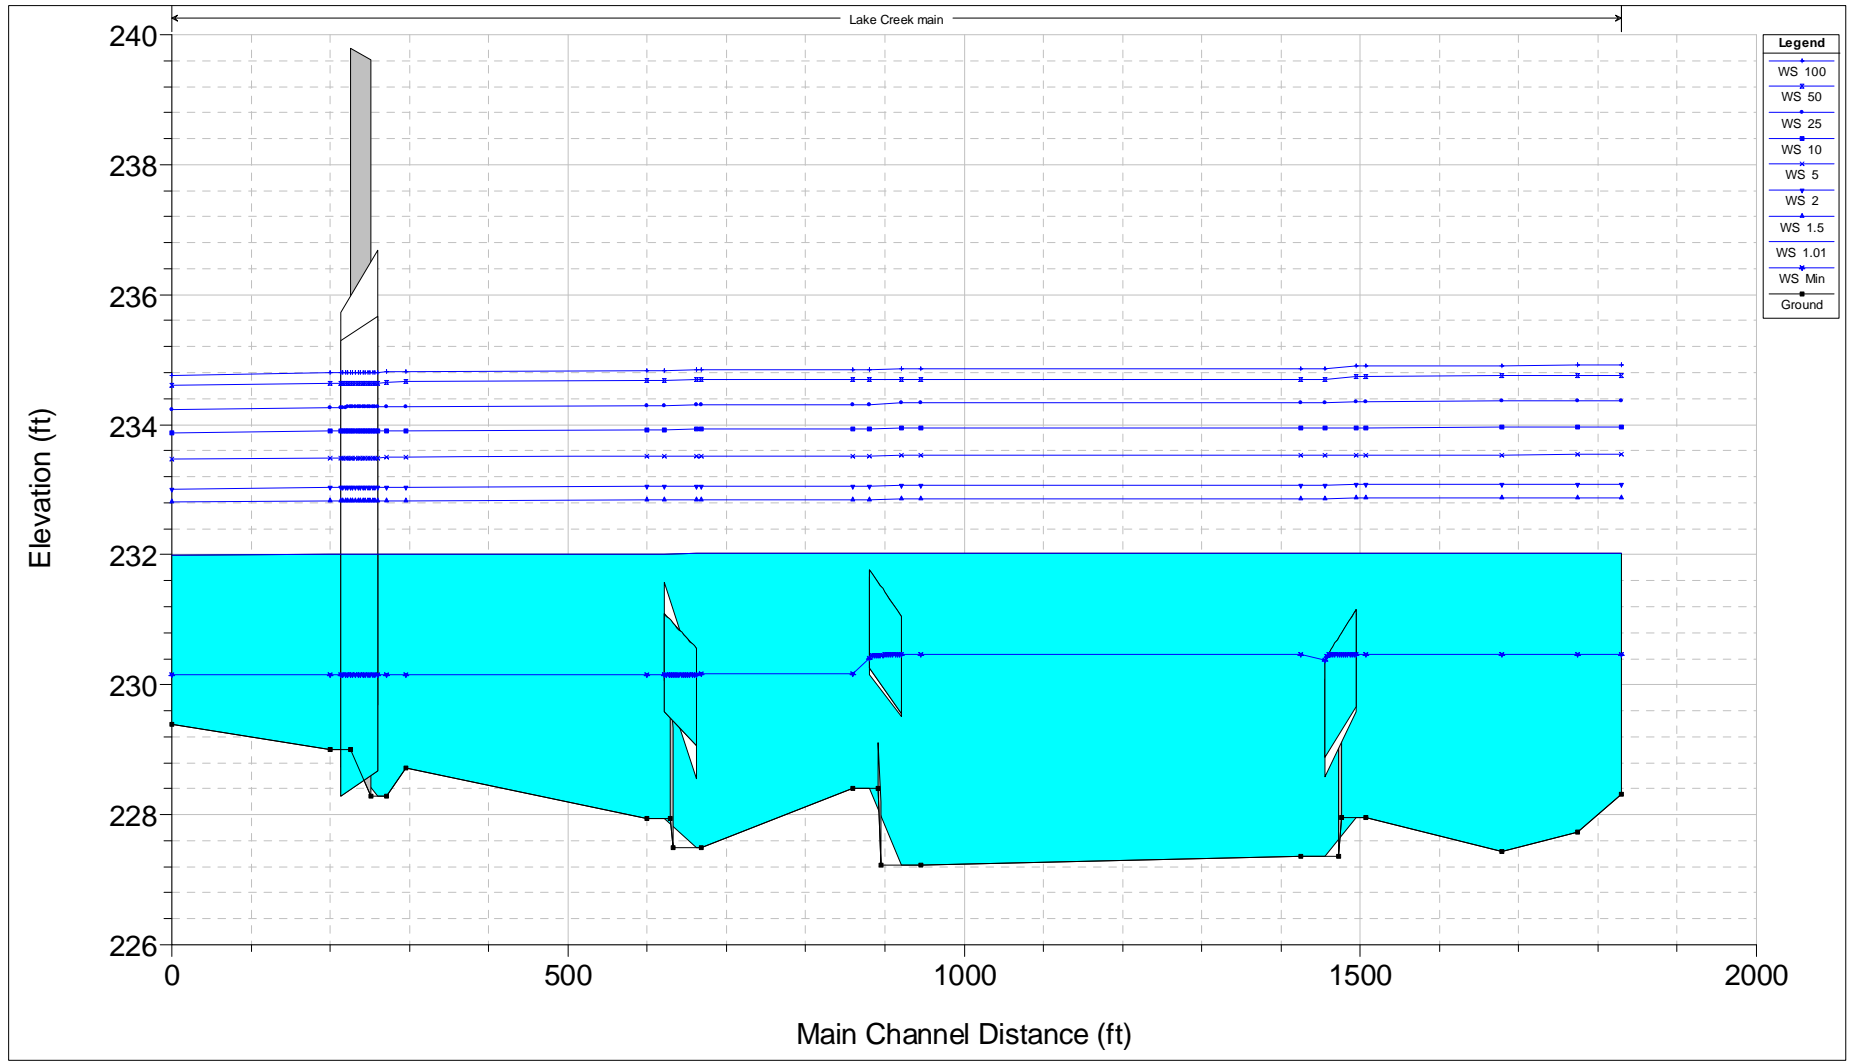
hydraulic profile with those improvements with the gravel bar, as it was surveyed in December 2009. As shown in the profile, the improvements have essentially no effect compared to existing conditions (Figure 9).

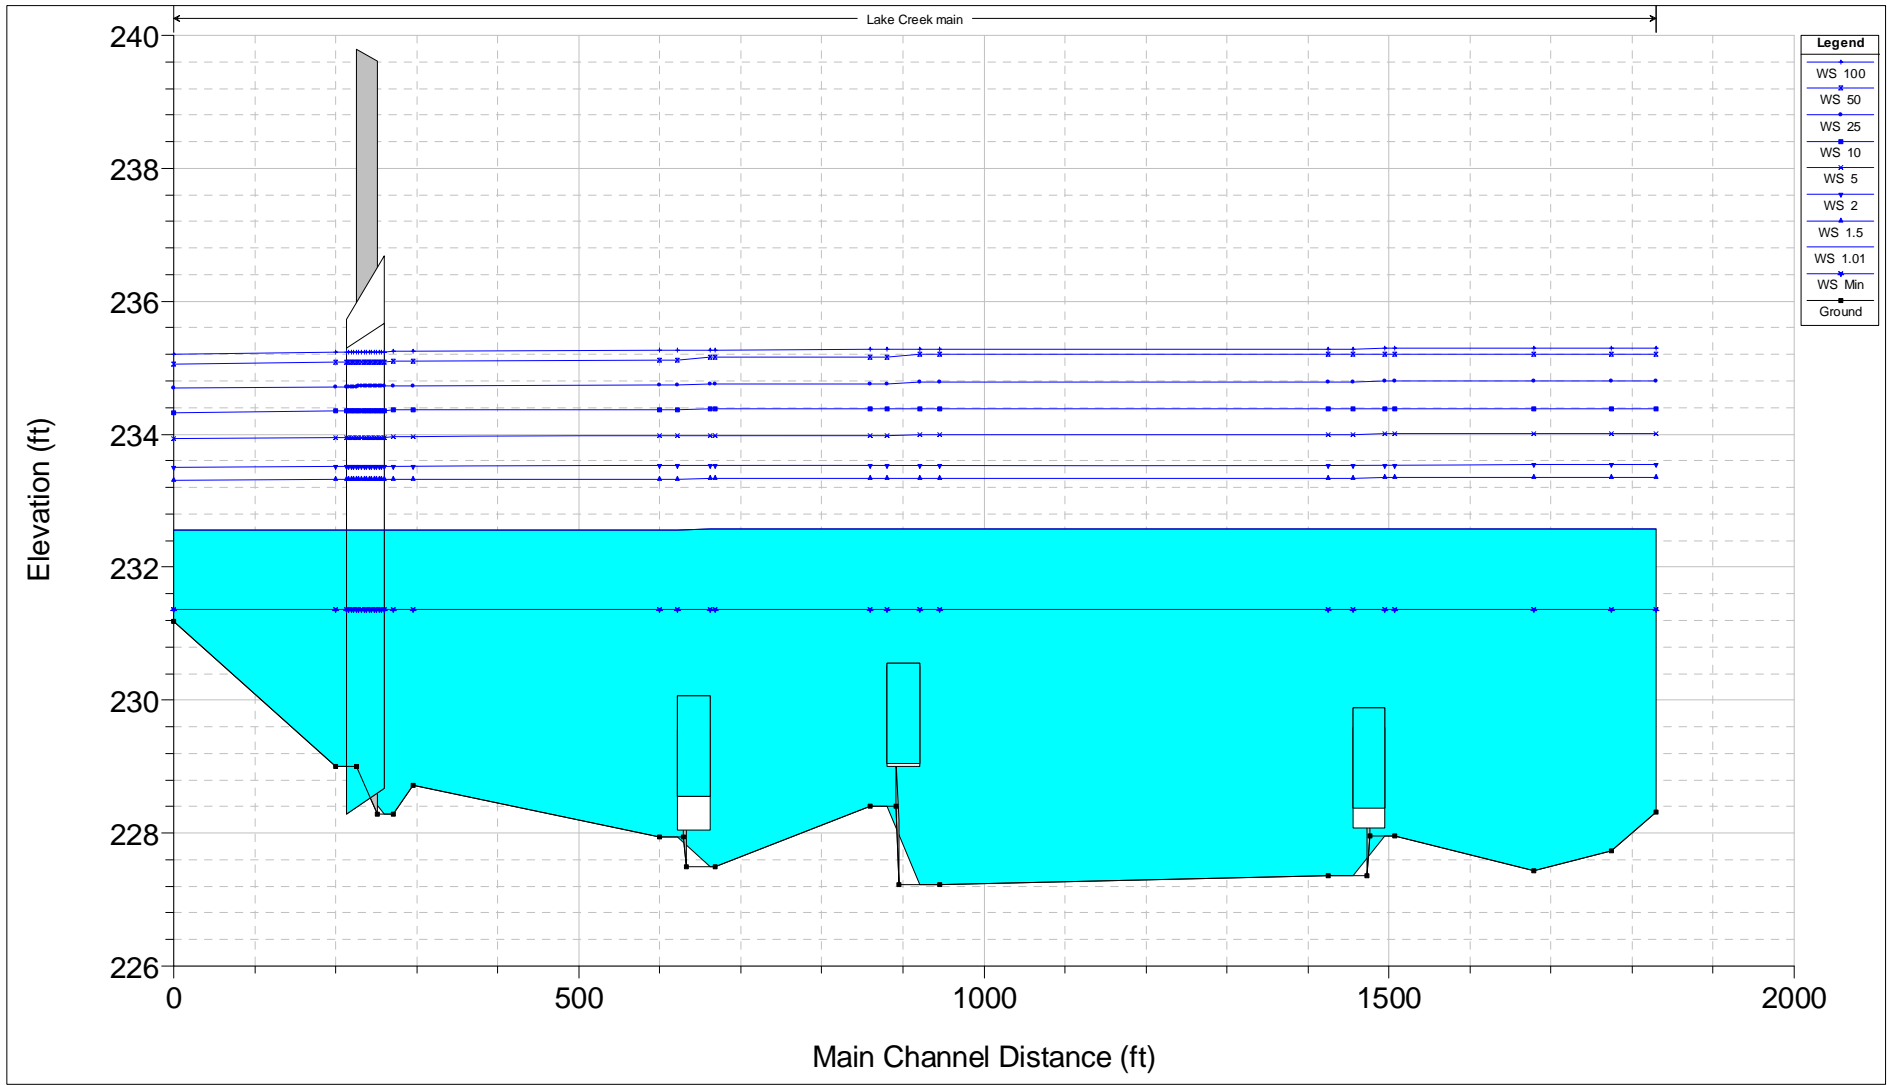
Figure 11 shows the hydraulic profile of a condition with the gravel bar completely blocking the channel (channel filled to the crest of the riffle observed in December 2009). Although it is unlikely that this condition could be maintained for a significant period of time or that it could persist at the highest flows, Figure 11 shows that filling the channel would cause a significant rise in lake level under frequent flood events (e.g. the annual flood would increase the lake level about 6 inches compared to the existing condition, and a 5-year flood would have similar results to the January 2009 flood).

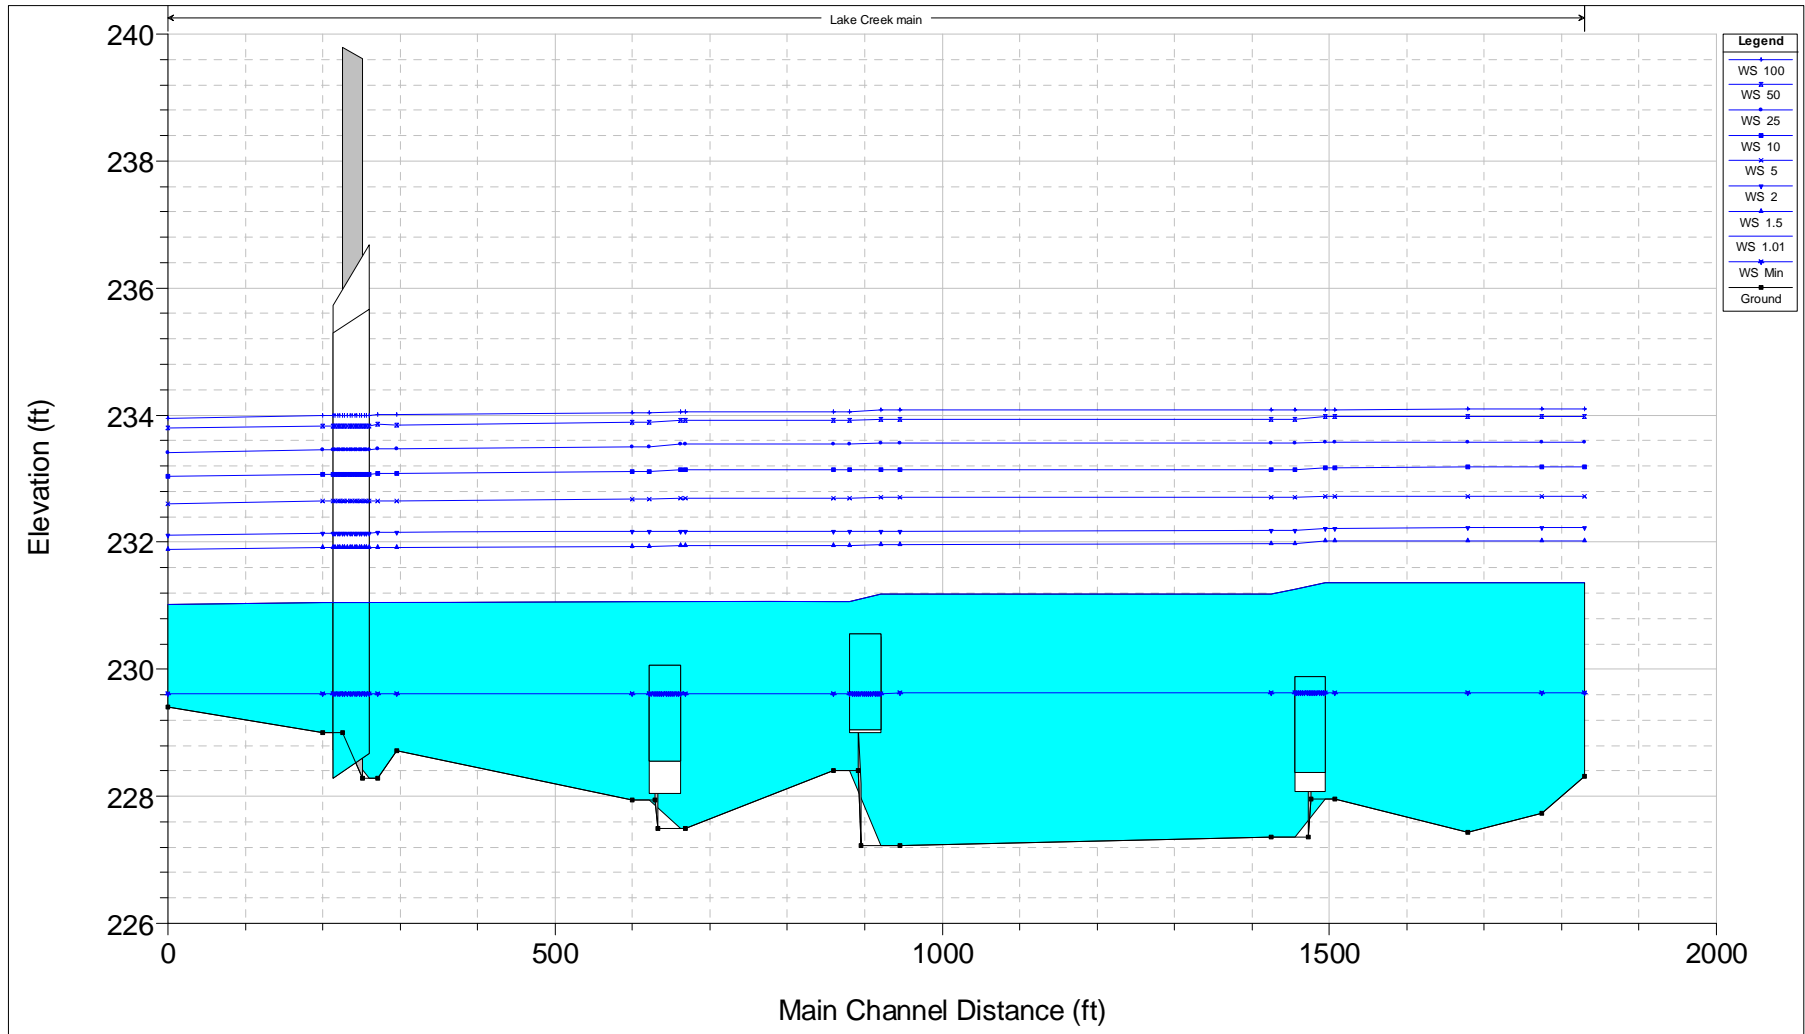
Figure 12 shows the hydraulic profile of a condition with the gravel bar removed across the full channel width (approximately 20 feet) to a depth of the surveyed invert. Figure 12 shows the maximum benefit that could be achieved. This is because after clearing the channel and making the upstream improvements, the channel may refill after a single large storm event or more gradually over a longer period of time. Figure 12 also shows that the minimum lake level would be slightly reduced, and that more significant floods would not result in lake levels experienced in the January 2009 flood.

Therefore, based on this initial assessment and in light of the likely permitting constraints, Anchor QEA recommends that the County pursue permits to:
