FINAL FLOOD REDUCTION INVESTIGATION FOR LAKE McMURRAY, HULL DRIVE & HULL ROAD

Prepared for:
Skagit County Public Works
1800 Continental Place
Mount Vernon, WA 98273

Prepared by:
  **WATERSHED**
SCIENCE & ENGINEERING
506 2nd Avenue, Suite 2700
Seattle, WA 98104
206-521-3000

January 7, 2021

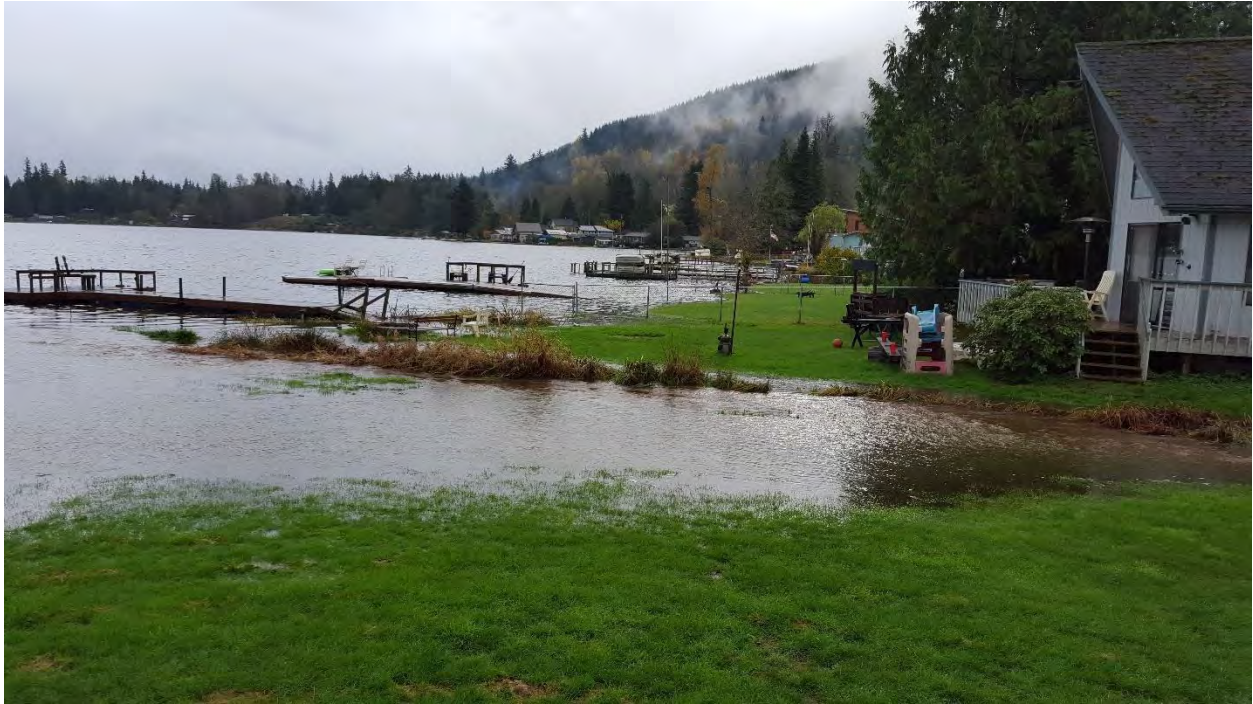
Photo 1. High lake levels during winter flood. Photo is immediately north of where Lake Creek empties into the Lake McMurray. (Photo provided to County by landowner, photo taken 11-15-2015).

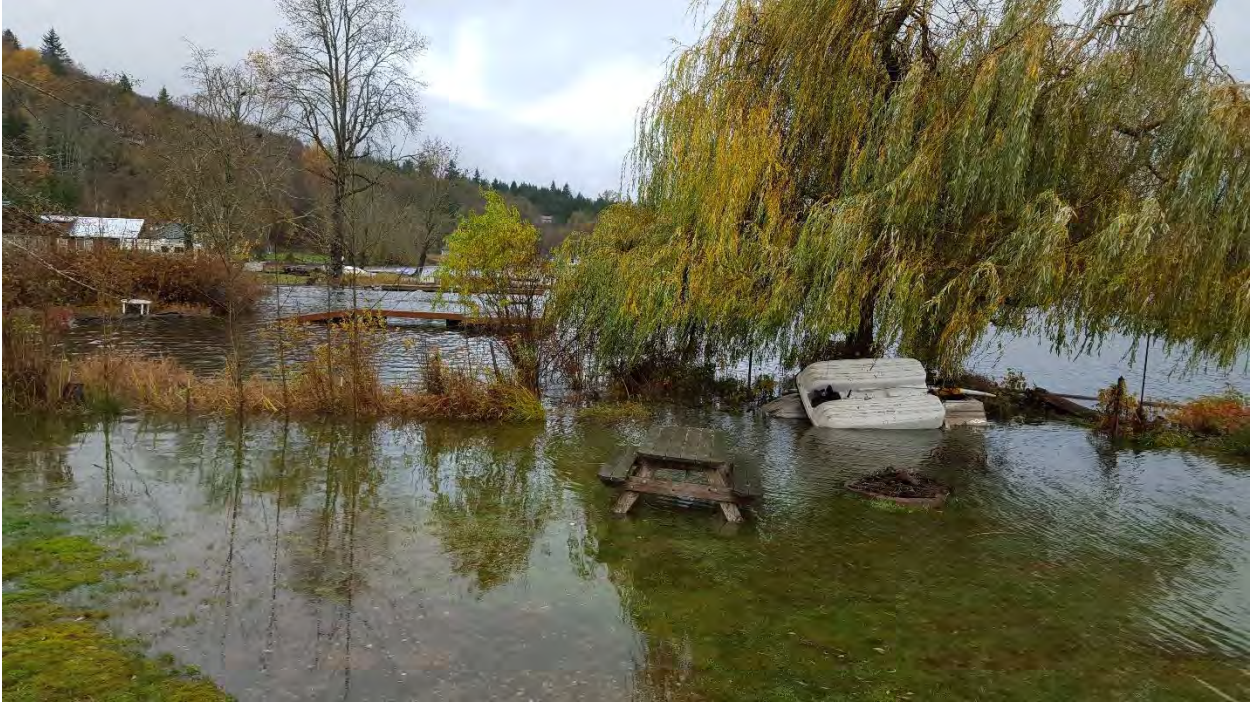
Photo 2. High lake levels during winter flood. Photo is immediately north of where Lake Creek empties into the Lake McMurray. (Photo provided to County by landowner, photo taken 11-15-2015).

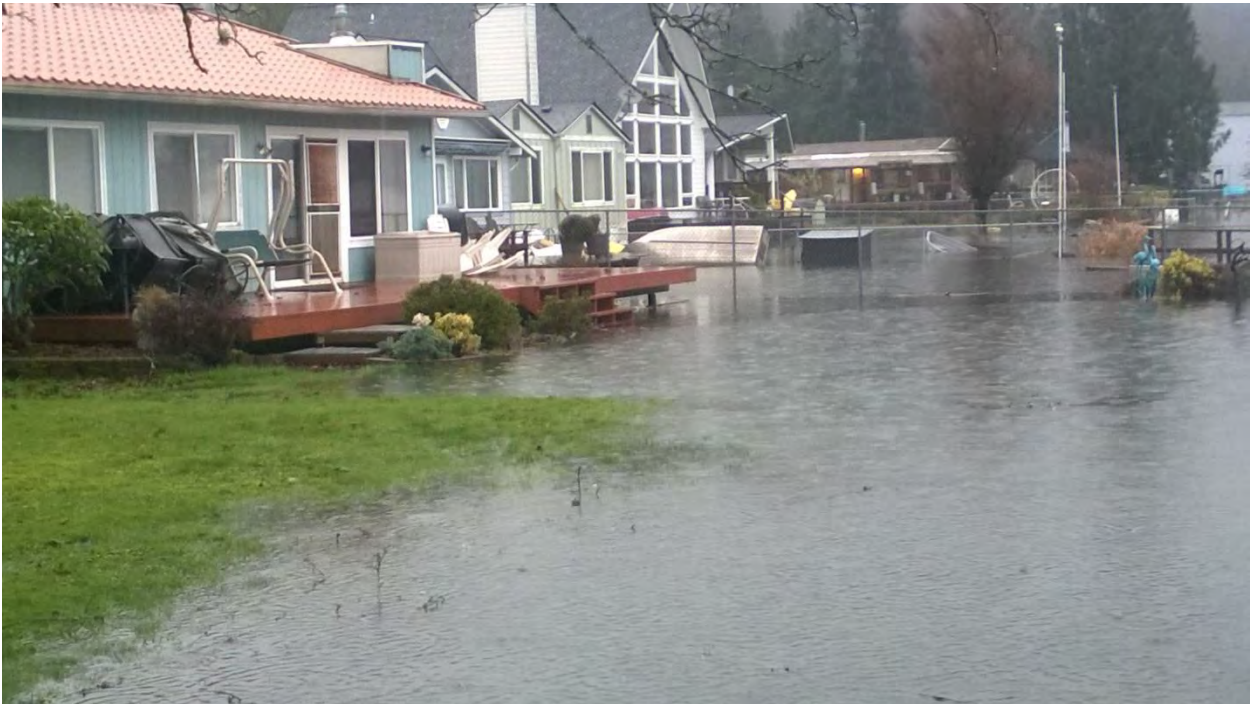
Photo 3. High lake levels during winter flood. Photo is looking north from approximately 300 feet south of where Lake Creek empties into the Lake McMurray. (Photo provided to County by landowner, photo taken 2-5-2018).

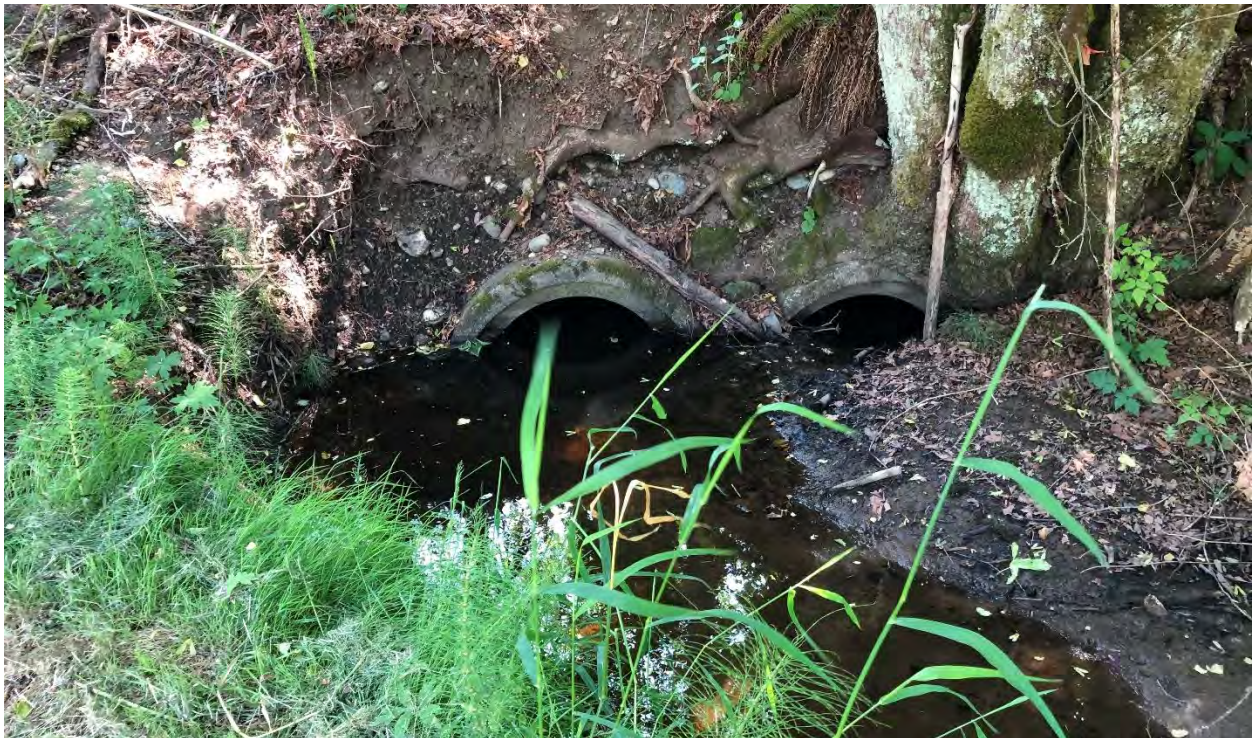
Water from Lake Creek and the unnamed creek flood a large area of land along the upstream (west) side of the abandoned railroad berm (Figures 6 to 9). The water ponds because the existing culverts under the berm do not have the capacity to pass the flow in-part because they are 50% plugged with sediment (Photo 5) and they are too small even if they were free of sediment. Other factors contribute to the ponding as well including the flatness of Lake Creek and the unnamed creek, thick vegetation leading to the culverts, and the near 90-degree right-hand turn the channel must make to enter the culverts. The ponding impacts one home located just upstream (west) of the culverts and contributes to the flooding described in item 4.

Photo 5. Viewing downstream (east) to the inlets of the culverts under the abandoned railroad berm. The culverts are partially plugged with sediment (May 30, 2019).

3. Increase the size of the channel between Hull Road and Lake McMurray, replace the Hull Road culvert with a fish passable culvert, and either clean, replace, or remove the abandoned railroad culverts. This will eliminate or reduce flooding at the house upstream of the abandoned railroad berm, in the RV park, and on five additional lake front properties during the 100-year event.

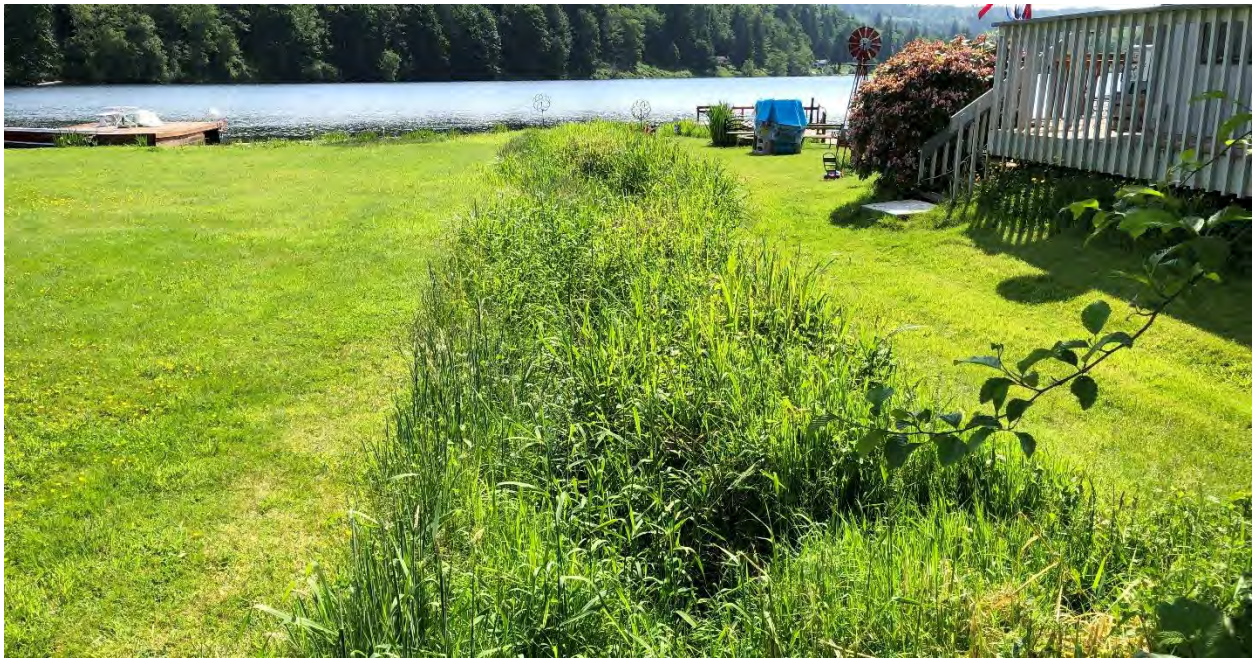
The channel between Hull Road and the lake was choked with grass and sediment (Photos 7 and 8). Fortunately, flooding along both properties has been limited due in part to the limited capacity of the Hull Road and abandoned railroad berm culverts (Photos 9 and 10). Flooding caused by the high lake level has been the primary problem for both properties (Figures 6 to 9). This channel segment will need to be cleaned periodically to maintain capacity to prevent flooding, regardless of whether the culverts under Hull Road or the abandoned railroad berm are enlarged.

Photo 8. Viewing downstream (east) along the channel between Hull Road and Lake McMurray. Channel is choked with grass (May 30, 2019).

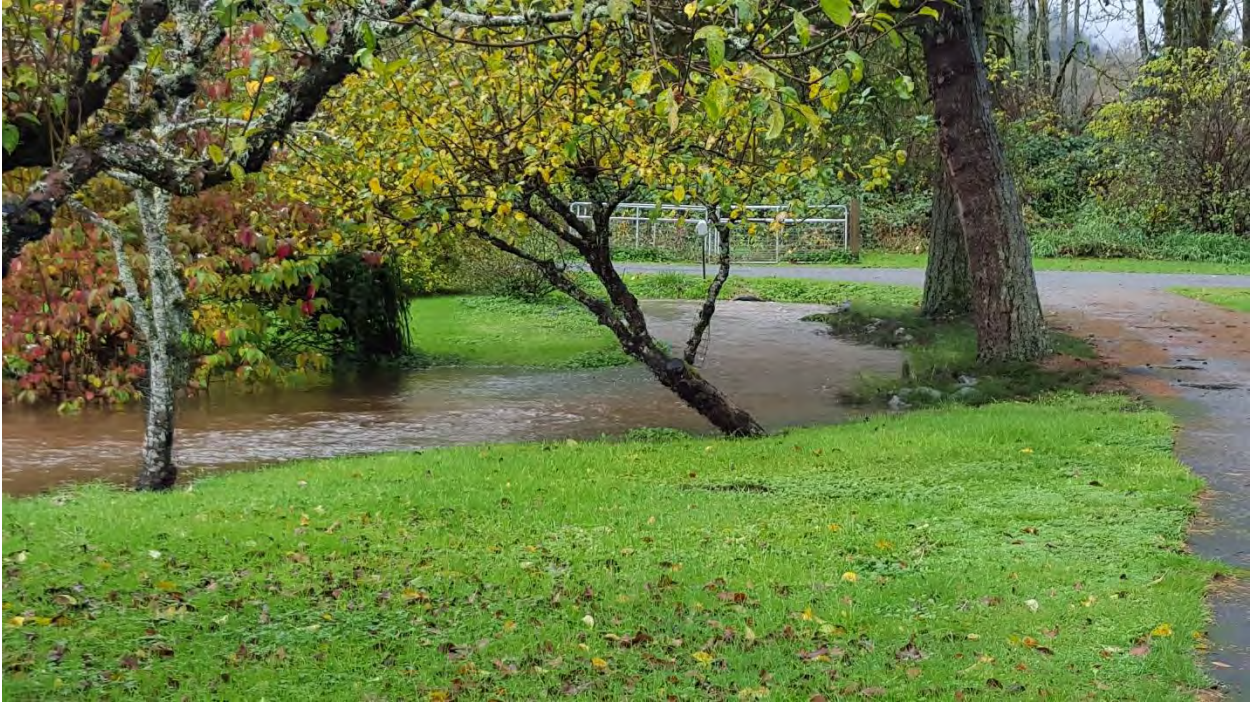
Photo 9. Viewing upstream (west) to Hull Road culvert along the channel that leads to the lake. (Photo provided to County by landowner, November 15, 2015).

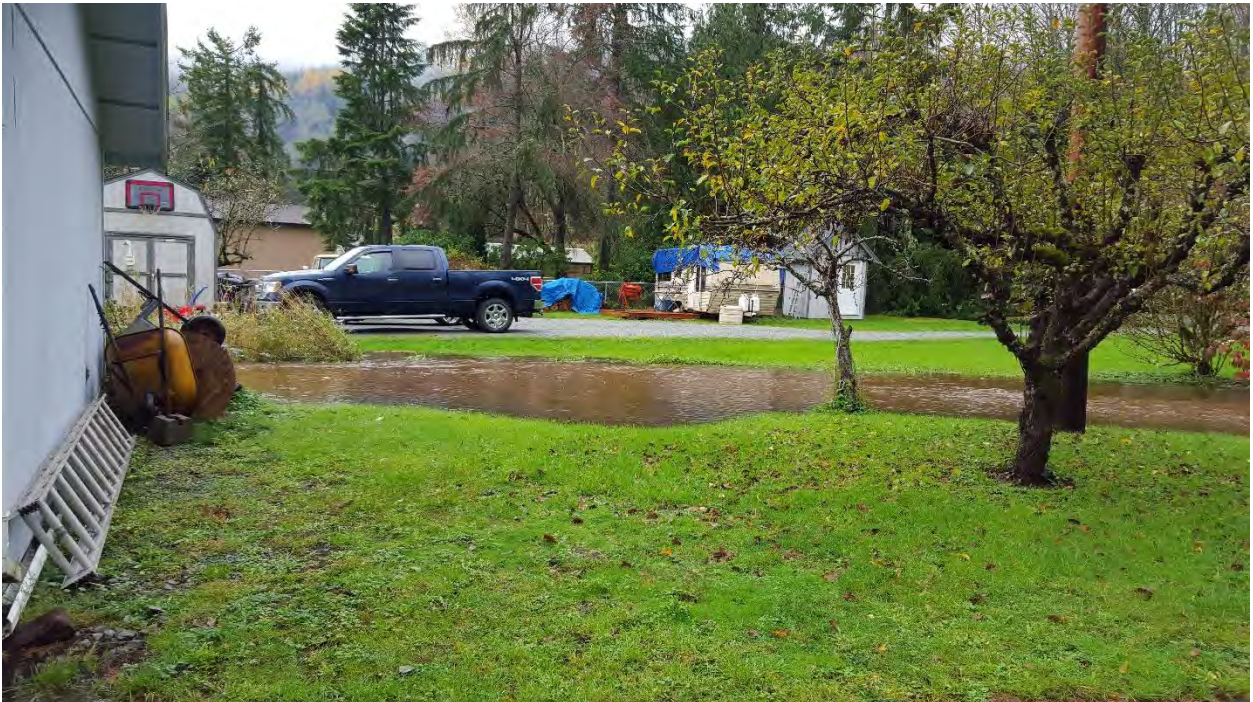
Photo 10. Viewing south across channel that leads to the lake. (Photo provided to County by landowner, November 15, 2015).

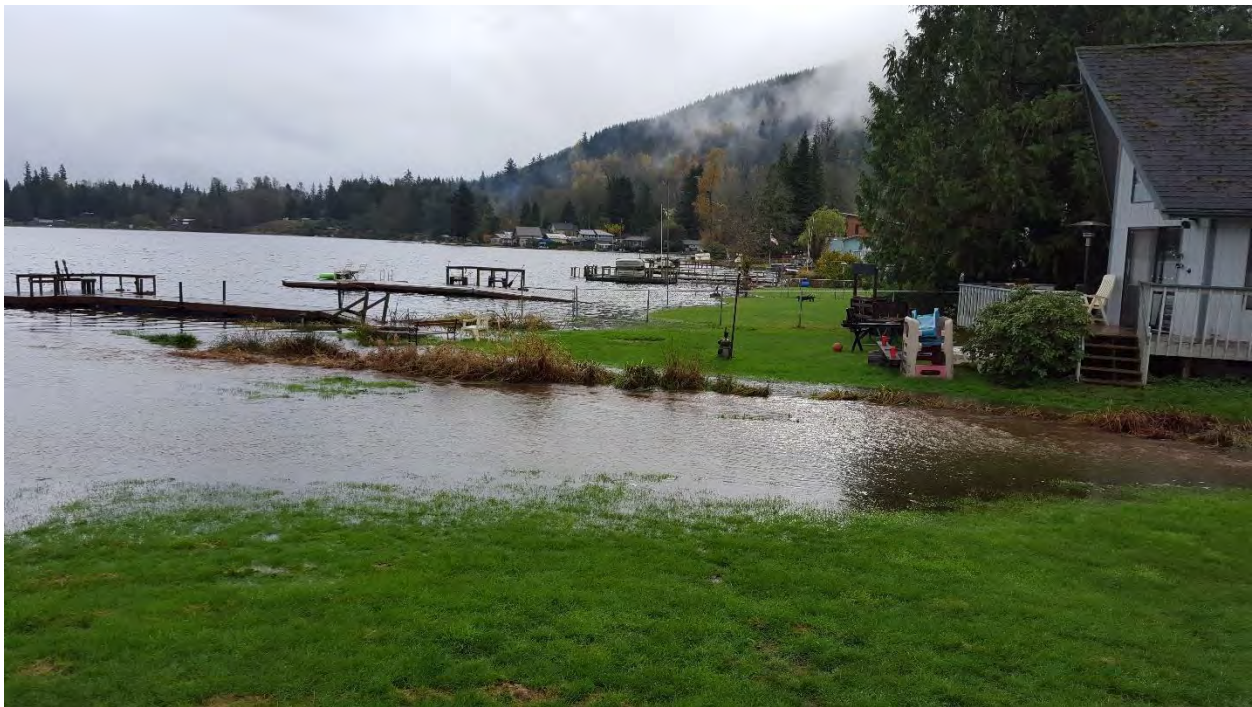
Flood photos from three different high lake level events were provided to the County by lakefront landowners. Photos 1 to 4 show examples of flooding that occurred in November 2015, February 2018, and during an event following these, for which the date is unknown. The property owners mentioned that the high lake levels typically occur during long duration heavy rains and that levels remain high for many days. They also said that during these events, lake levels rise 1 to 2 feet above the typical non-flood level. This information appears to confirm that inflows exceed outflows during long duration winter rain events. It is also reasonable to conclude that the lake outlet channel does not have the capacity needed to drain the lake rapidly enough during and after these rain events.

Photo 1. High lake levels during winter flood. Photo is viewing south at the location where Lake Creek flows into the Lake McMurray. (Photo provided to County by landowner, photo taken 11-15-2015).

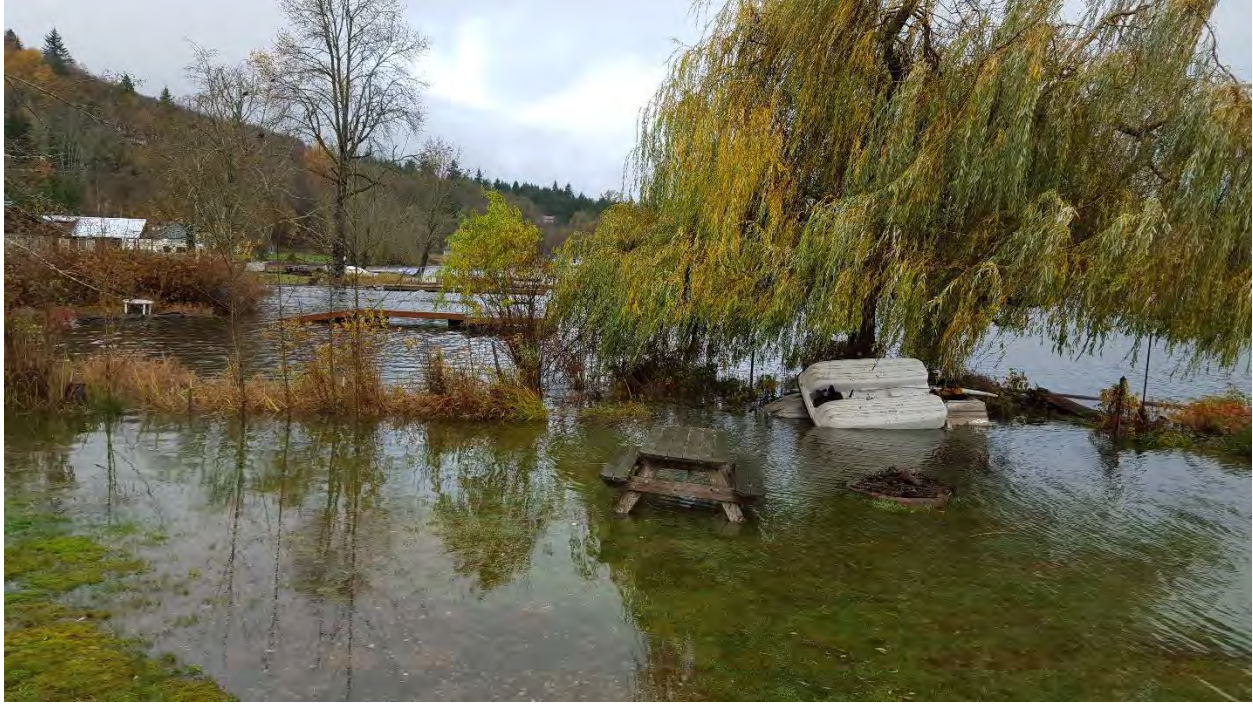
Photo 2. High lake levels during winter flood. Photo is viewing north from the same location as Photo 1. (Photo provided to County by landowner, photo taken 11-15-2015).

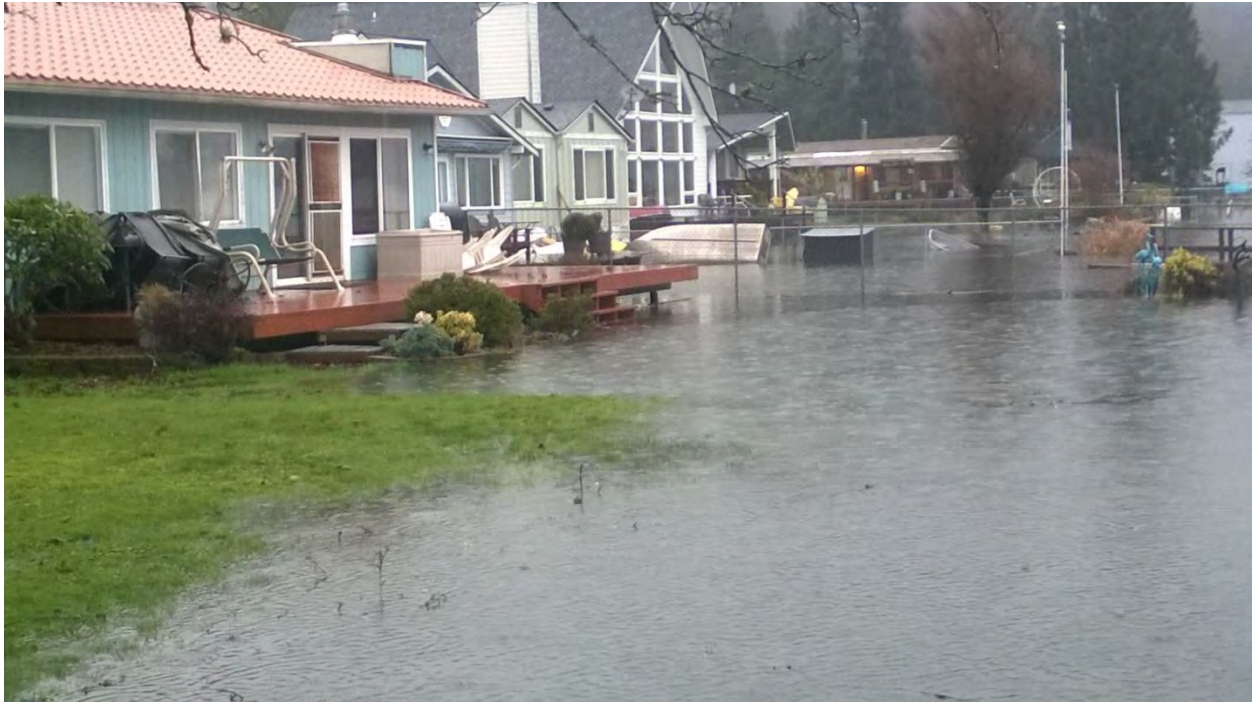
Photo 3. High lake levels during winter flood. Photo is looking north from approximately 300 feet south of where Lake Creek enters Lake McMurray. (Photo provided to County by landowner, photo taken 2-5-2018).

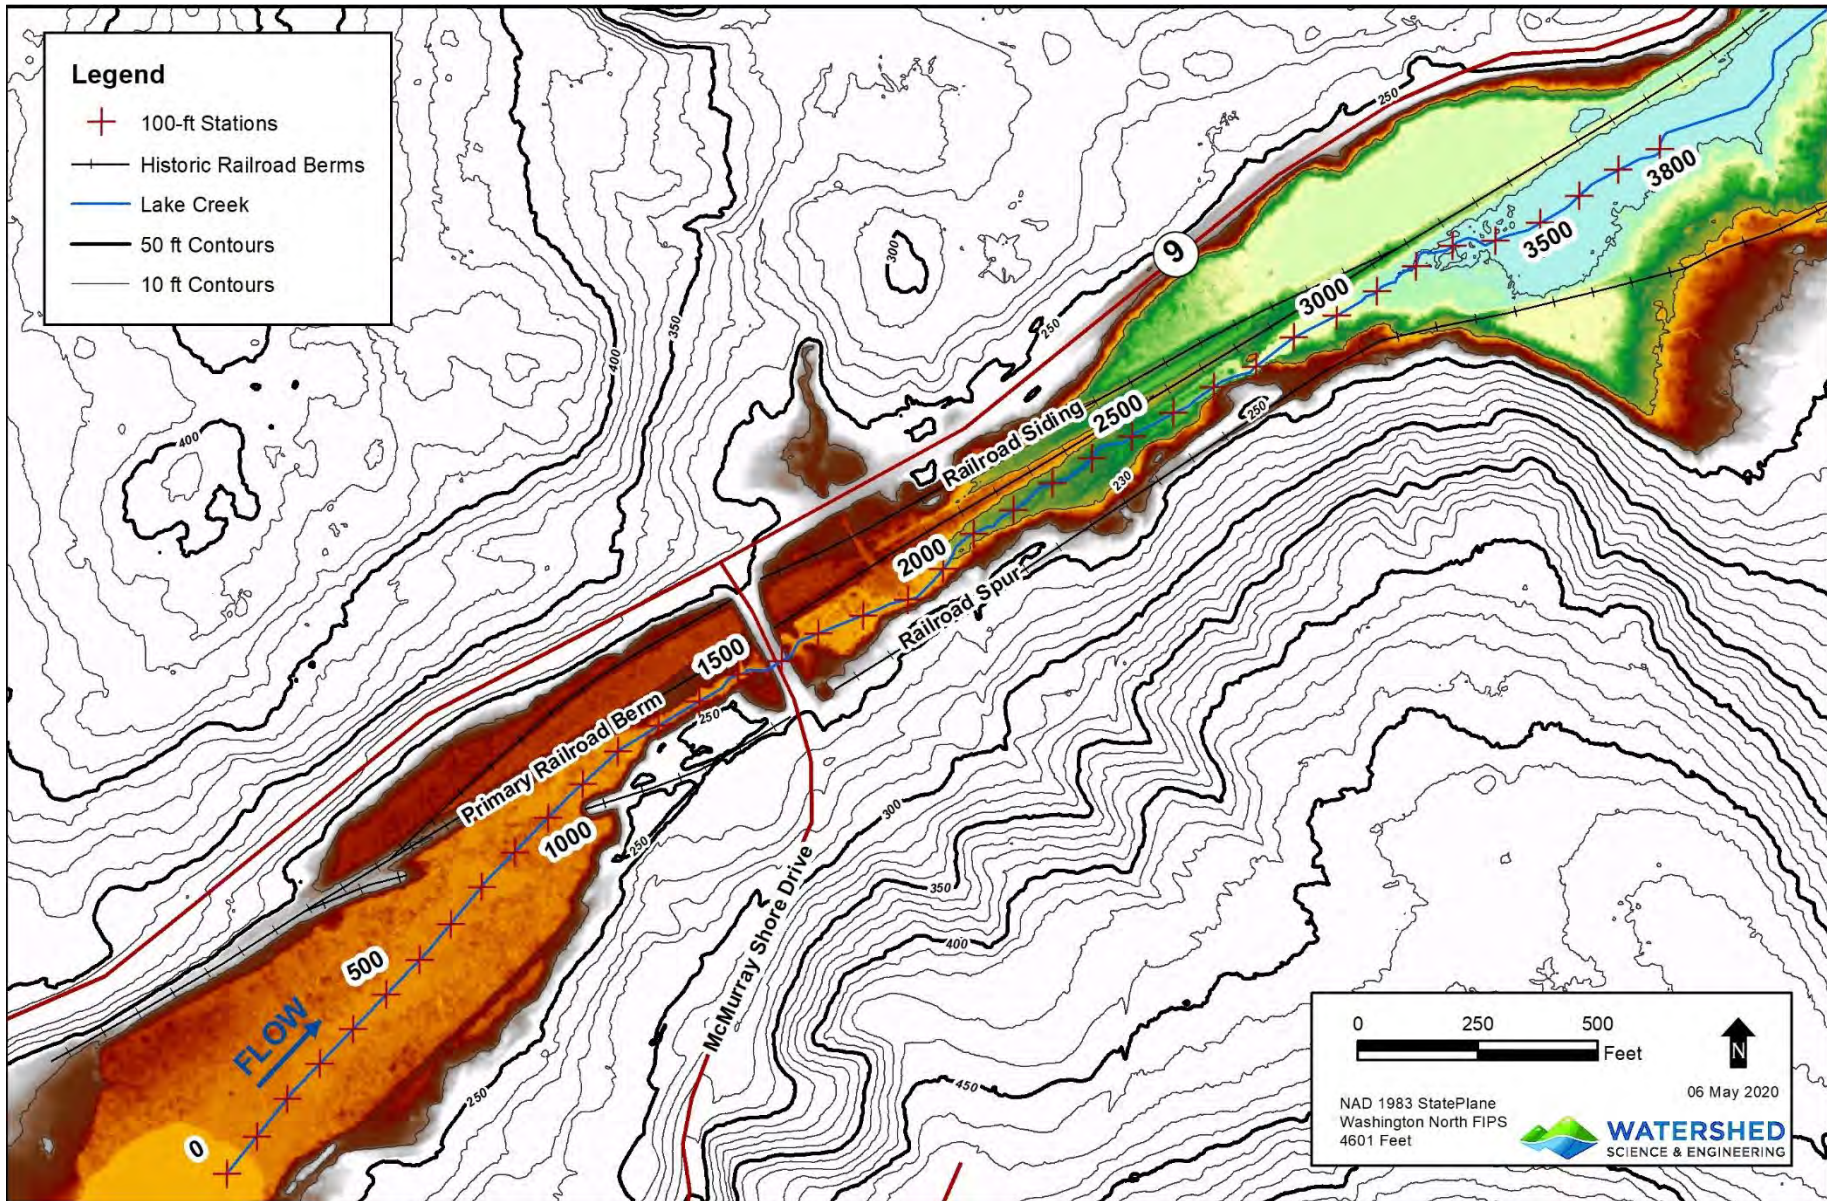
Figure 2. Lake McMurray Outlet Topography

The first task of the investigation was to examine the size, shape, and slope of the outlet channel, which as noted in the introduction is identified as Lake Creek. The topographic map in Figure 2 shows the planform size and shape of the outlet. The map was created from 2017 North Puget Sound LiDAR Data (Quantum Spatial, 2017). The colored area is the valley floor and the black contours define the confining hills. The LiDAR data does not penetrate the water; therefore, where water was present at the time of the LiDAR flight the figure shows the water surface, not the underlying bathymetry. Figure 2 reveals several features worth noting: 1) McMurray Shores Drive is clearly visible in the center of the figure; 2) the primary historical logging railroad route that follows the valley is visible in the form of a berm that passes through the heart of the valley floor; 3) near the left edge of the image, two earthen spurs extend from this primary berm, one to the south and one to the north. The southern spur extends a short distance then ends in the outlet channel, but reemerges a short distance downstream on the opposite (south) side of the valley floor. We suspect that there once was a trestle that bridged the outlet channel at this location. The spur extending to the north from the primary route is a siding that follows the northern toe of the valley wall and rejoins the primary berm near the right edge of the image.

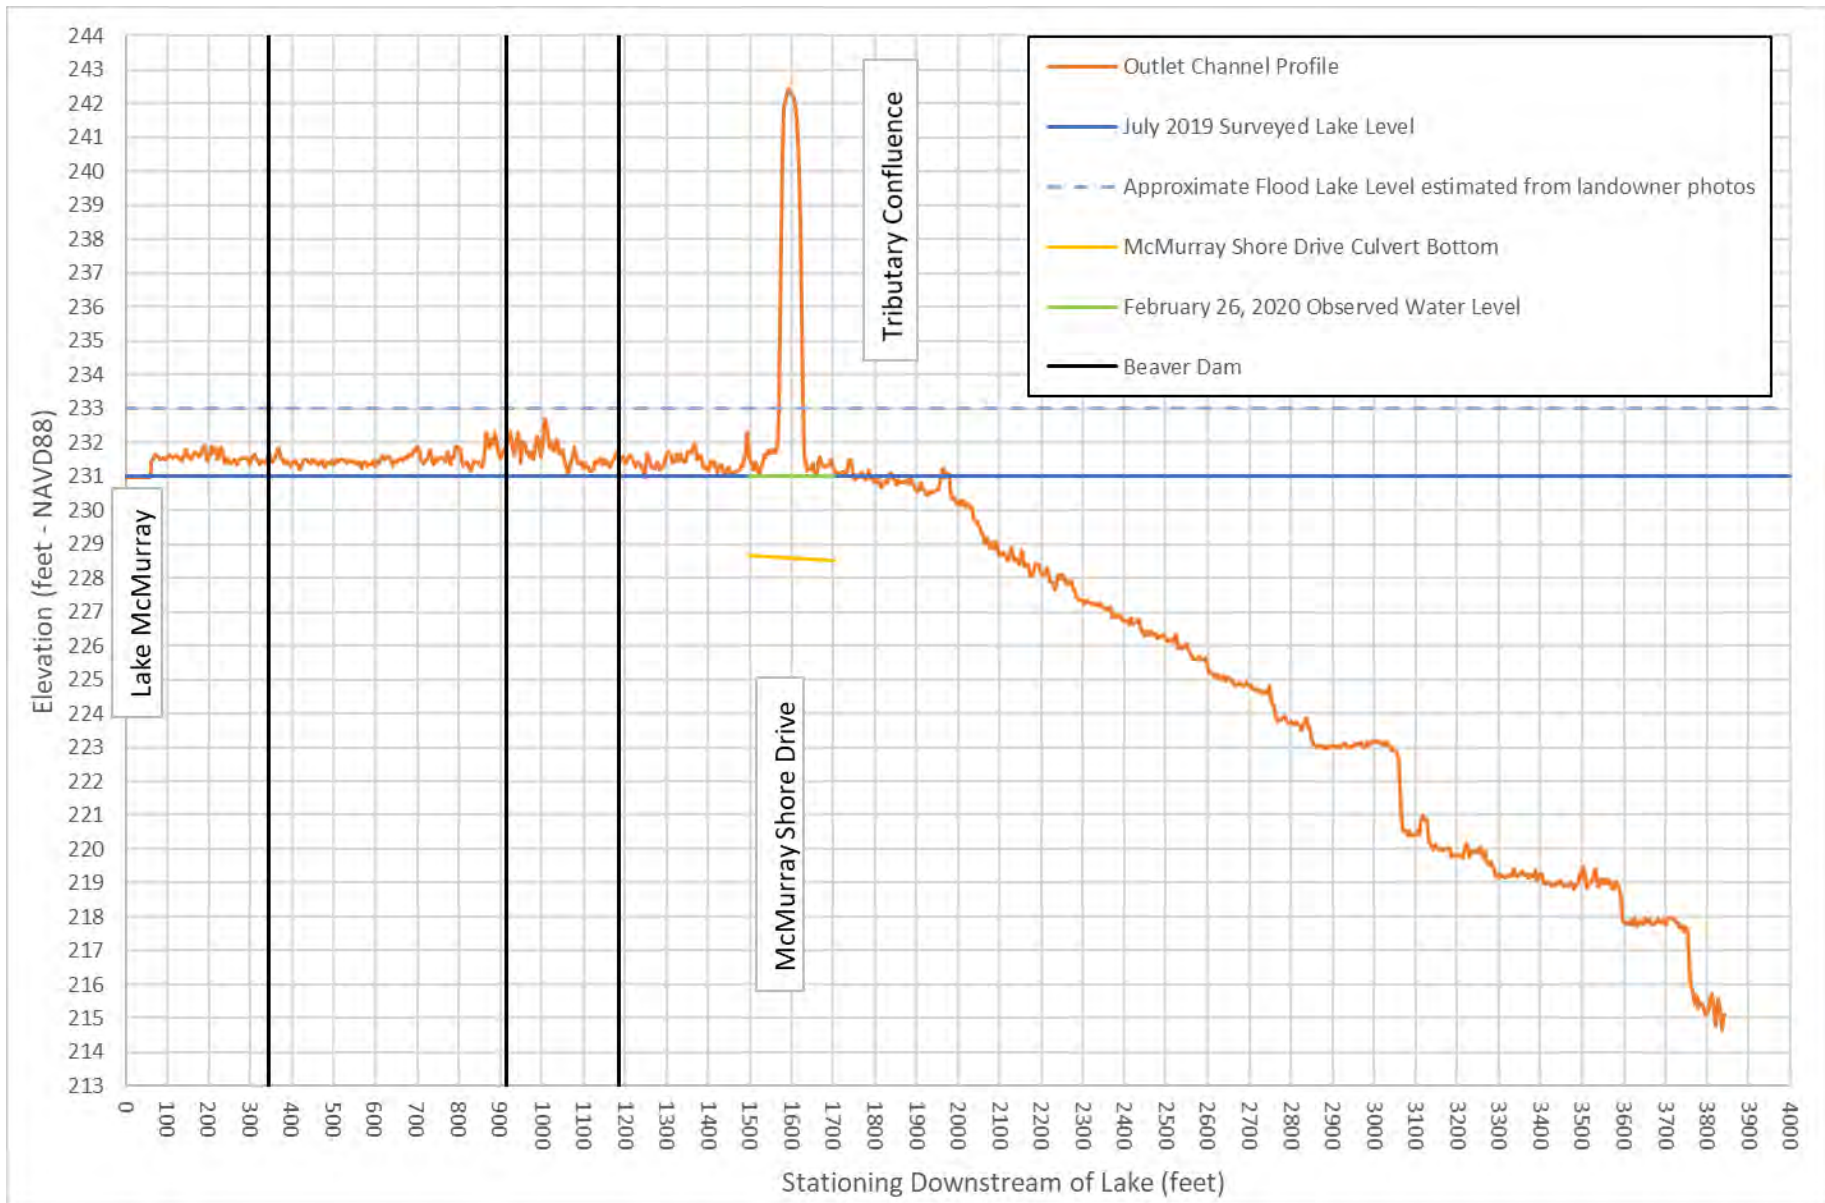
Figure 3. Lake Creek profile downstream of Lake McMurray outlet.

Figure 3 reveals that water levels remain nearly flat from the lake to McMurray Shore Drive. The slope then increases slightly (0.002 feet/feet) along the first 300 feet downstream of McMurray Shore Drive, then steepens significantly along the remainder of the profile (0.008 feet/feet). The solid horizontal blue line in Figure 3 represents the lake water surface elevation that was surveyed by the County in July 2019 for the Hull Drive/Hull Road flood investigation. It represents a typical non-flood lake level. The water surface elevation on February 26, 2020, the day WSE first examined the outlet channel, is shown by the light green horizontal line at McMurray Shore Drive. It was approximately the same as the July elevation. The dashed horizontal blue line is an estimate of the February 2018 lake flood level estimated from the flood photographs presented above. The lake was approximately two feet higher than normal during that flood event.

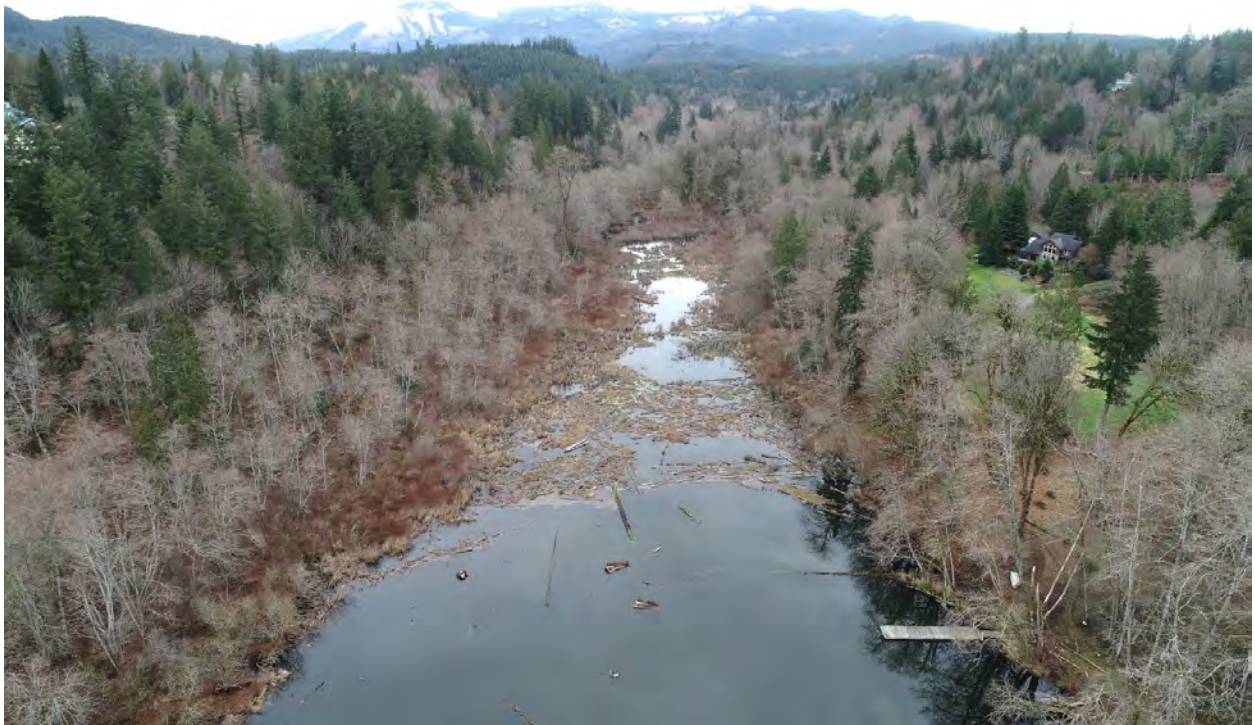
Photos 5 and 6 show that patches of vegetation and logs clog the outlet channel in many locations. One interesting obstruction feature is the wedge-shaped area of dense vegetation visible in Photo 7 adjacent to a beaver dam (vegetation is also shown in Photo 11). This is the site where we believe there once was a railroad trestle bridge. The vegetation wedge appears to follow roughly the alignment of the trestle, which may indicate that remnants from the bridge remain which have clogged with debris promoting the growth of vegetation. This, however, is purely speculation for we did not see remnant bridge features and it was not within our scope to conduct the detailed inspection that would be required to determine if remnants of the bridge remain.

Photo 5. Drone aerial looking downstream from Lake McMurray into the outlet channel (Photo taken March 10, 2020).

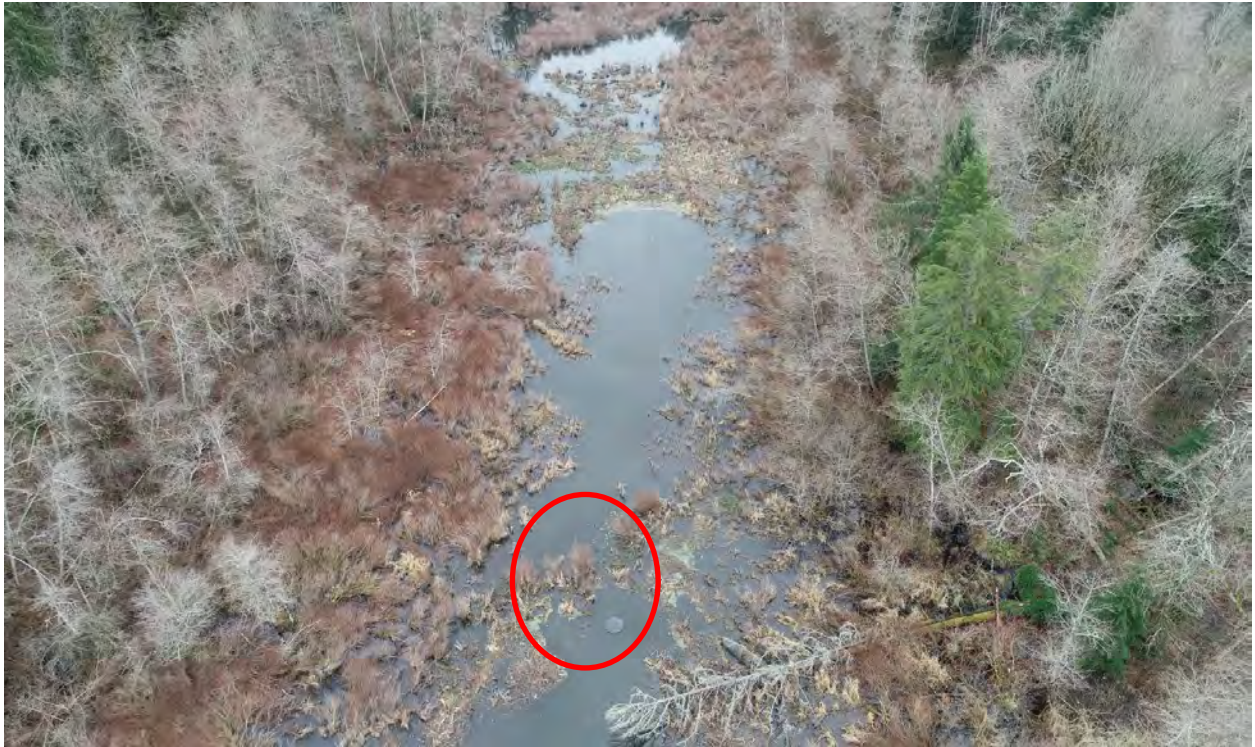
Dense vegetation, woody debris and at least three abandoned beaver dams are contributing to a “cheese cloth” effect which is impeding flow. Photos 5 through 8 show the congested character of the reach and the three abandoned beaver dams identified in Figure 4. Each beaver dam is outfitted with a beaver deceiver, each in some level of disrepair. Sections of the beaver deceiver pipes have become untethered from their tiedowns and are now floating. The dams appear old and have holes in them suggesting that the beavers are no longer maintaining them and are not active in this reach. WSE did not see any evidence of recent beaver activity; however, Photo 8 shows a pile of beaver sticks next to the beaver dam in Photo 7. These were removed by someone, likely in an attempt to help the lake drain. The community has told the County they were working with Washington Department of Fish and Wildlife (WDFW) to obtain a permit to remove constructed dams but the County is not actively involved in that effort.

Photo 6. Beaver dam and Beaver Deceiver (circled in red) located near Station 300 in Figure 2 (March 10, 2020).

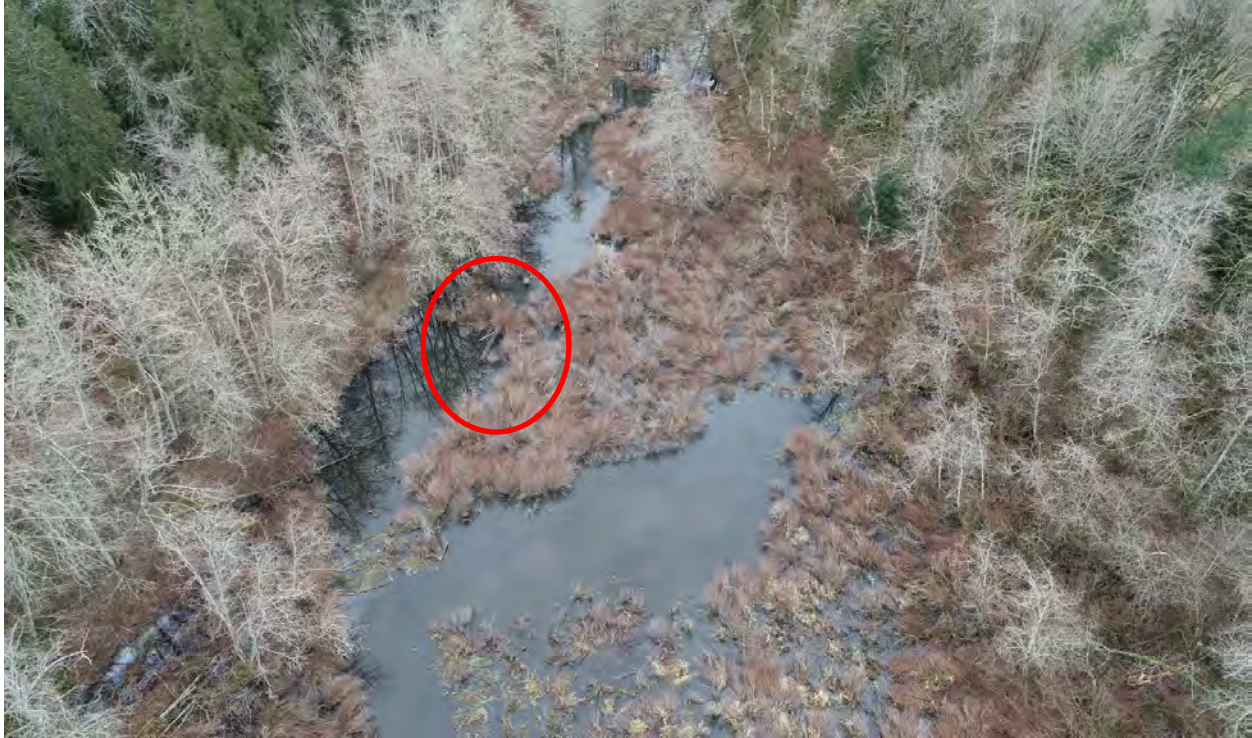
Photo 7. Beaver dam and beaver deceiver (circled in red) located near Station 900 in Figure 2. Note the thick stand of vegetation to the right of the beaver deceiver. We believe this was the site of an old railroad trestle, which may have something to do with why the vegetation has formed (March 10, 2020).

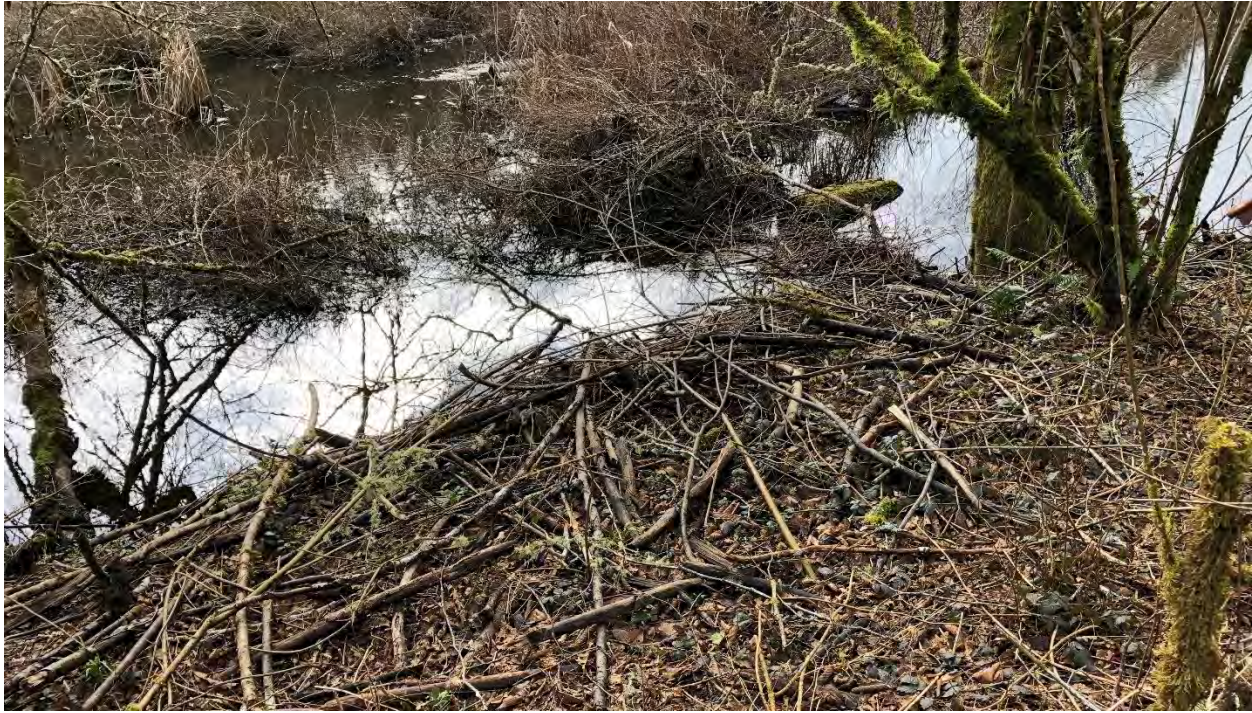
Photo 8. Viewing east to beaver dam in Photo 7 (Feb. 26, 2020). Sticks on the bank were removed by someone to open a hole in the dam.

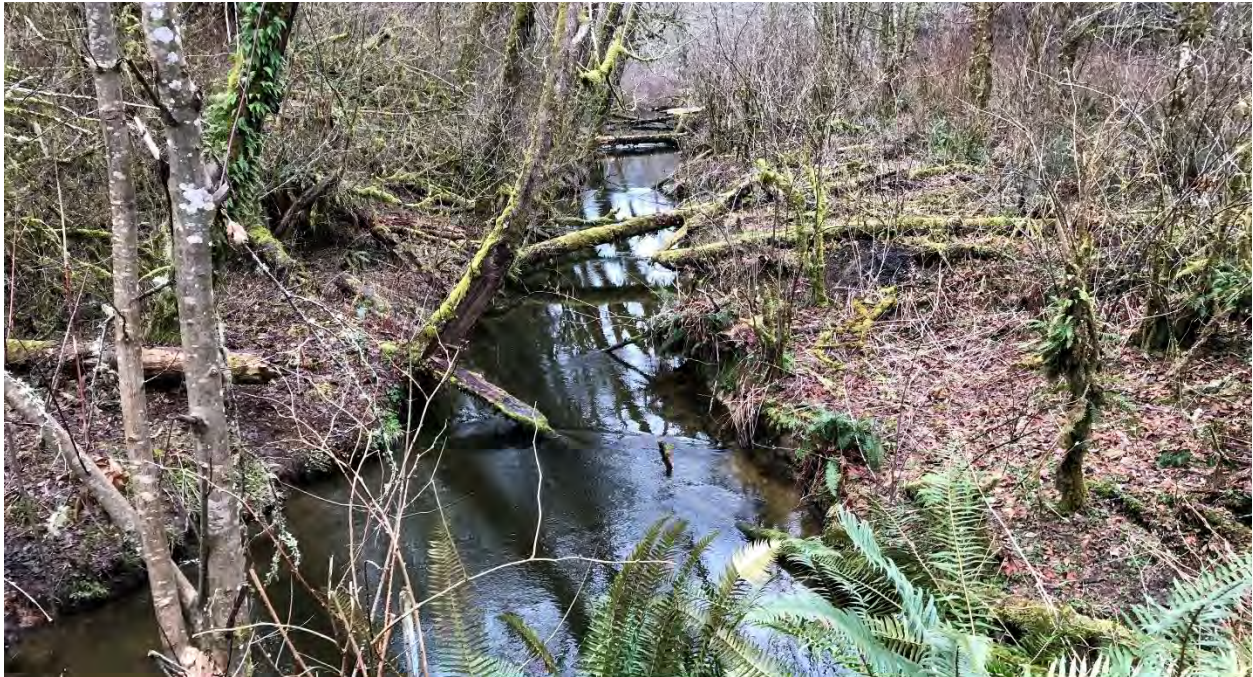
Downstream from the northern most beaver dam (Photo 9) the channel is open and generally free from obstructions except for a few fallen trees (Photo 10). It is possible beaver dams may have existed in the reach in the past, but we did not see current evidence of any.

Photo 10. Viewing upstream (south) from McMurray Shores Drive (March 10, 2020). The channel is free of vegetation and other than a few logs, there are no significant features obstructing flow.

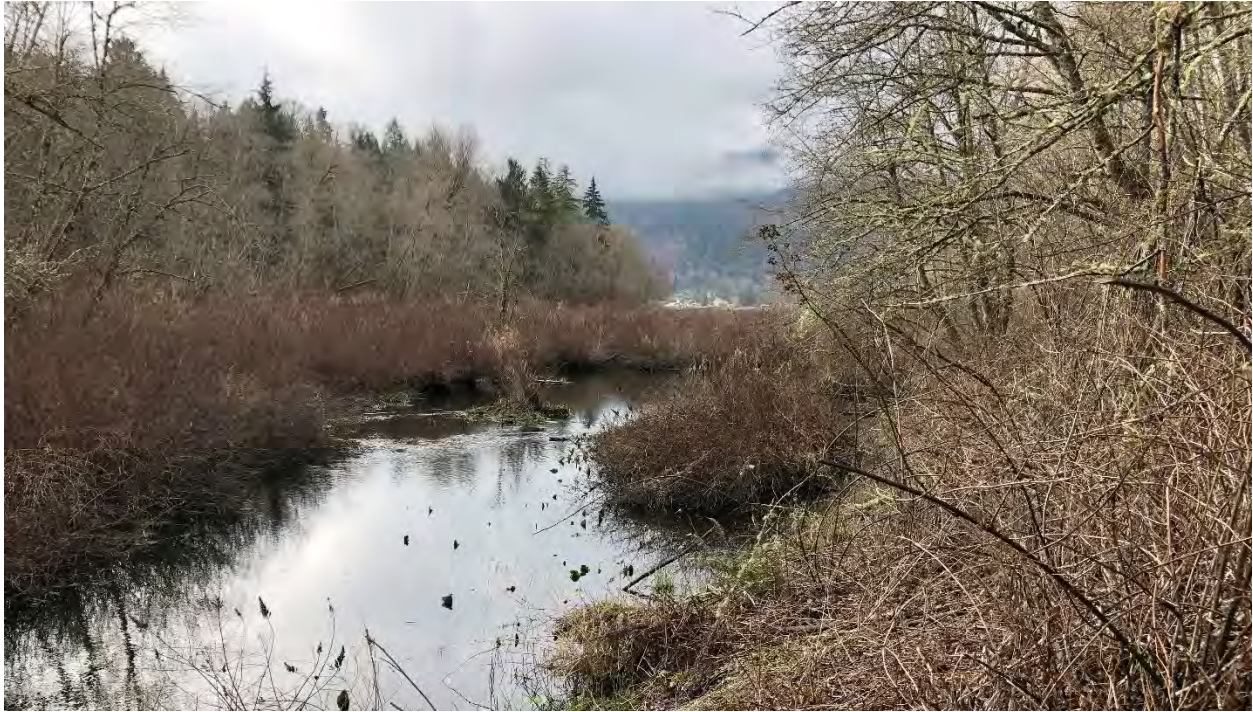
Photo 11. Viewing upstream (south) to the vegetation within the channel at the site of the old railroad trestle bridge (see Photo 7) (February 26, 2020).
